# NATIONAL TRANSPORTATION SAFETY BOARD

## Electronic Devices

Specialist's Factual Report  
by Bill Tuccio, Ph.D.

Location: Lebec, California  
Date: April 14, 2015  
Aircraft: Pitts S2E  
Registration: N75BH  
Operator: Private  
NTSB Number: WPR15FA147

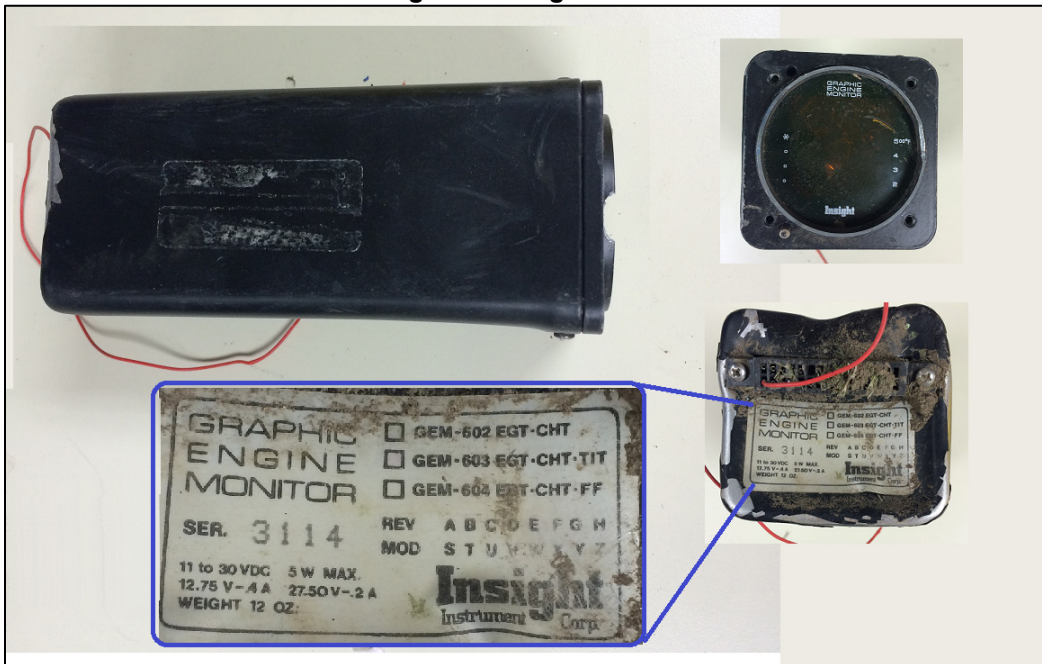
Figure 1. Insight GEM-603.

Figures 1 through 4 show the Insight GEM-603, Appareo Stratus (1st Generation), Apple iPad, and Apple iPad Mini, respectively. The Insight GEM-603 and 1st generation Appareo Stratus did not have the capability to record information internally. The Apple iPad and iPad Mini were capable of recording information; however, both units were damaged. The Apple iPad was repaired; however, it would not start. The Apple iPad Mini suffered a dislodged chip, as shown in figure 5. In agreement with the Investigator-in-Charge, no further recovery attempts were made on the Apple iPad or Apple iPad Mini.

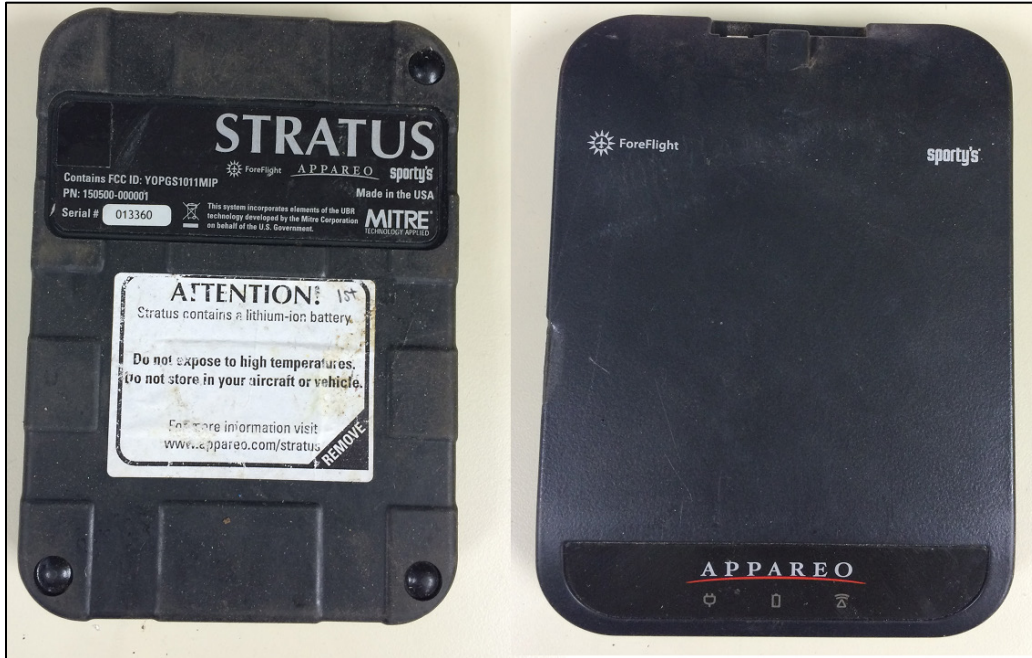
Figure 2. Appareo Stratus (1<sup>st</sup> Generation).

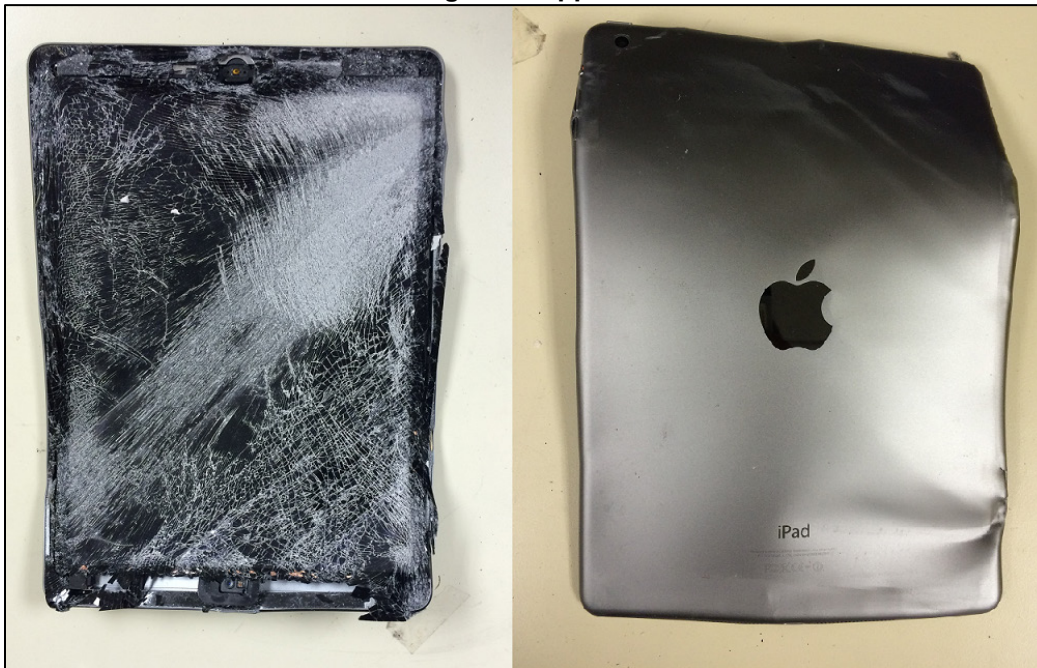
Figure 3. Apple iPad.

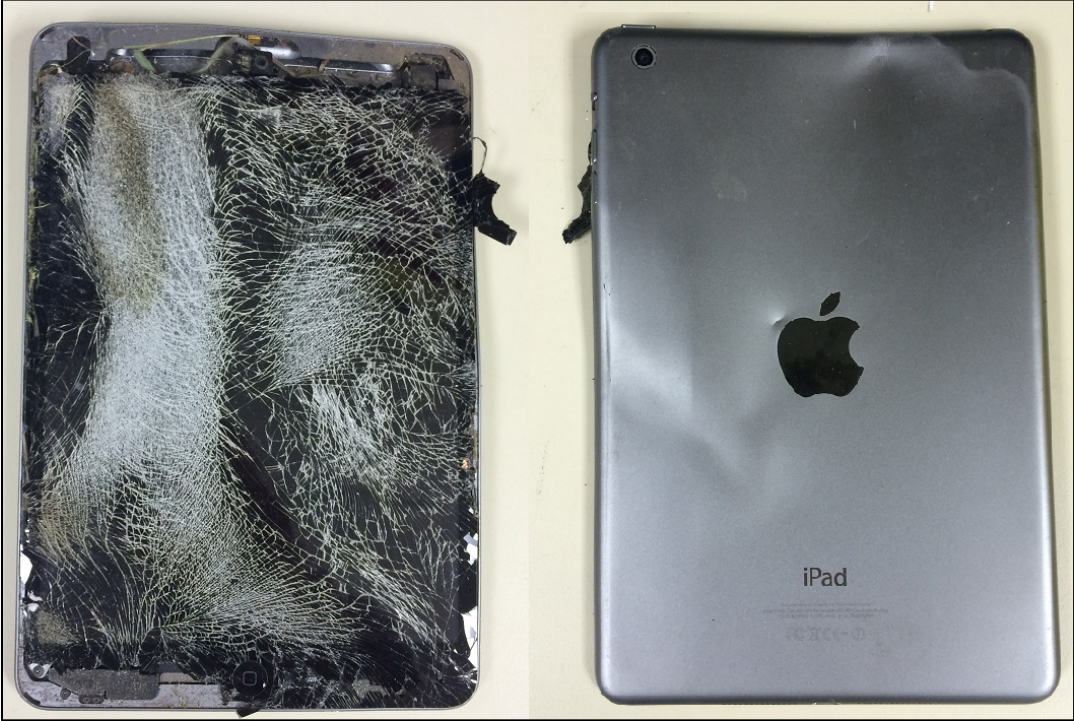
Figure 4. Apple iPad Mini.

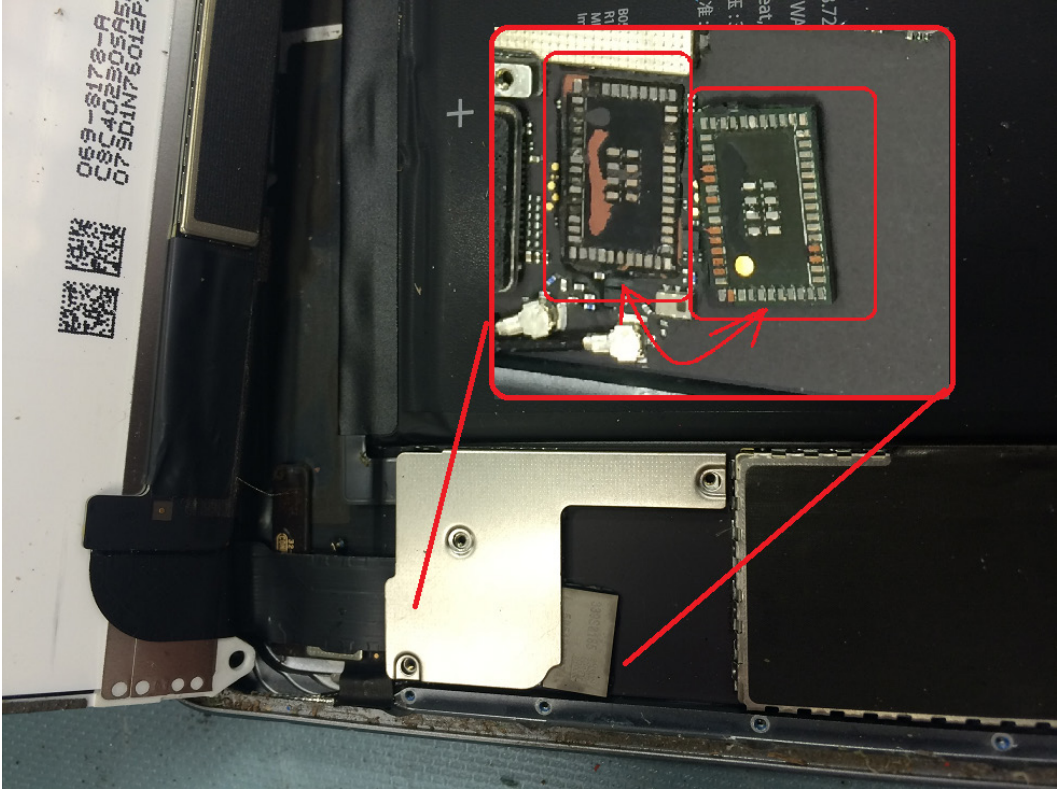
Figure 5. Apple iPad Mini – dislodged chip.

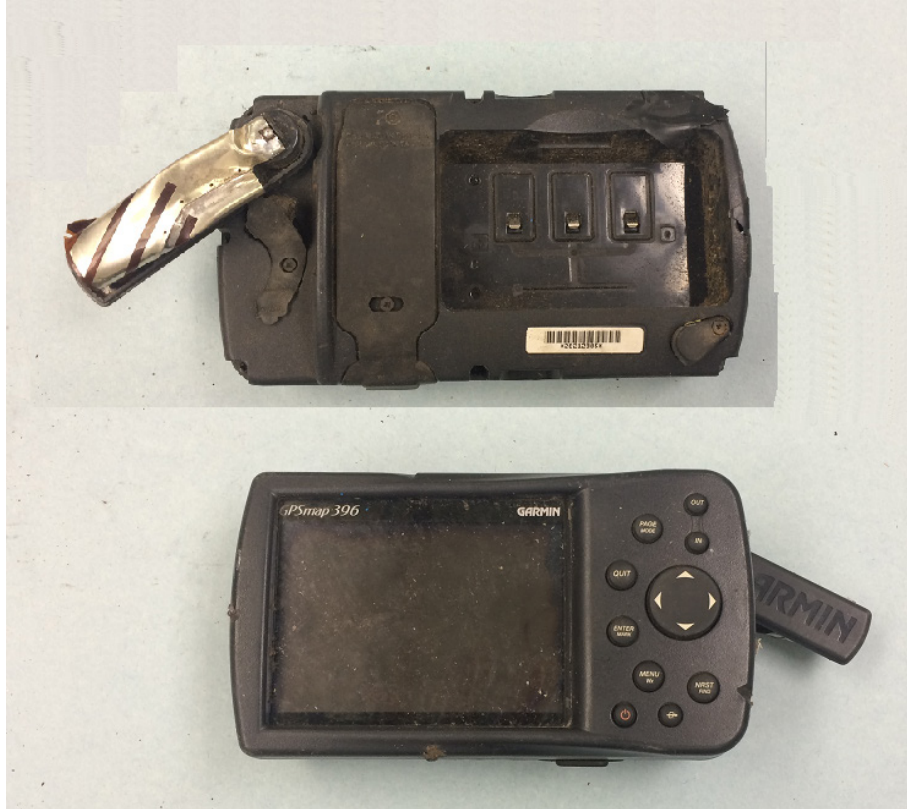
Upon arrival at the Vehicle Recorder Division, an exterior examination revealed the unit had sustained minor damage, as shown in figure 6 (back and front views). The unit was powered on and, although the screen did not work properly, information was extracted using the manufacturer's software normally, without difficulty.

Figure 6. Garmin GPSMAP 396.

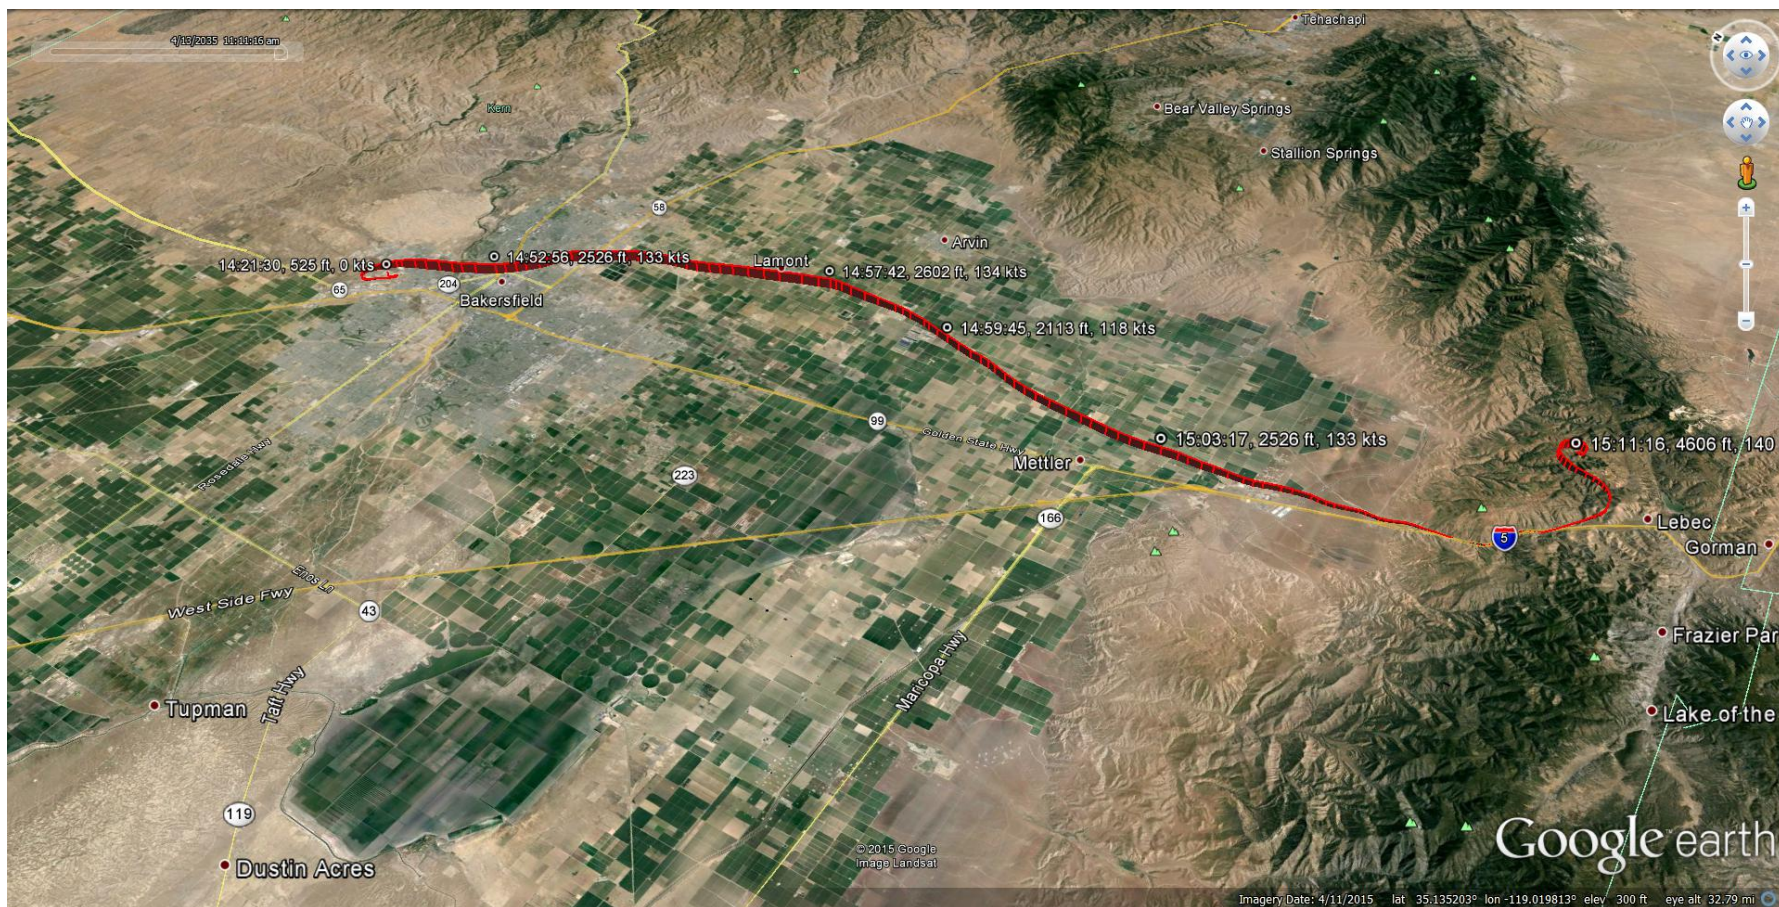
Figure 7 shows the accident flight overlaid on terrain imagery and figure 8 shows the accident flight overlaid on a Federal Aviation Administration Los Angeles Sectional Chart. The flight departed BFL and proceeded south towards the Tehachapi Mountains and Tejon Pass. From BFL to north of the Tehachapi Mountains, the aircraft reached a maximum recorded GPS altitude of 2,703 feet (about 2,300 feet above ground level (AGL)) at 1452:09 UTC, shortly after takeoff. The aircraft then flew at about 2,500 feet GPS altitude until about 15 nautical miles south of BFL, after which the aircraft descended. At about 1505:54 UTC, the aircraft was over Interstate 5 at a GPS altitude of 2,238 feet.

Figure 7. Overview of accident flight (terrain overlay).

Figures 7 through 11 were generated using data extracted from the Garmin GPSMAP 396 and overlaid using Google Earth. The weather and lighting depicted in Google Earth are not necessarily representative of the weather and lighting conditions experienced during the accident flight.

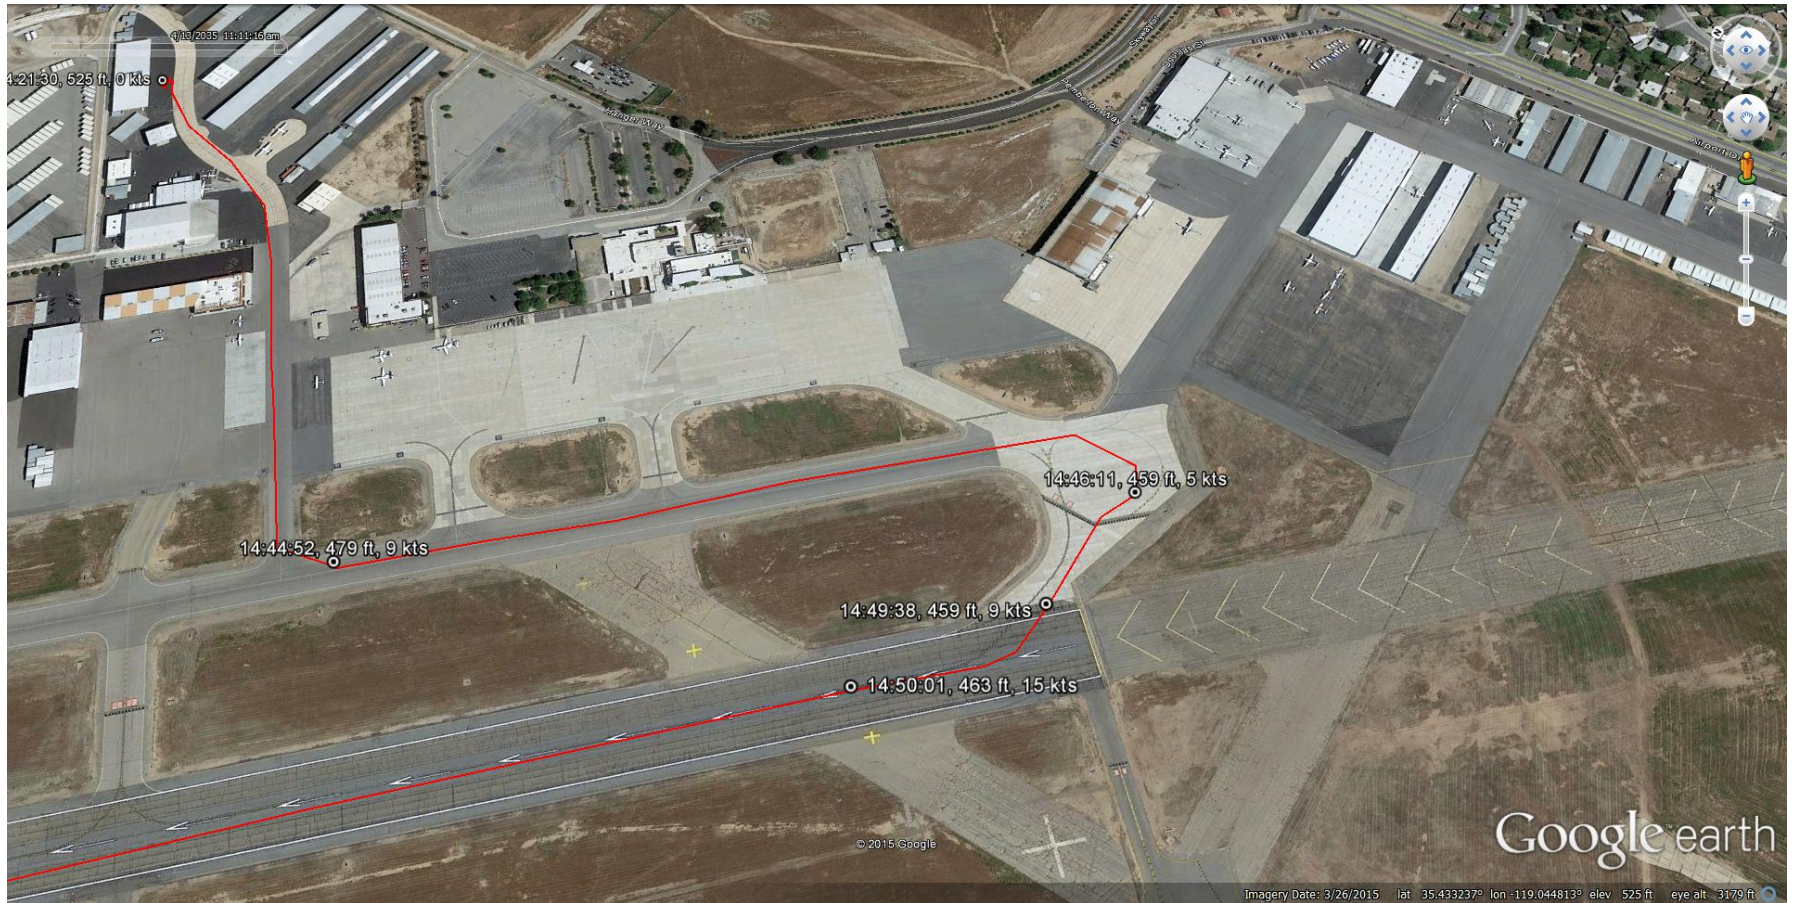
Figure 9 shows ground operations at BFL. The recording began at 1421:30 UTC. By 1444:52 UTC, the aircraft was taxiing for takeoff. By 1446:11 UTC, the aircraft was in the runup area for runway 30R. By 1450:01 UTC, the aircraft began its takeoff roll.

Figure 9. Ground operations at BFL.

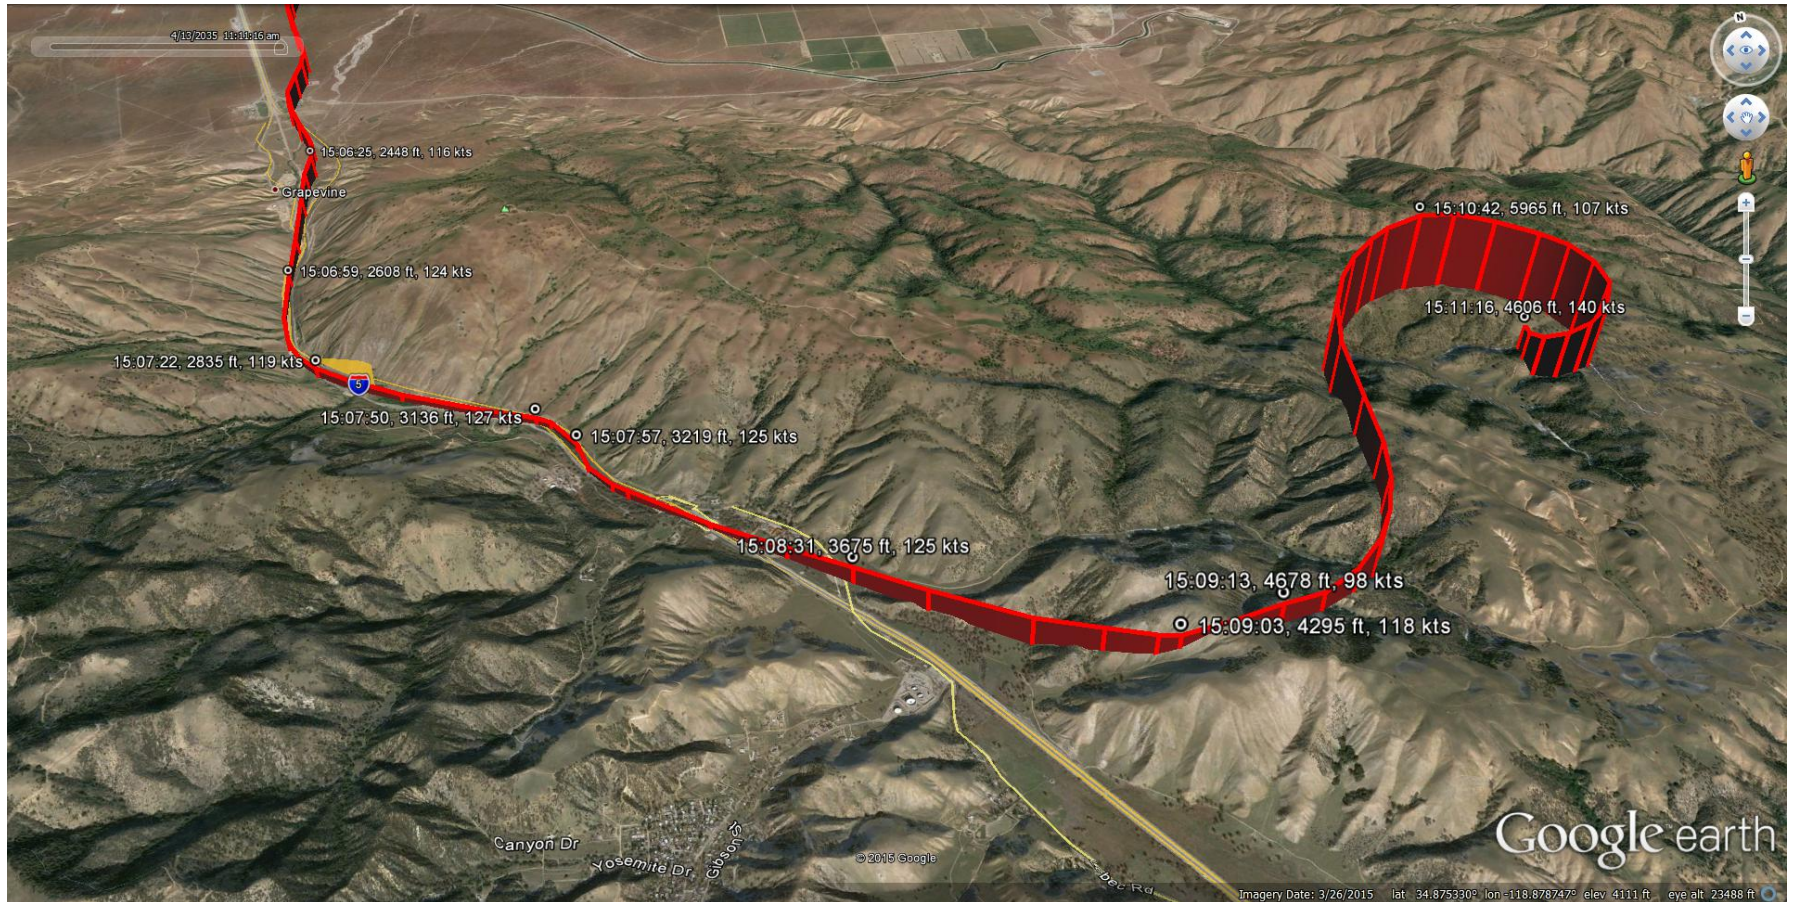
Figure 10 shows the aircraft path through the Tehachapi Mountains. At 1506:59 UTC, the aircraft was over Interstate 5 at a GPS altitude of 2,608 feet (about 340 feet AGL). At 1507:50 UTC, the aircraft was over Interstate 5 at a GPS altitude of 3,136 feet (about 210 feet AGL). At 1507:57 UTC, the aircraft was over Interstate 5 at a GPS altitude of 3,219 feet (about 200 feet AGL). By 1508:31 UTC, the aircraft began to track east of Interstate 5 at a GPS altitude of 3,675 feet (about 330 feet AGL). The aircraft continued to climb towards the northeast, away from Interstate 5 and towards higher terrain.

Between 1509:03 UTC and 1509:13 UTC, the aircraft climbed from 4,295 feet GPS altitude to 4,678 feet GPS altitude, with a computed AGL altitude below 100 feet AGL.

Figure 10. Flight over Interstate 5 until end of recording.

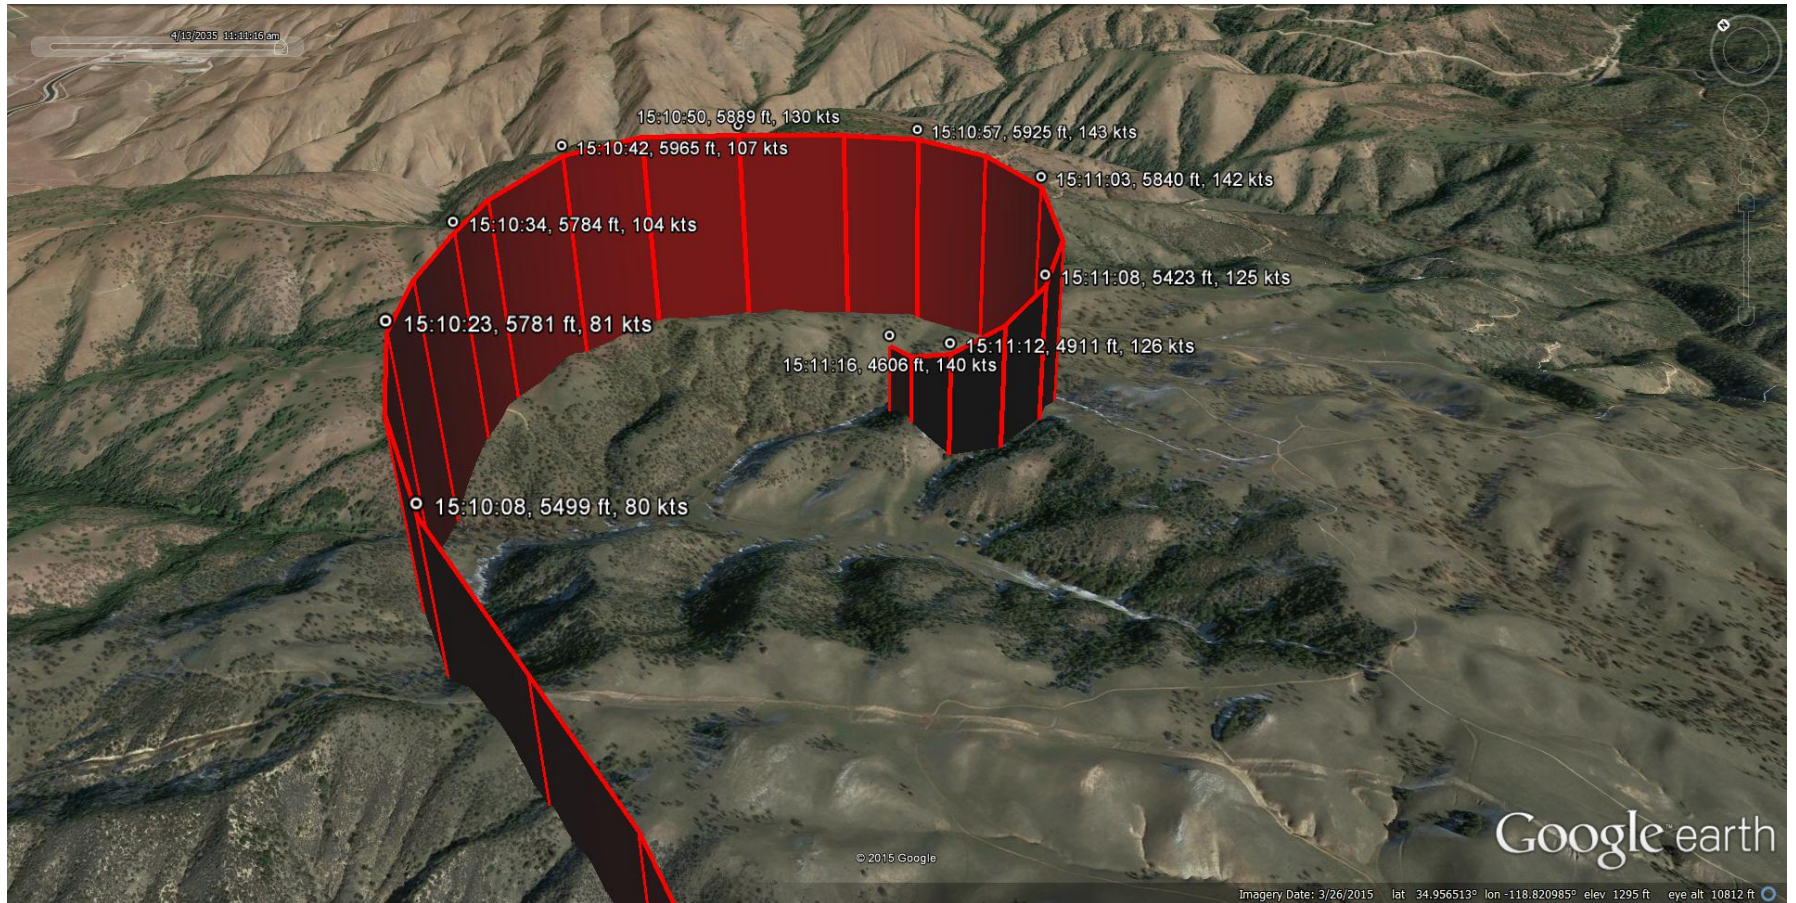
Figure 11 shows the end of the recording. Between 1509:03 UTC and 1510:23 UTC, the aircraft continued to climb and turn left towards the north; thereafter, the aircraft began a right turn, reaching a maximum GPS recorded altitude of 5,971 feet (about 900 feet AGL) at 1510:46 UTC. Thereafter, the aircraft began a descending right turn. The last recorded point was at 1511:16 UTC at a recorded GPS altitude of 4,606 feet (about 650 feet AGL).

Figure 11. End of recording.
