NATIONAL TRANSPORTATION SAFETY BOARD

Specialist's Factual Report
by Bill Tuccio, Ph.D.

Location: Chicago, Illinois
Date: November 18, 2014
Aircraft: Aero Commander 500B
Registration: N30MB
Operator: Central Air Southwest
NTSB Number: CEN15FA048

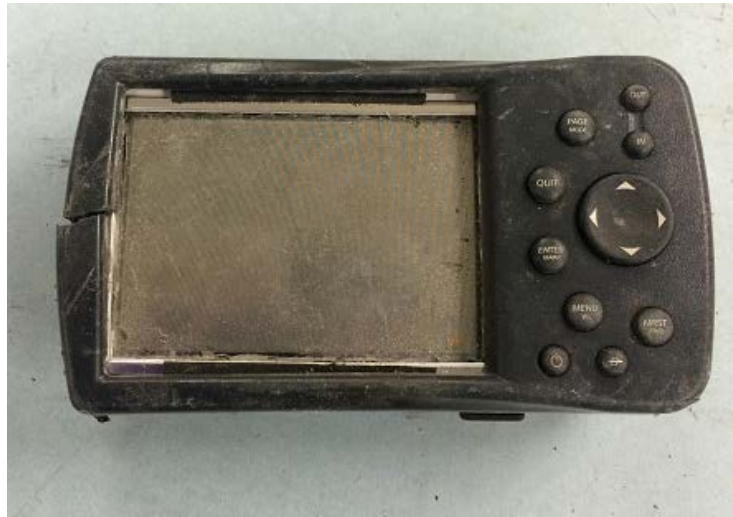
Figure 1. Garmin GPSMAP 396 as received.

Upon arrival at the Vehicle Recorder Laboratory, an exterior examination revealed the device had sustained impact damage, as shown in figure 1. An internal inspection revealed damage to electronic components; however, the non-volatile memory chip was undamaged, as shown in figure 2. The chip was removed, downloaded, and decoded.

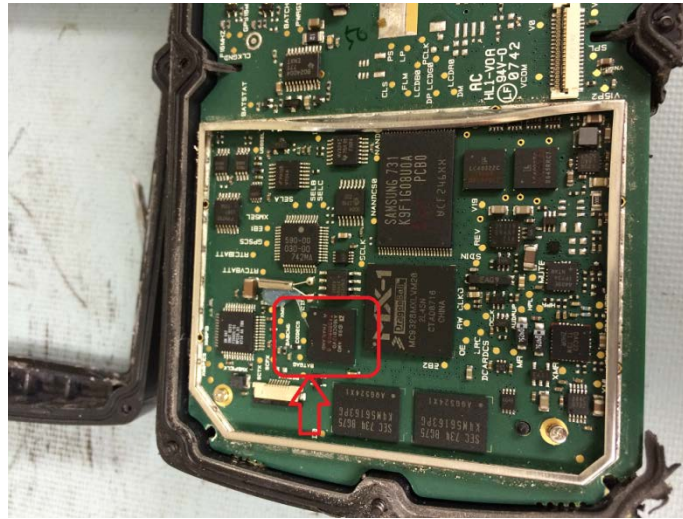
Figure 2. Garmin GPSMAP 396 internal, with non-volatile memory annotated.

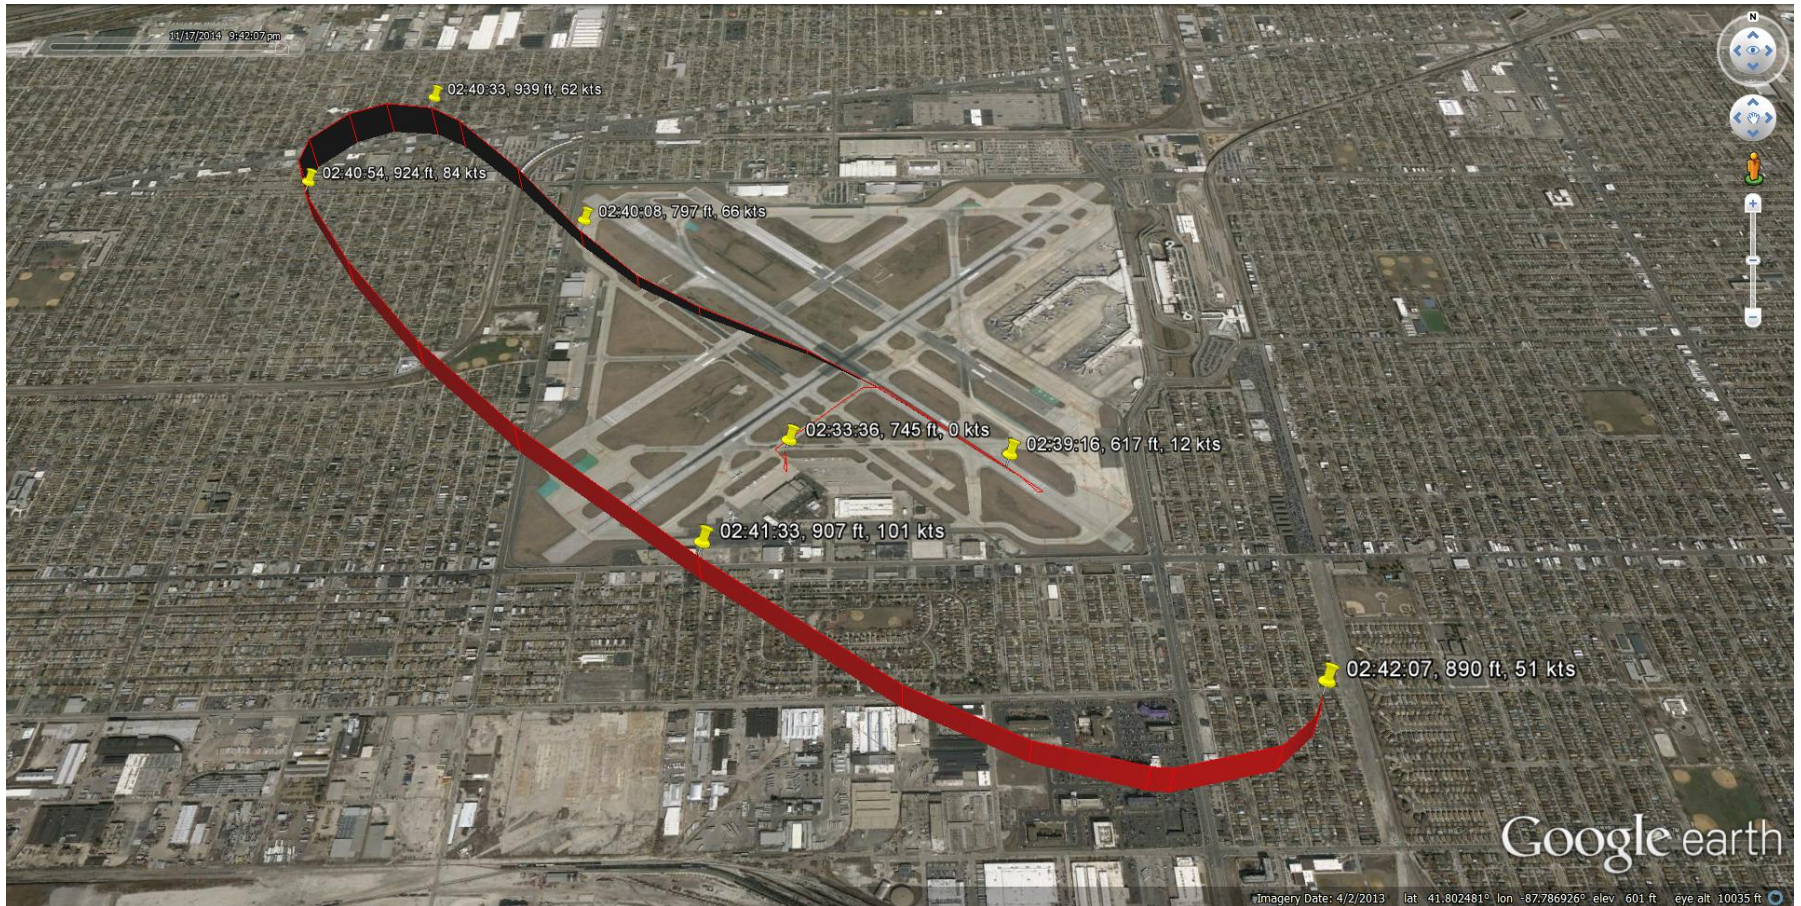
Figure 3. Accident flight, as recorded by Garmin 396.

Figure 3 shows an overview of the accident flight. The recording began at 2:33:36 CDT on a ramp area at MDW. By 02:39:16 CDT, the aircraft began the takeoff roll. By the time the aircraft had crossed the intersection of runway 4R, the track had turned to the left. By 2:40:33 CDT, the aircraft track turned left and then followed a path similar to a left downwind for a northwest runway at an altitude of about 950 feet. The recording ended at 2:42:07 CDT, as the aircraft track was in a descending left turn.

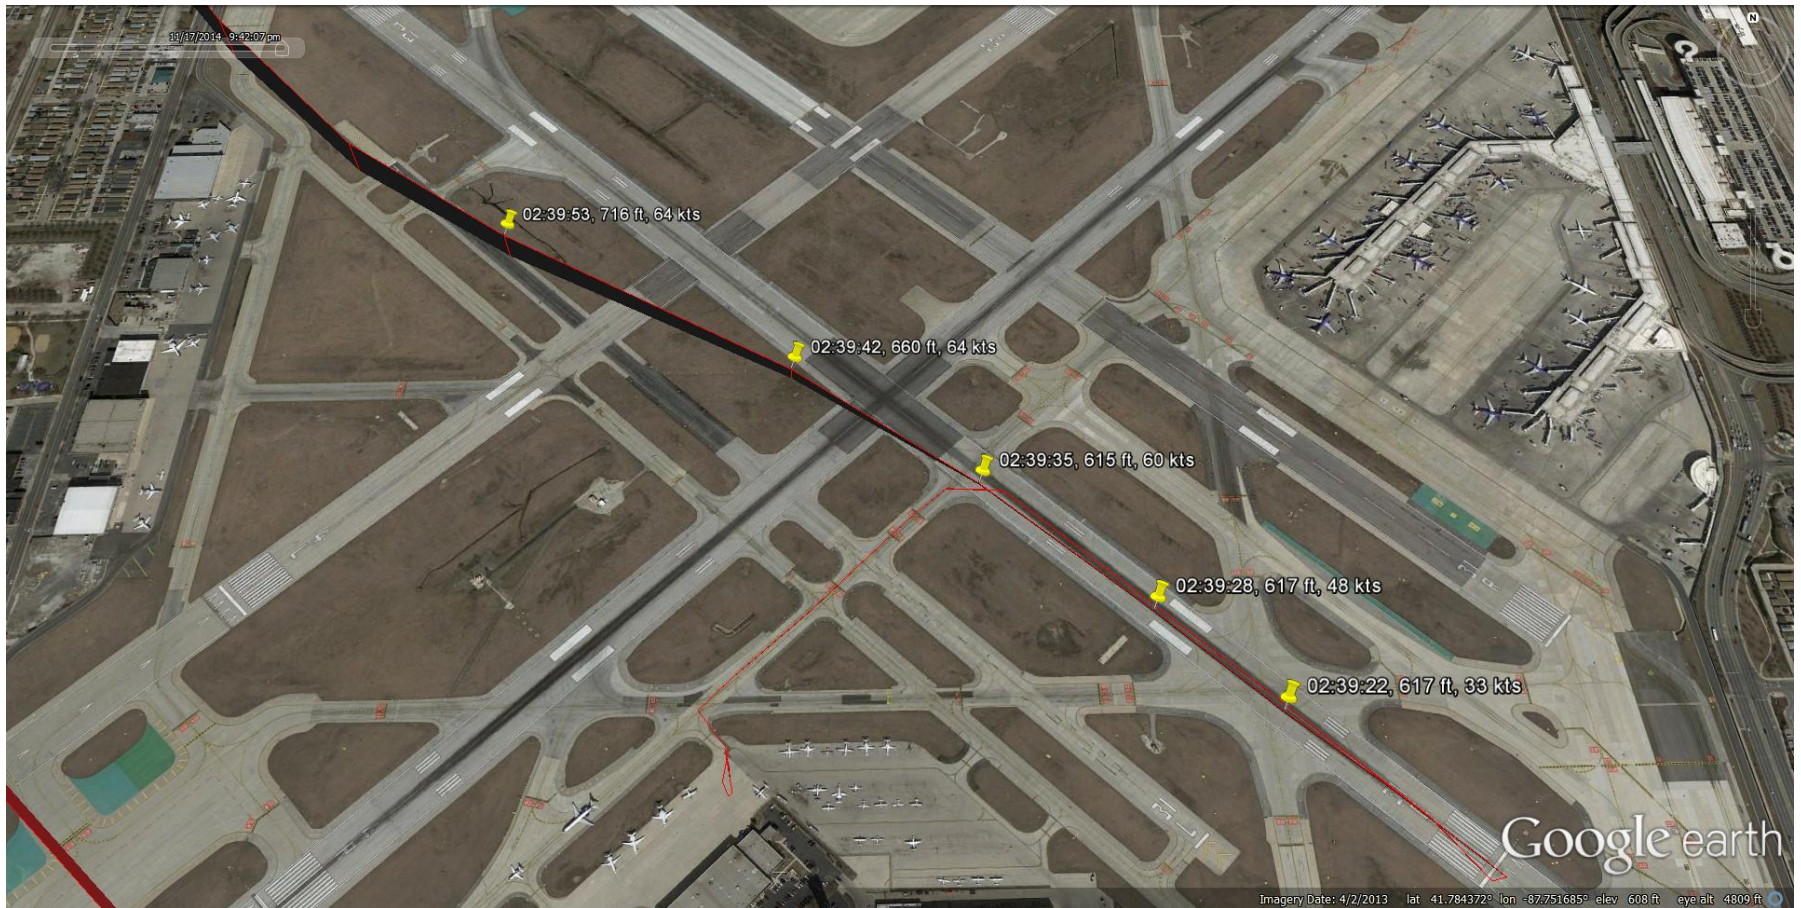
Figure 6. Takeoff roll and initial climb, as recorded by Garmin 396.

Figure 6 shows the later part of the takeoff roll and initial climb. By 2:39:35 CST, the ground track started to deviate to the left. By 2:39:53 CDT, when the aircraft was at a recorded altitude of 716 feet (about 100 feet above ground level), the ground track had deviated to the left, nearly aligned with runway 31L.

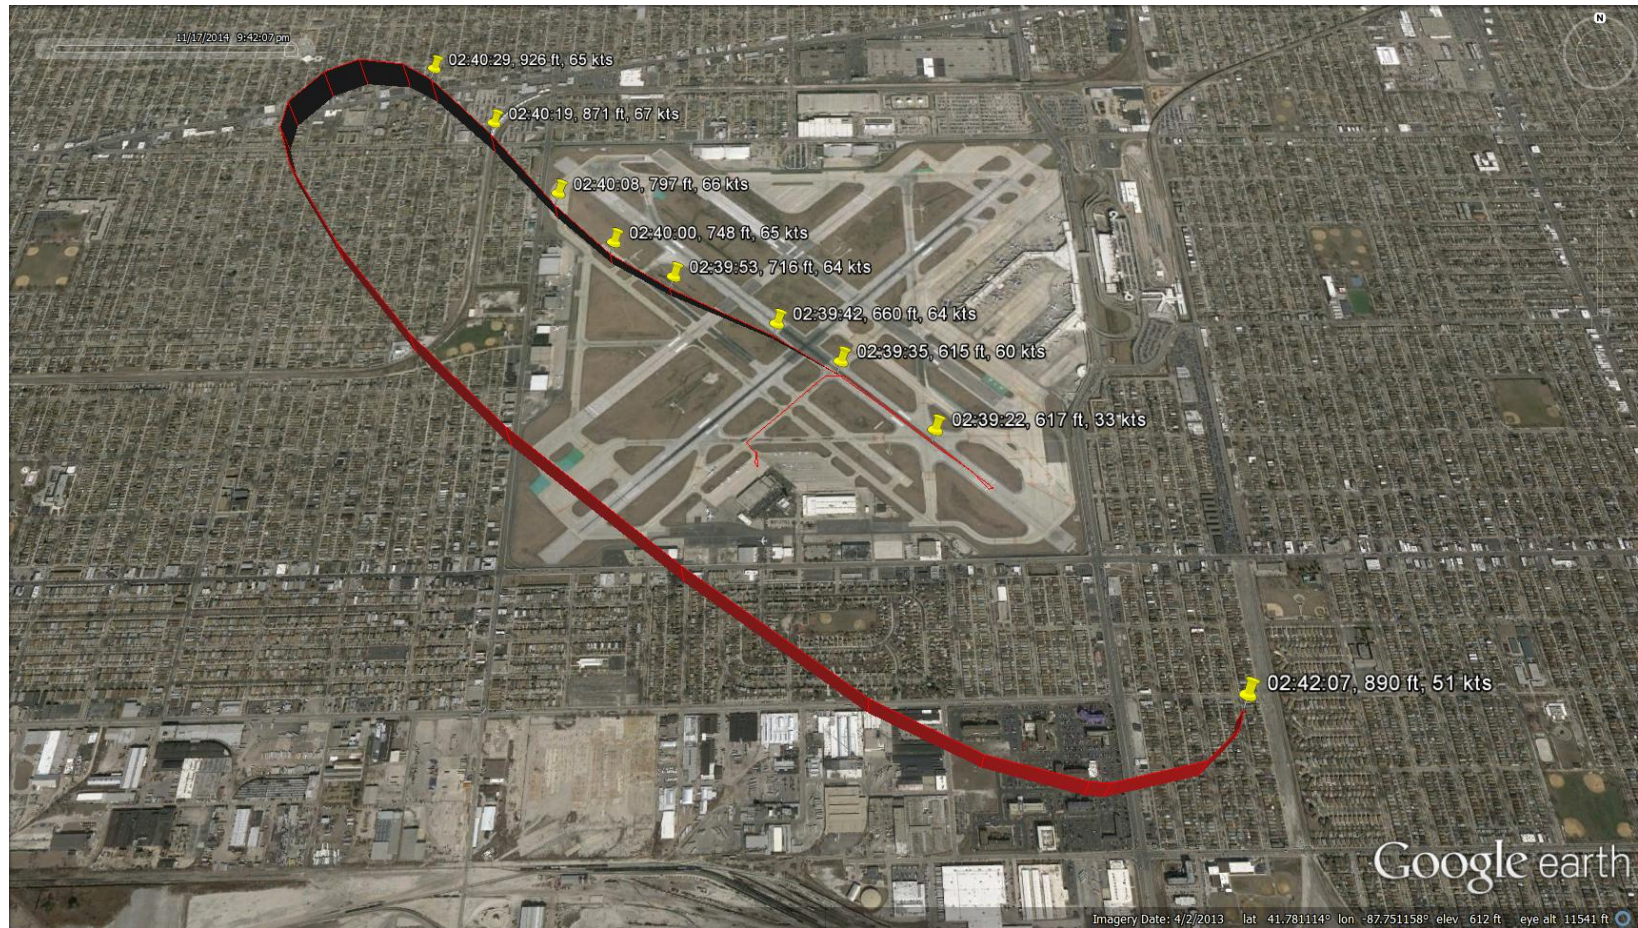
Figure 7. Initial climb, as recorded by Garmin 396.

Figure 7 shows detailed track points for the initial climb. Figure 8 shows all track points for the end of the recording.
