# NATIONAL TRANSPORTATION SAFETY BOARD

## Electronic Devices

Specialist's Factual Report  
By Bill Tuccio, Ph.D.

Location: Farmington, Pennsylvania  
Date: December 11, 2015  
Aircraft: Beech A36  
Registration: N72054  
Operator: Private  
NTSB Number: ERA16FA064

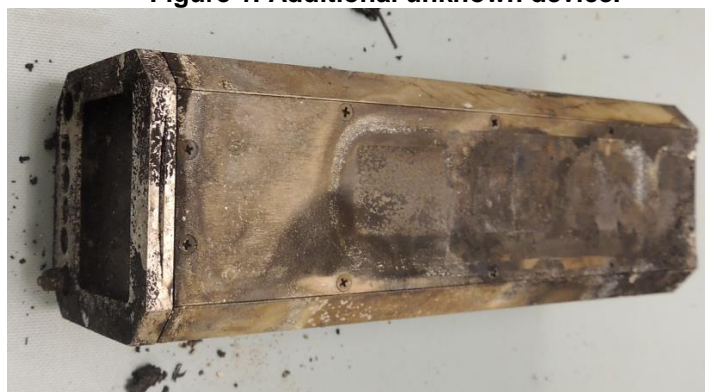
**Figure 1. Additional unknown device.**

Figure 1 shows a photo of the unknown item. Due to the damage, no identification or recovery was attempted.

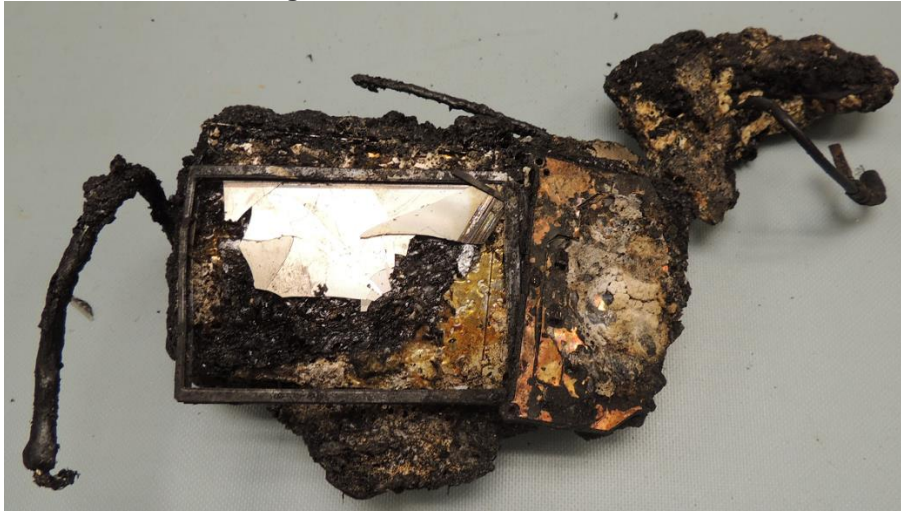
Figure 2. Unit as received at NTSB.

The unit suffered extreme thermal damage, as shown in figure 2. An internal inspection revealed the non-volatile memory chip was intact, as shown in figure 3. The non-volatile memory chip was removed from the printed circuit board using a hot air re-work station. The 6x8 ball grid array on the back of the chip was reworked and a raw-data binary readout of the chip was obtained using a Xeltek SP-3000u EEPROM programmer. Recorded tracklog data was identified and converted to engineering units using an in-house software program.

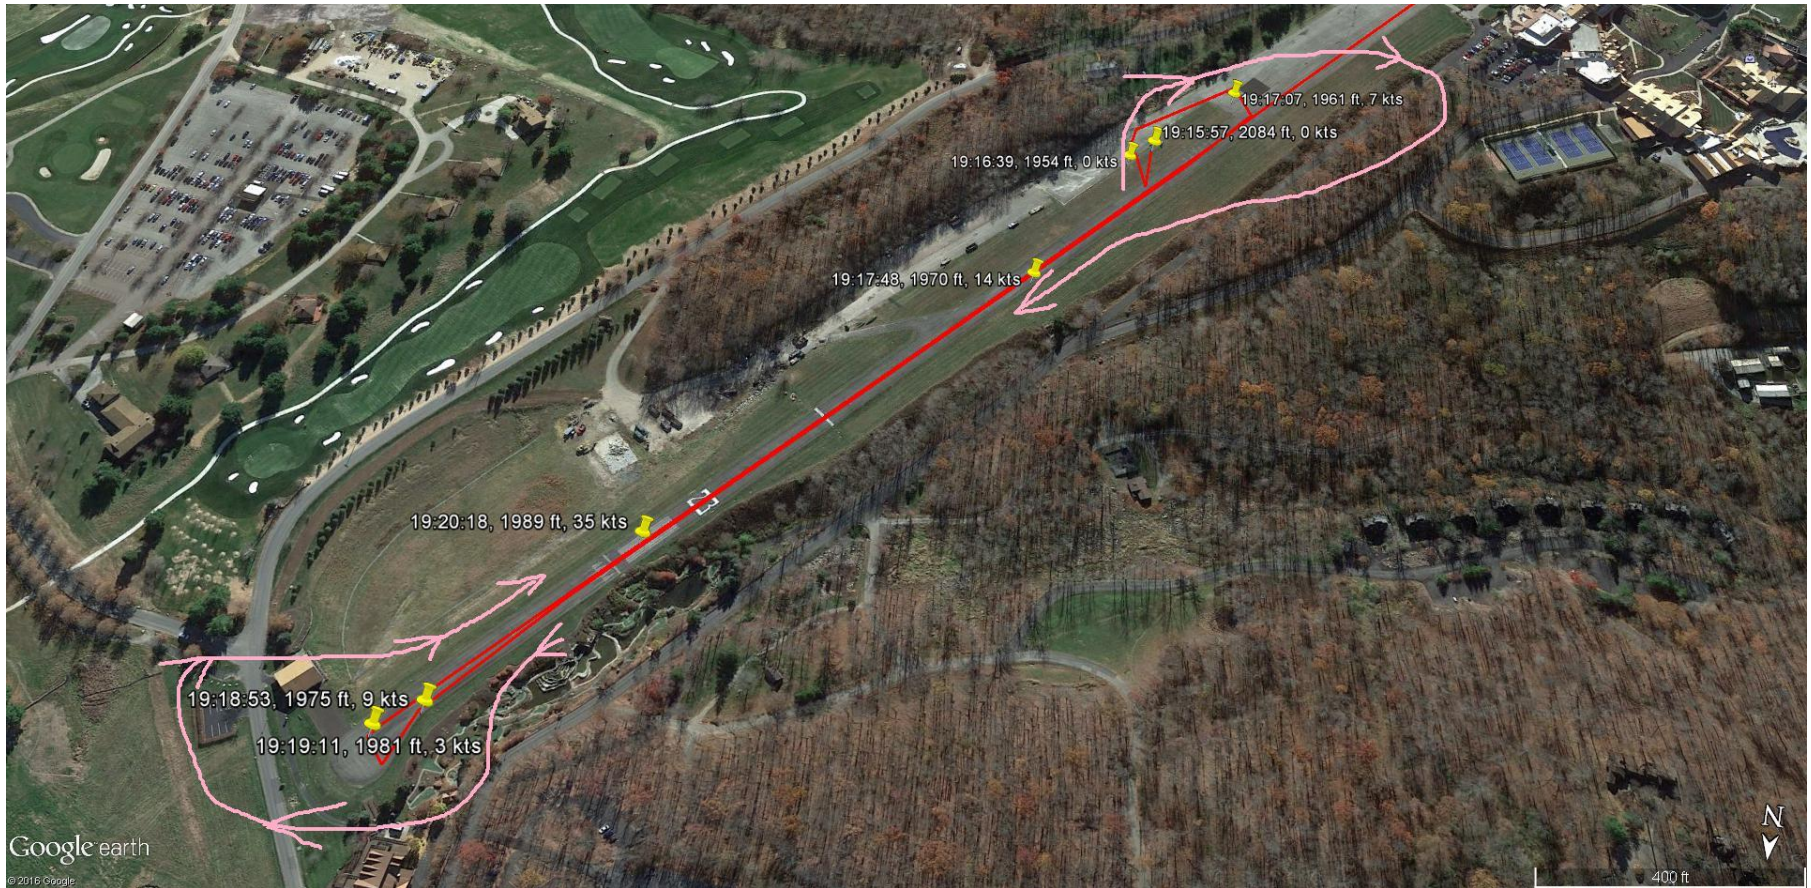
Figure 4. Start of accident flight recording.

- The recording began at 1915:57 UTC near the parking area. By 1917:07 UTC the aircraft had taxied southwest out of the parking area, then turned northeast and back-taxed down the runway. By 1919:11 UTC, the aircraft was at the northeast end of runway 23. By 1920:18 UTC, the aircraft had started its takeoff roll. Recorded GPS altitudes during the taxi were about 1,975 feet MSL.
- At about 1921:00 UTC, at an altitude of 2,184 feet MSL, the aircraft began a left, climbing turn. At this time the aircraft was about 2,500 feet from the departure end (southwest end) of runway 23.
- The aircraft continued the climbing left turn, reaching a maximum recorded altitude of 2,457 feet MSL at 1921:36 UTC when it was flying northeast-bound, parallel to runway 23.

Figures 2 through 4 collectively show:

Tabular data used to generate these figures are included as attachment 1. This attachment is provided in electronic comma-delimited (.CSV) format.

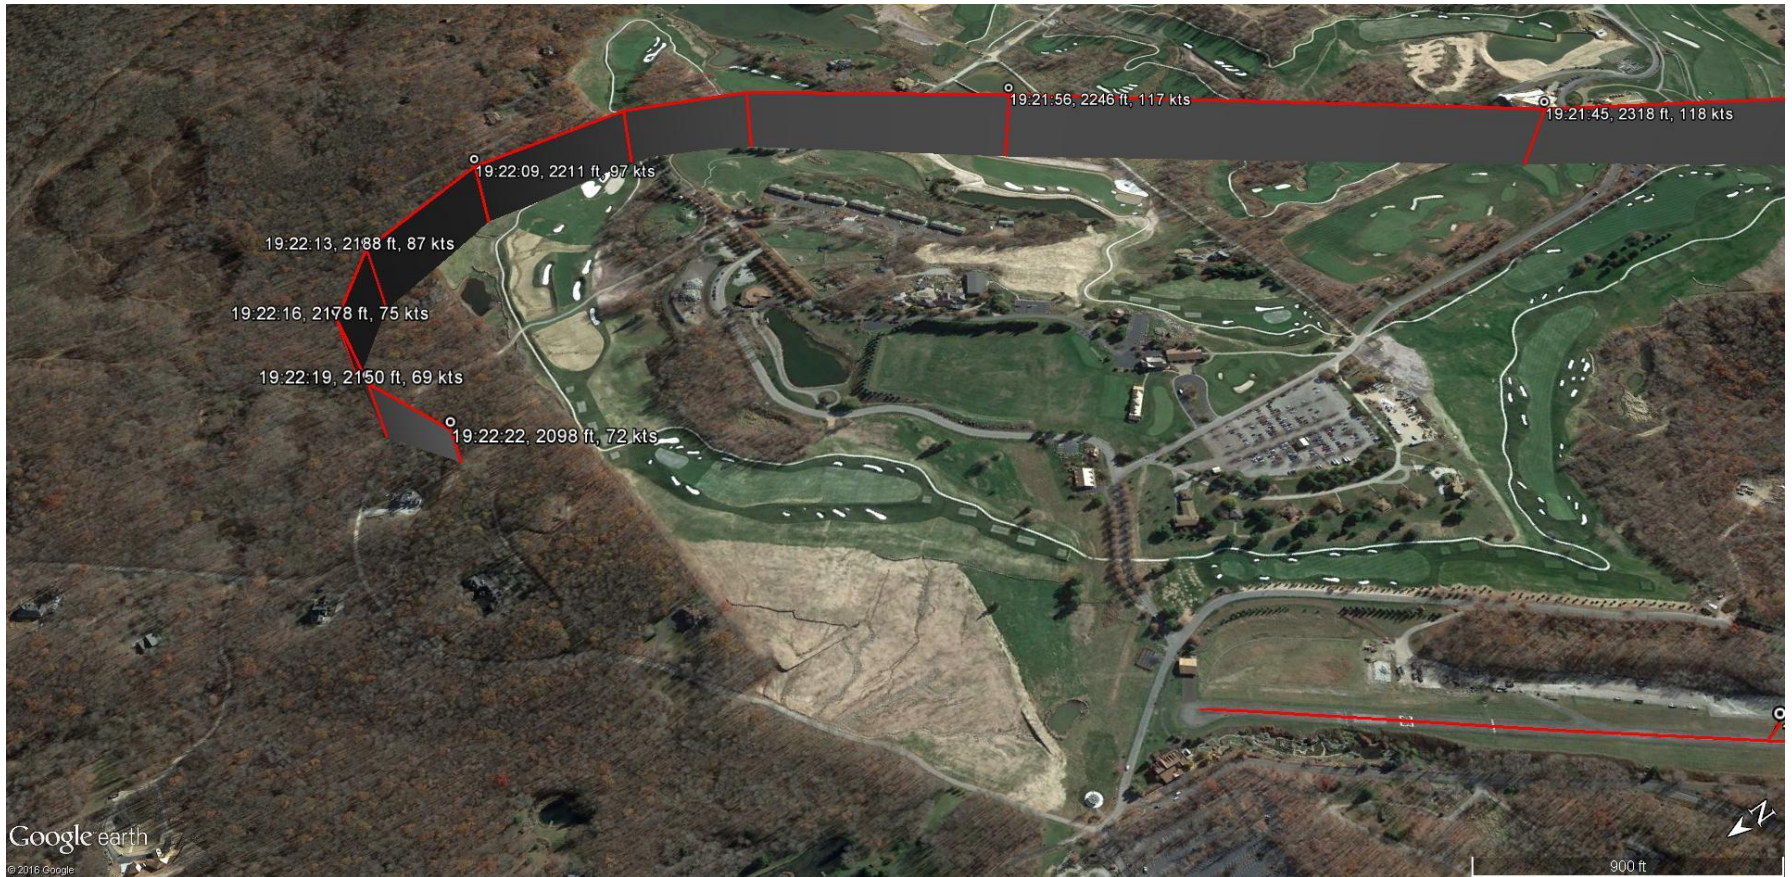
Figure 6. End of accident flight recording.

- By 1922:09 UTC, the aircraft had begun turning left again and was descending through 2,211 feet at 97 knots groundspeed.
- The last recorded point was at 1922:22 UTC.
