# NATIONAL TRANSPORTATION SAFETY BOARD

**Specialist's Factual Report**  
**By Bill Tuccio, Ph.D.**

Location: Enterprise, Alabama  
Date: March 26, 2016  
Aircraft: Airbus Helicopters AS350B2  
Registration: N911GF  
Operator: Metro Aviation Inc.  
NTSB Number: ERA16FA140

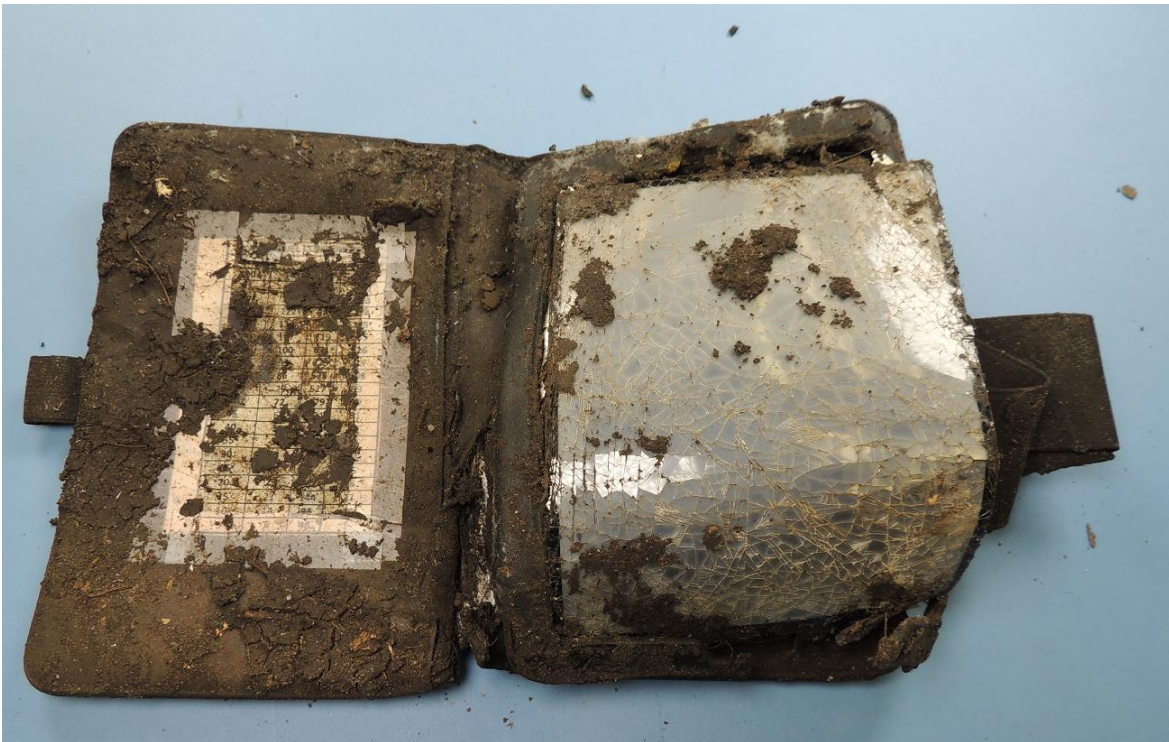
Figure 2. Apple iPad Mini 2, as received.

Figure 2 shows the iPad Mini 2 as received.

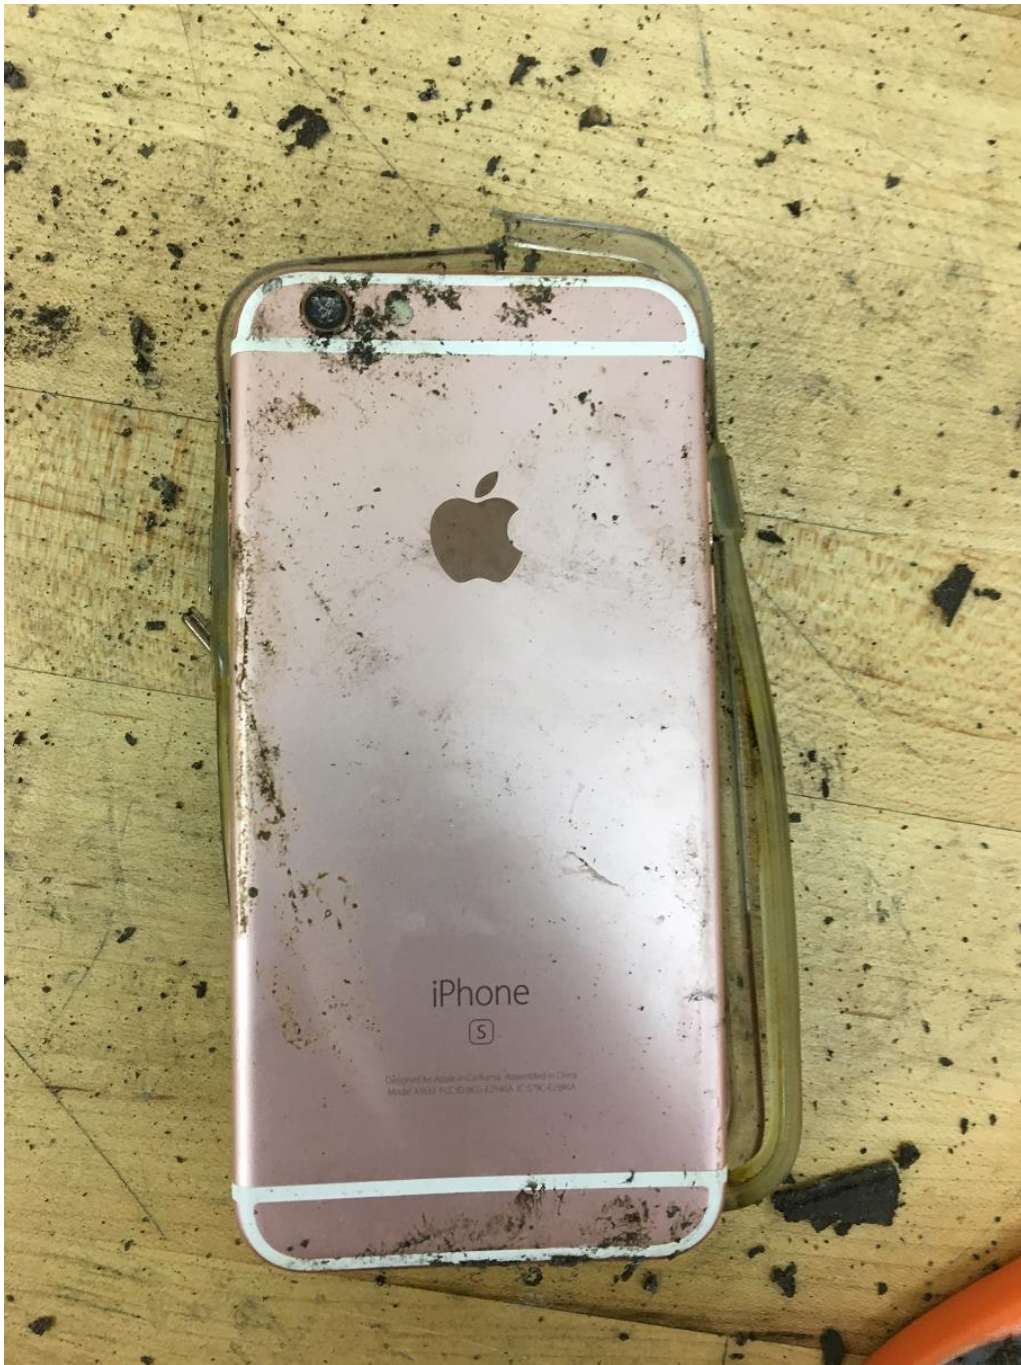
Figure 3. Apple iPhone 6s, as received.

Figure 3 shows the iPhone 6s as received.

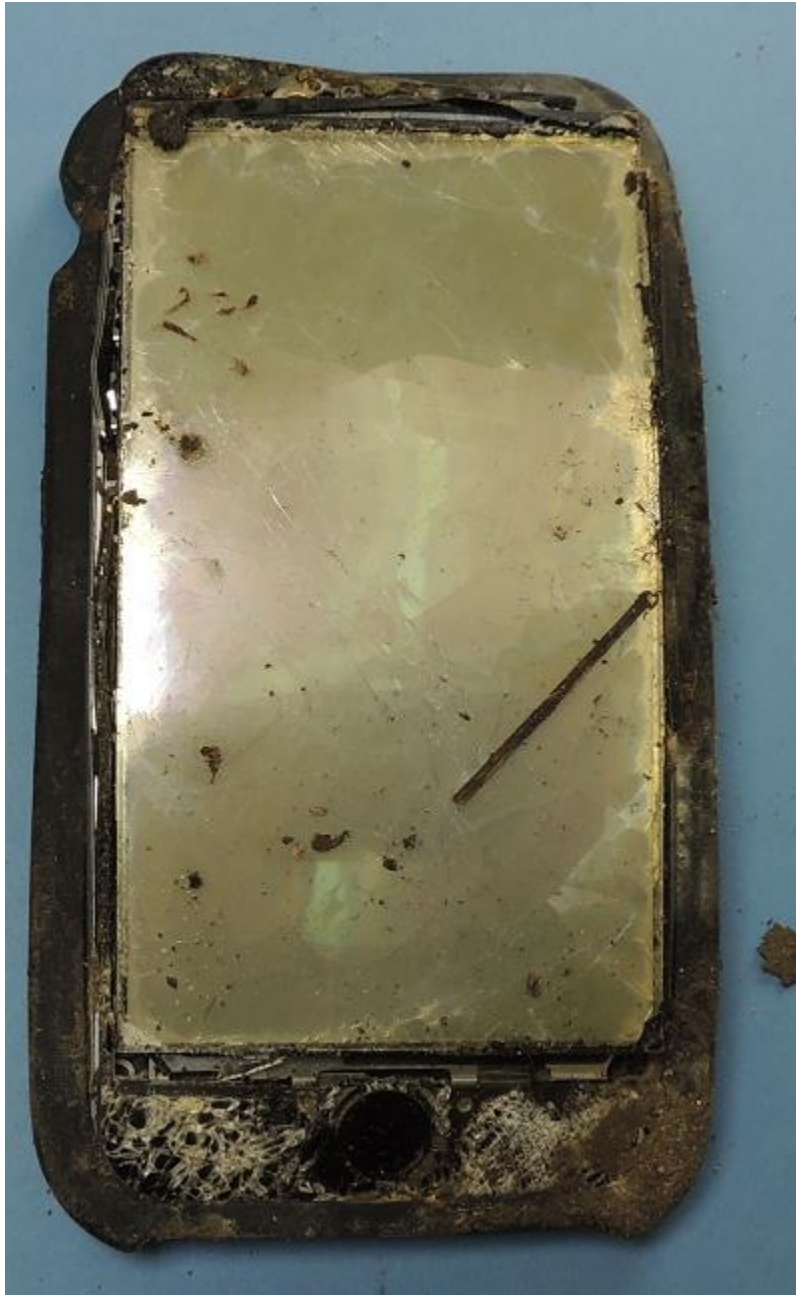
Figure 4. Apple iPhone 6, as received.

Figure 4 shows the iPhone 6 as received.

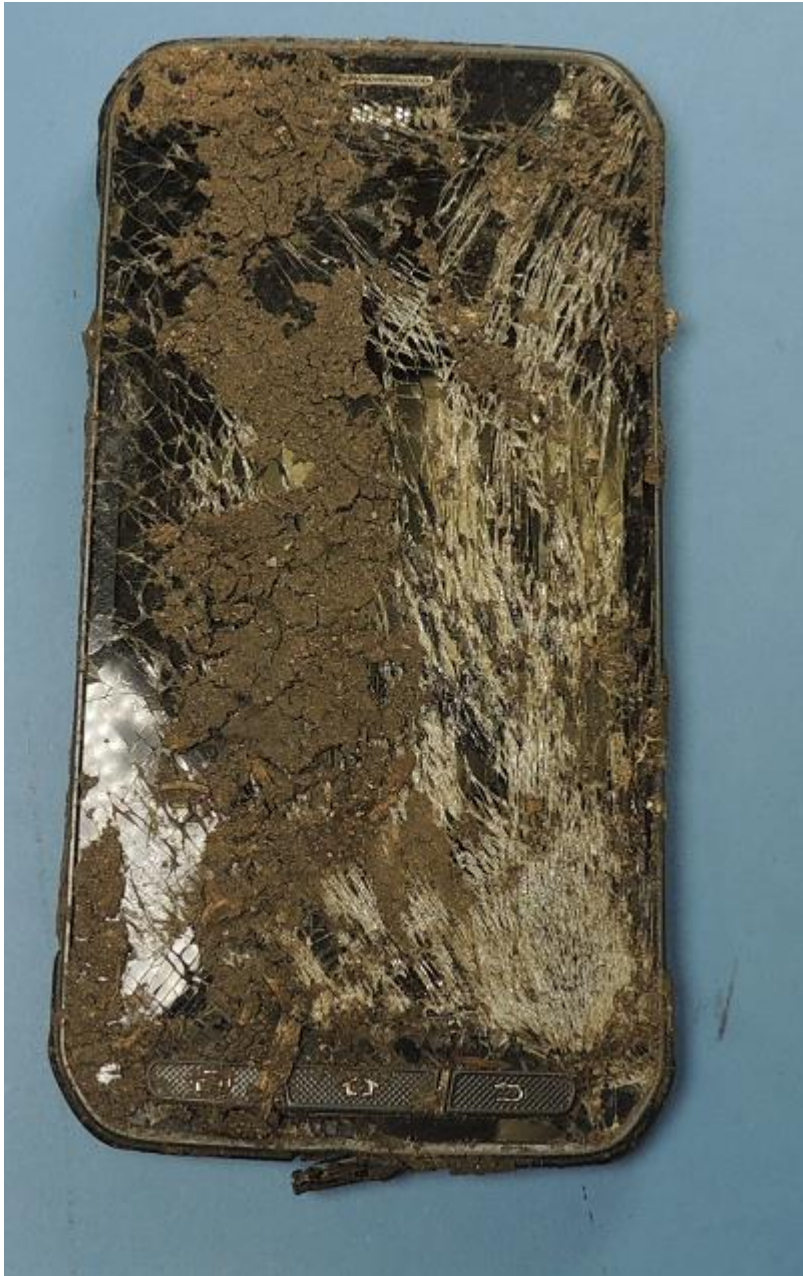
**Figure 5. Samsung Galaxy S5, as received.**

Figure 5 shows the Galaxy S5 as received.

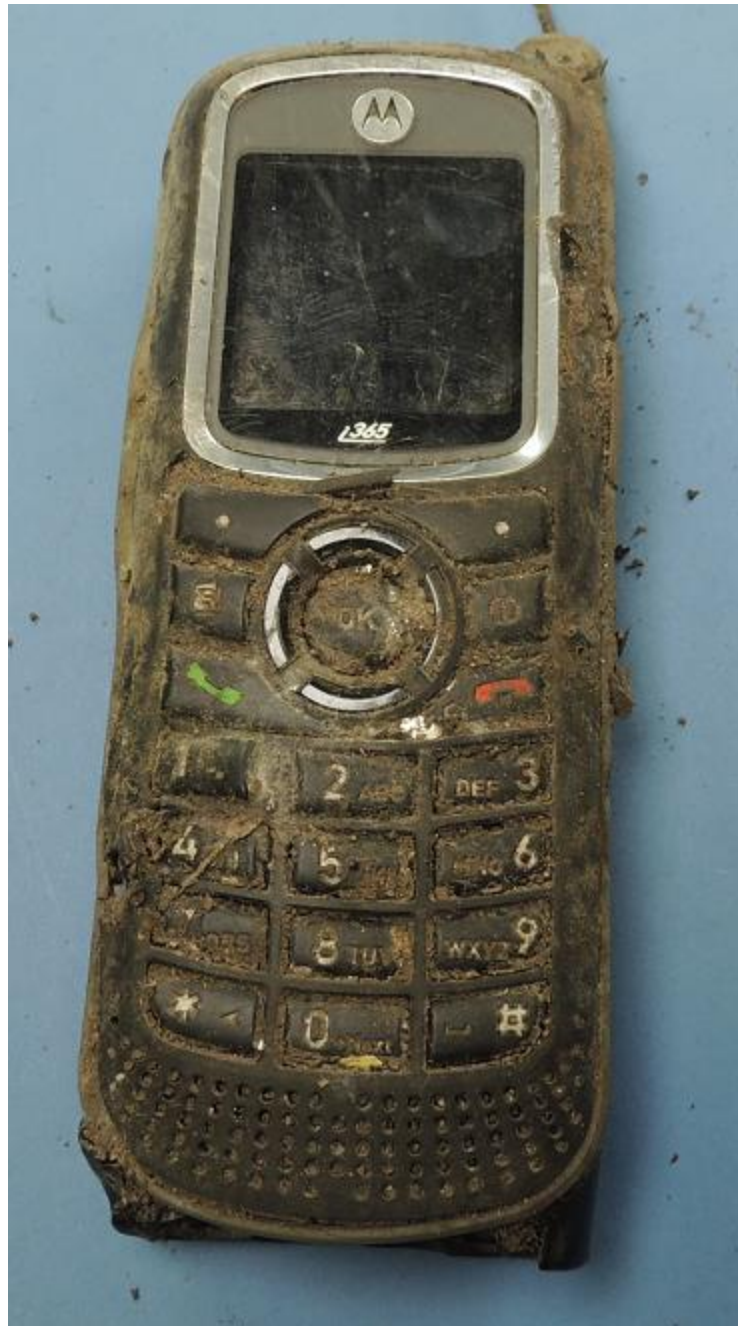
**Figure 6. Motorola i365, as received.**

Figure 6 shows the i365 phone as received.
