# NATIONAL TRANSPORTATION SAFETY BOARD

## Electronic Devices

Specialist's Factual Report  
by Bill Tuccio, Ph.D.

Location: Bartow, Florida  
Date: July 11, 2016  
Aircraft: Cessna 310Q  
Registration: N100CP  
Operator: Private  
NTSB Number: ERA16LA252

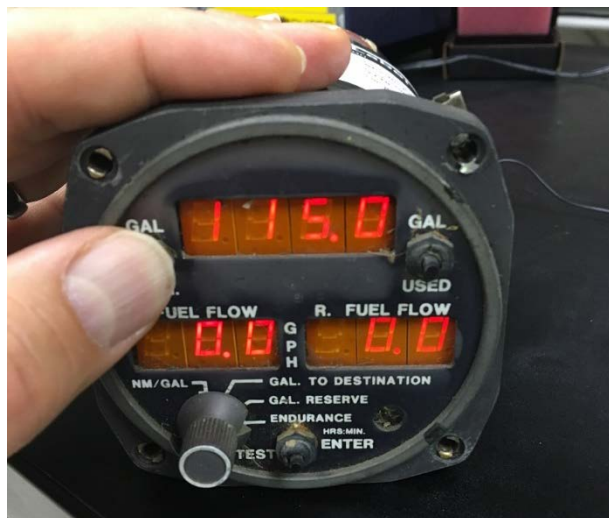
Figure 1. Gallons remaining.

- **Gallons remaining (figure 1).** 115.0 gallons displayed.
- **Gallons used (figure 2).** 62.3 gallons displayed.

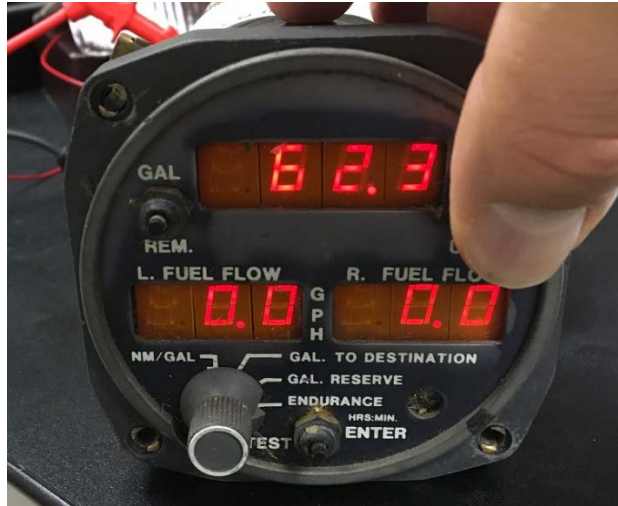
Figure 2. Gallons used.

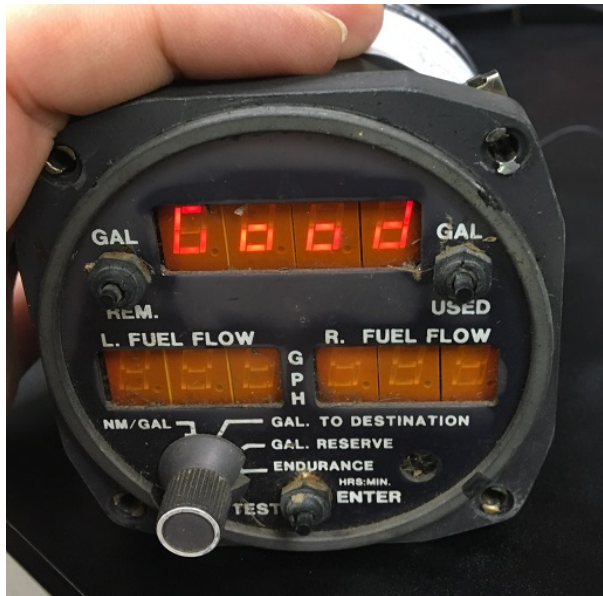
Figure 3. Test message: "Good".

- **Test completion (figure 3).** Good.
- **K values (figure 4).** 85.0 left, 85.0 right. K values are calibration constants that should match the fuel sensor K value.
- **Message (figure 5).** LoFF. Means the Loran or GPS is off; this message is expected when started not installed in the aircraft with no Loran or GPS connected.
- **Version (figure 6).** 51.01.
- **Error message (figure 7).** Err1. This is an error message, the meaning of which was unclear from the manual and may have been due to the unit operating not installed in the aircraft.

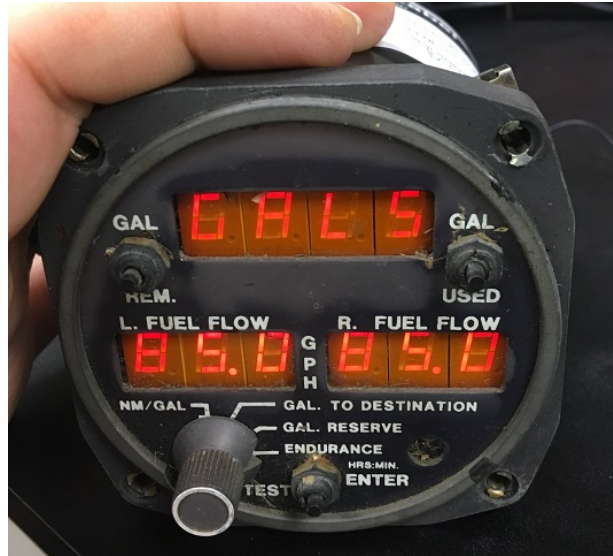
Figure 4. Test message: K factors.

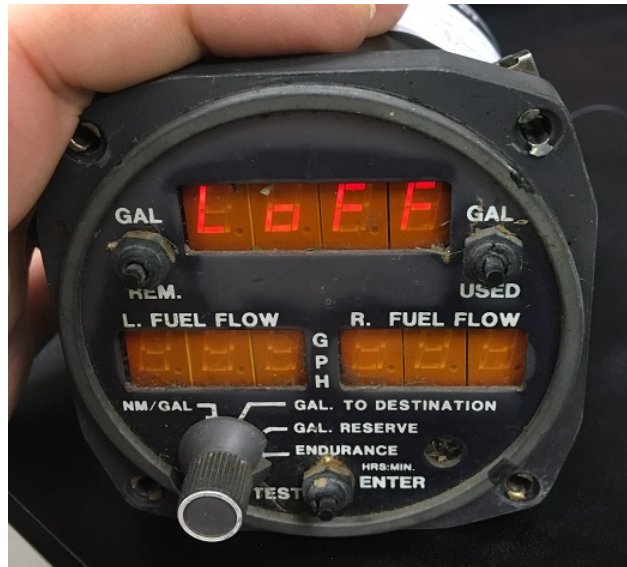
Figure 5. Test message: "LoFF".

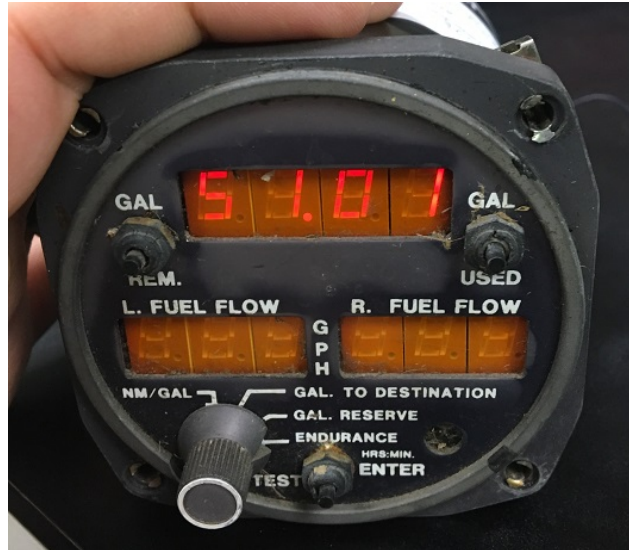
Figure 6. Test message: version.

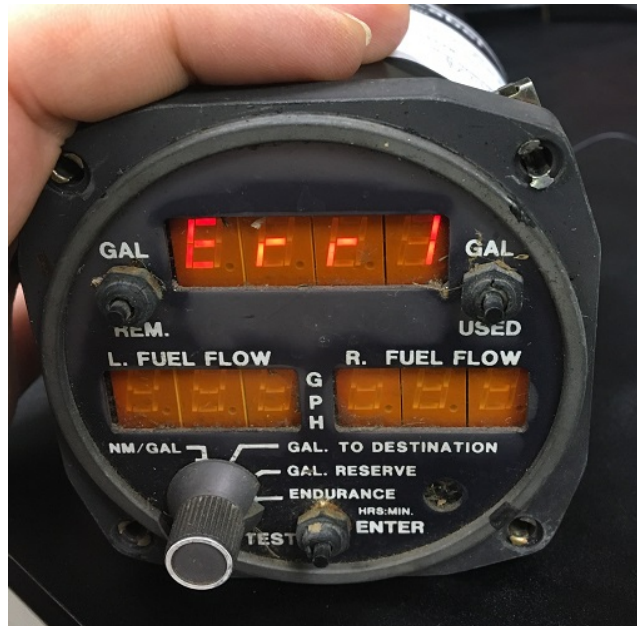
Figure 7. Test message: "Err1".
