NATIONAL TRANSPORTATION SAFETY BOARD

17 – Electronic Devices Factual Report

Specialist's Factual Report
by Bill Tuccio

Location: Hooksett, New Hampshire
Date: October 25, 2012
Aircraft: Hawker Beechcraft A36
Registration: N4325W
Operator: Private
NTSB Number: ERA13FA039

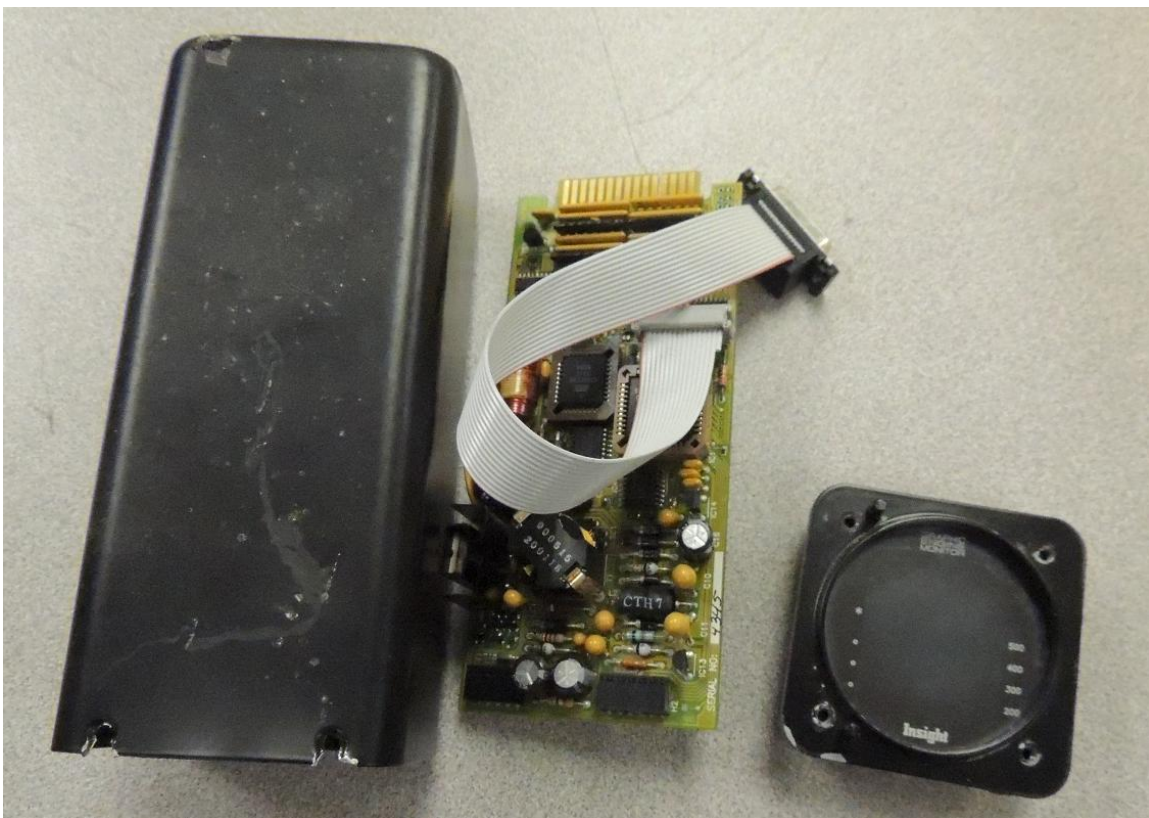
Figure 1. Insight GEM-610.

Upon arrival at the Vehicle Recorder Laboratory, an exterior examination revealed the unit had sustained significant impact damage, as shown in figure 1. An internal inspection revealed damage to electronic components on the display subassembly, as shown in figure 2. The display subassembly was replaced with an NTSB surrogate, external power applied, and information extracted normally using the manufacturer's software.

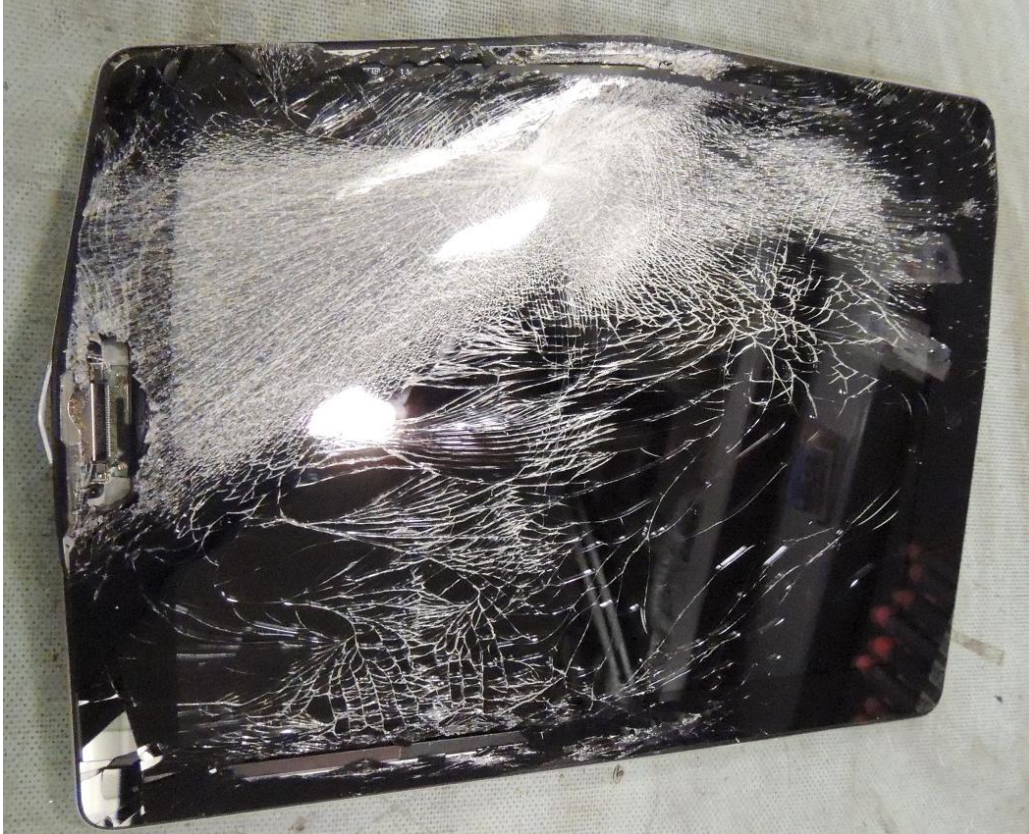
Figure 3. Apple iPad 2.

Upon arrival at the Vehicle Recorder Laboratory, an exterior examination revealed the unit had sustained significant impact damage, as shown in figure 3. An internal inspection revealed the main A5 processor chip had been damaged, as shown in figure 4. Other chips were also damaged. Due to the damage, no further recovery was attempted and no data was retrieved.
