NATIONAL TRANSPORTATION SAFETY BOARD

17 – Electronic Devices Factual Report

Specialist's Factual Report
by Bill Tuccio, Ph.D.

Location: Johnstown, New York
Date: May 24, 2013
Aircraft: Piper PA-34-200T
Registration: N31743
Operator: Private
NTSB Number: ERA13FA253

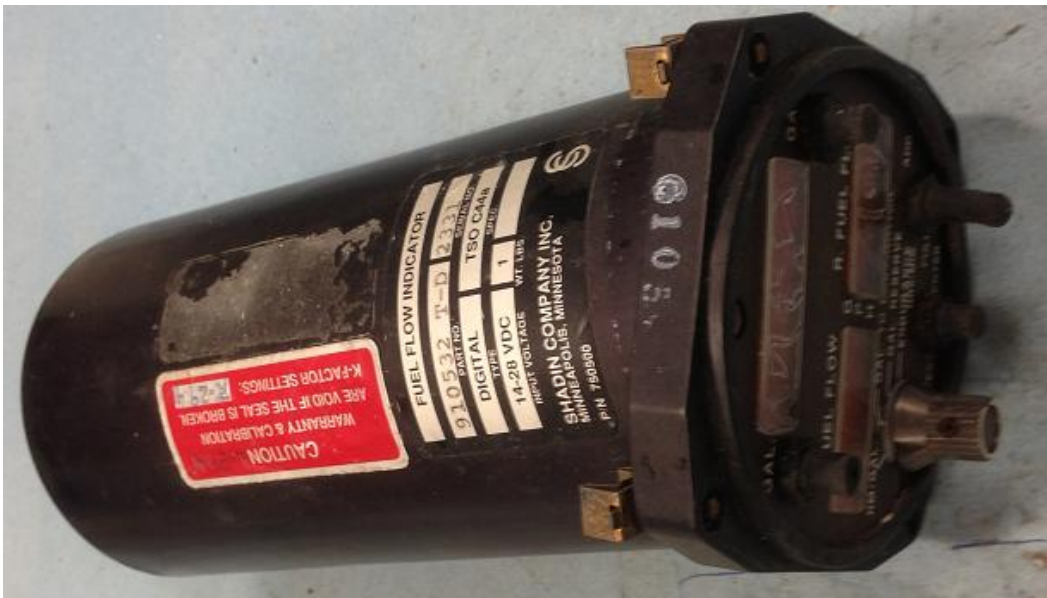
Upon arrival at the Vehicle Recorder Laboratory, an exterior examination revealed the unit had sustained significant impact and water damage, as shown in figure 1. An internal inspection was performed revealing no internal damage. External power was applied to the unit and it started normally. The various display modes were examined and documented.

Figure 1. Shadin fuel flow indicator.

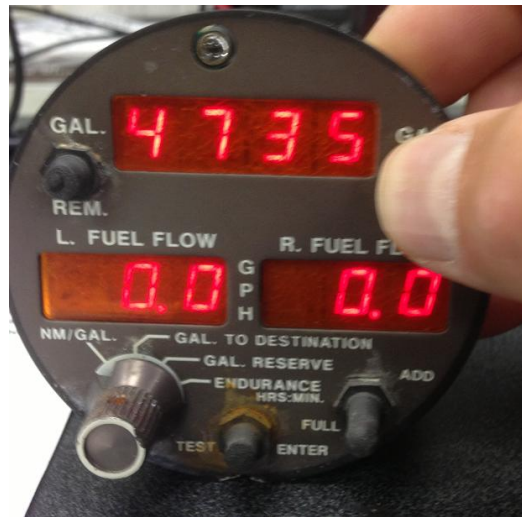
When the gallons remaining button was depressed it displayed "0.0." When the gallons used button was pushed it displayed the digits "4735" with no decimal point, as shown in figure 2. The calibration k-factor for each engine's fuel flow sending unit was set to 29.4 for both engines. The full fuel value of the unit was set to "123.0" gallons.

Figure 2. Shadin fuel flow fuel used indication.

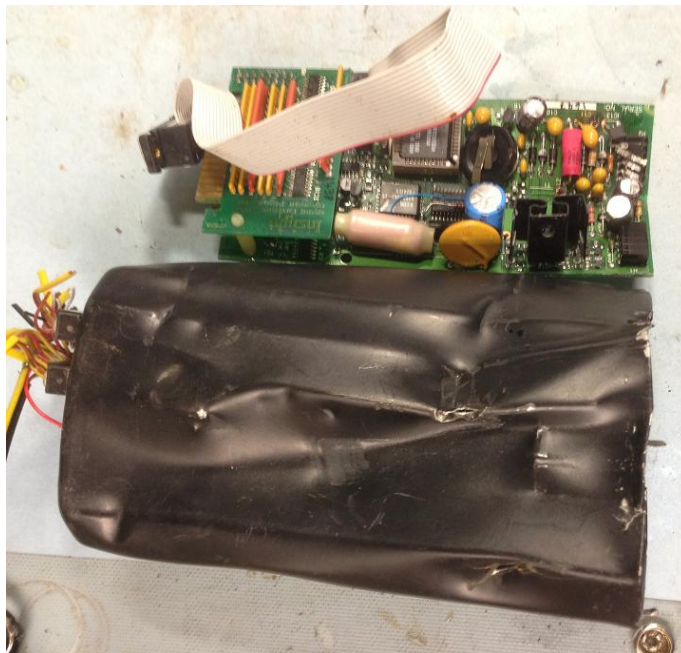
Upon arrival at the Vehicle Recorder Laboratory, an exterior examination revealed the unit had sustained significant impact and water damage, as shown in figures 3 and 4. The damage rendered the unit inoperable. A functioning surrogate unit was obtained and the memory chip from the damaged unit, shown in figure 5, was installed in the surrogate unit. Information was downloaded from the surrogate unit normally; however, certain configuration and time setting information from the accident unit could not be retrieved.

Figure 4. Insight GEM-1200 unit - internal inspection.

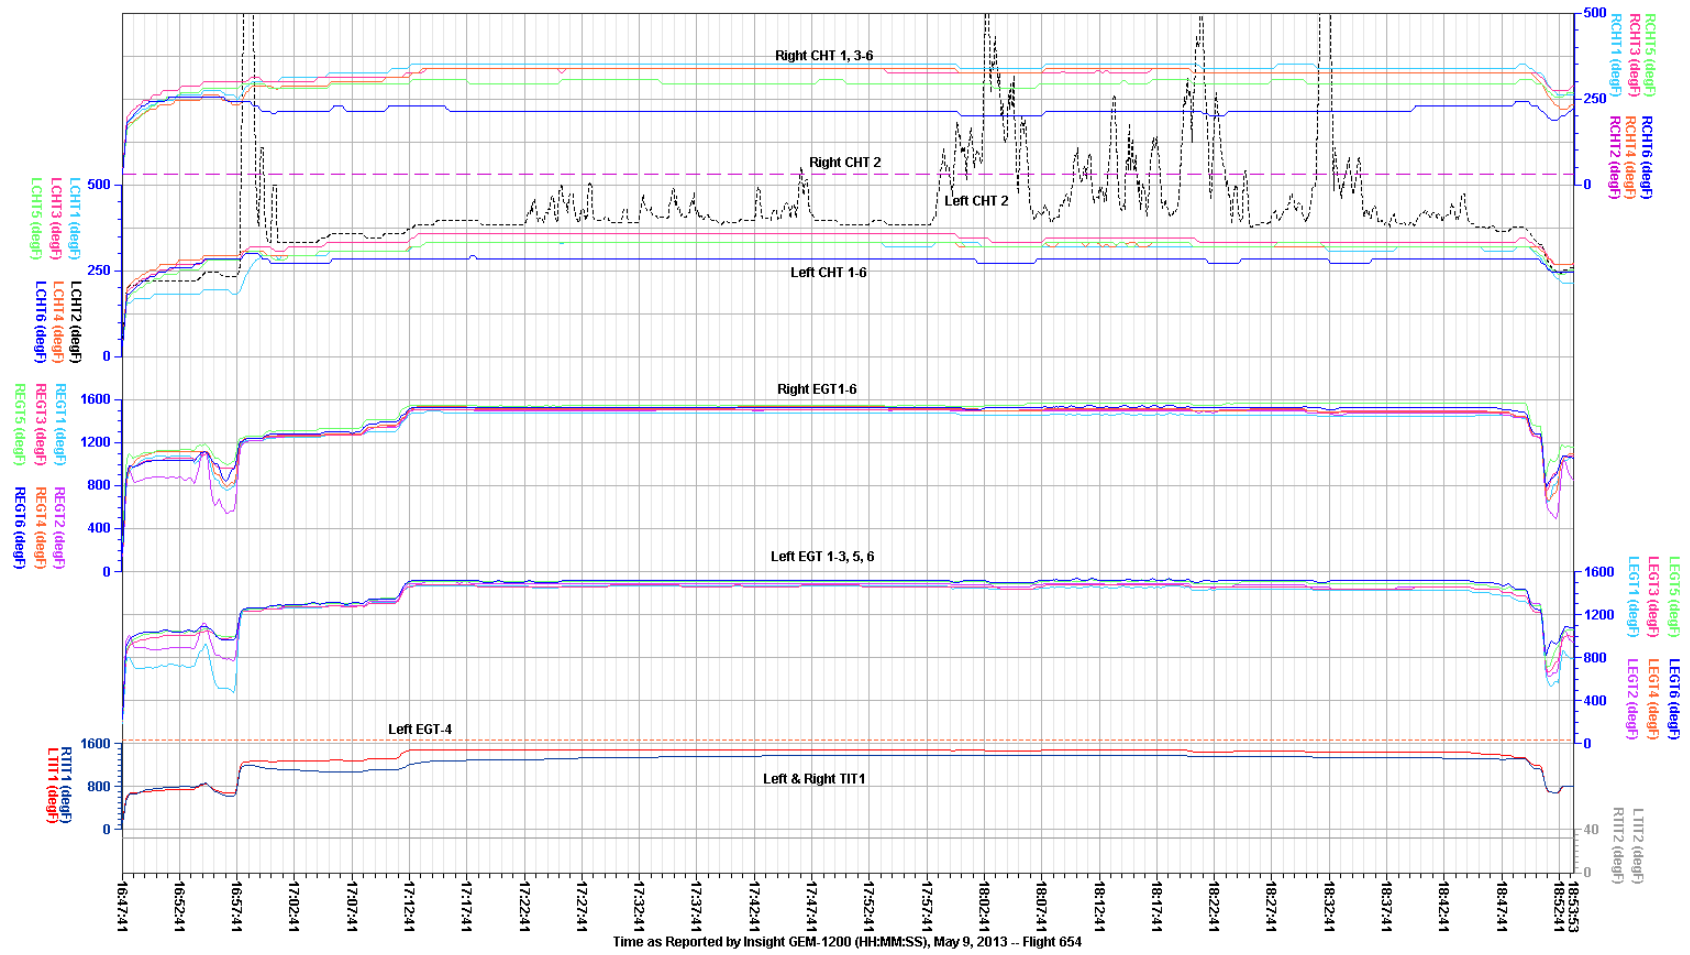
Figure 6 shows flight number 654 that occurred on May 9, 2013 between 1647:11 and 1853:53 GEM recorded time; a duration of 2 hours and 6 minutes.

Figure 6. Insight GEM-1200 Flight 654.

Each of the figures 6 through 12 show each of the flights 654 through 660, respectively. Across all flights, the left engine EGT-4 recorded a constant value of 32 degF, and TIT2 for both engines recorded a constant value of 32 degF. Across all flights, the right engine CHT-2 recorded either 0 degF or erratic values. In flights 654, 655, 656, and 658, the left engine CHT-2 recorded erratic values. Some of the erratic right and left engine CHT-2 values exceeded the 500 degF maximum value of the vertical CHT plot scales.
