NATIONAL TRANSPORTATION SAFETY BOARD

17 – Electronic Devices Factual Report

Specialist's Factual Report by Bill Tuccio

Location: Delray Beach, Florida
Date: March 23, 2012
Aircraft: Bell 407
Registration: N31PB
Operator: Palm Beach County Sherriff's Office
NTSB Number: ERA12TA251

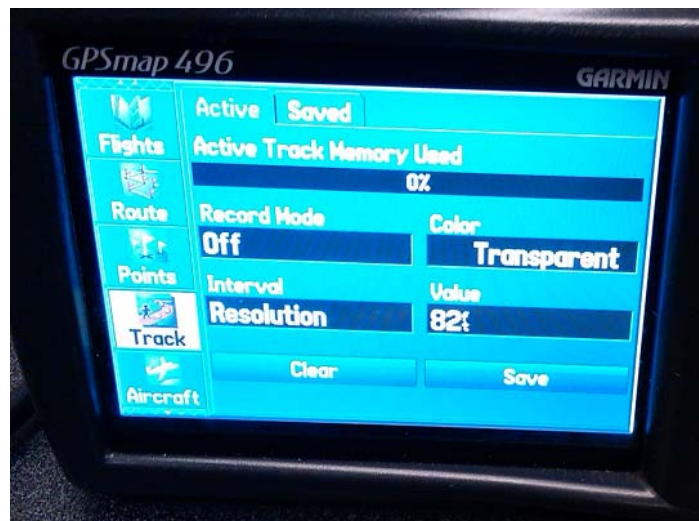
Upon arrival at the Vehicle Recorder Laboratory, an exterior examination revealed that the unit had not sustained any damage. However, an examination of the unit settings, shown in figure 1, revealed the track log record mode was set to off and 0% internal memory was used. As such, no data pertinent to the investigation was retrieved from the unit.

Figure 1. GPSMap 496, track log settings.

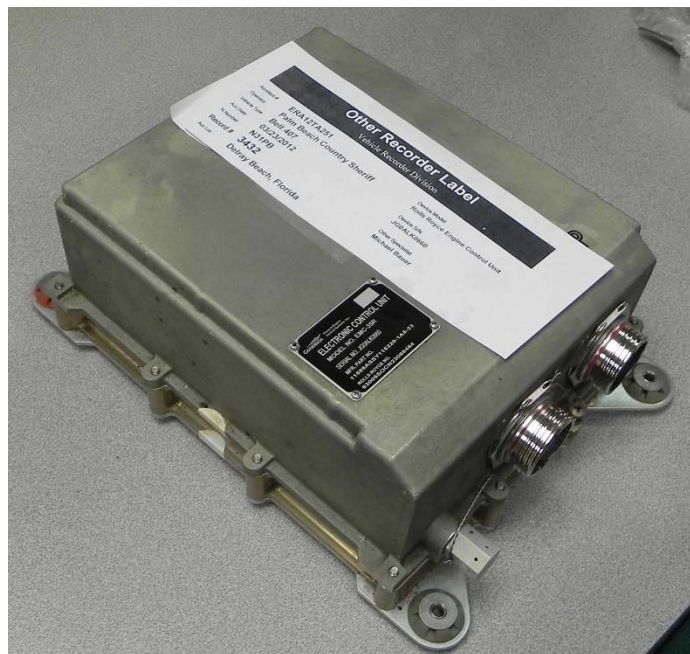
Upon arrival at the Vehicle Recorder Laboratory, an exterior examination revealed that the unit had not sustained any damage (figure 2). With the assistance of Rolls Royce personnel, recorded data was downloaded normally, without difficulty.

Figure 2. Rolls Royce DECU unit.

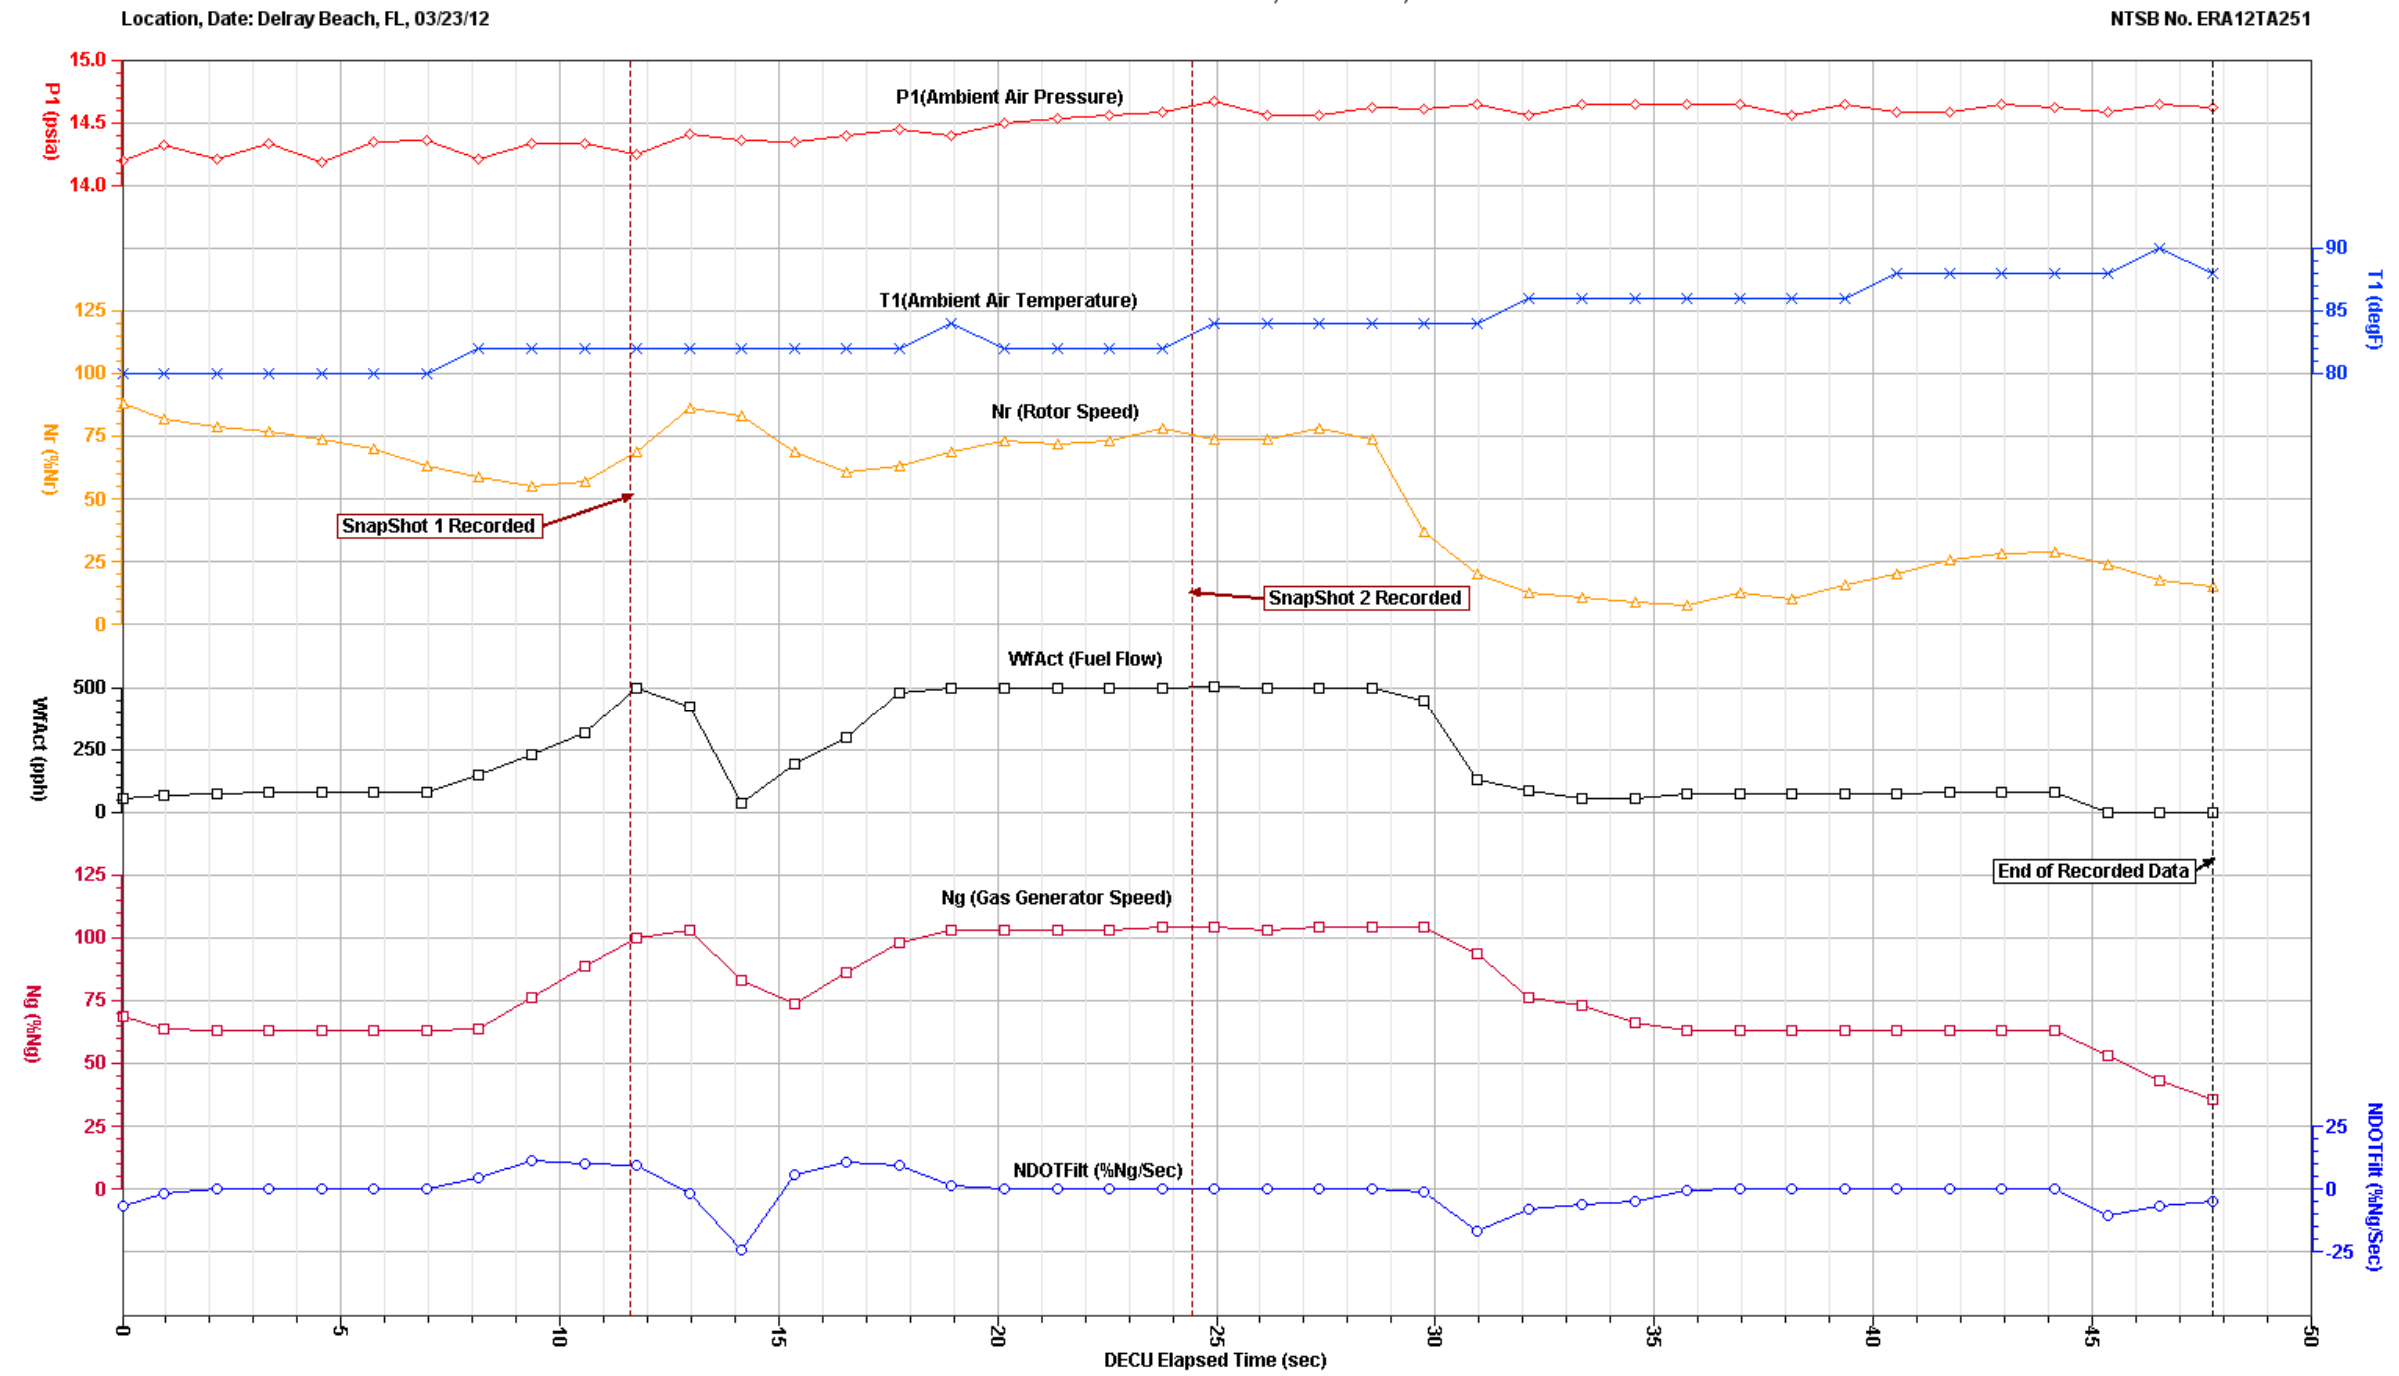
Additional Parameters

Figure 4 shows ambient air pressure and temperature recorded during the event. The recorded ambient air pressure was about 14.2 psi and the temperature about 81 degF.

Figure 4. DECU plot of additional parameters.
 Palm Beach Sheriff's Office, Bell 407, N31PB

The following two plots are expressed in elapsed time as recorded by the DECU unit. The data contains information from the March 23, 2012 event. The recording content began about 12 seconds prior to the first triggering event and continued for about 48 seconds. Two IR snapshot events were triggered at about 12 and 24 seconds.

The corresponding tabular data used to create these two plots are provided in electronic (*.csv³) format as Attachment 1 to this report.
