# NATIONAL TRANSPORTATION SAFETY BOARD

## 17 – Electronic Devices Factual Report

Specialist's Factual Report  
by Bill Tuccio

Location: Amarillo, Texas  
Date: December 14, 2012  
Aircraft: Beechcraft E-90  
Registration: N67PS  
Operator: Private  
NTSB Number: CEN13FA105

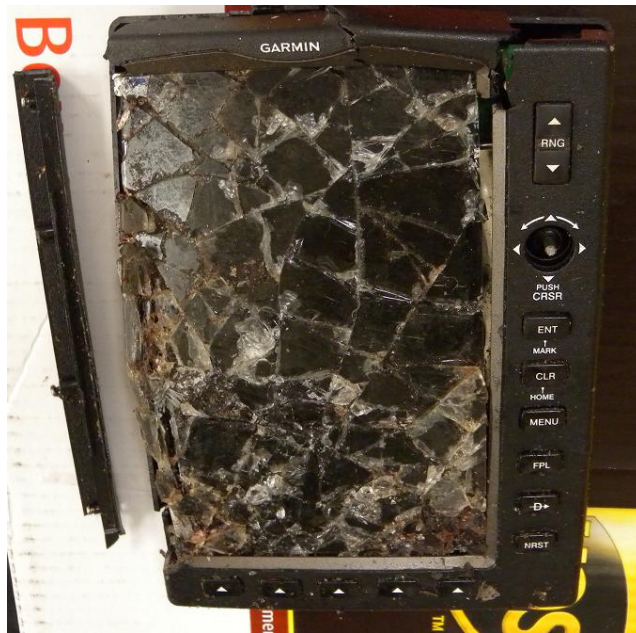
Upon arrival at the Vehicle Recorder Laboratory, an exterior examination revealed the unit had sustained significant impact damage, as shown in figure 1. An internal inspection revealed the main memory chip, Samsung KMAKG0000M, had separated from the printed circuit board, as shown in figure 2. The 169-connection, ball grid array was re-soldered, and a binary chip download was attempted. The download was unsuccessful.

Figure 1. Garmin GPSMAP 696 damage photograph.

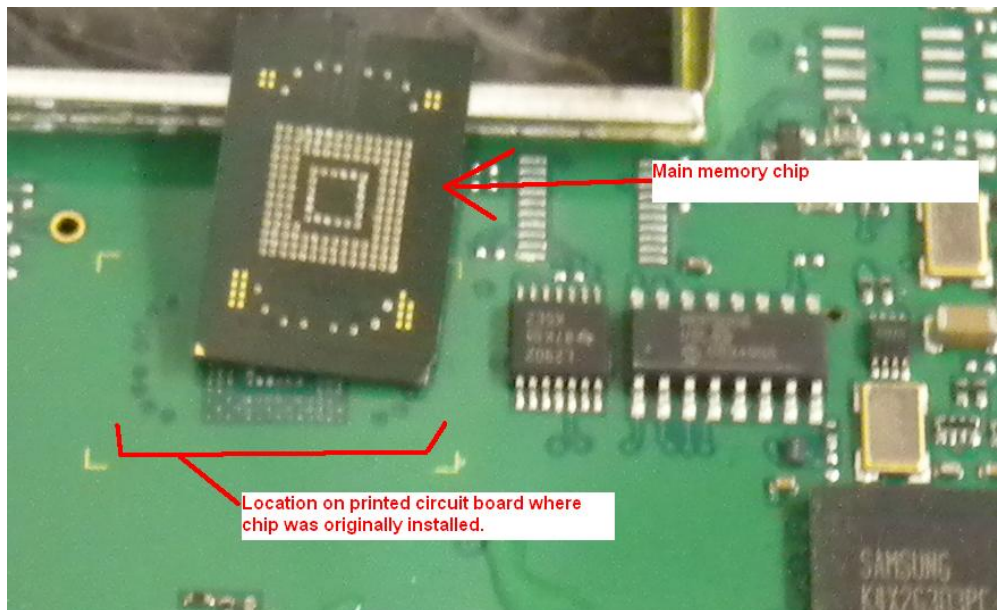
Figure 2. Garmin GPSMAP 696 separated main memory chip.

The chip was sent to the State University of New York (SUNY)-Binghamton for further x-ray and optical analysis. The report identified the likelihood of data recovery as low. As such, no further data recovery attempts were made. The SUNY-Binghamton report is included as Attachment 1 to this report.

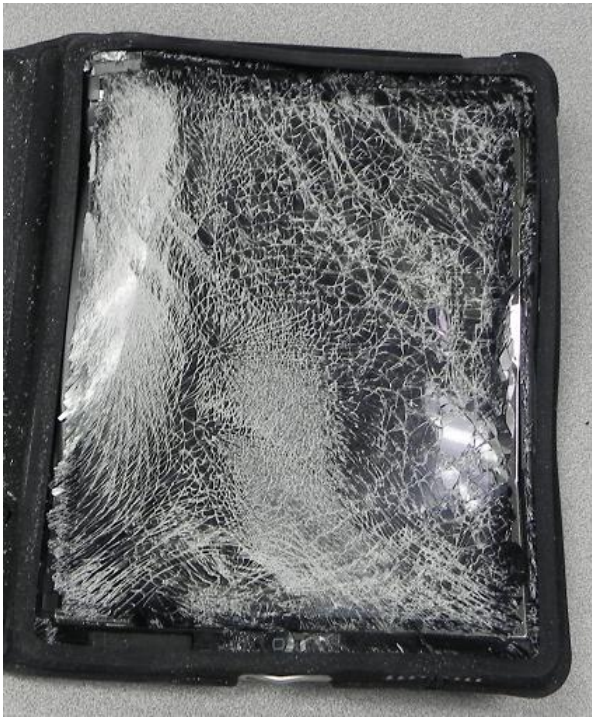
Upon arrival at the Vehicle Recorder Laboratory, an exterior examination revealed the unit had sustained significant damage, as shown in figure 3. The internal circuit board was removed from the unit, as shown in figure 4. The board was installed in a surrogate NTSB iPad. However, the unit would not start. No further data recovery efforts were attempted.

**Figure 3. Apple iPad damage photo.**

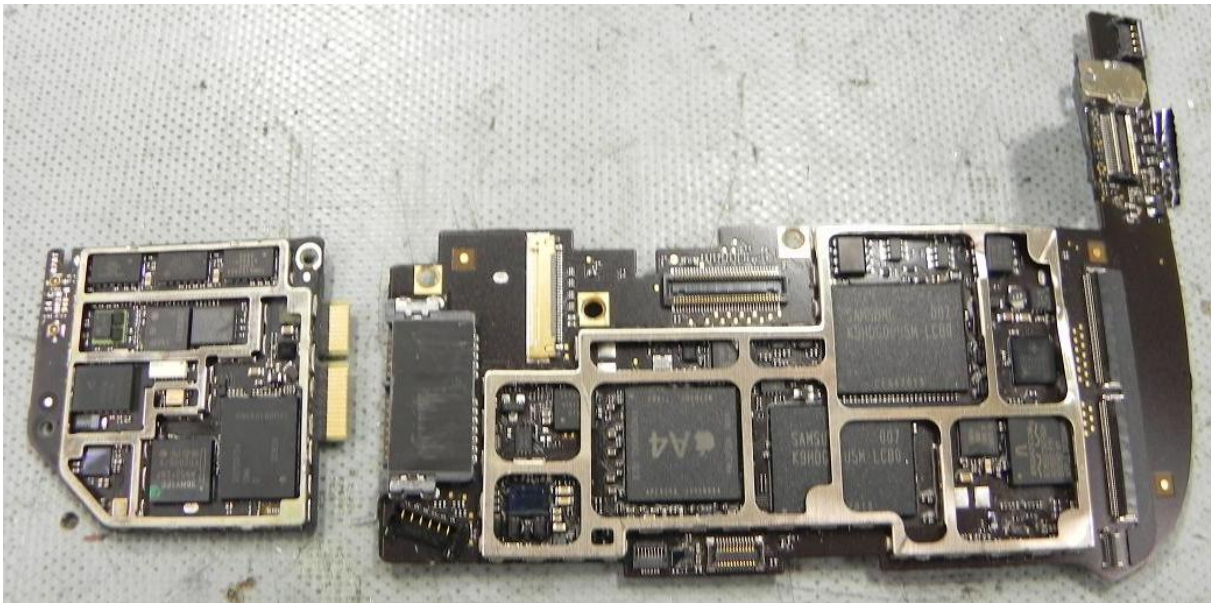
**Figure 4. Apple iPad circuit board.**
