**NATIONAL TRANSPORTATION SAFETY BOARD**  
Vehicle Recorder Division  
Washington, D.C. 20594

## **17 – Electronic Devices Factual Report**

Location: Greensburg, Indiana  
Date: December 2, 2012  
Aircraft: Piper PA-46-350P  
Registration: N92315  
Operator: Private  
NTSB Number: CEN13FA085

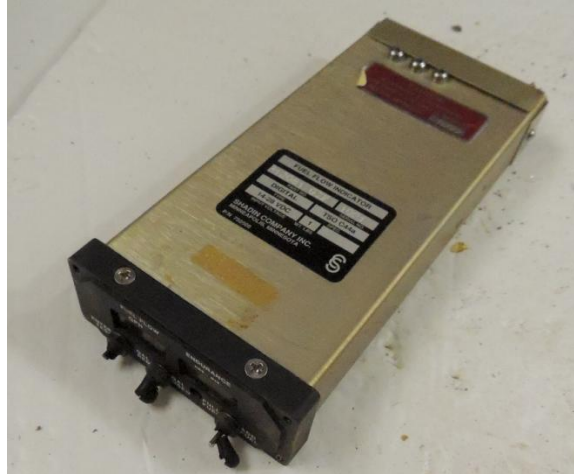
Upon arrival at the Vehicle Recorder Laboratory, an exterior examination revealed the unit had sustained minor impact damage as shown in figure 1. Power was applied to the unit, however the LED digits were of insufficient intensity to discern displayed values. The unit was disassembled, and the internal intensity screw (figure 2) was used to increase the intensity of the LED display. The unit displays were documented.

**Figure 1. Shadin fuel flow indicator.**

The unit self-tested “-Good-”, indicating firmware version 60.01.54. The self-test then displayed “78.0 GAL”, followed by “FUL 120”. The fuel used value displayed 72.7 gallons, fuel remaining was 18.8 gallons.

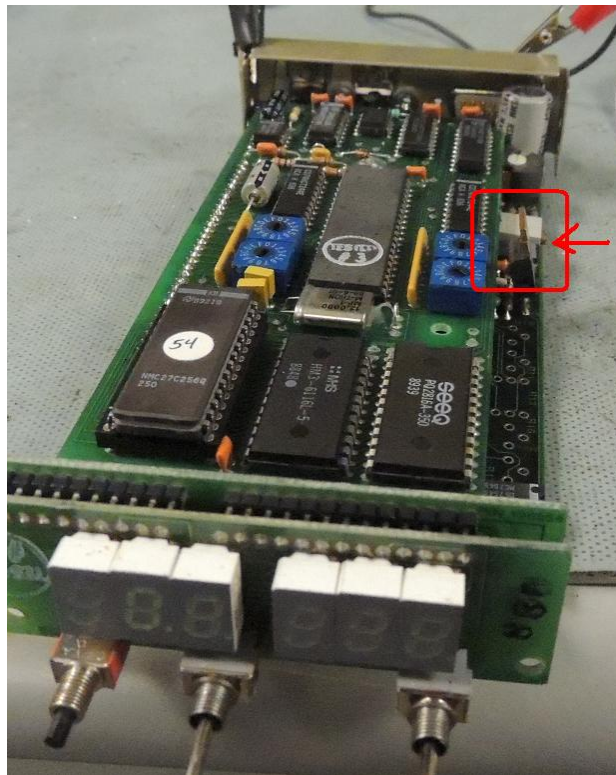
**Figure 2. Shadin LED intensity display screw.**

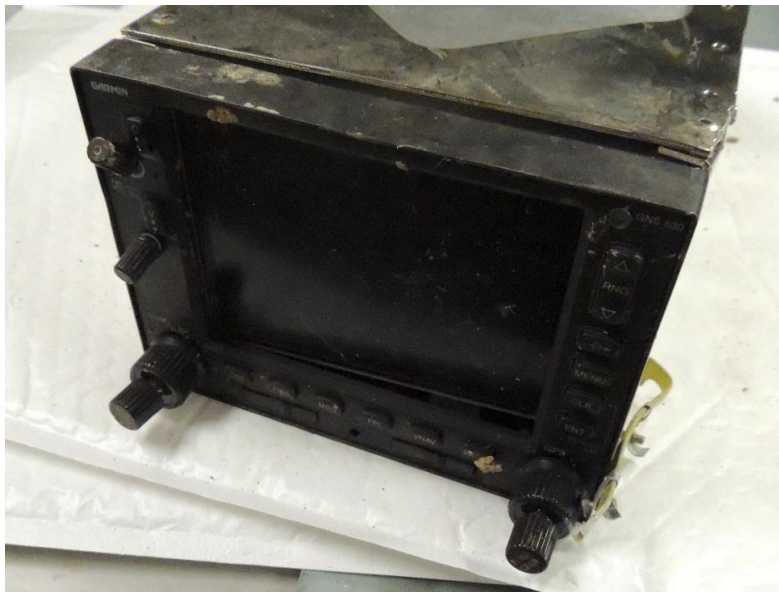
Upon arrival at the Vehicle Recorder Laboratory, an exterior examination revealed the unit had sustained significant impact damage, as shown in figure 3. An internal inspection revealed internal cabling was disconnected. The cables were re-attached and the unit started normally. The screens were explored and documented.

Figure 3. Garmin 530W as received.

The IFR database installed in the unit's front-loading data card expired December 13, 2012, the obstacle database expired July 31, 2008. The unit was configured for Terrain Awareness and Warning System (TAWS). The unit was also configured to interface with an external fuel flow system, XM weather, and traffic information. The active

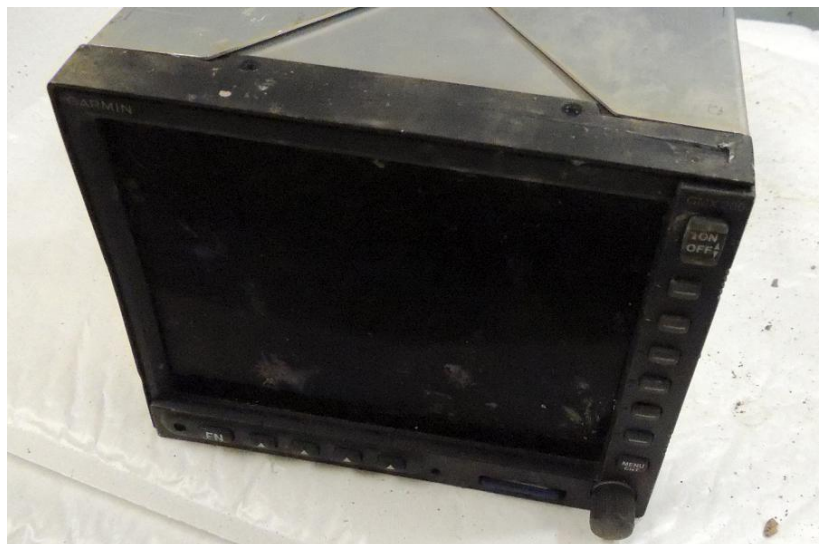
Upon arrival at the Vehicle Recorder Laboratory, an exterior examination revealed the unit had sustained minor impact damage as shown in figure 4. Power was applied to the unit, but the screen would not start. The front-mounted SD card was removed and examined.

**Figure 4. Garmin GMX 200 as received.**

The SD card indicated the approach charts on the device were from the August 17, 2012 cycle and had expired September 20, 2012. No further information was recovered from the SD card.
