#### NATIONAL TRANSPORTATION SAFETY BOARD

# 17 - Electronic Device Factual Report

Location: Houston, Texas
Date: September 10, 2012
Aircraft: Robinson R22 Beta

NTSB Number: CEN12FA621

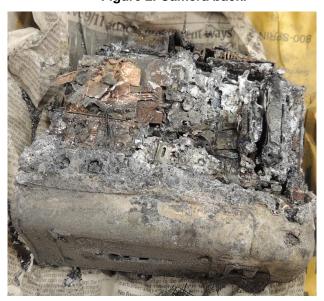
Figure 1. Camera front.

A camera was received. Due to the damage, the make and model could not be determined.

Upon arrival at the Vehicle Recorder Laboratory, an exterior examination revealed the unit had sustained significant fire damage as shown in figures 1 and 2. No non-volatile memory<sup>1</sup> components could be retrieved.

No data was recovered.

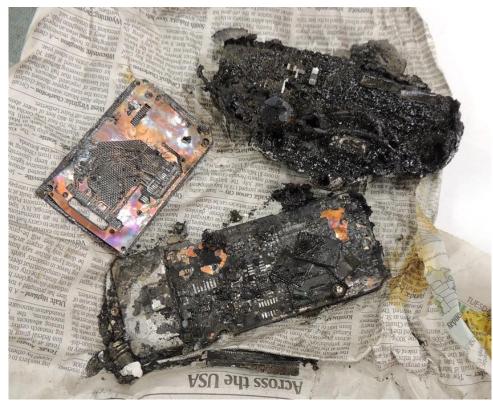
Figure 3. Cell phone.

A cell phone was received. Due to the damage, the make and model could not be determined.

Upon arrival at the Vehicle Recorder Laboratory, an exterior examination revealed the unit had sustained significant fire damage as shown in figure 3. No non-volatile memory components could be retrieved.

No data was recovered.
