# NATIONAL TRANSPORTATION SAFETY BOARD

## 17 – Electronic Devices Factual Report

Specialist's Factual Report  
by Bill Tuccio

Location: Cumming, Georgia  
Date: September 13, 2012  
Aircraft: Vans Aircraft RV-7  
Registration: N517DG  
Operator: Private  
NTSB Number: ERA12FA561

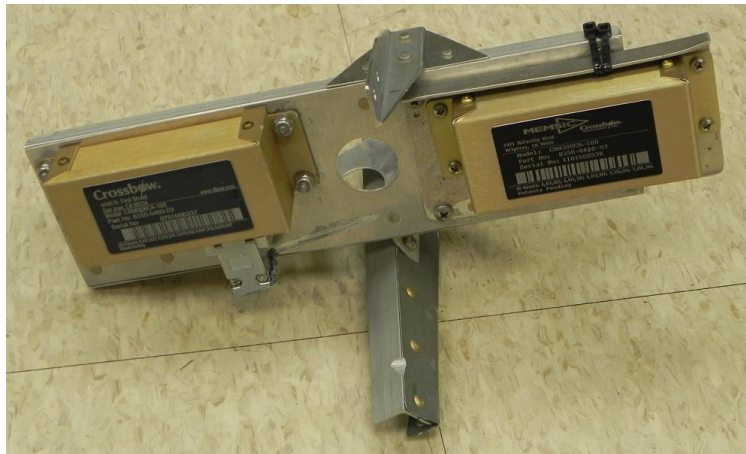
Upon arrival at the Vehicle Recorder Laboratory, an exterior examination revealed the two units had not sustained any damage, as shown in figure 1. No attempt was made to extract information from these devices, as heading information was available on the AF-3500EE.

Figure 1. Memsic Crossbow Magnetometer.

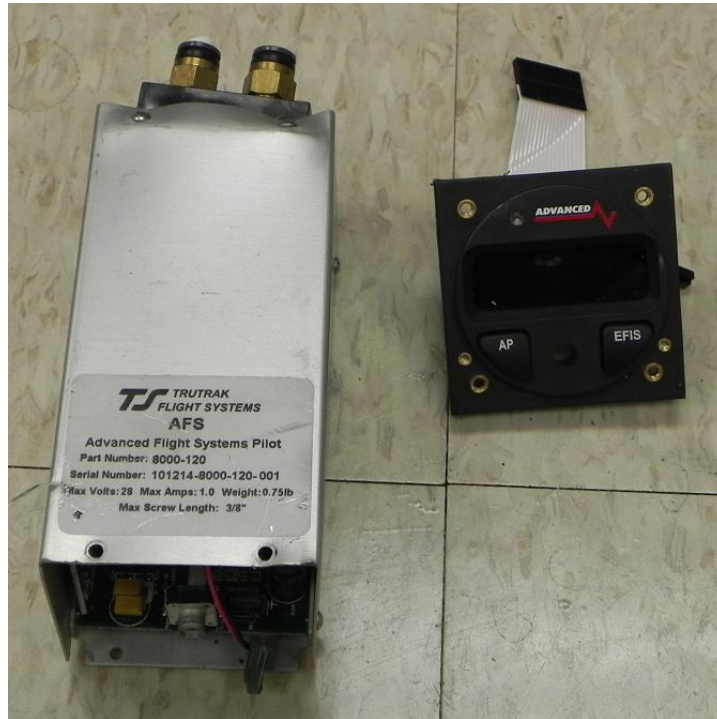
Upon arrival at the Vehicle Recorder Laboratory, an exterior examination revealed the unit had sustained minor damage, as shown in figure 2. No attempt was made to extract information from this device.

**Figure 2. Advanced Flight Systems Inc. Pilot.**

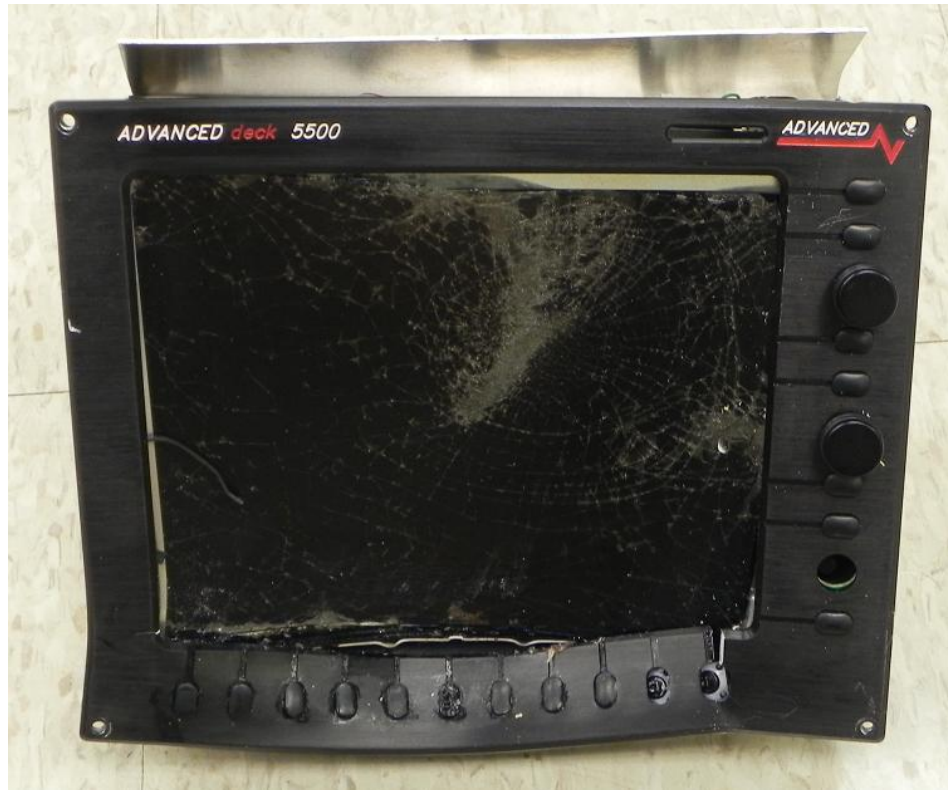
Upon arrival at the Vehicle Recorder Laboratory, an exterior examination revealed the unit had sustained significant impact damage, as shown in figure 3. Limited attempts were made to recover information from the device.

**Figure 3. Advanced Flight Systems Inc. AF-5500EF.**

No data was recovered from this particular device. However, much of the data was recovered from the Advanced Flight Systems Inc. AF-3500EE as described in the next section.

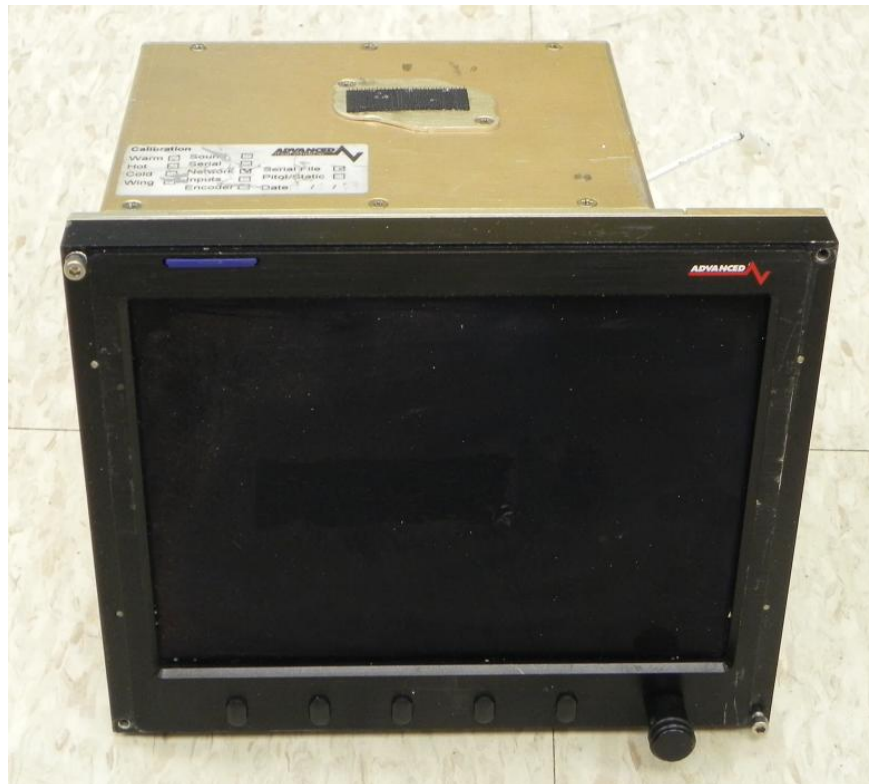
Upon arrival at the Vehicle Recorder Laboratory, an exterior examination revealed the unit had sustained minor impact damage, as shown in figure 4. An internal examination revealed no significant damage. External power was applied to the unit and information was extracted normally, without difficulty.

Figure 4. Advanced Flight Systems Inc. AF-3500EE.

The unit contained 266 data points between September 5, 2012 and September 13, 2012 at 1914:09. The date and time accuracy could not be verified. Given the accident was reported at about 1941 EDT, times are assumed to be EDT for this report. Between device reported times of 1905:30 and 1907:52, the GPS latitude and longitude

did not update; during this period the recorded latitude and longitude remained the same as the 1905:30 values. During this time period, all other values appeared to change.

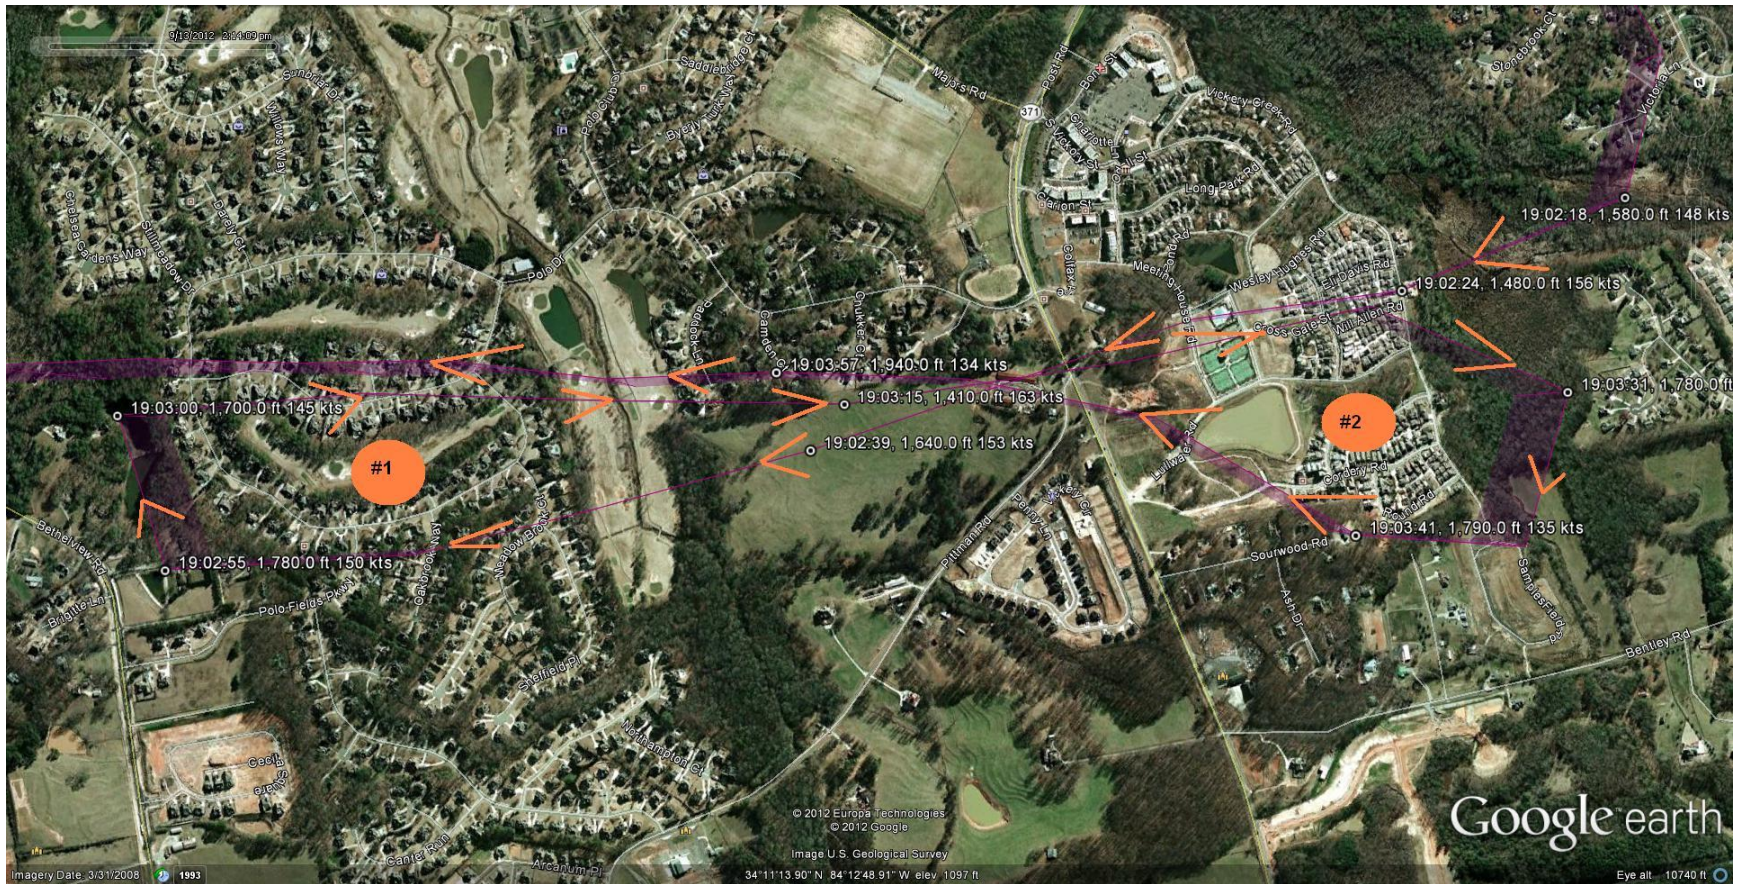
Figure 6 shows the aircraft climbed towards the northwest, circled in a figure eight pattern, and then proceeded towards the east until the latitude/longitude recording became unreliable after 1905:24. Figure 7 shows the annotated path of the aircraft during the figure eight pattern. The aircraft first proceeded towards the east, towards the area annotated as “#1”, then turned to the south, then back to the west. Thereafter, the aircraft turned north, then back towards the easterly route of flight.

Figure 7. Graphical overlay of figure eight flight pattern in first part of flight.

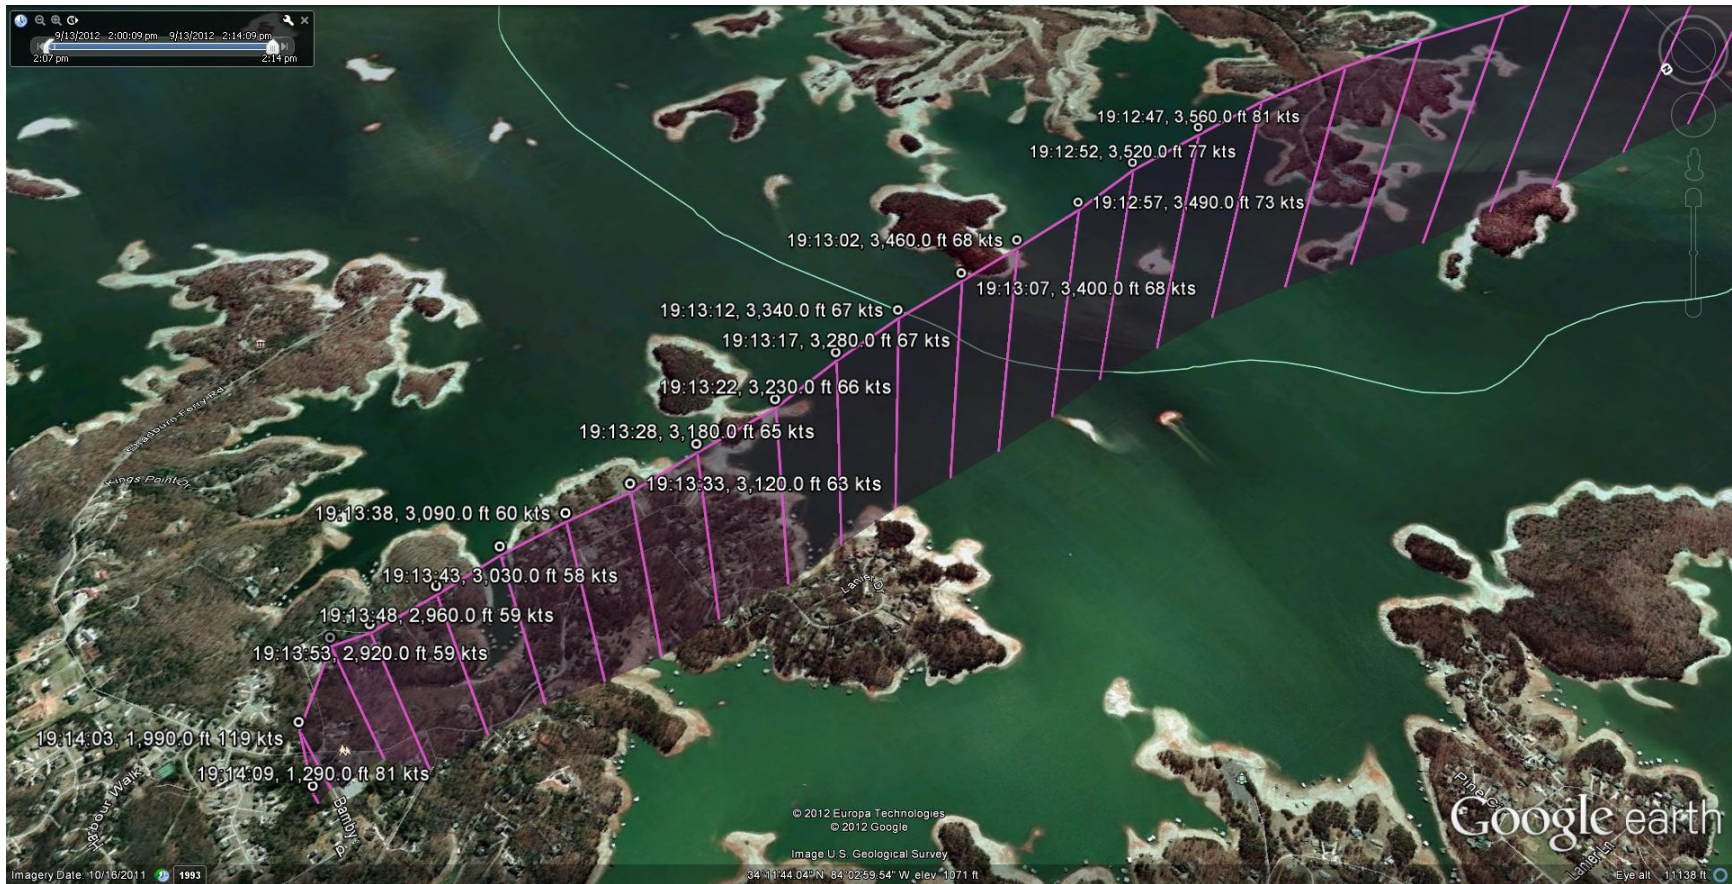
Figure 8 shows the second part of the flight after latitude and longitude began to change again. The path began at 1907:57 as the aircraft was proceeding south. At around 1909:14, the aircraft began to turn towards the north. Figure 9 shows all points recorded at the end of the flight. The aircraft descended on a northerly track over a lake. The last few points recorded may be unreliable due to the subsequent impact.

Figure 9. Graphical overlay of all points at the end of the flight.

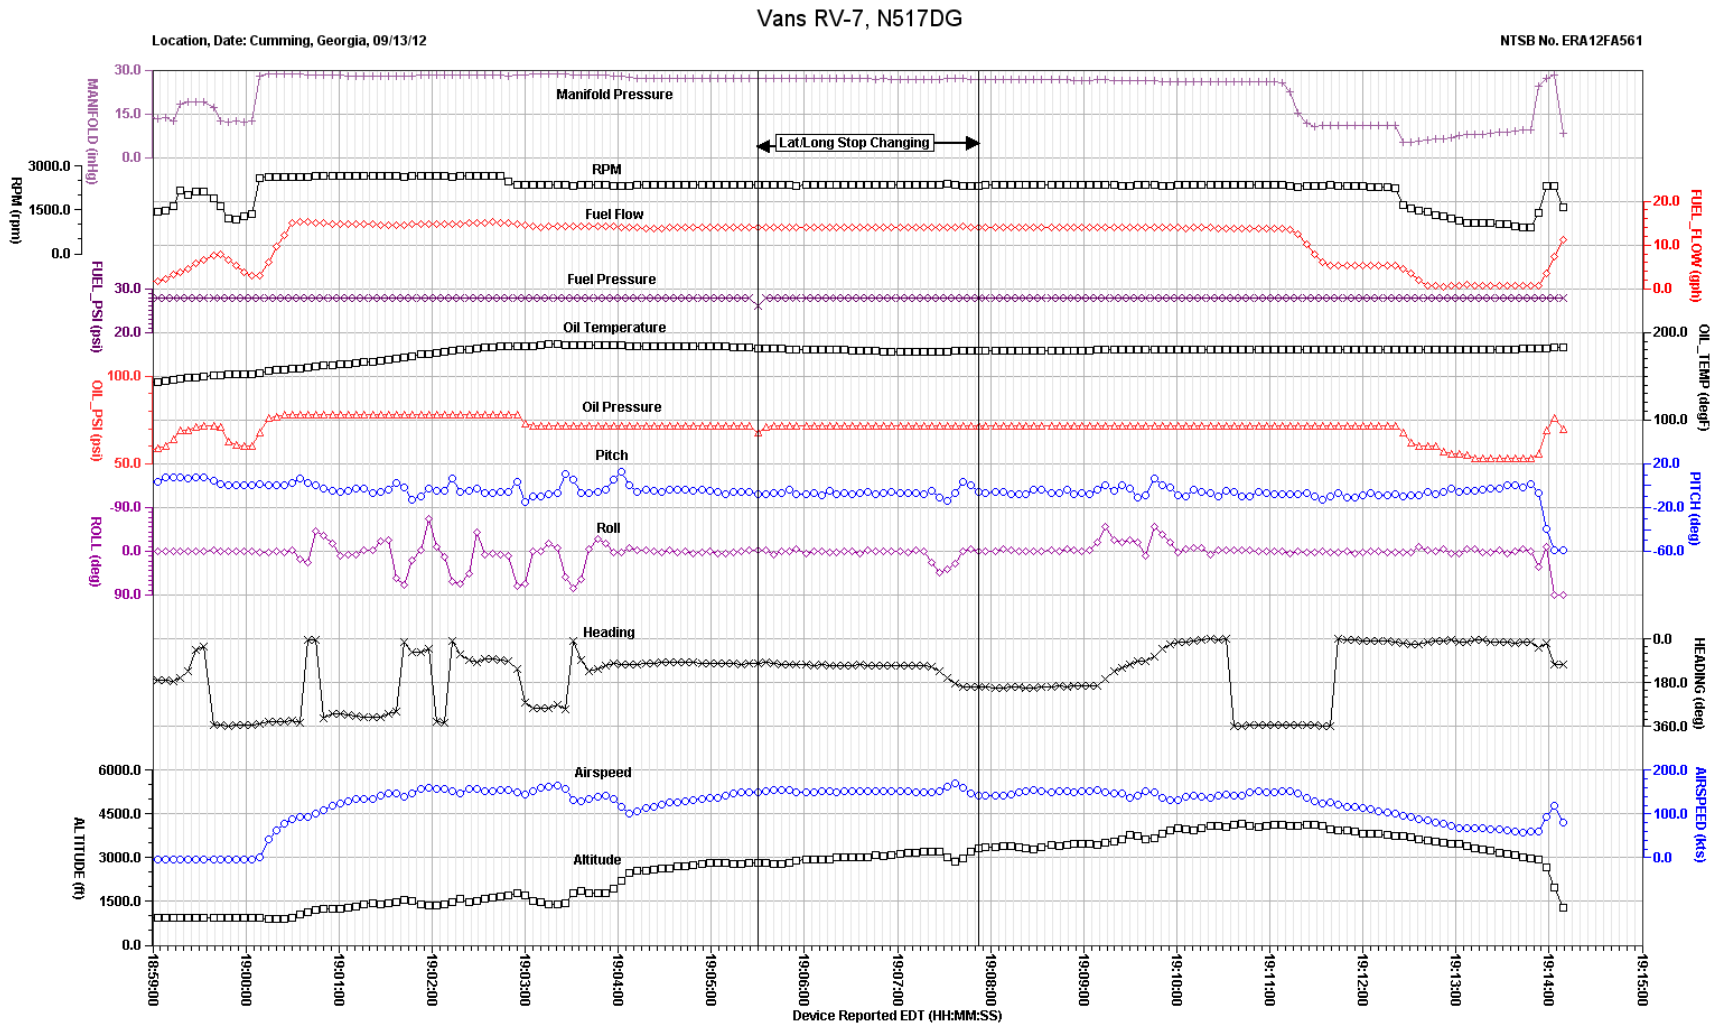
Figure 10 is a plot of basic parameters recorded by the AF-3500EE for the accident flight. The aircraft manifold pressure and RPM increased at 1900:06 while the aircraft was at an indicated altitude of 940 feet, followed shortly thereafter by increases in airspeed and altitude. As the aircraft climbed after departure, between 1900:36 and 1903:59, the roll angle changed direction 12 times with maximum roll angles between +/- 68 degrees. After the roll angle directional changes, the aircraft was heading easterly, climbing out of 2,200 feet. The aircraft climbed to a maximum altitude of 4,160 feet by 1910:42.

At 1905:30, when the latitude and longitude stopped changing, the fuel pressure and oil pressure recorded one sample of values inconsistent with the trend of other values surrounding that time period. The aircraft resumed an easterly heading until about 1907:20, at which time the aircraft turned right towards the south. The aircraft was heading southerly when latitude and longitude began to change again at 1907:51. At 1909:09, the aircraft turned left towards the north and remained in this direction until near the end of the recording.

At about 1911:06, the manifold pressure decreased from 26 inHg to about 11 inHg, coincident with a reduction in fuel flow and reduction in airspeed. The altitude began to decrease at about 1911:30, and continued to decrease until the end of the recording. At

1912:21, the manifold pressure further reduced, and the oil pressure began to reduce from 72 psi to about 55 psi by about 1913.

At about 1913:46, 23 seconds before the end of the recording, the manifold pressure, fuel flow, oil pressure, and airspeed increased. During this 23 second period, the altitude decreased from 3,030 feet to a last recorded value of 1,290 feet at 1914:09.

Figure 10. Plot of basic parameters for accident flight.

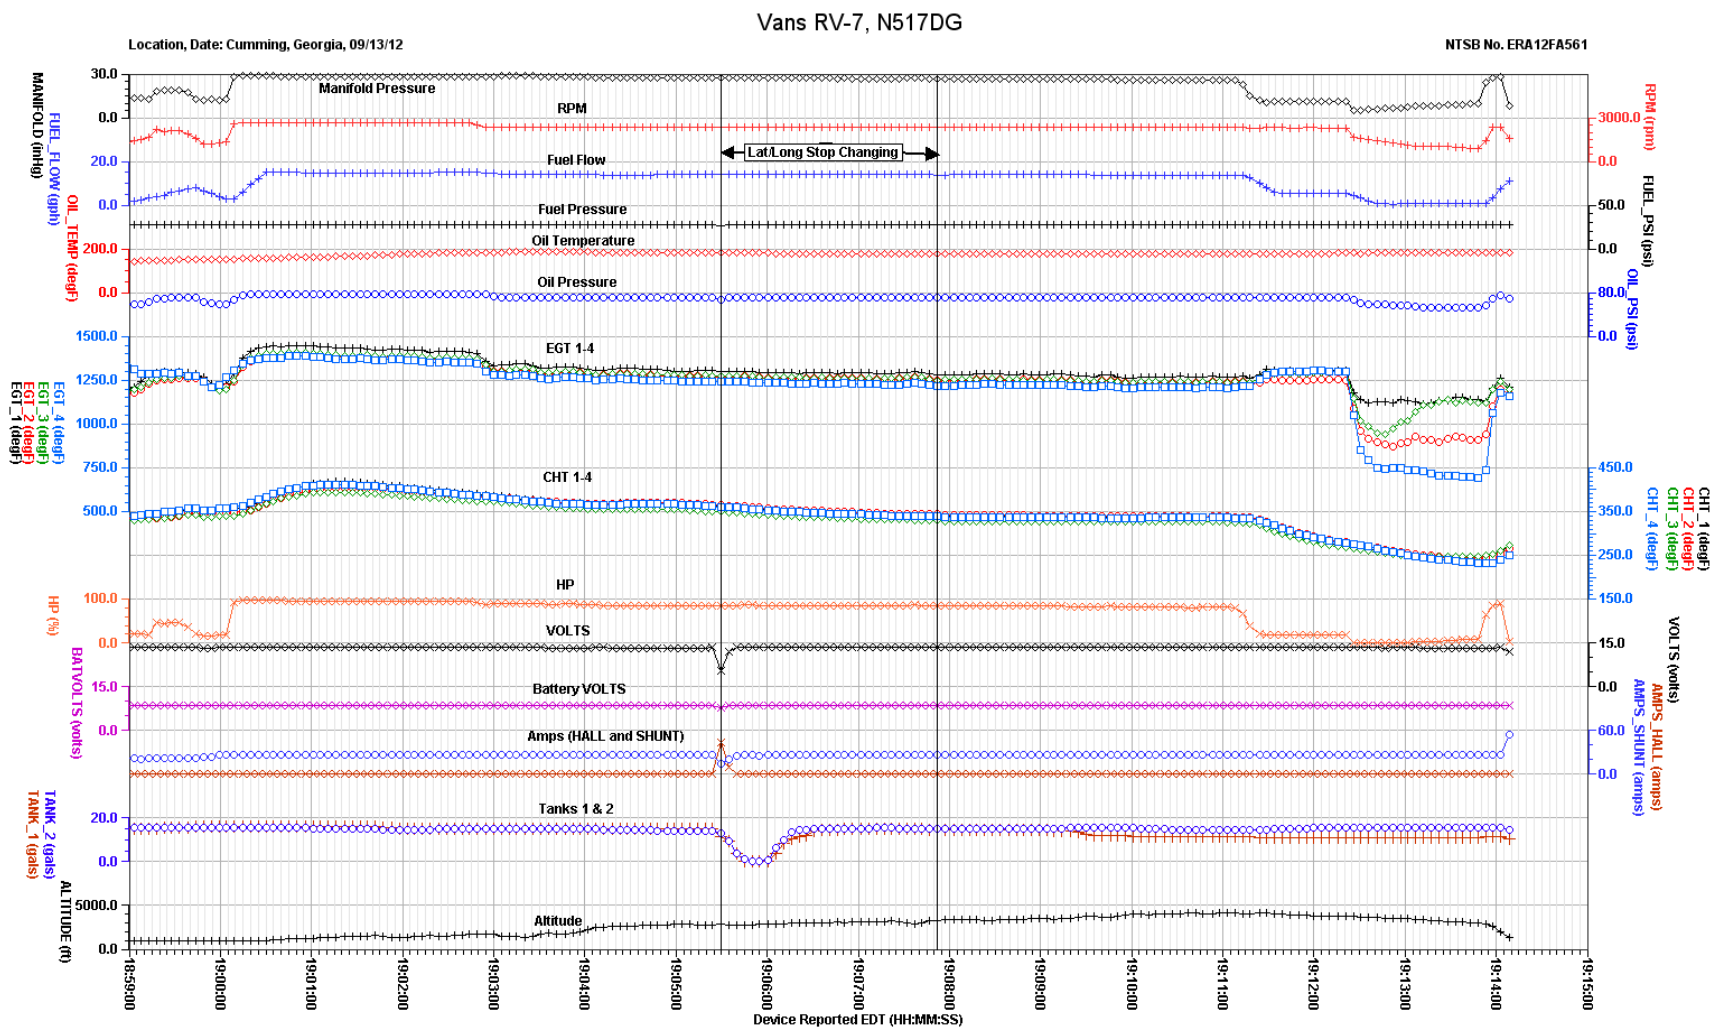
Figure 11 is a plot of engine parameters for the accident flight. The engine parameters show one sample of volt, amps, and fuel tank values inconsistent with the trended values around 1905:30, the time latitude and longitude stopped changing. At about 1911:18, the EGT values increased for about 1 minute. After 1911:18, CHT decreased until 1913:58, when CHT started to increase along with the manifold pressure and fuel flow until the end of the recording at 1914:09.

Figure 11. Plot of engine parameters for accident flight.
