NATIONAL TRANSPORTATION SAFETY BOARD

Electronic Devices Factual Report

Location: Dover, DE
Date: January 13, 2013
Aircraft: Piper PA-28R-200
Registration: N4975S
Operator: Private
NTSB Number: ERA13LA111

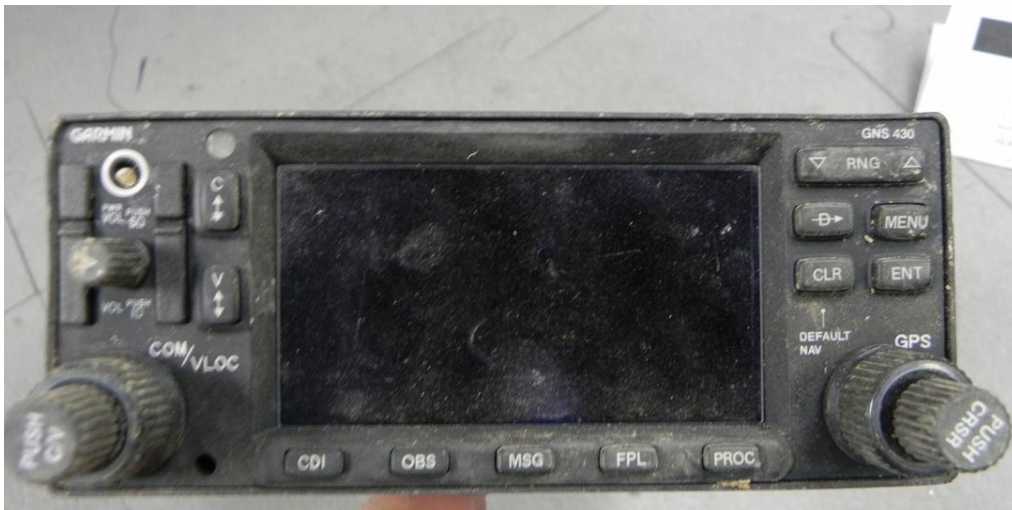
Figure 1. Garmin GNS 430W unit.

Upon arrival at the Vehicle Recorder Laboratory, an exterior examination revealed the unit had sustained minor impact damage, as shown in figure 1. Power was applied to the device and it started normally, without difficulty. Screen displays were examined and documented.

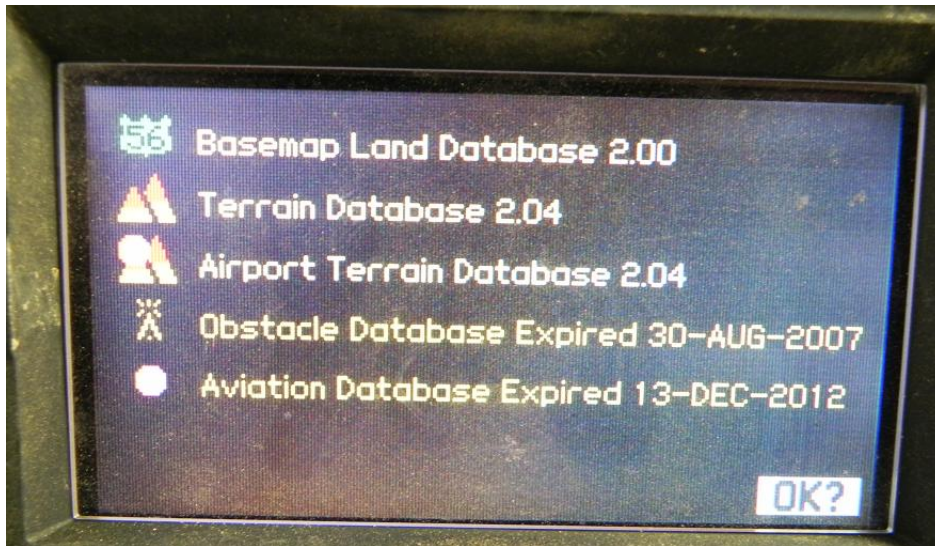
Figure 2. Garmin GNS 430W database expiration dates screen.

The unit was configured to integrate with external fuel flow information and the Garmin GTX 330 traffic information service (TIS). The unit had the Garmin terrain avoidance warning system (TAWS) option installed. The installed IFRW front-loading, IFR database card expired on December 13, 2012. The TAWS front-loading, obstacle database card expired on August 30, 2007. Figure 2 shows the startup screen database information.

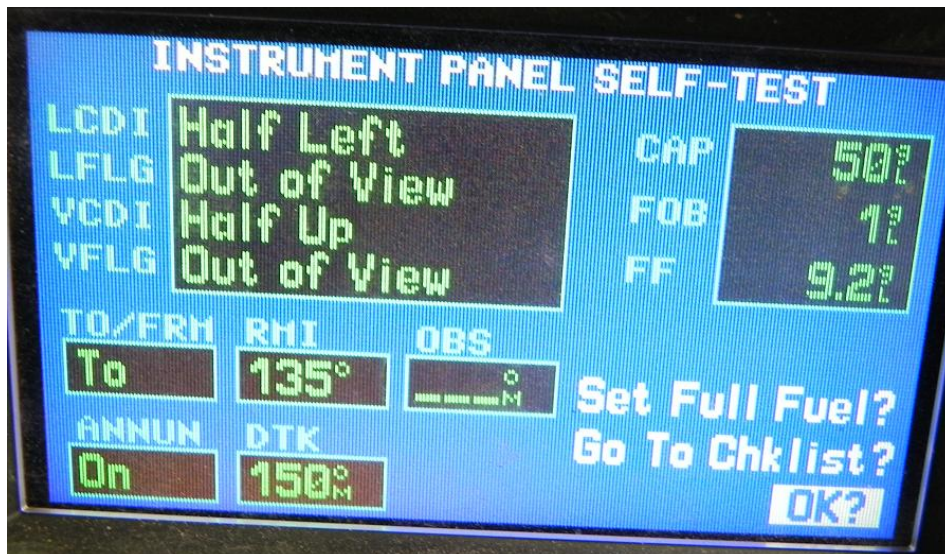
Figure 3. Garmin GNS 430W self-test screen.

Upon startup, the instrument panel self-test screen indicated the fuel capacity of the aircraft was set to 50 gallons, and 1 gallon of fuel was on board, as shown in figure 3.

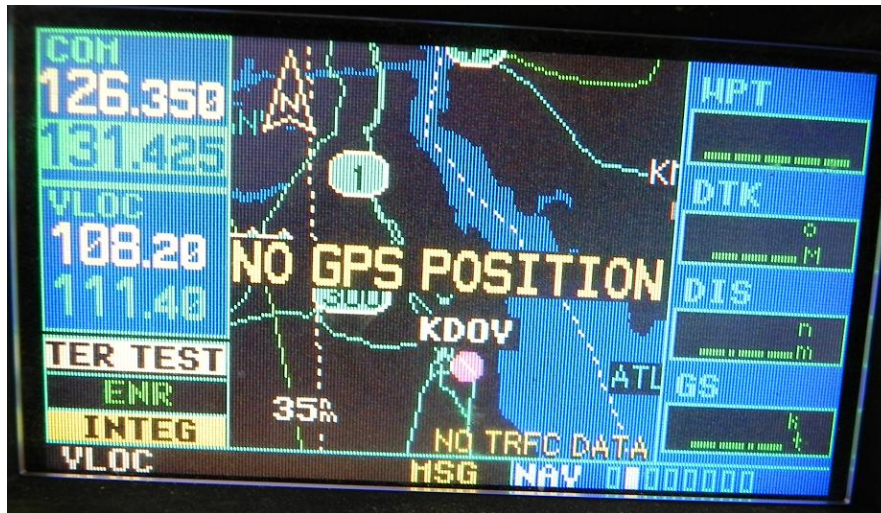
Figure 4. Garmin GNS 430 default navigation screen.

The default navigation screen indicated the unit was set to "VLOC" mode. The active communication frequency was 126.350, the standby communication frequency was 131.425. The active navigational VOR/LOC frequency was 108.20; the standby navigation frequency was 111.40. The default navigation screen is shown in figure 4.

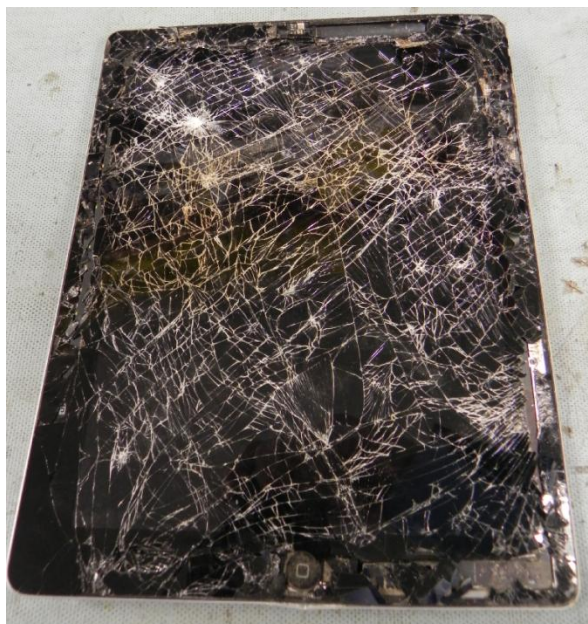
Figure 5. Apple iPad 2 unit.

Upon arrival at the Vehicle Recorder Laboratory, an exterior examination revealed the unit had sustained significant impact damage, as shown in figure 5. An internal inspection revealed the main processor board was not damaged, as shown in figure 6. The main processor board was installed into an NTSB surrogate unit. The surrogate unit powered on normally and the contents were examined.
