# NATIONAL TRANSPORTATION SAFETY BOARD

## Electronic Devices Factual Report

Location: Talihina, Oklahoma  
Date: October 21, 2013  
Aircraft: Piper PA-28-140  
Registration: N113WS  
Operator: Private  
NTSB Number: CEN14FA019

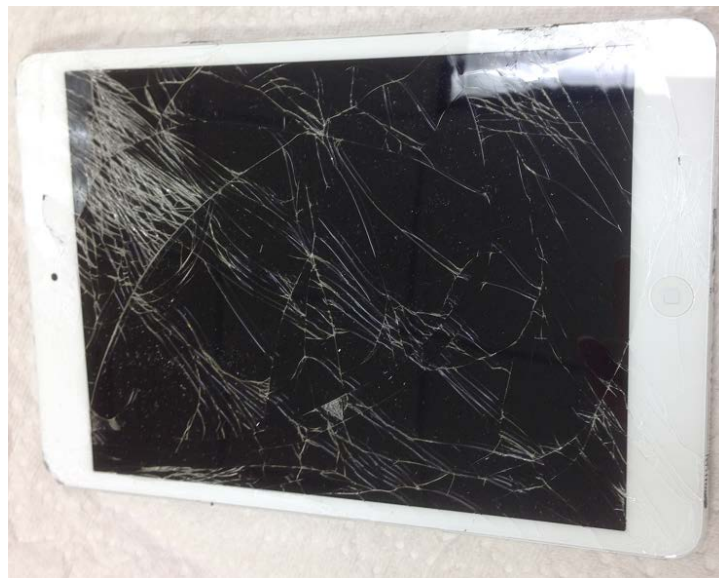
**Figure 1. Apple iPad Mini.**

Upon arrival at the Vehicle Recorder Laboratory, an exterior examination revealed the unit had sustained structural damage, as shown in figure 1. Despite the damage, the unit started normally and screens were examined and information downloaded.

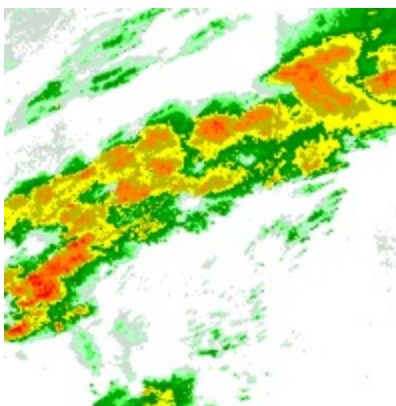
**Figure 4. Garmin Pilot cached tile image from October 21, 2013 at 14:27:23 CDT.**

Various images were retained on the iPhone. During the time period when the aircraft was in flight<sup>2</sup>, tiles of images were being received by the iPhone. For example, figure 4 shows a tile image received by the phone on October 21, 2013 at 14:27:23 CDT representing a portion of a NEXRAD image. The Garmin Pilot application uses the tiles to compose NEXRAD and satellite images geographically overlaid on a chart.

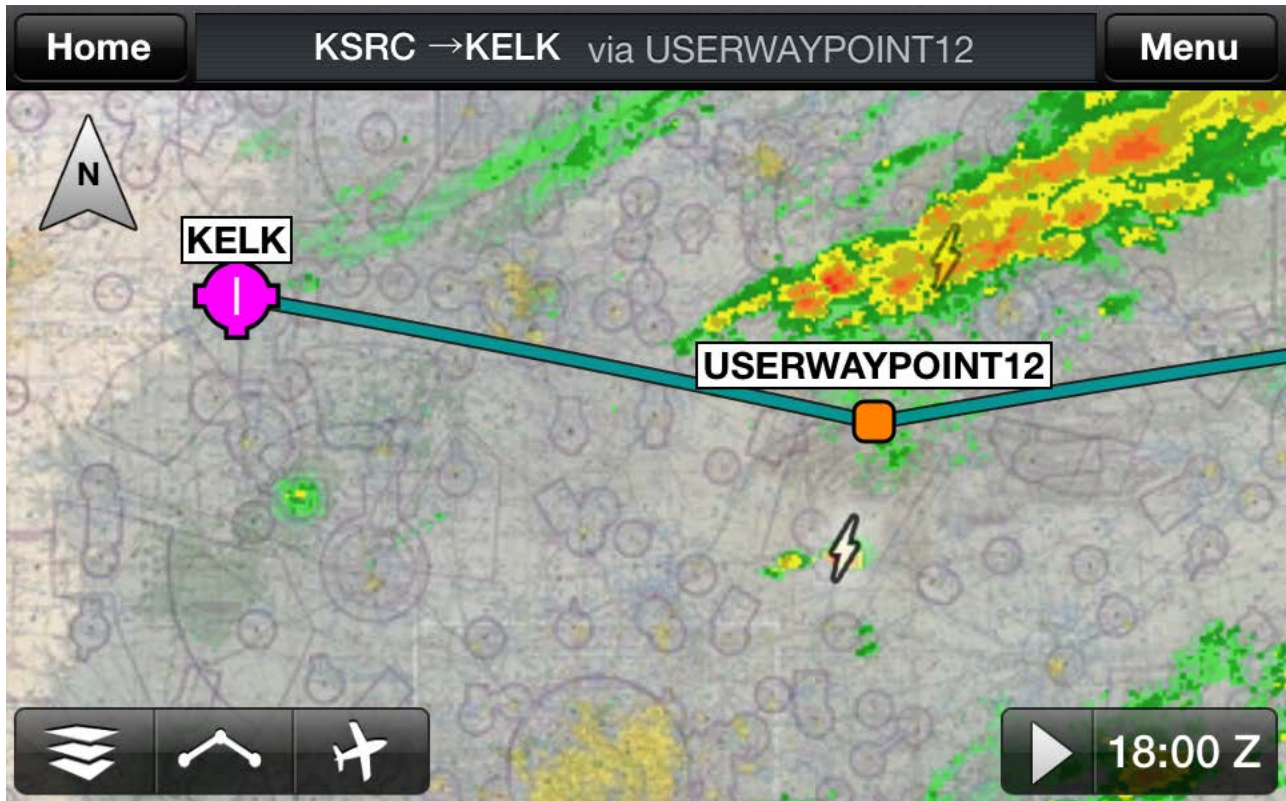
Figure 5. Garmin Pilot image - October 21, 2013 13:10:12 CDT

On occasion, logic within the iPhone operating system and Garmin Pilot application will retain an application image. Figure 5 shows an application image stored on October 21, 2013 at 13:10:12 CDT. The stored image lacks sufficient resolution to identify the precise location of "USERWAYPOINT12;" however, comparing the image to an FAA sectional indicates that "USERWAYPOINT12" was in the vicinity of the Talihina (6F1) airport.

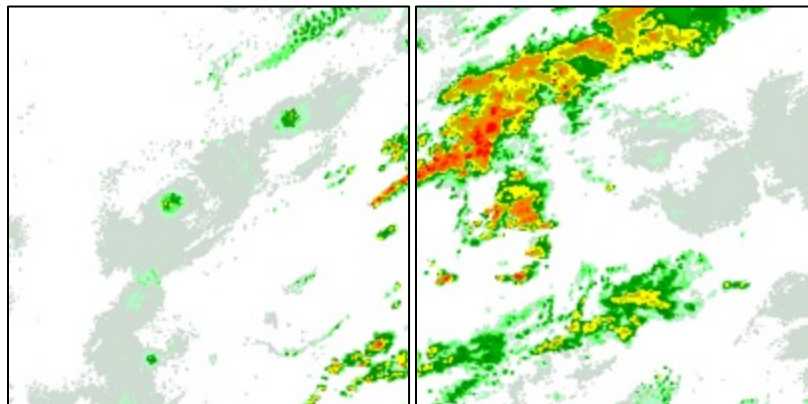
Figure 8. Garmin Pilot last two images received - October 21, 2013 15:11:21 CDT

From the period October 21, 2013 at 13:30 through 15:11:21 CDT, about 300 tiled weather images were received by the accident aircraft. The last two images received by the phone were weather tiles at 15:11:21 CDT, as shown in figure 8.
