NATIONAL TRANSPORTATION SAFETY BOARD

17 – Electronic Devices Factual Report

Specialist's Factual Report
by Joe Gregor

Location: Maxwell, Nebraska
Date: August 11, 2012
Aircraft: Beech V35B
Registration: N11JK
Operator: Private
NTSB Number: ERA12LA500

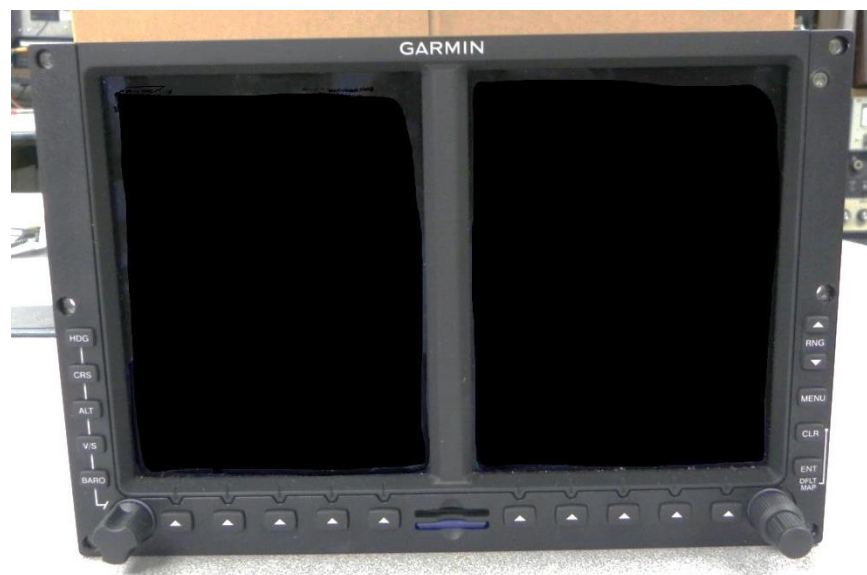
Figure 1. External view of the Garmin GDU-620 primary-flight / multi-function display (PFD/MFD).

The Garmin GDU-620 is a panel-mounted primary flight / multi-function display (PFD/MFD) utilizing two side-by-side color displays. The PFD function of this unit is designed to display flight performance data such as airspeed, altitude, vertical speed, aircraft attitude, and navigation data. The GDU-620 can also as an option support the display of Garmin Synthetic Vision Technology. The MFD function of this unit can display data stored on data-cards inserted in the front panel, and from other sources, including: custom maps, IFR charts, VFR charts, terrain, traffic information, lighting,

Upon arrival at the Vehicle Recorder Laboratory, an exterior examination revealed the unit had no visible damage. According to the manufacturer, this unit only records internal fault codes. Multiple requests for manufacturer support in downloading and interpreting these fault codes ultimately met with no response.

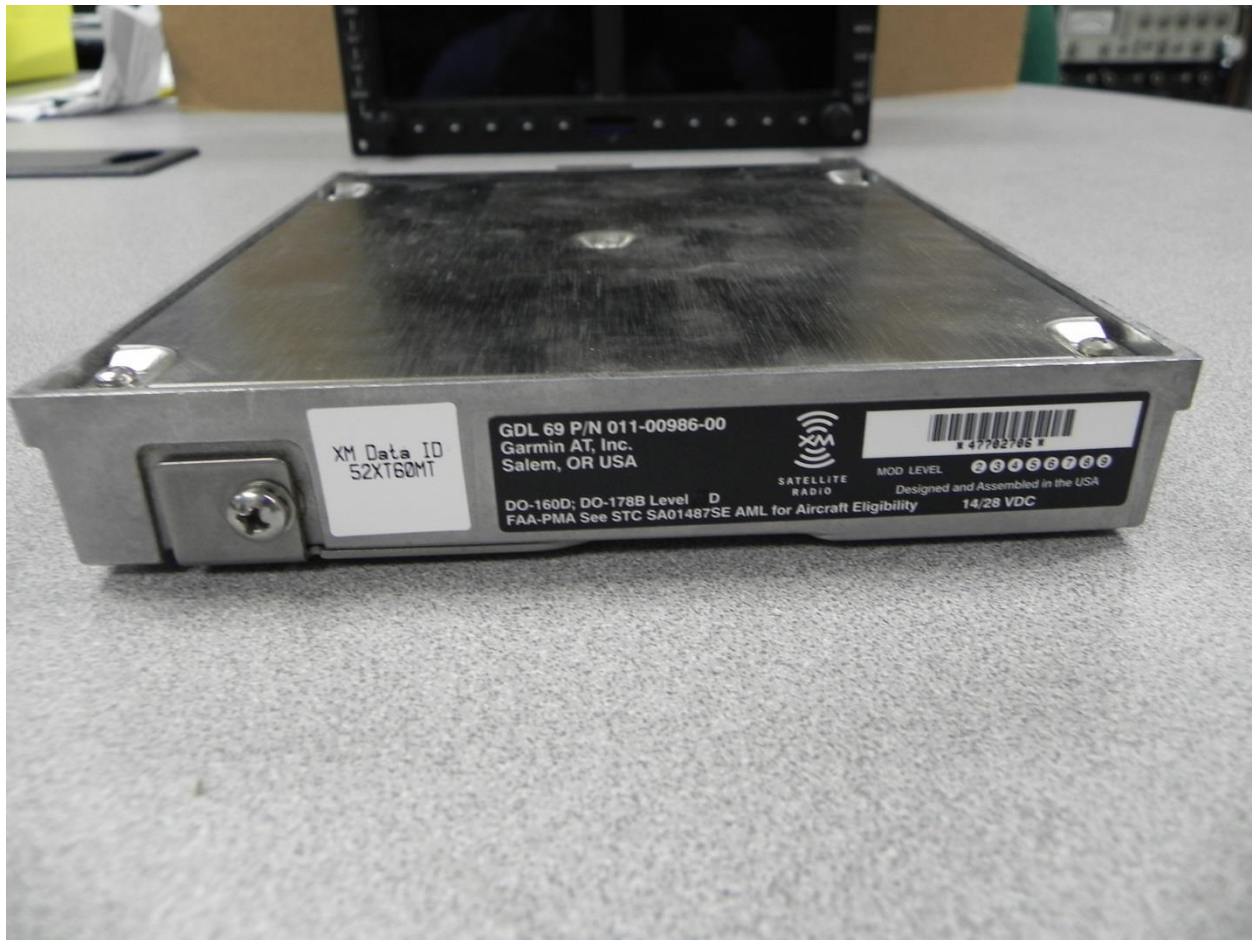
Figure 2. External view of the Garmin GDL-69 XM satellite weather receiver.

The Garmin GDL-69 is a remote datalink receiver designed to receive and distribute data from an XM WX Satellite Weather subscription to a compatible PFD / MFD.

Upon arrival at the Vehicle Recorder Laboratory, an exterior examination revealed the unit had no visible damage. According to the manufacturer, this unit only records internal fault codes. Multiple requests for manufacturer support in downloading and interpreting these fault codes ultimately met with no response.

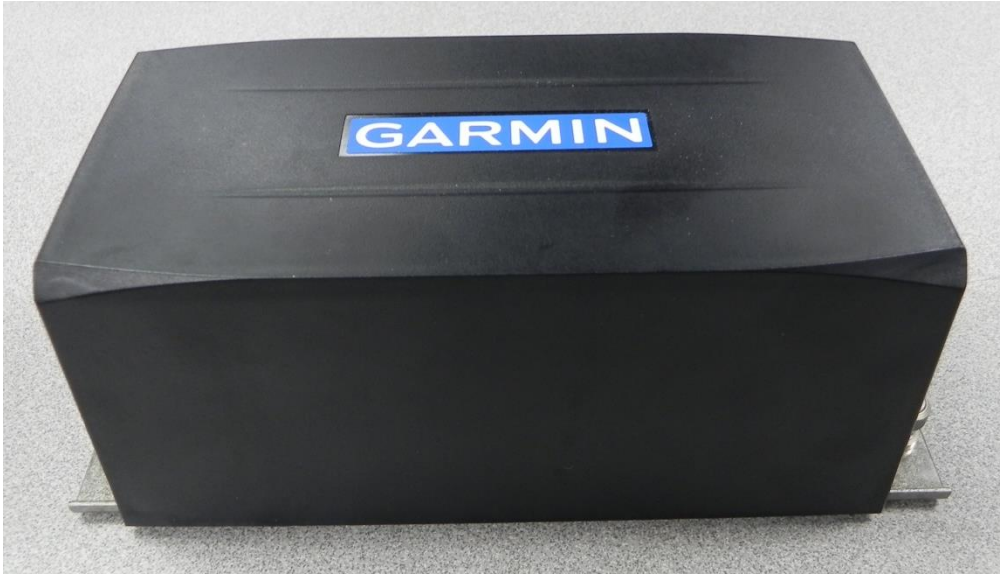
Figure 3. External view of the Garmin GRS-77 attitude heading and reference system (AHRS).

The Garmin GRS-77 is an Attitude Heading and Reference System (AHRS) designed to provide attitude and heading information to Garmin Integrated Flight Decks (G1000, G1000H, G950, G900X, G500, G500H, G600). The GRS-77 employs accelerometers and rate sensors, together with GPS data from the Garmin GIA63, to compute aircraft heading and attitude, and sends this information to the flight display using an ARINC 429 digital interface. The GRS-77 is subject to recent Garmin Service Advisories including:

Upon arrival at the Vehicle Recorder Laboratory, an exterior examination revealed the unit had no visible damage. According to the manufacturer, this unit only records internal fault codes. Multiple requests for manufacturer support in downloading and interpreting these fault codes ultimately met with no response.
