# NATIONAL TRANSPORTATION SAFETY BOARD

## Electronic Devices

Specialist's Factual Report  
By Jane Foster

Location: Biloxi, Mississippi  
Vehicle #1: 2016 Vanhool Motor coach  
Operator #1: Echo Transportation  
Vehicle #2: Locomotive  
Operator #2: CSX Transportation  
Date: March 7, 2017  
NTSB Number: HWY17MH010

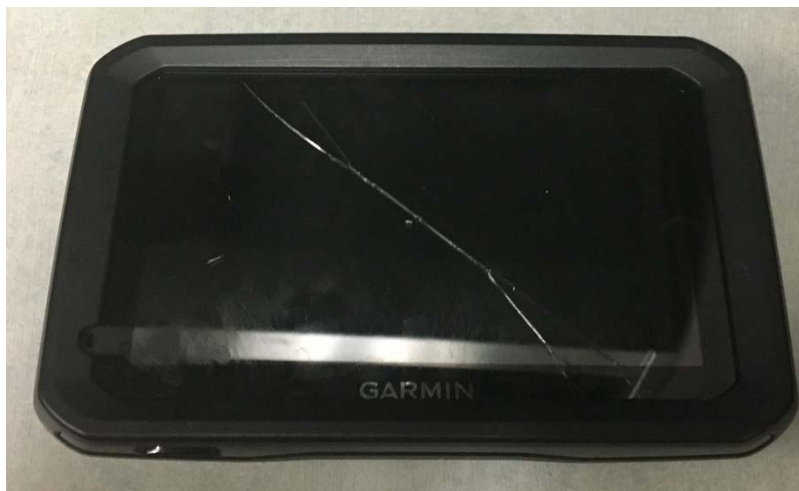
Figure 1. Front of Garmin DEZL 570MT.

The Garmin DEZL 570MT GPS was imaged at the Biloxi Police Department. Figures 1 and 2 show the front and back of the GPS. There was some impact damage, but the device was read out normally using manufacturer's and forensic software.

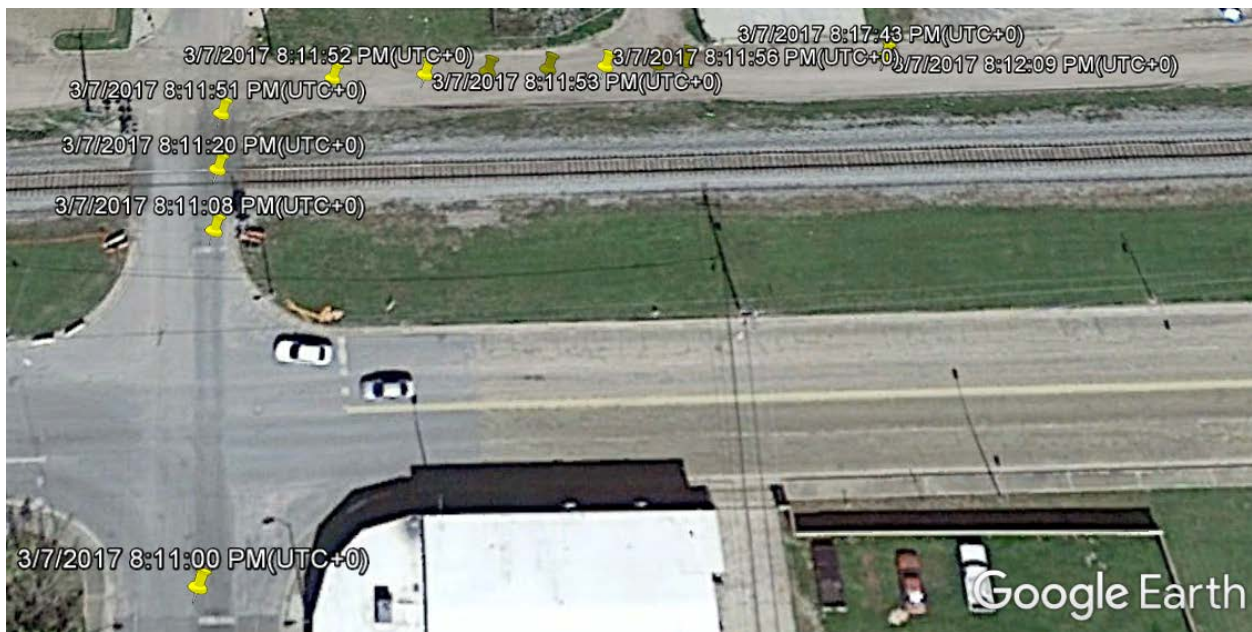
**Figure 4. Google Earth plot showing the grade crossing in UTC.**

Figure 4 is a graphical overlay generated using Google Earth zoomed in on the grade crossing. Figure 4 highlights the motor coach crossing the train tracks.

Tabular data used to generate figures 3 and 4 are included as attachment 1. The attachment is provided in electronic comma-delimited (.CSV) format.

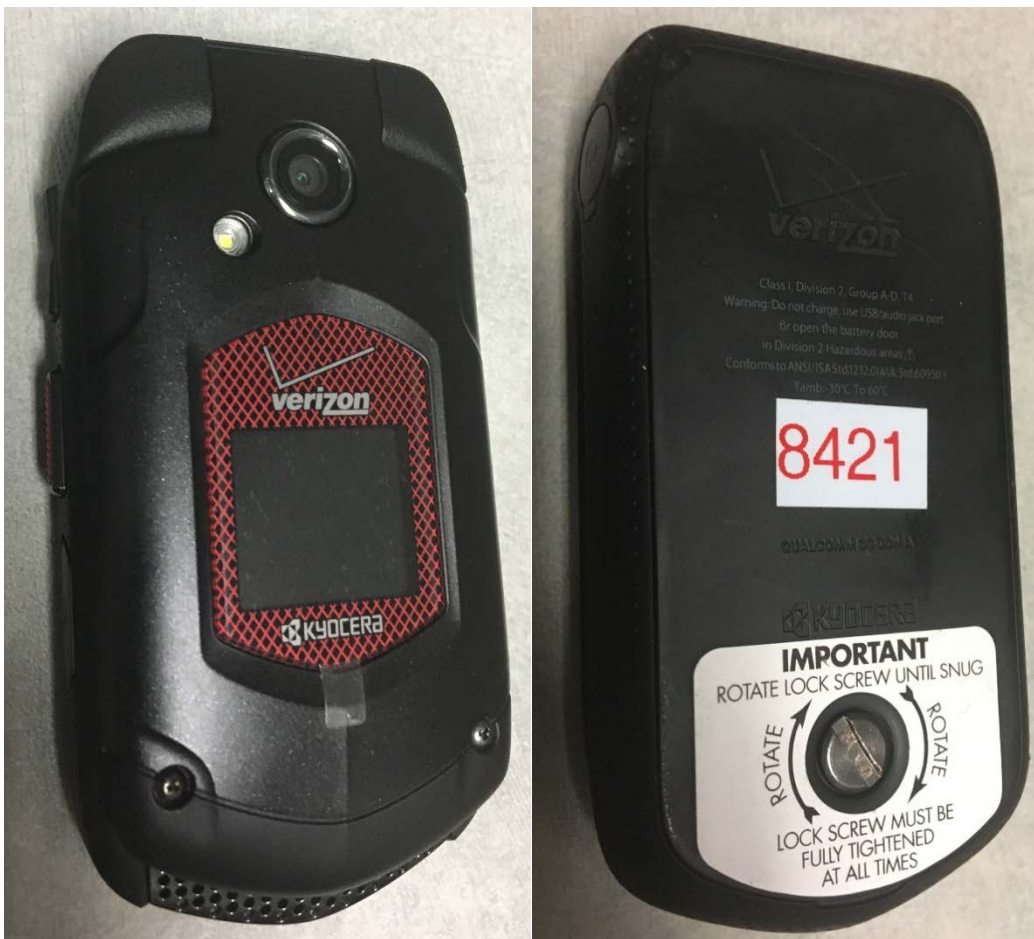
Figure 5. Front and Back of Kyocera DuraXV+ cell phone.

The Kyocera cell phone was imaged at the Biloxi Police Department. The Kyocera cell phone was the motor coach driver's work phone. Figure 5 shows the front and back of the cell phone. The cell phone was read out in three separate pieces (SIM Card, Memory, and Phone) using forensic software.

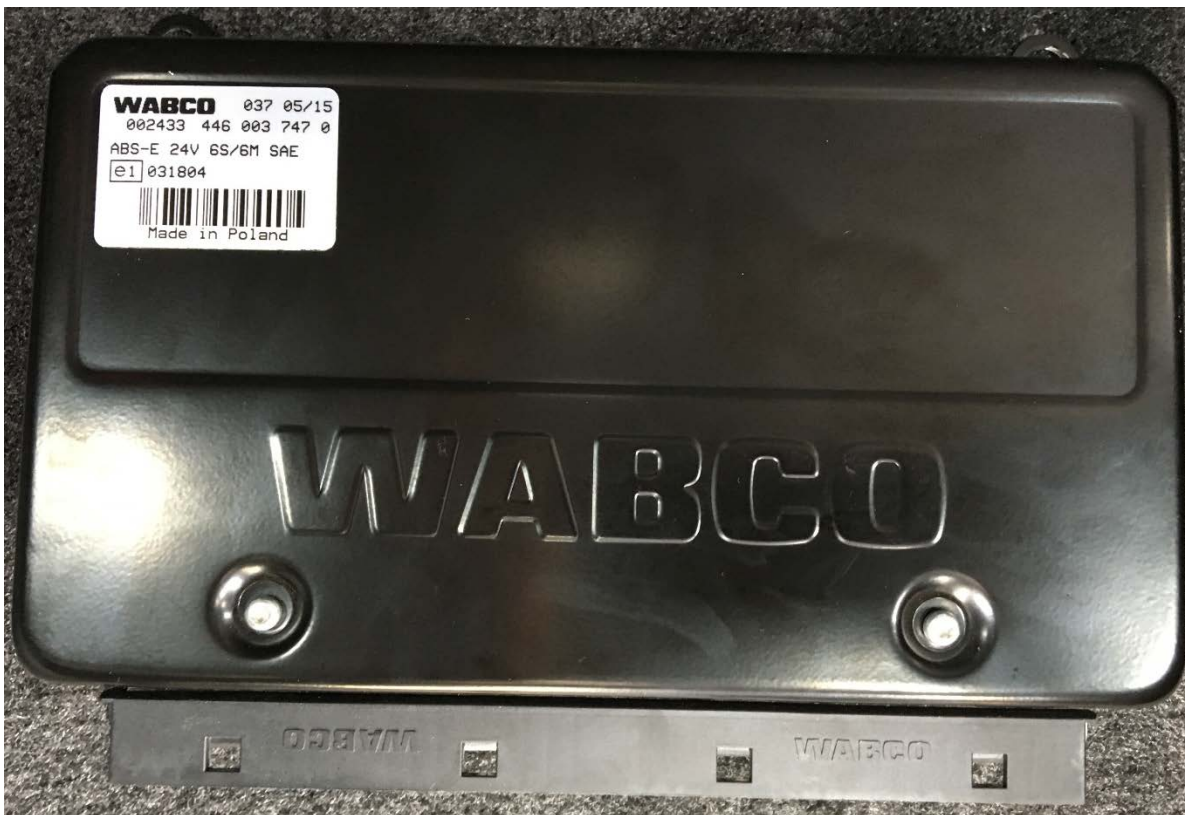
Figure 6. Front of Wabco ABS-E module.

Normal imaging of the Wabco brake module was attempted but a persisting communication error prevented imaging. The module was removed from the vehicle and brought to the manufacturer for download. Figures 6 and 7 show the Wabco ABS-E module.

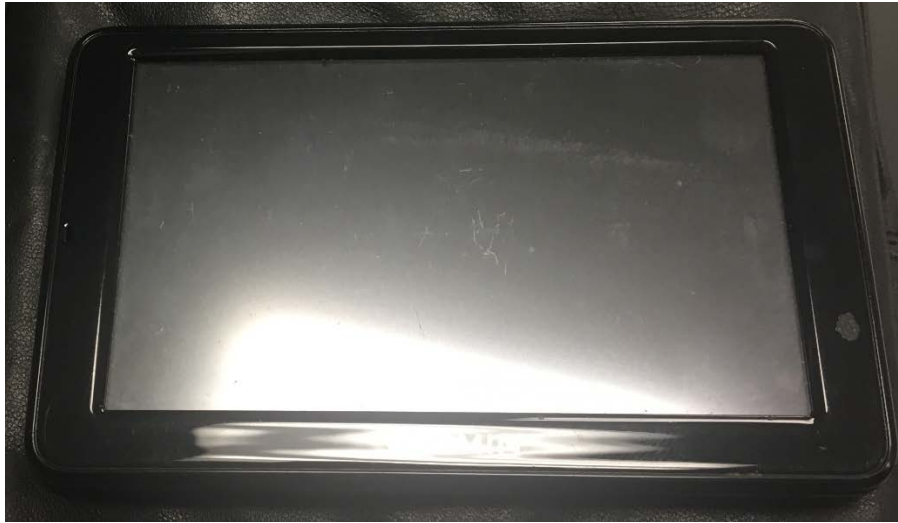
**Figure 8. Front of Garmin Nuvi 2555LMT.**

The Garmin Nuvi 2555LMT was imaged at the Biloxi Police Department. Figures 8 and 9 show the front and back of the GPS. The device was not damaged, and the device was read out normally using forensic software.

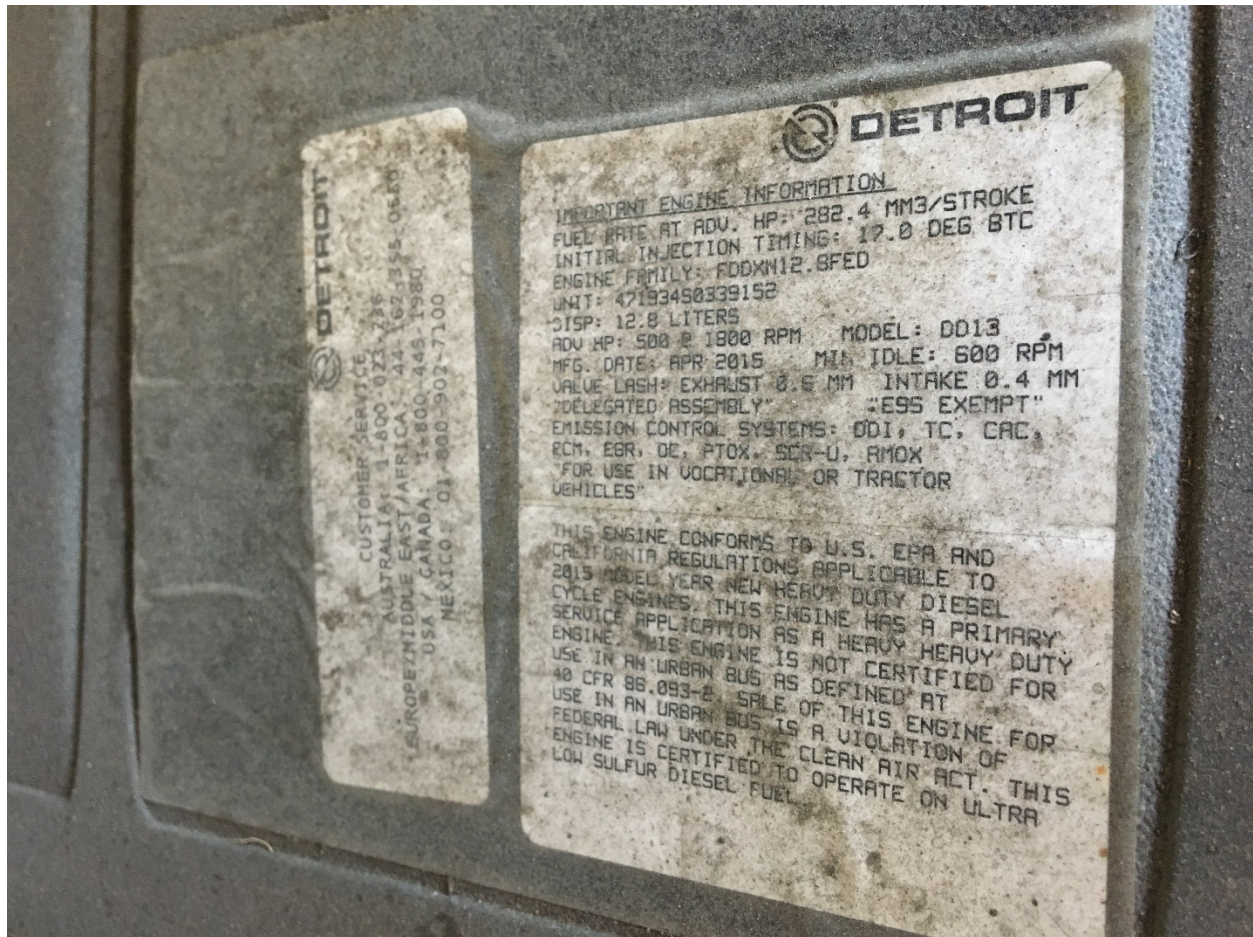
Figure 10. Motor coach engine information.

The DDEC IV was not damaged and was read out normally using the manufacturer's software. Figure 10 shows the motor coach engine information.

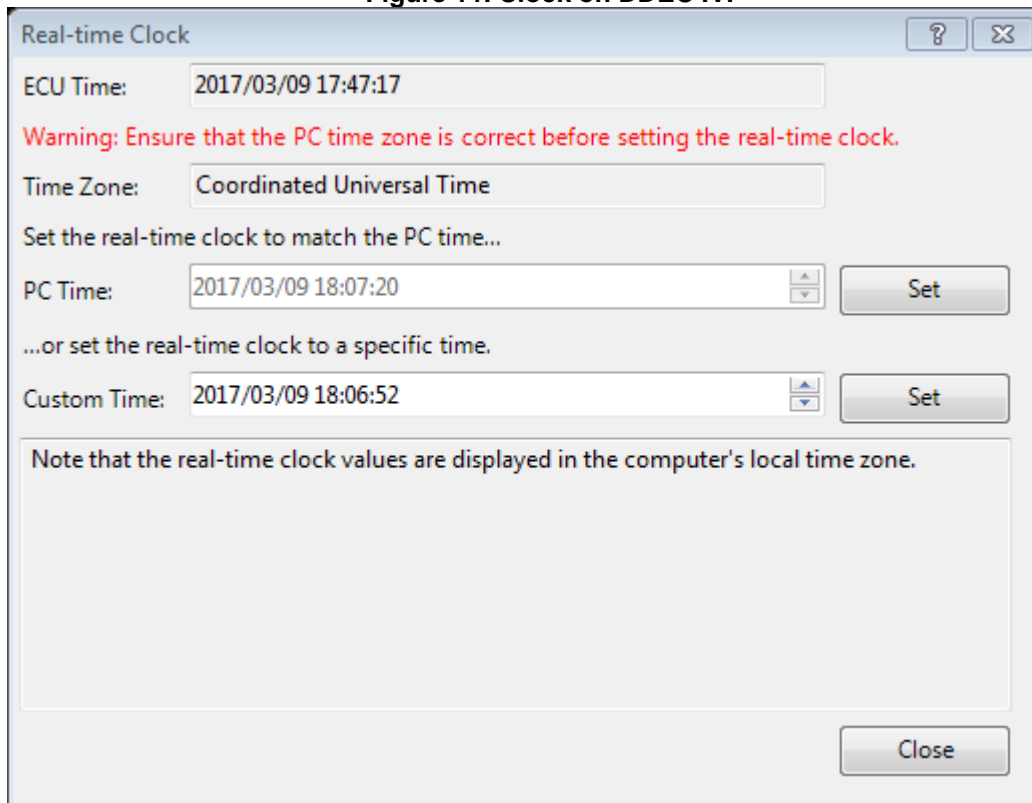
Figure 11. Clock on DDEC IV.

Figure 11 shows a screenshot with both the PC Time (time on the computer/UTC) and the ECU time (time on the DDEC IV). The ECU time can be shifted to UTC by using the below formula:

$$\text{ECU Time} + 20 \text{ minutes} + 3 \text{ seconds} = \text{UTC}$$

The local time was central standard time (CST) which is six hours less than UTC.
