NATIONAL TRANSPORTATION SAFETY BOARD

Vehicle Recorder Division

Electronic Devices

Specialist's Factual Report

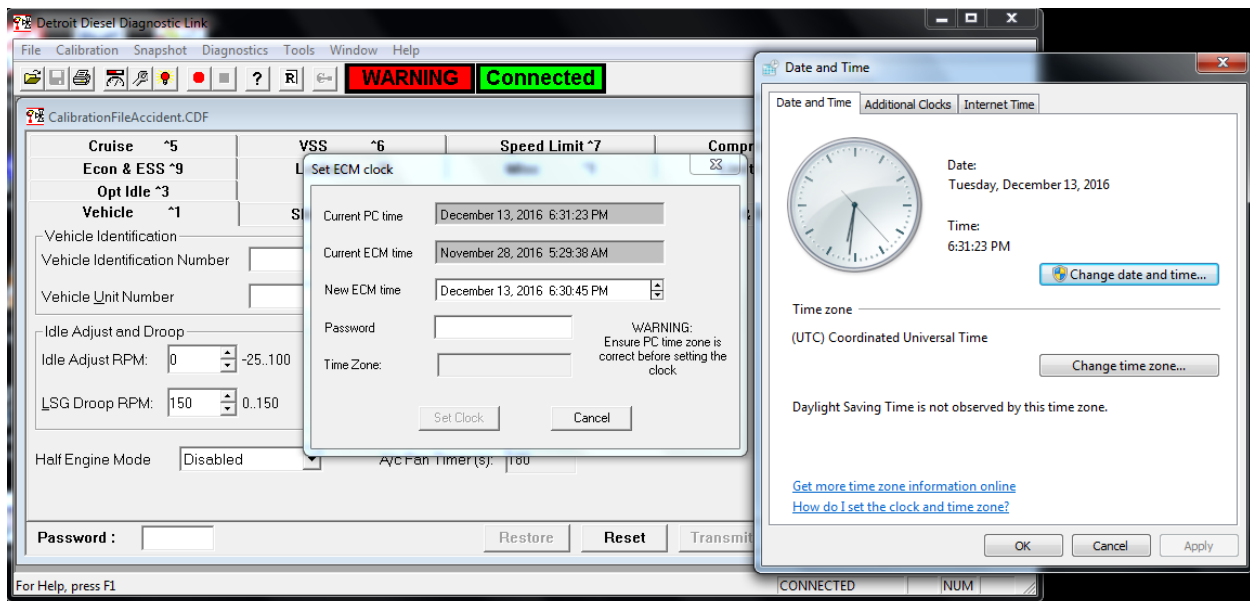
Figure 1 shows the clock of the DDEC IV ECM which was used to calculate the drift of the internal clock. The imaging computer was set to Coordinated Universal Time (UTC). The accident occurred in PDT (-7 UTC). The ECM was programmed in Eastern Standard Time (EST), and the internal clock was determined to be 15 days, 13 hours, 1 minute, 45 seconds slow. To correct for clock drift, 15 days, 13 hours, 1 minute, 45 seconds were added to each of the time-stamped records. Two hours (2:00:00) were then subtracted to adjust for the local time (EST to PDT). In this analysis, local time will be used, with the actual time-stamped record referenced below.

Figure 1. Clock of the DDEC IV.

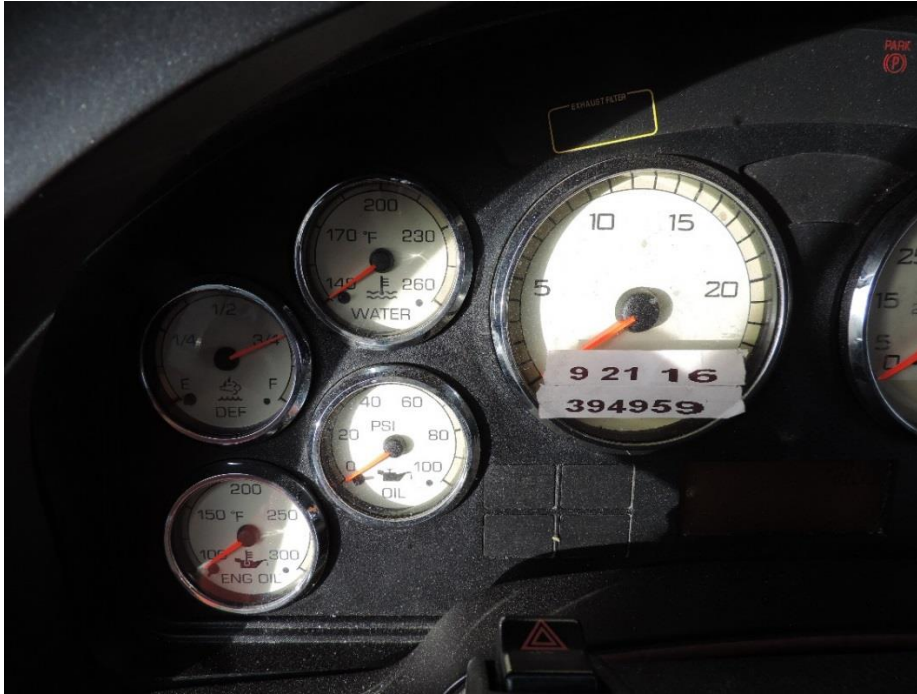
Figure 2. Left side of instrument panel on tractor trailer.

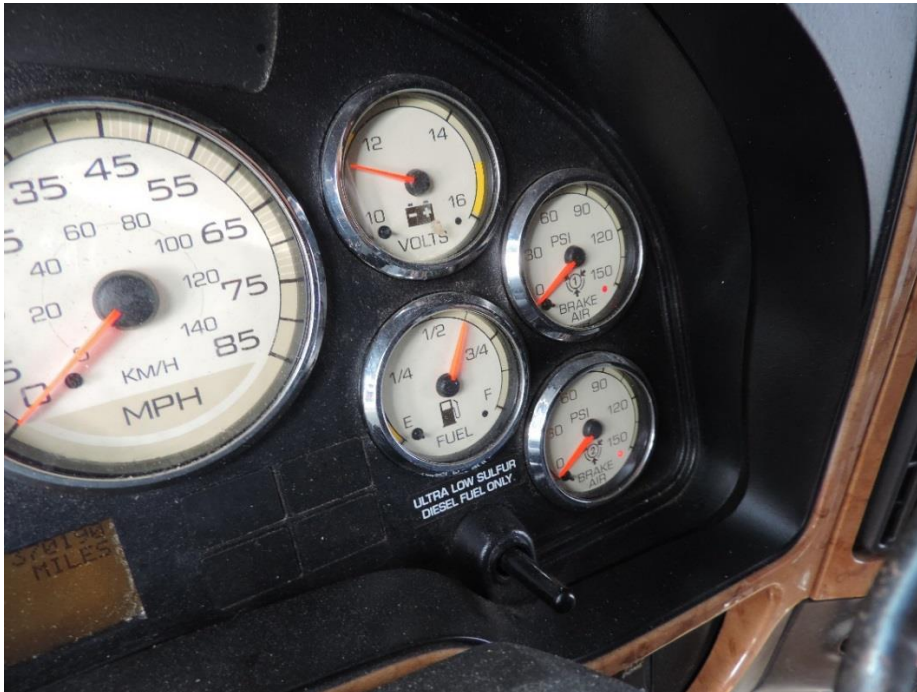
Figure 3. Right side of instrument panel on tractor trailer.

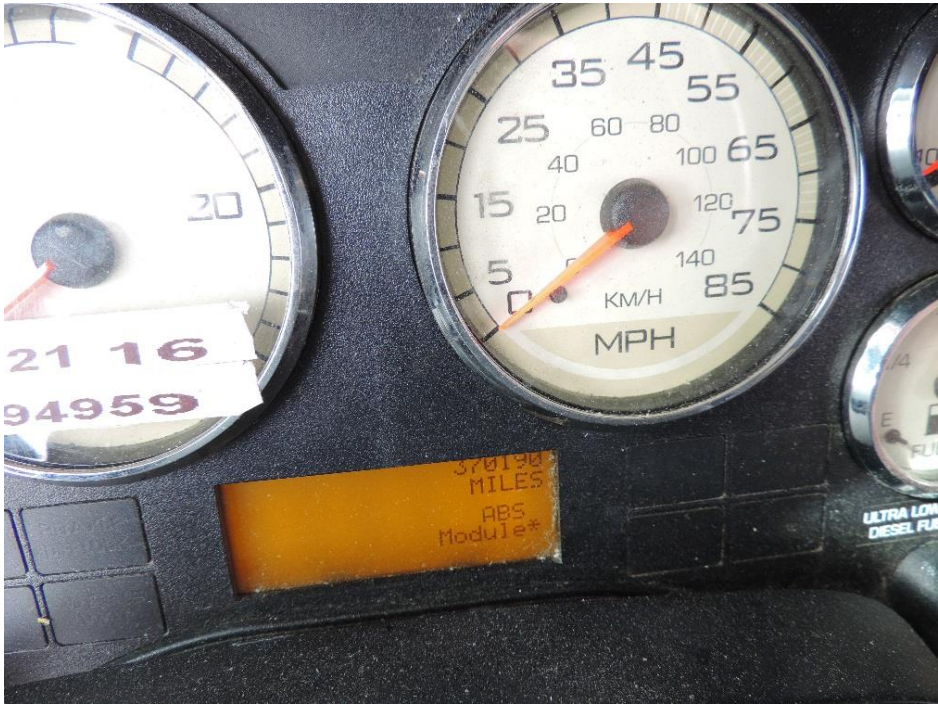
Figure 4. Mileage of the tractor trailer displayed on the instrument panel. The screen read 370190 miles.

The image of the tractor trailer ECM did not have all the same information as the instrument panel. Table 1 shows the differences in the data. The engine hours were used to help align events when looking at the data.

Parameter	Instrument Panel Display	ECM Image Information
Mileage	370190	83952.2
Engine Hours	2520	2520.44

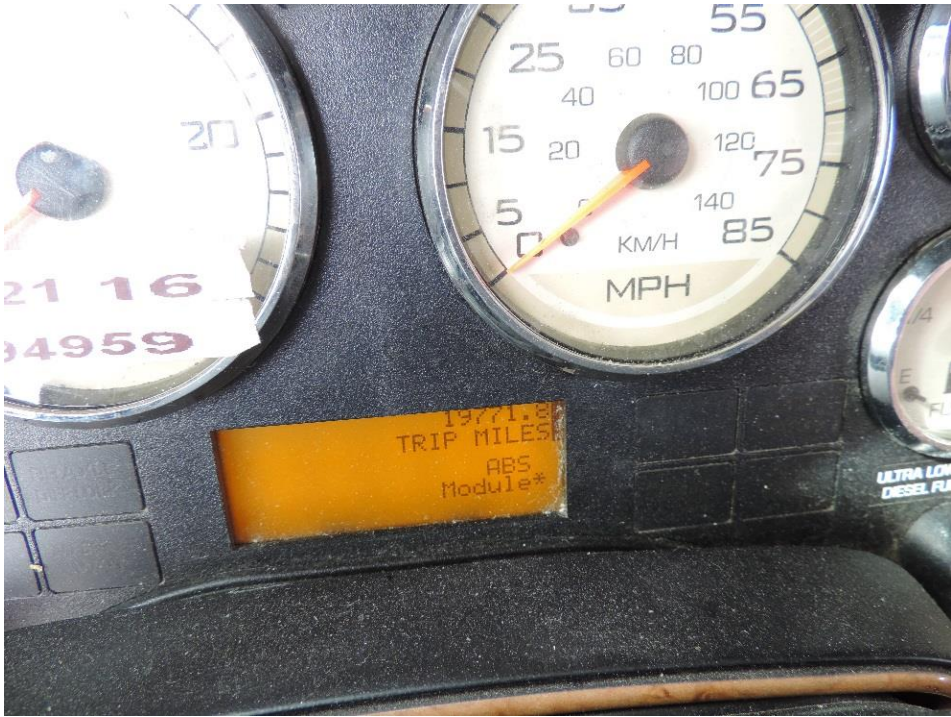
Figure 5. Trip Miles of the tractor trailer displayed on the instrument panel. The screen read 19771.8 miles.

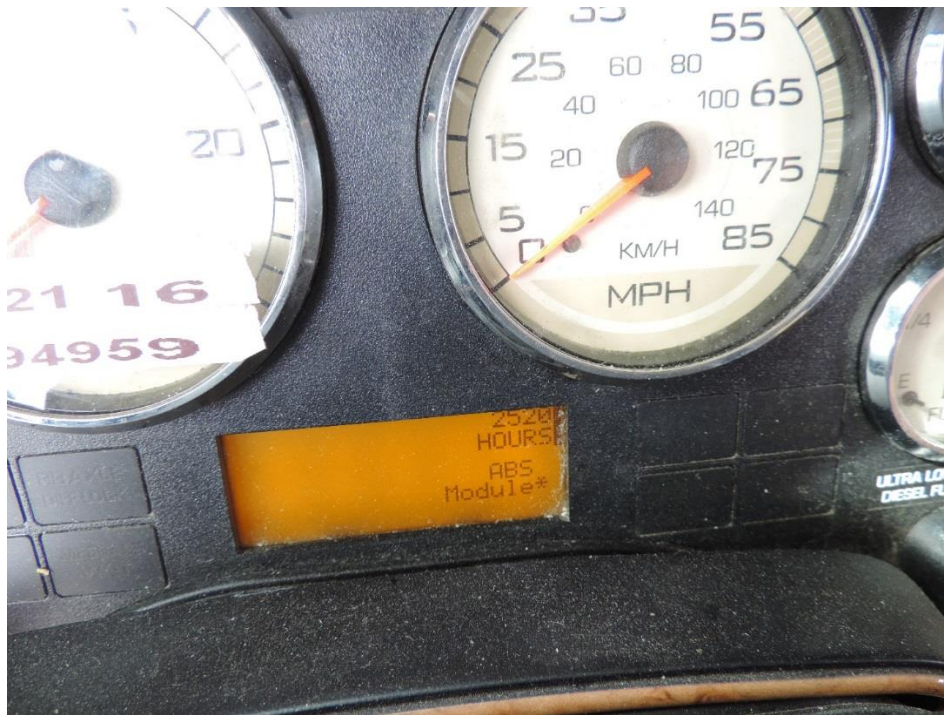
Figure 6. Engine hours of the tractor trailer displayed on the instrument panel. The screen read 2520 hours.

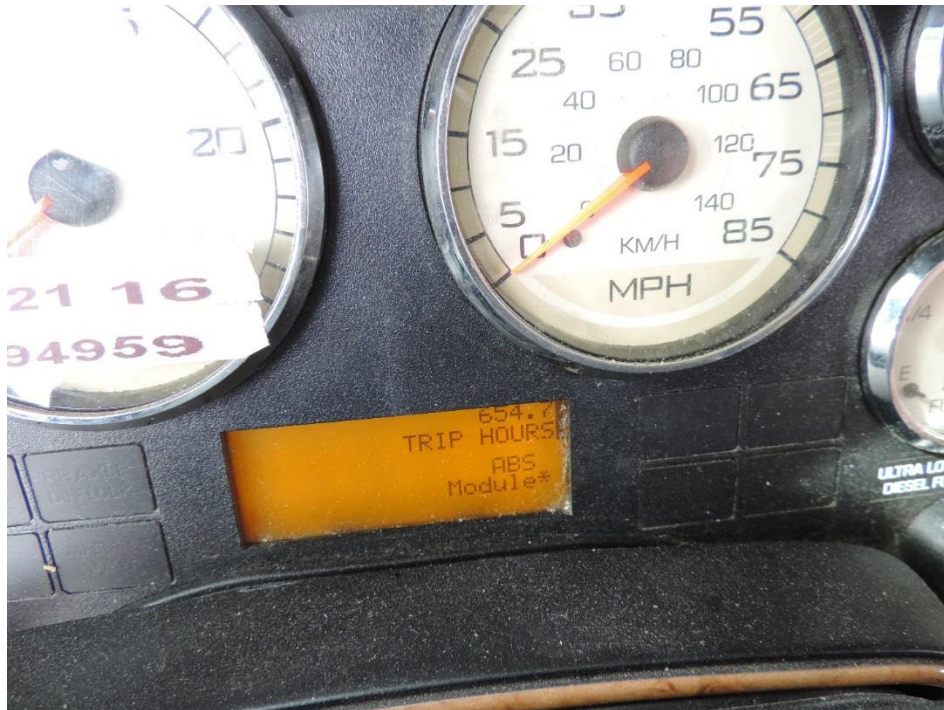
Figure 7. Trip engine hours of the tractor trailer displayed on the instrument panel. The screen read 654.7 hours.

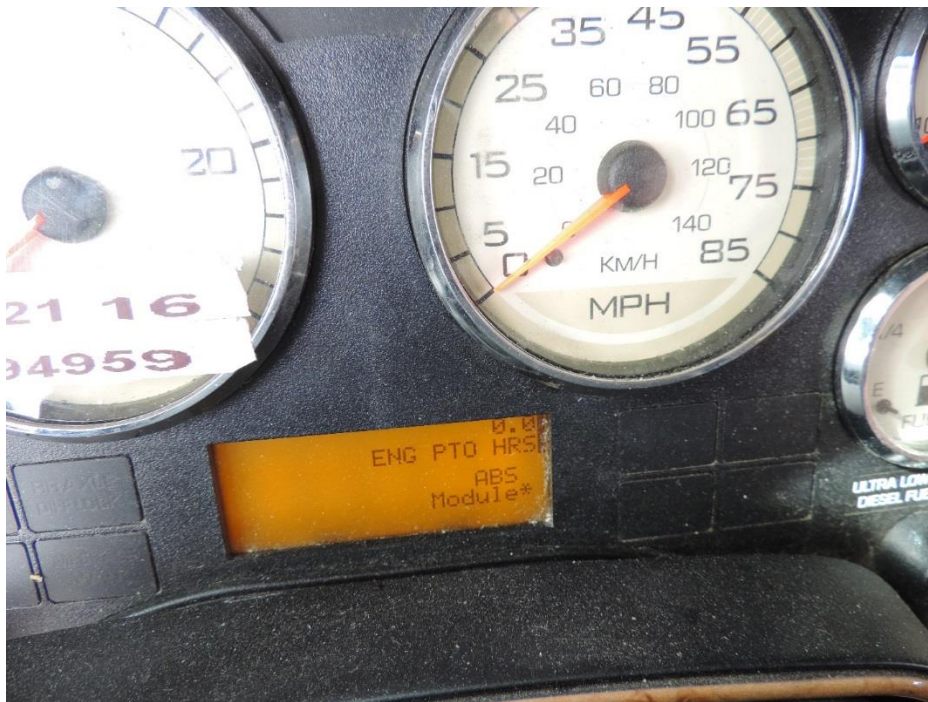
Figure 8. Engine PTO hours of the tractor trailer displayed on the instrument panel. The screen read 0.0 hours.

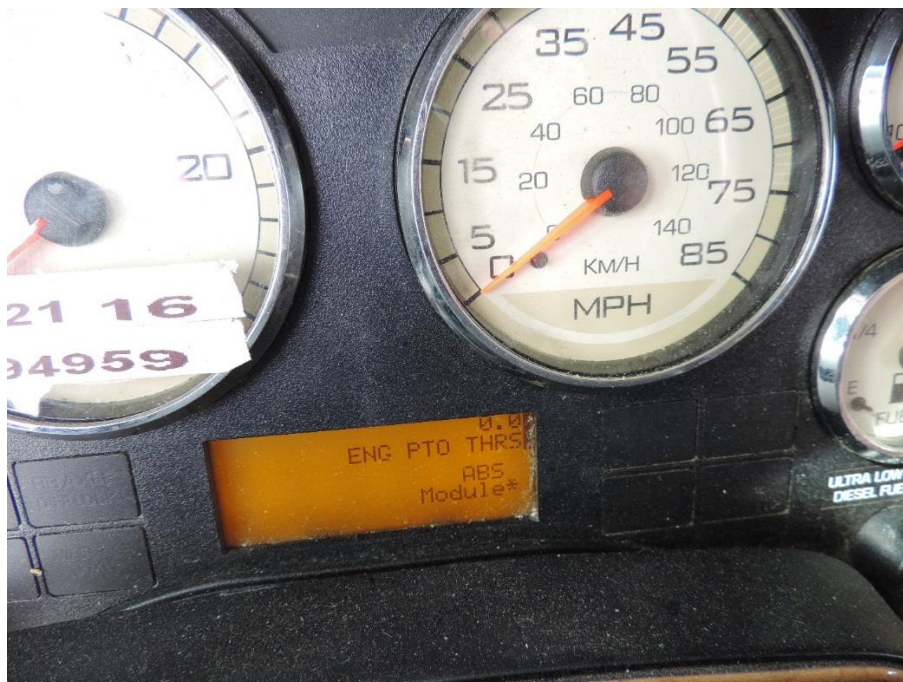
Figure 9. Total Engine PTO hours of the tractor trailer displayed on the instrument panel. The screen read 0.0 hours.

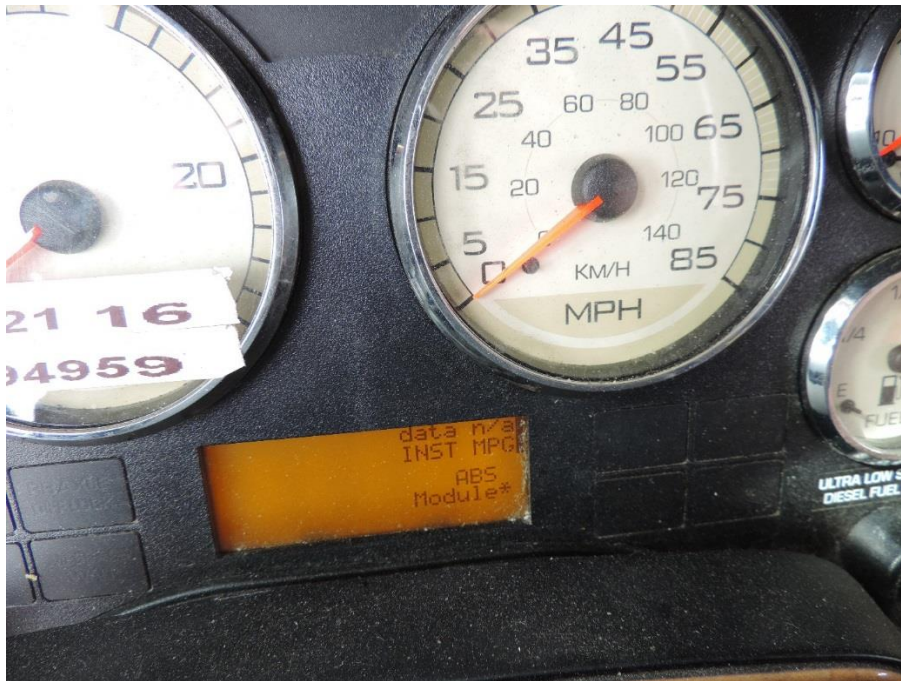
Figure 10. Instant miles per gallon (MPG) of the tractor trailer displayed on the instrument panel. The screen read data n/a.

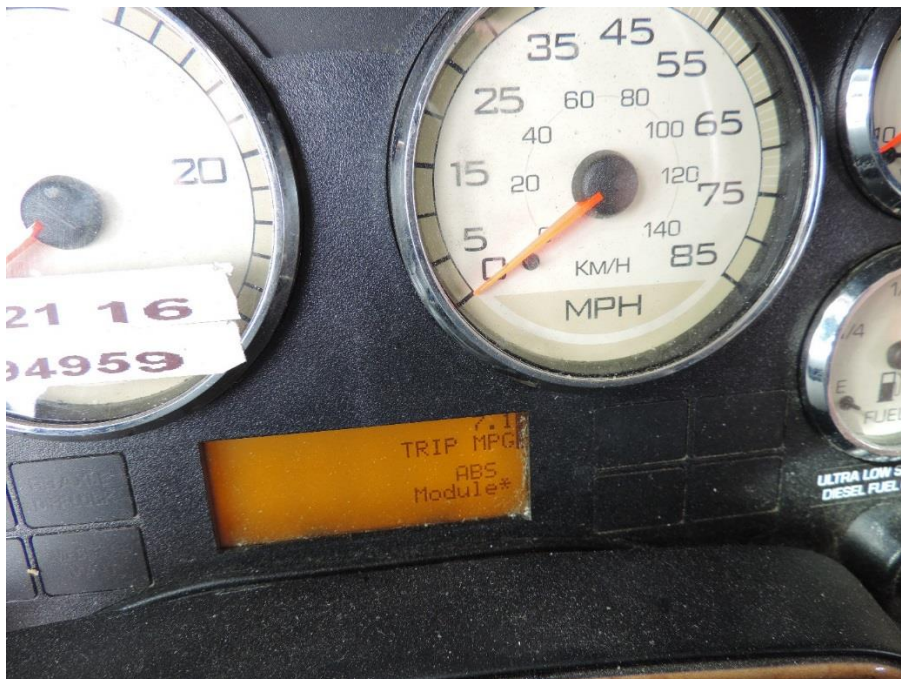
Figure 11. Trip miles per gallon (MPG) of the tractor trailer displayed on the instrument panel. The screen read 7.1 mpg.

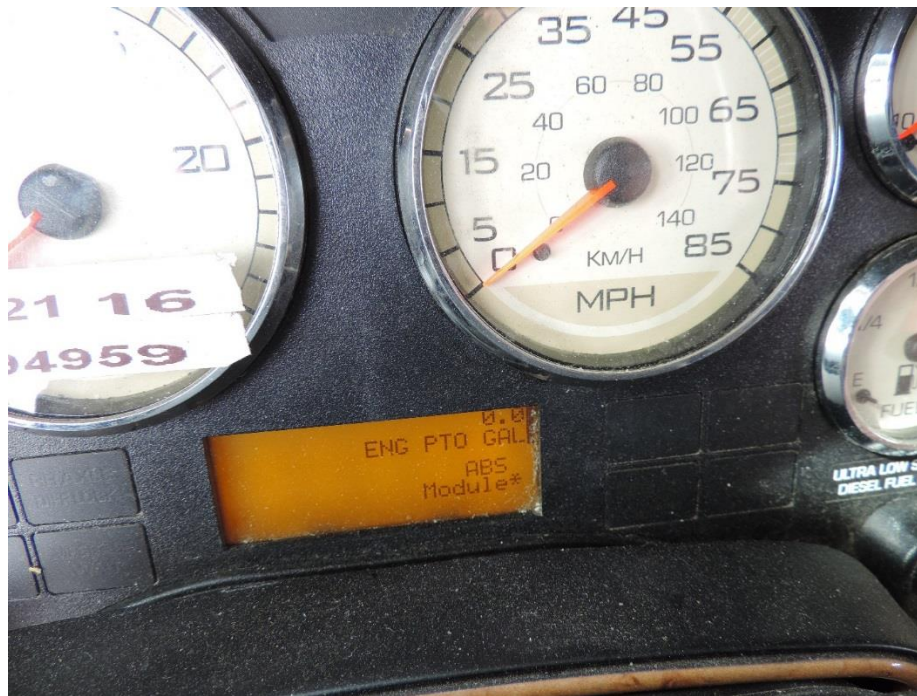
Figure 12. Engine PTO Gallons of the tractor trailer displayed on the instrument panel. The screen read 0.0 gallons.

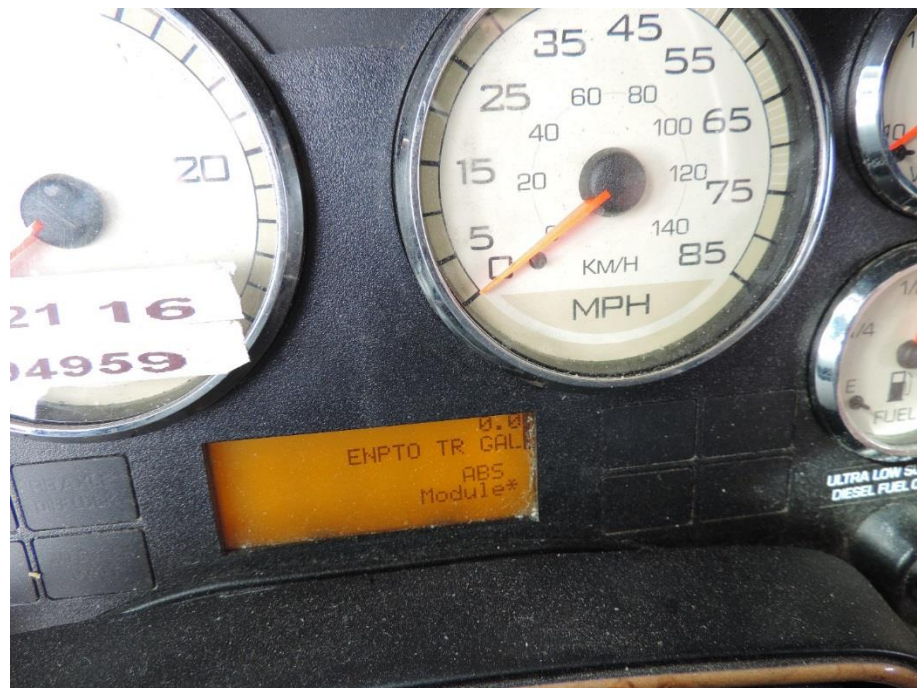
Figure 13. ENPTO TR gallons of the tractor trailer displayed on the instrument panel. The screen read 0.0 gallons.

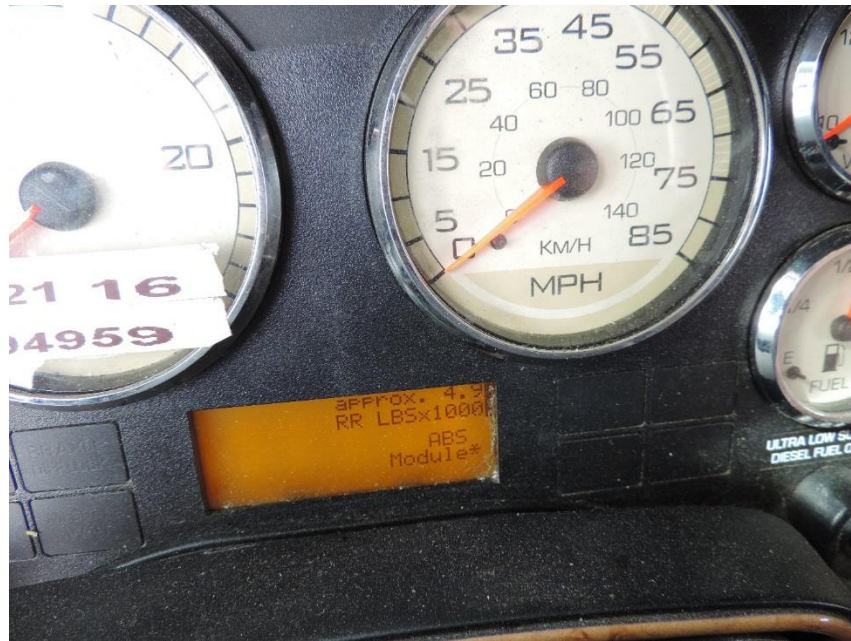
Figure 14. RR thousand pounds of the tractor trailer displayed on the instrument panel. The screen read approx. 4.9 thousand pounds.

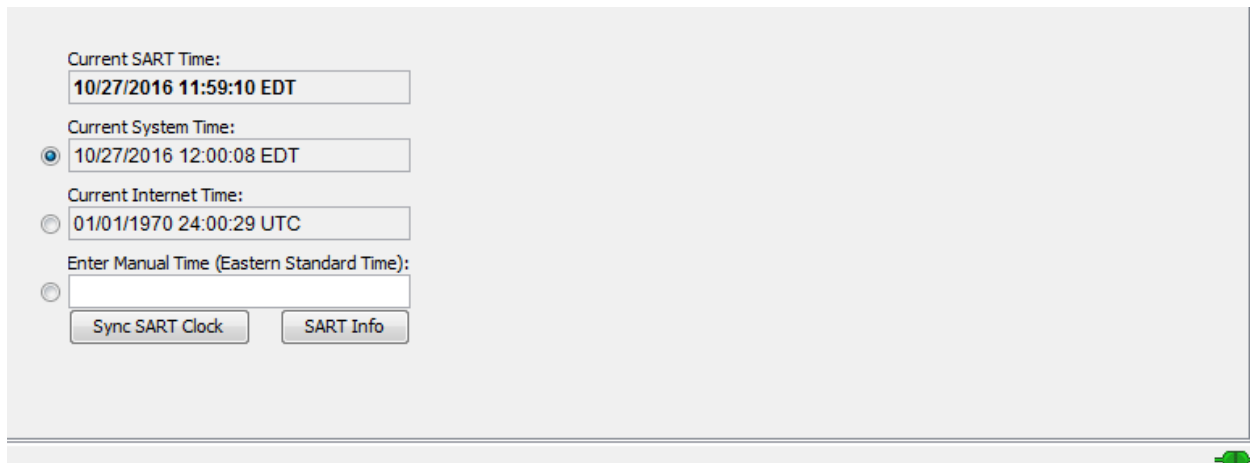
The engine clock was documented for time correlation. Figure 16 shows the system clock and the engine clock. The system clock is also shown on the bottom left hand corner of the screen. This is the computer clock and it is aligned with the correct time in eastern daylight time (EDT). The current SART time is the engine clock, and it differs from the correct time by -58 seconds. Time stamps for recorded events were stored in Coordinated Universal Time (UTC), which was 7 hours ahead of Pacific Daylight Time (PDT). Therefore, reported times were corrected for clock drift by adding 58 seconds and for time zone by subtracting 7 hours.

Figure 16. Clock screenshot for time alignment purposes.

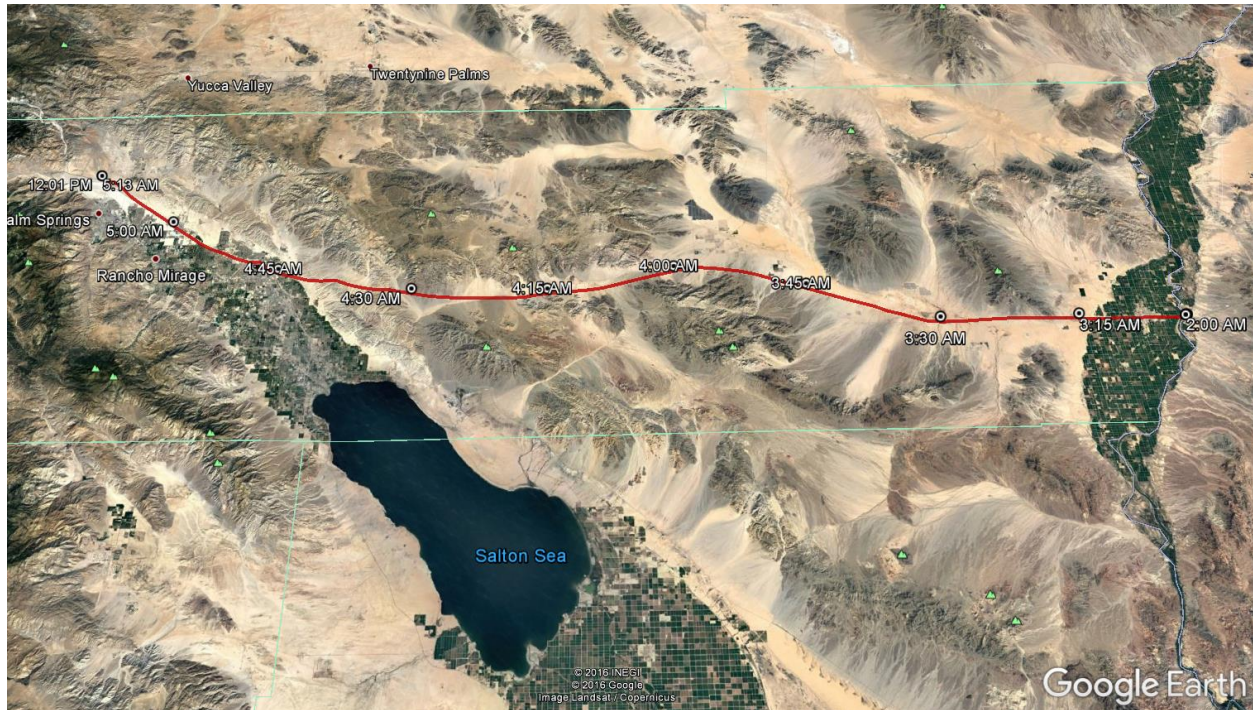
Figure 17 is a graphical overlay generated using Google Earth for the day of the crash starting at 2:00 AM PDT. The weather, traffic, and lighting conditions in Google Earth are not necessarily the weather, traffic, and lighting conditions present at the time of the recording.

Figure 17. Graphical overlay generated using Google Earth for the day of the crash starting at 2:00 AM PDT.

Tabular data used to generate figures 17 and 18 are included as Attachment 3. This attachment is provided in electronic comma-delimited (.CSV) format.

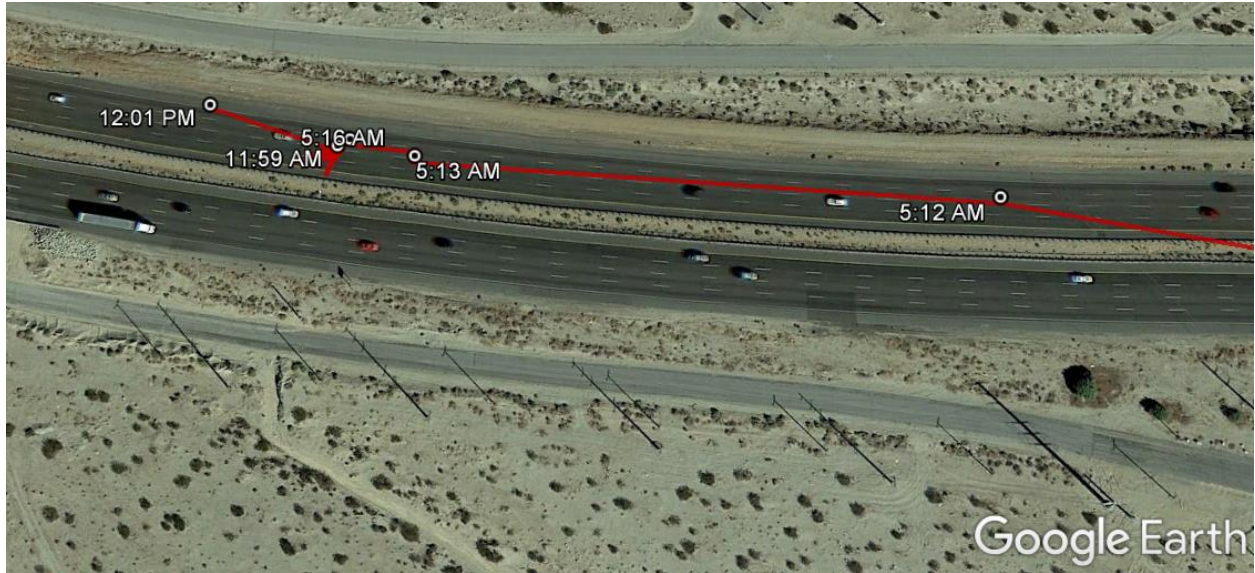
Figure 18 is a graphical overlay generated using Google Earth zoomed in on the time of the crash. The vehicle stops at 5:13 AM PDT on the highway and then is impacted at 5:16 AM PDT. The final data point for October 23, 2016 is at 12:01 PM PDT.

Figure 18: Graphical overlay generated using Google Earth during the timeframe of the crash.
