NATIONAL TRANSPORTATION SAFETY BOARD

Electronic Devices Factual Report

1. EVENT

Location: South Bend, Indiana
Date: March 17, 2013
Aircraft: Hawker Beechcraft 390 (Premier 1A)
Registration: N26DK
Operator: Digidut Systems
NTSB Number: CEN13FA196

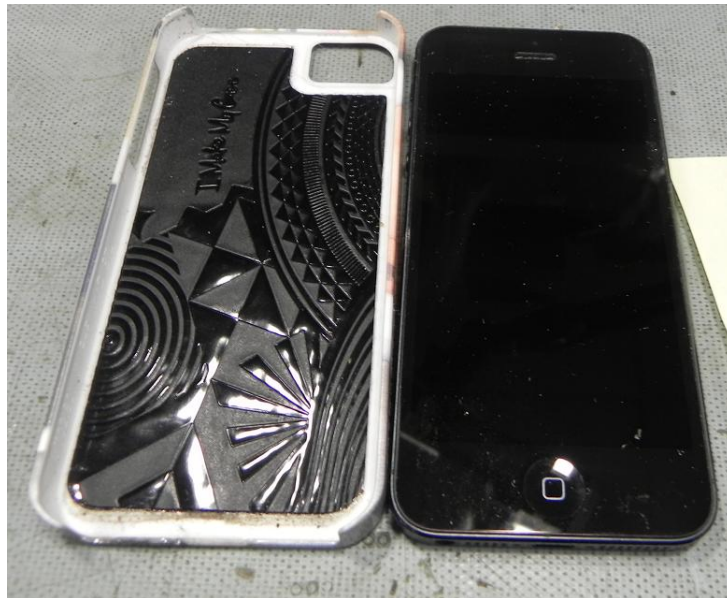
Upon arrival at the Vehicle Recorder Laboratory, an exterior examination revealed that the unit had not sustained any damage, as shown in figure 1. Power was applied to the accident unit and it started normally. The unit was not password protected. The screens were examined using the user interface.

Figure 1. Apple iPhone 5, after removal from the case.

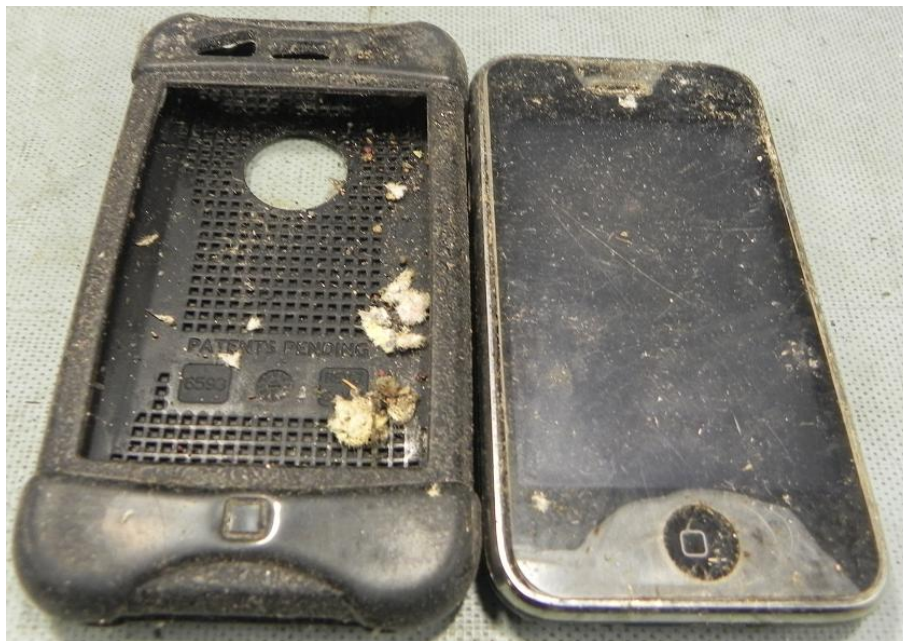
Upon arrival at the Vehicle Recorder Laboratory, an exterior examination revealed that the unit had sustained minor impact damage, as shown in figure 2. Power was applied to the accident unit; however the screen would not display any information. The unit was connected to forensic download software and a logical extraction of the data was successfully performed.

Figure 2. Apple iPhone 3GS, after removal from the case.

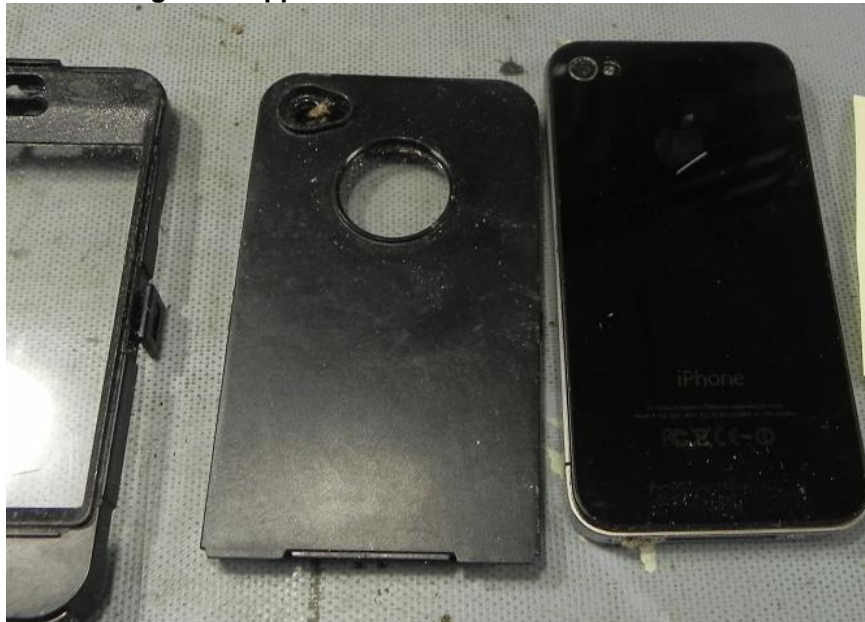
Upon arrival at the Vehicle Recorder Laboratory, an exterior examination revealed the unit had sustained minor damage, as shown in figure 3. Power was applied to the accident unit and it started normally; however the unit was password protected. The

Figure 3. Apple iPhone 4 after removal from the case.

phone identification indicated the phone belonged to one of the surviving passengers. The passenger could not recall the proper password, and forensic software was used to determine the password. During password recovery attempts, the touchscreen failed; as a result, the internal processor and memory board of the iPhone were installed in an NTSB surrogate for recovery.

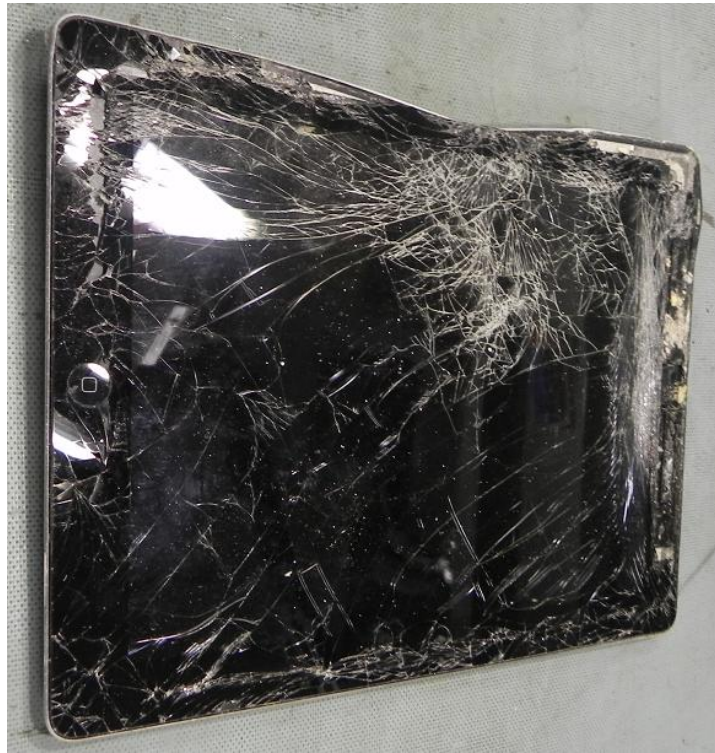
Upon arrival at the Vehicle Recorder Laboratory, an exterior examination revealed the unit had sustained significant impact damage, as shown in figure 4. An internal inspection revealed the internal processing board was intact, as shown in figure 5. The internal processing board was removed and installed in an NTSB surrogate unit. The surrogate unit, with the accident processing board installed, started normally. The unit was examined by browsing screens using the user interface and by logical extraction of data using forensic software.

Figure 4. Apple iPad3 as received.
