NATIONAL TRANSPORTATION SAFETY BOARD
Vehicle Recorder Division
Washington, D.C. 20594

Multiple Electronic Devices

Specialist's Factual Report
by Bill Tuccio, Ph.D.

Location: Challis, Idaho
Date: April 10, 2015
Aircraft: Cessna T210M
Registration: N732YQ
Operator: Private
NTSB Number: WPR15FA143

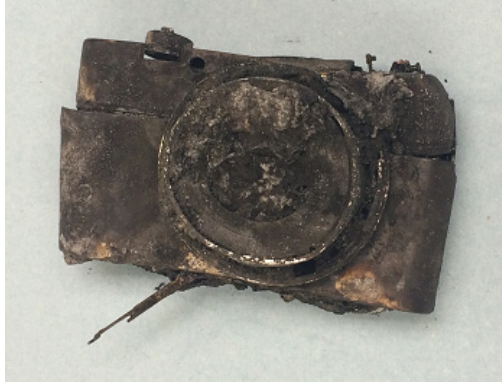
Figure 1. Camera (make and model unknown).

Figures 1 and 2 show two cameras received with extensive fire damage. Due to the fire damage, no information could be recovered.

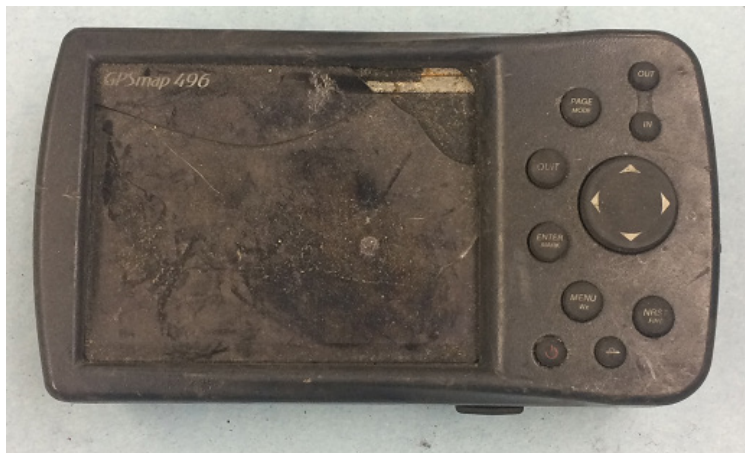
Figure 3. Garmin GPS 496 as received.

Upon arrival at the Vehicle Recorder Division, an exterior examination revealed the unit had sustained heat and impact damage, as shown in figure 3. An internal inspection revealed the non-volatile memory was intact, as shown in figure 4.

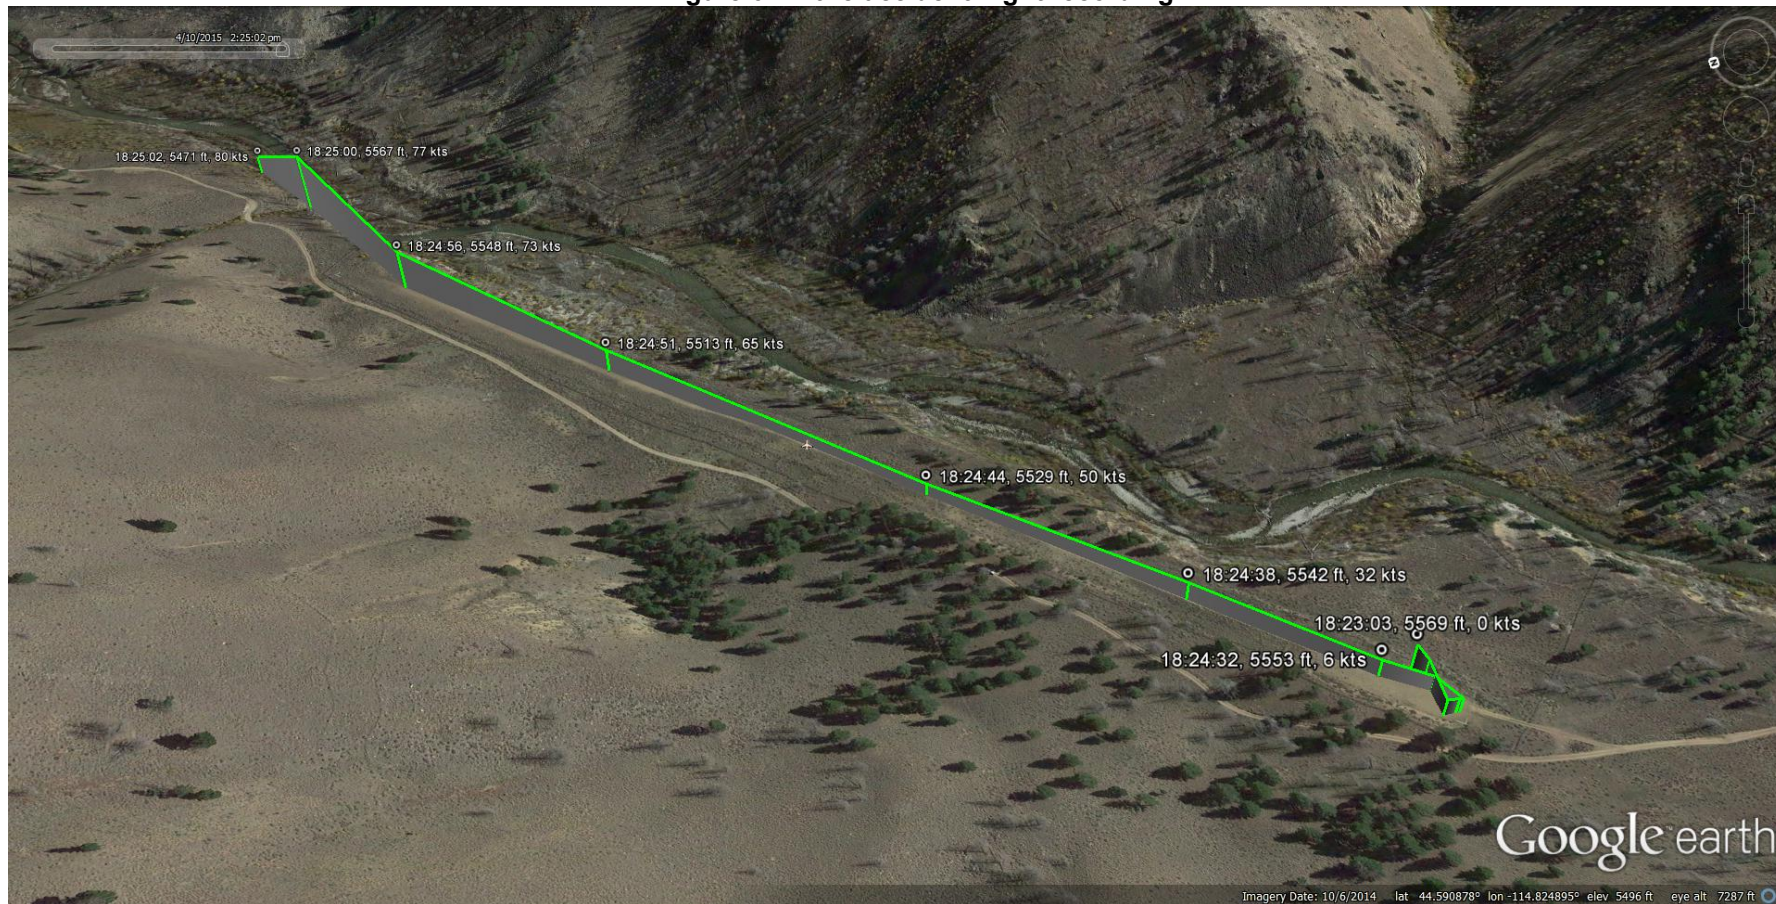
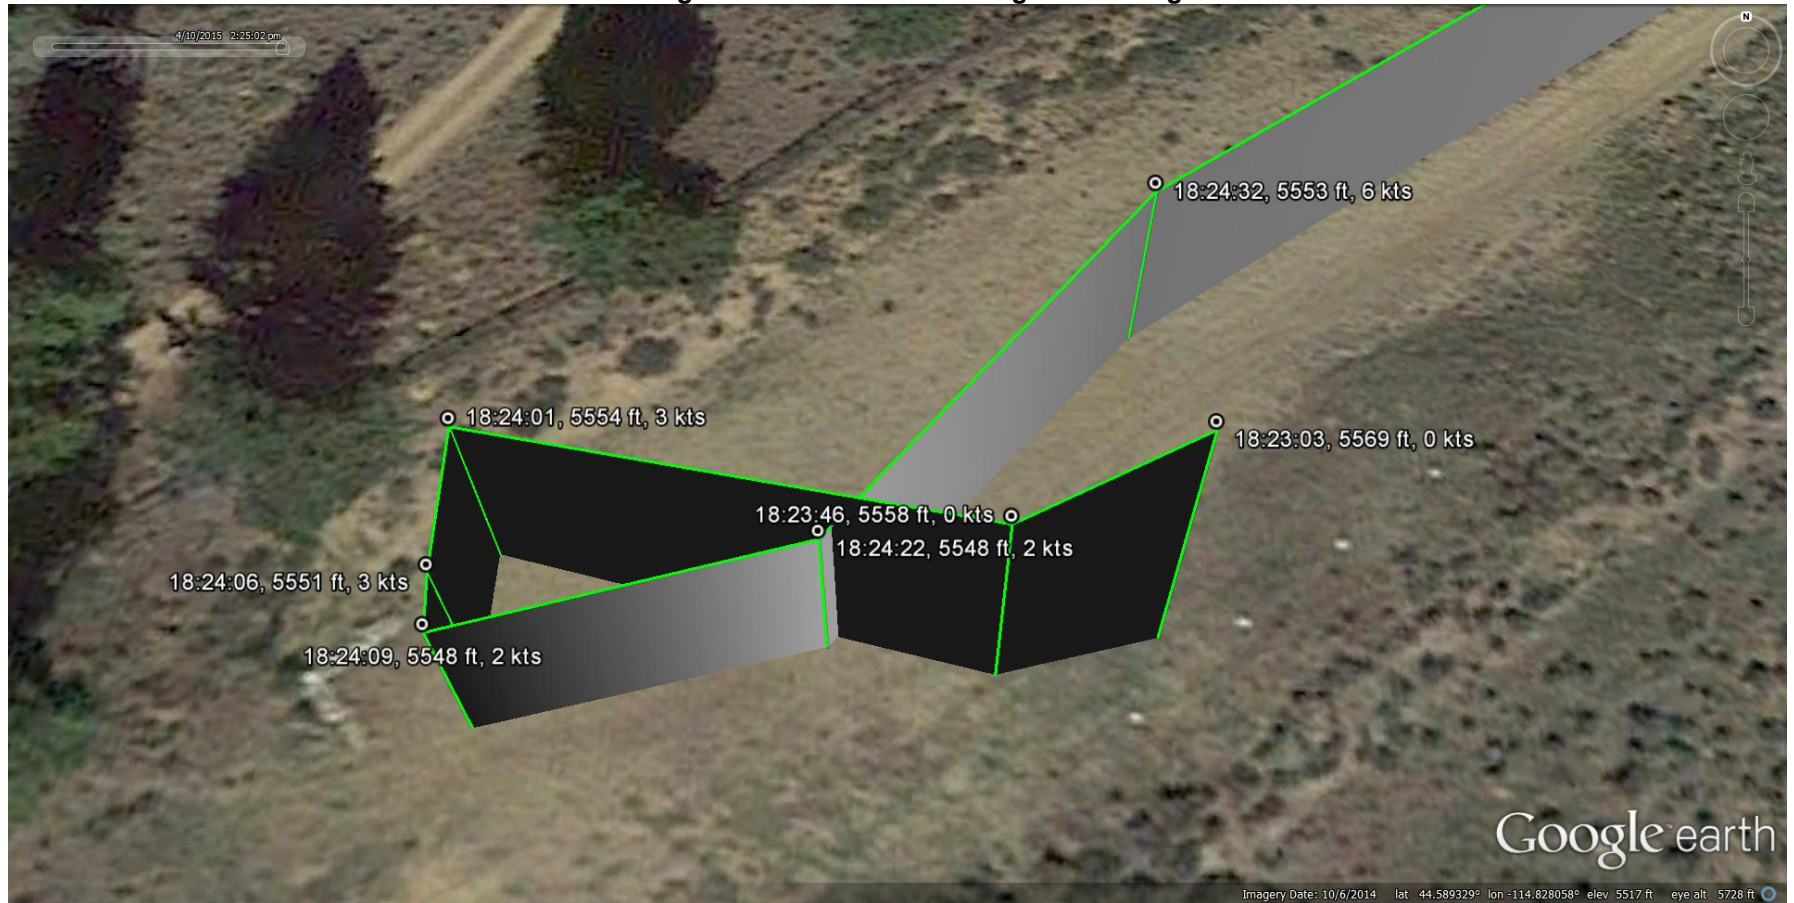
Figure 6. Entire accident flight recording.

Figures 6 through 8 show all recorded data for the accident flight. The recording began at 1823:03 UTC and ended at 1825:02 UTC. The aircraft maneuvered into position for takeoff from 1823:03 UTC through 1824:09 UTC. The takeoff roll began sometime between 1824:09 UTC and 1824:32 UTC, when the recorded altitude on the ground was about 5,550 feet. The aircraft reached a maximum recorded altitude of 5,567 feet.

Figures 6 through 11 were generated using data extracted from the Garmin GPSMAP 496 and overlaid using Google Earth. The weather and lighting conditions depicted in Google Earth are not necessarily representative of the weather and lighting conditions experienced by the accident flight.

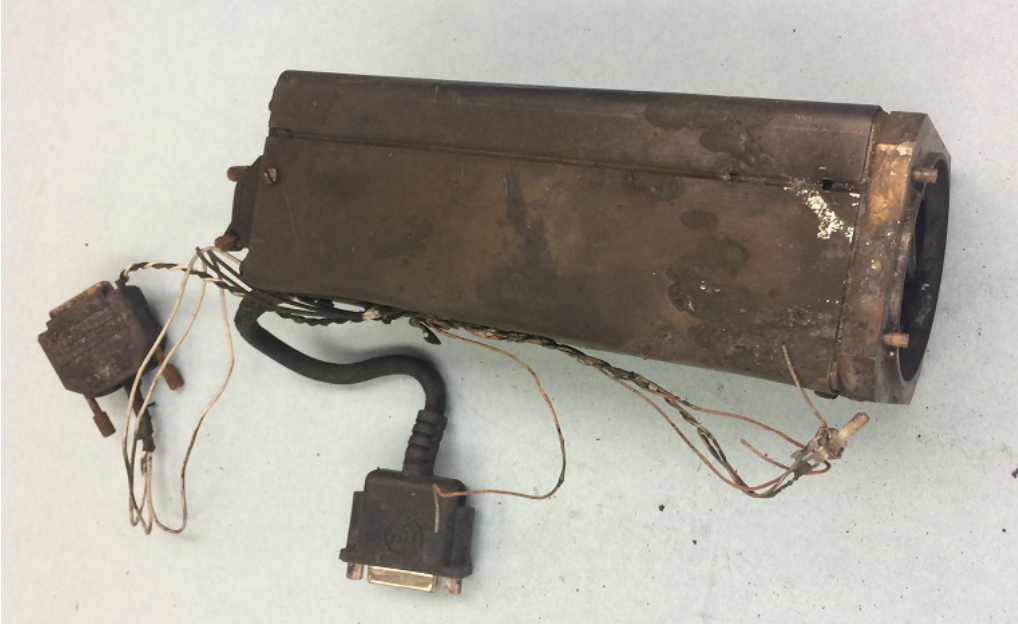
Figure 12. JPI EDM-700 as received.

Upon arrival at the Vehicle Recorder Laboratory, an exterior examination revealed the unit had sustained significant heat and minor structural damage, as shown in figure 12. An internal inspection revealed that non-volatile memory chips containing recorded information were intact, as shown in figures 13 and 14⁶.

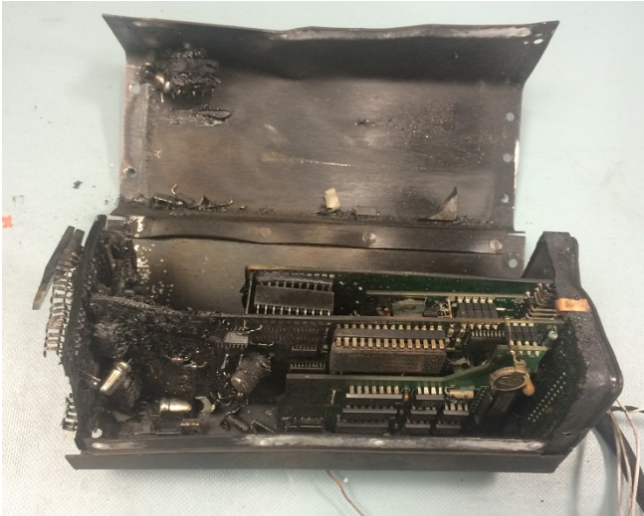
Figure 13. JPI EDM-700 internal inspection.

⁶ Recorded data is contained on the chips located at PCB locations U4,U5,U6,U7. Optional configuration information is contained on the chip located at U19. The U19 chip was destroyed in this accident.

The non-volatile memory chips were removed from the printed circuit board (PCB) using a hot air re-work station. A raw-data binary readout of the chips was obtained using a Xeltek SP-3000u EEPROM programmer. Recorded data was identified and converted to engineering units using an in-house software program.
