SAFETY ALERT

Rail Transit Vehicle Emergency Brake Push-button Electrical Switch Failure

SA-063 April 2017

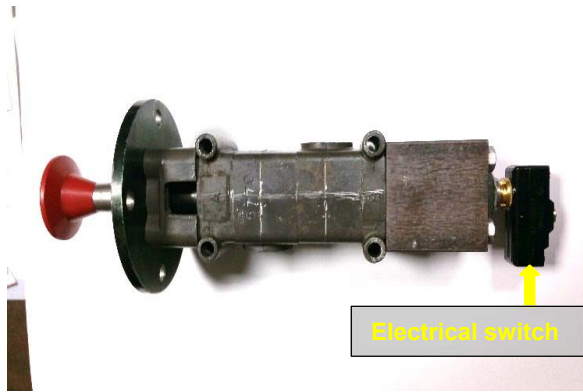
The trolley car's emergency brake push-button (Westinghouse Air Brake Company Fluid Power Division, part number 0584566) is a two-position, on/off, manually operated push-button pneumatic valve with an electrical switch. (See figure 1.) The push-button controls the flow of air and activates the electrical switch, depending on its position.

Figure 1. Emergency brake push-button with the electrical switch.

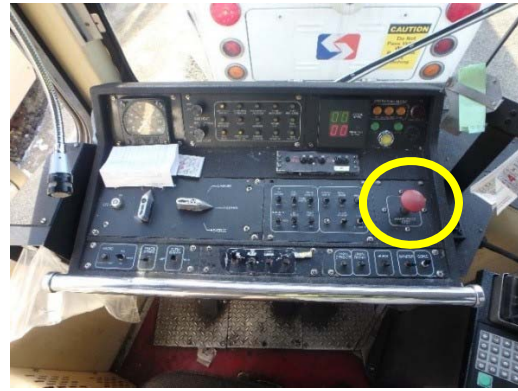
Pressing the emergency brake push-button located on the right side of the console of the LRV activates the emergency brakes. (See figure 2.) When activated, the emergency brake push-button releases brake pipe air through the pneumatic portion of the switch and a push rod in the mechanism actuates the electrical switch. Releasing brake pipe air causes the in-board friction brakes on each axle to apply and the actuation of the electrical switch activates the track brakes. The track brakes are primarily used for emergency braking or when quick stops are necessary.

Figure 2. LRV operating console with the emergency brake push-button circled.

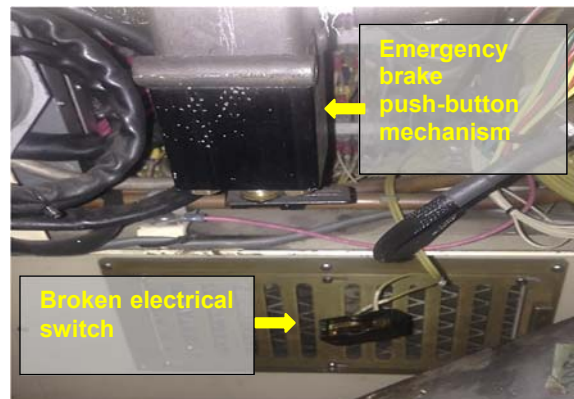
Following the accident, investigators tested the effectiveness of the emergency brake application using the emergency brake push-button. In these tests, investigators observed that the track brake portion of the LRV braking system was not functional. Further investigation attributed the failure to the electrical switch portion of the emergency brake push-button. (See figure 3.) The failure of the switch was caused by improper installation in the body of the push-button mechanism. The push rod portion of the emergency brake push-button can overstress the electrical switch if it is installed too far into the body of the mechanism, breaking the electrical switch and causing it to separate from the pneumatic valve.

Figure 3. Emergency brake push-button showing a broken electrical switch.

After identifying this failure, NTSB contacted the owner of the switch design, WABTEC Corporation, who issued a service bulletin that addressed the proper installation of the switch.³

- Identify all rail transit vehicles with emergency brake push-buttons that are equipped with electrical switches
- Once identified, inspect and test each switch in accordance with WABTEC Service Bulletin No. 115, January 2017
- Revise your maintenance procedures in accordance with *WABTEC Service Bulletin No. 115*
- Test after any maintenance to ensure proper operation
- If there are any questions contact WABTEC Corporation at 864-433-5900
