National Transportation Safety Board
Washington, D.C. 20594

Emergency Response Group Factual Report

Operator: Columbia Gas of Massachusetts
Location: Merrimack Valley Area, Massachusetts
Incident Date: September 13, 2018, multiple incidents
NTSB No.: PLD18MR003

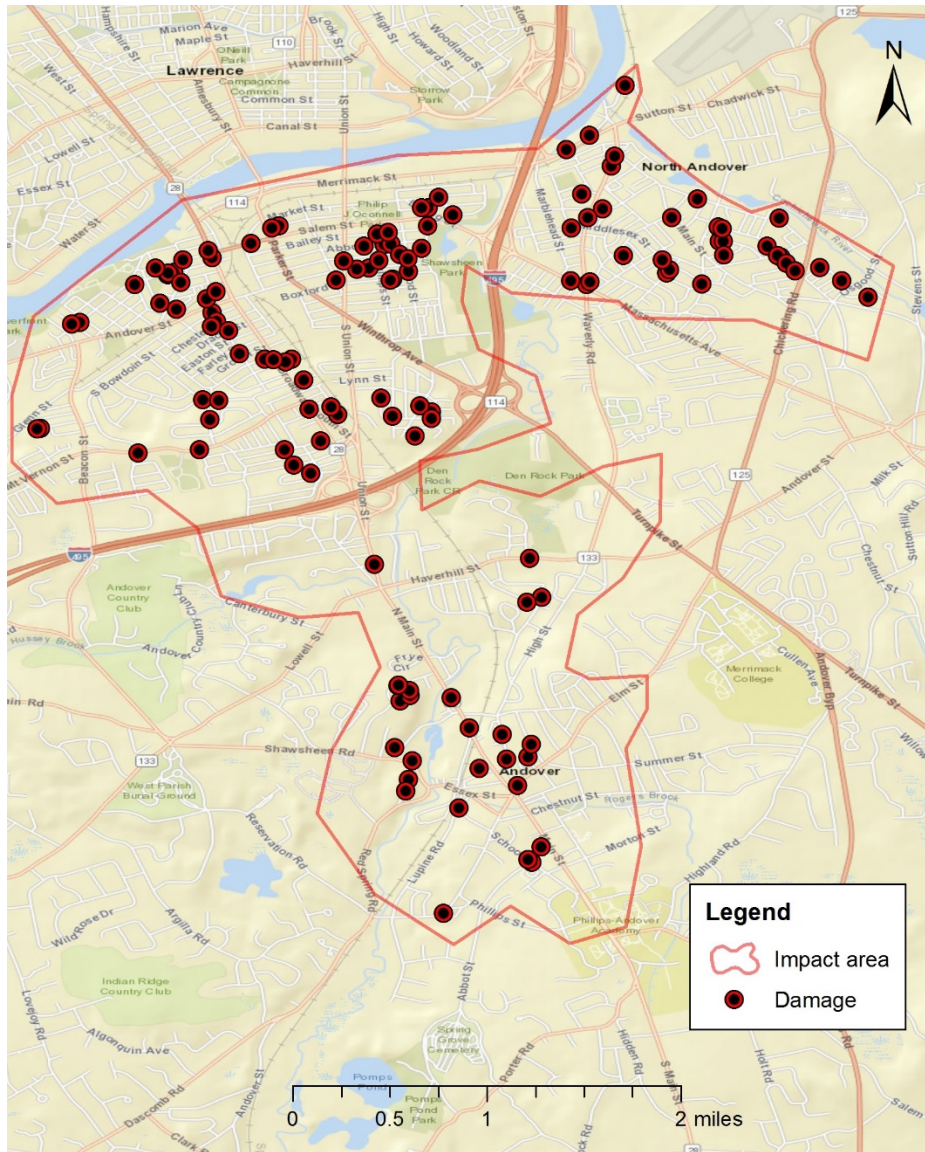
Figure 1: Area impacted on Sept. 13 and identifying damaged structures.

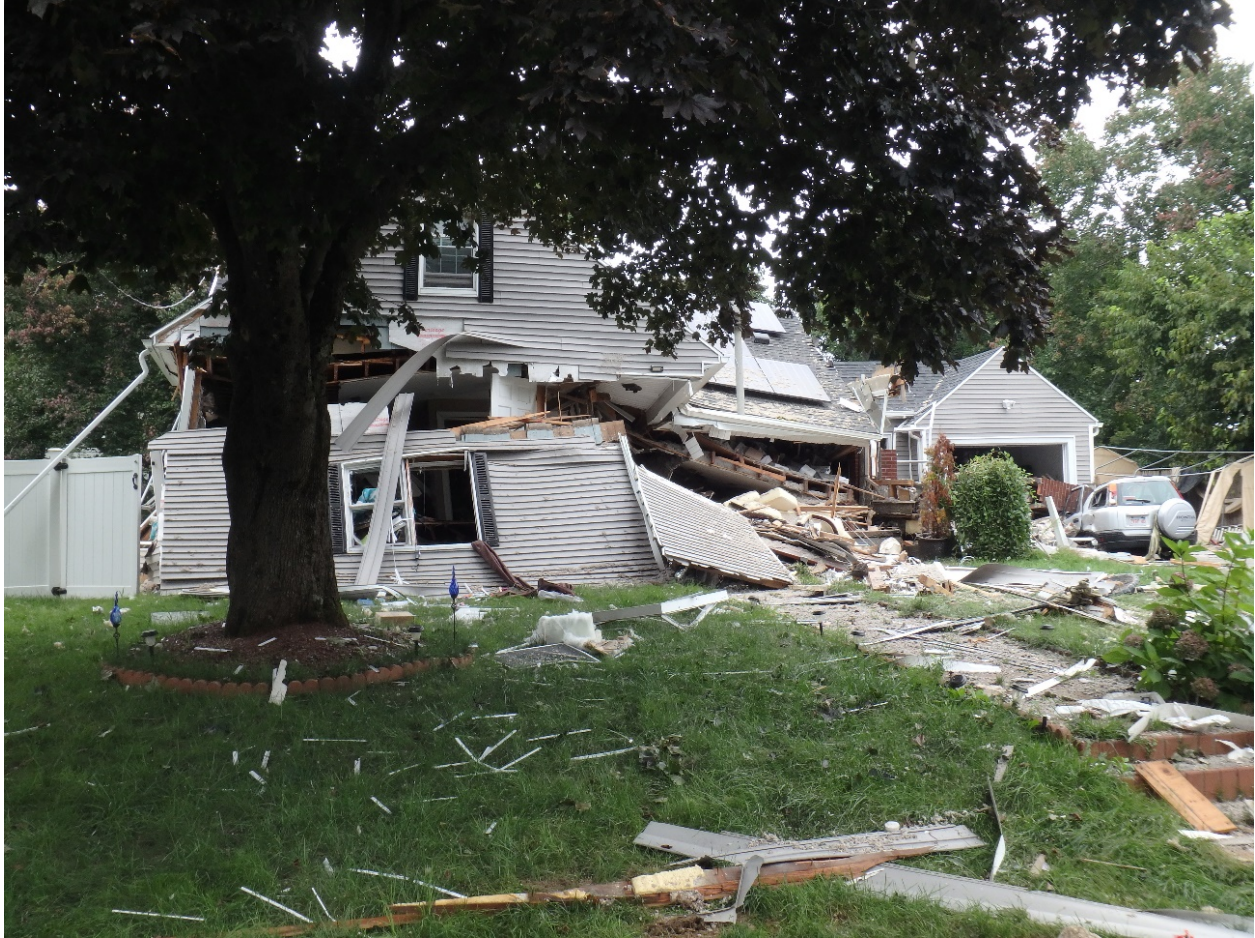
17 35 Chickering Road, Lawrence MA

18 This home experienced a gas explosion which resulted in the total destruction of the structure.
19 Based on the structural damage the explosion appeared to have originated on the first floor of the
20 residence and biased towards the right side of the residence as viewed from the street. The explosion
21 displaced the structure towards the right and caused the upper portion of the brick chimney to topple
22 over and land on a vehicle in the driveway. The portion of the chimney crushed the driver's side of
23 the vehicle and resulted in the fatality of the driver that was inside. The explosion did not result in a
24 fire. Due to the instability of the structure no entry was made to further identify the seat of the
25 explosion (See Figure 2).
26

1
2 *Figure 2: Exploded House where fatality occurred and two other severe injuries.*
3

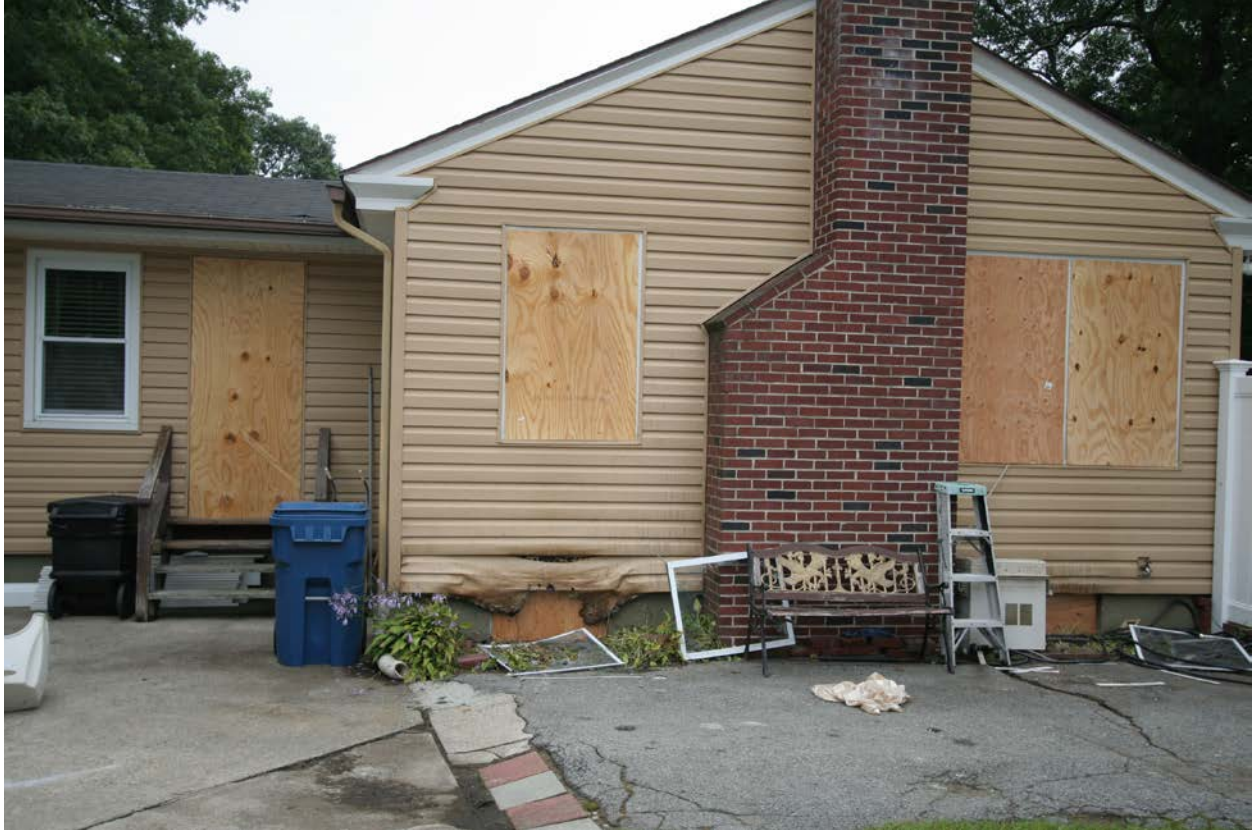
Figure 3: 85 Colonial Road, Lawrence, MA

5 This residence experienced an explosion that damaged the windows on the first floor of the
6 home. The windows had been already covered with plywood at the time of the examination. The
7 basement casement windows had also been damaged by the explosion and were also covered with
8 plywood. Above one of the casement windows thermal damage was observed on the vinyl siding of
9 the home indicating a fire having been present in the basement. The homeowner was not present, and
10 no entry was made into the home (See Figure 3).
11

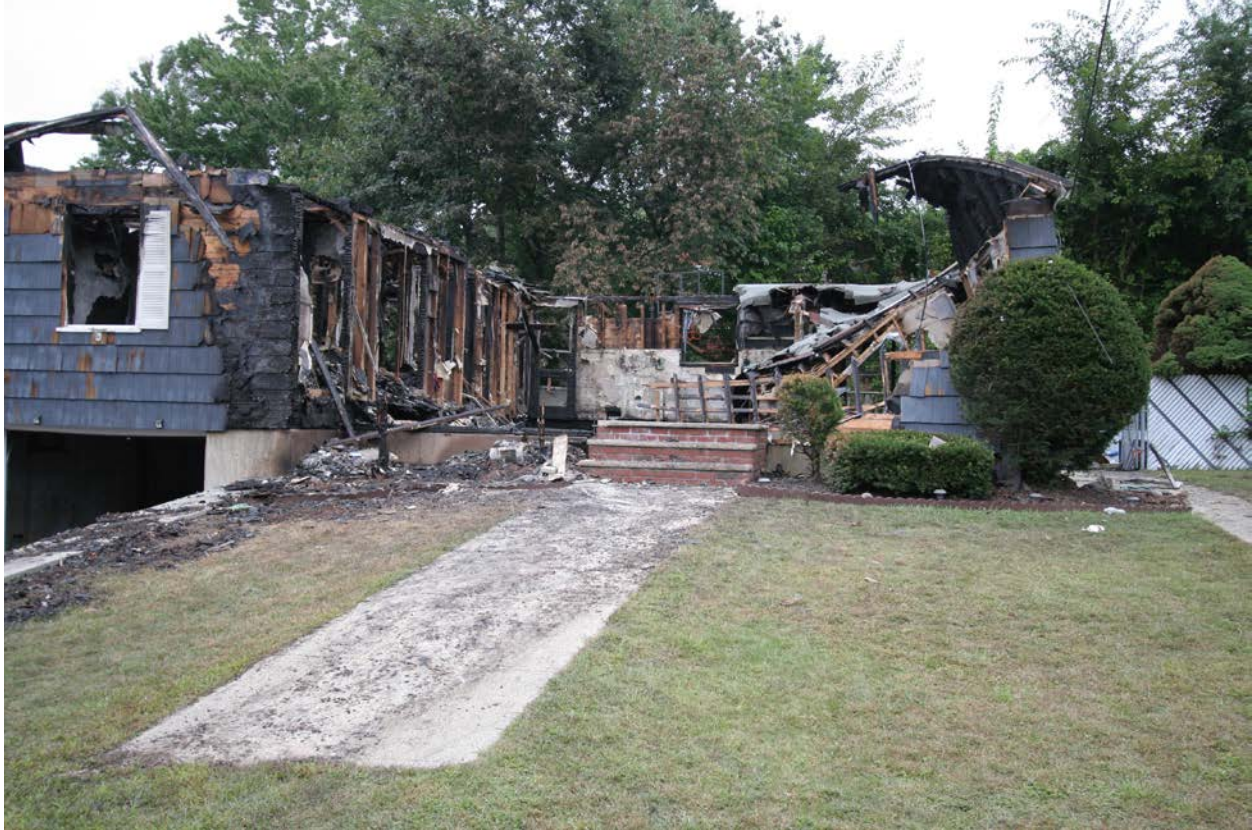
Figure 4: 60 Jefferson St., Lawrence, MA

This home was completely consumed by fire. The examination of the structure suggests that no explosion took place. The fire damage pattern suggests that the fire originated from the basement and then spread upwards and outwards through the rest of the structure. A gas furnace was visible in the rubble on the left side of the basement as viewed from the front steps of the home. No entry was made due to the instability of the structure (See Figure 4).

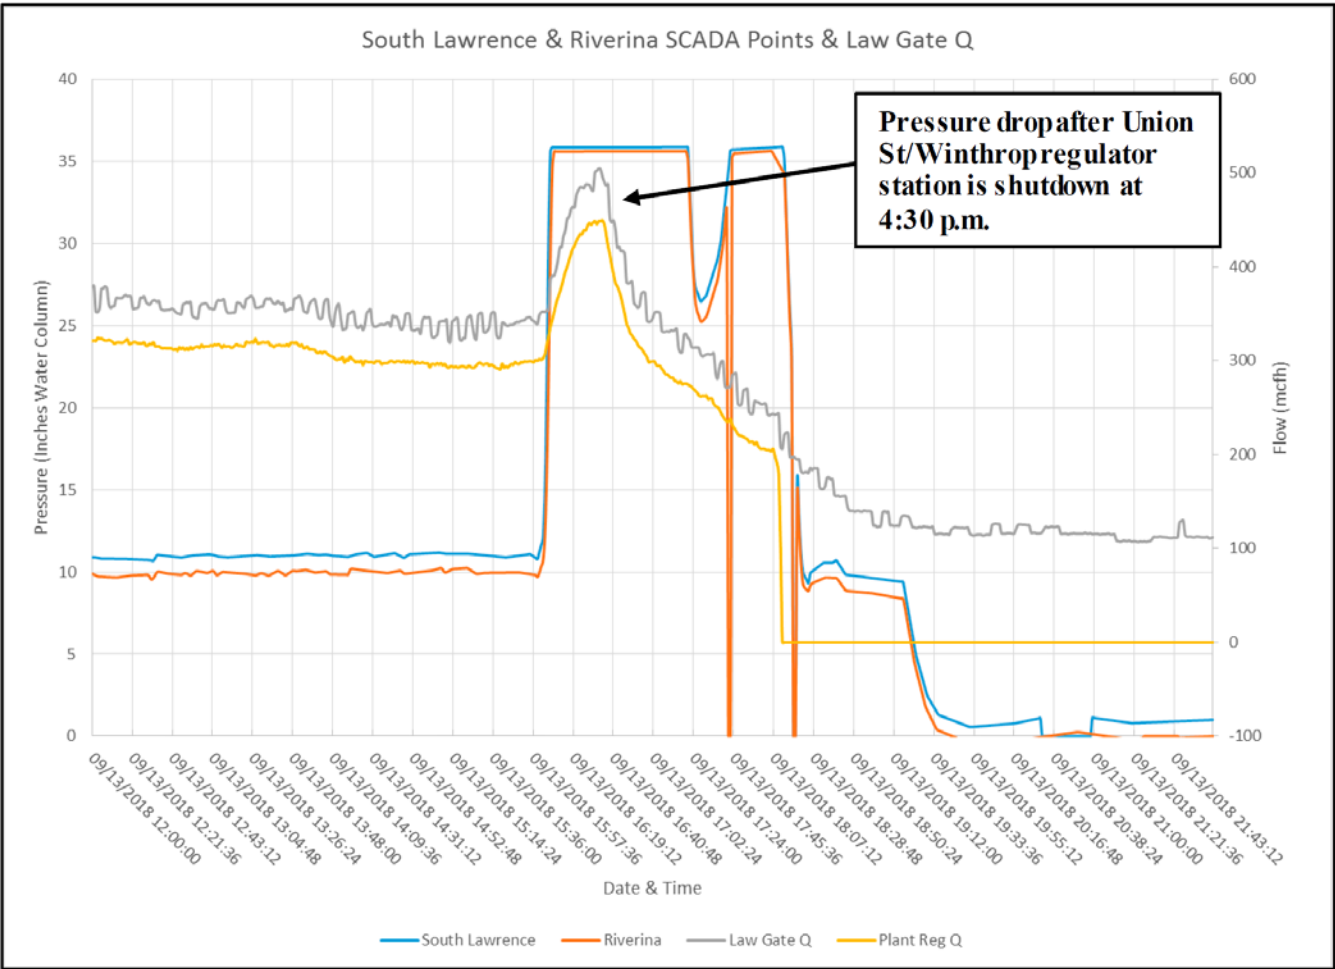
6 At approximately 4:30 p.m., an M&R technician at the Winthrop Avenue regulator station
7 observed a loud sound and gas was flowing. He backed off the setpoint on the two regulators and
8 shut down the station. Flow began to drop as reflected in the SCADA monitoring system in Figure 5.
9

Figure 5: SCADA monitor data on September 13, 2018
