Continental Motors, Inc.

ENGINE OPERATIONAL TEST

REPORT

DATE	December 17, 2013
REGISTRATION #	N406DC
ENGINE MODEL	IO360ES
ENGINE SERIAL	357900
INSPECTOR	Phillip Grice
SEARCH CODE	15-12-68

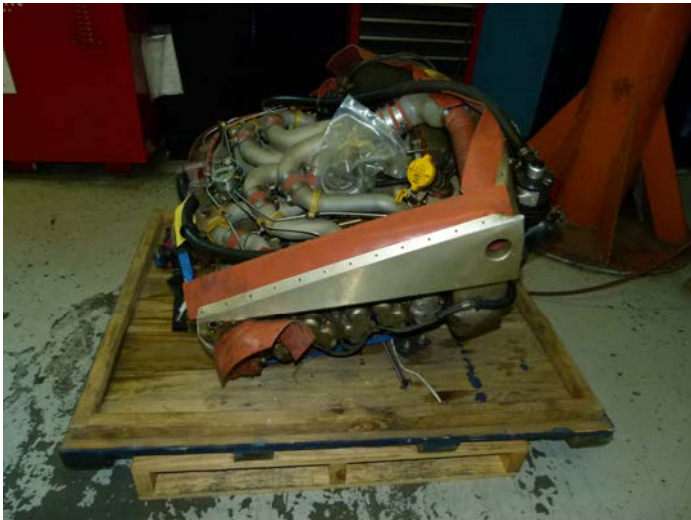
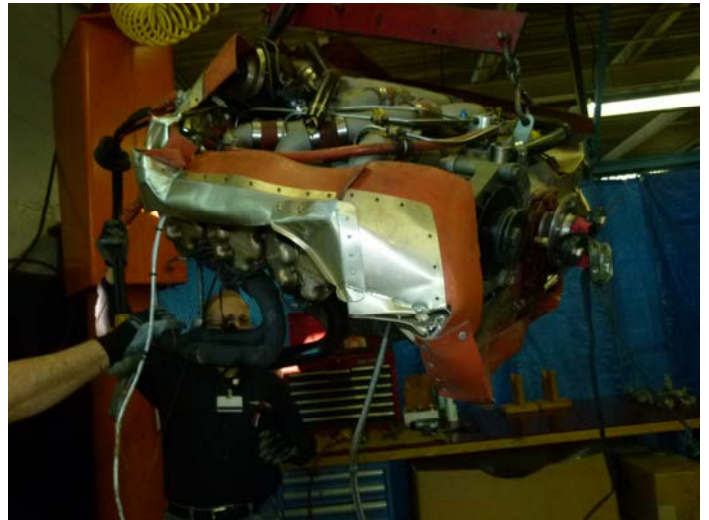
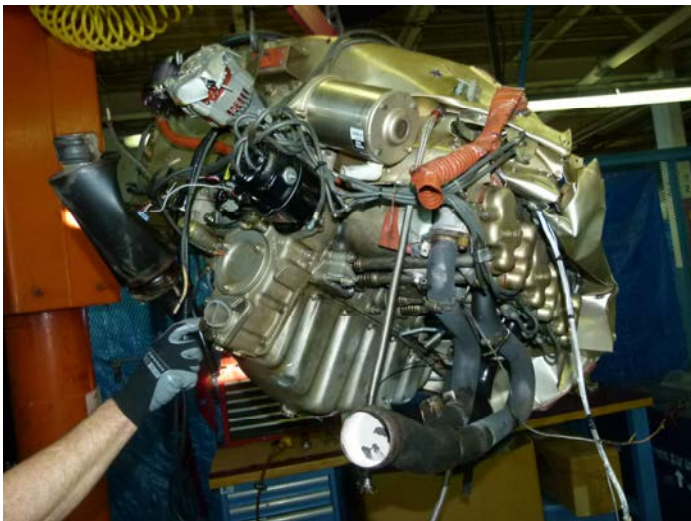
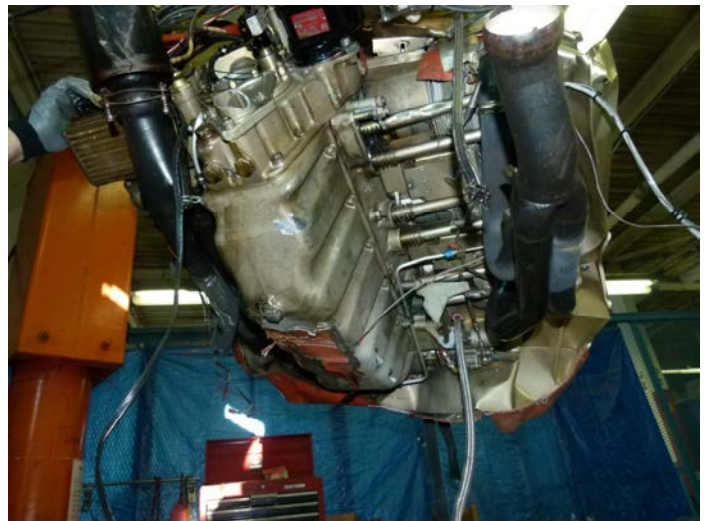
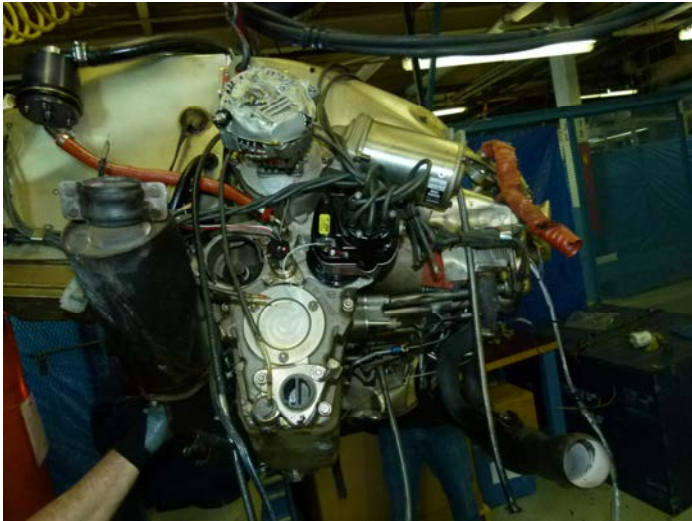
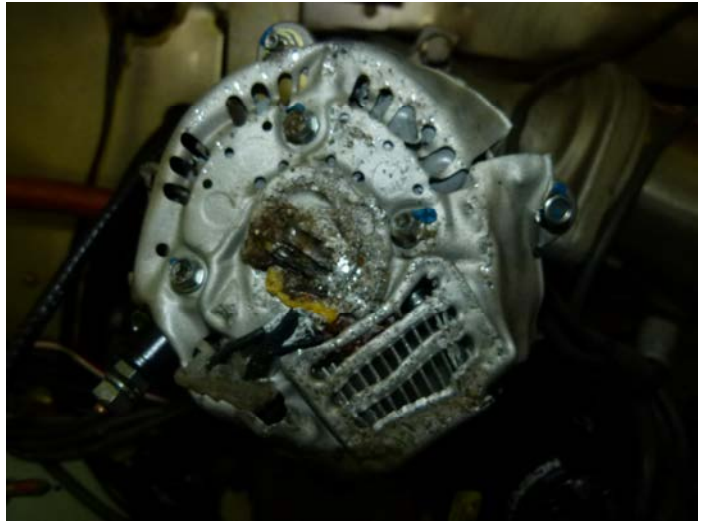
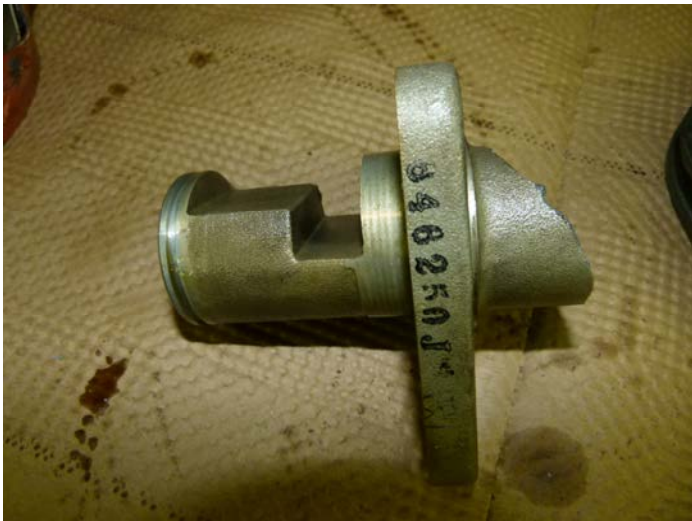
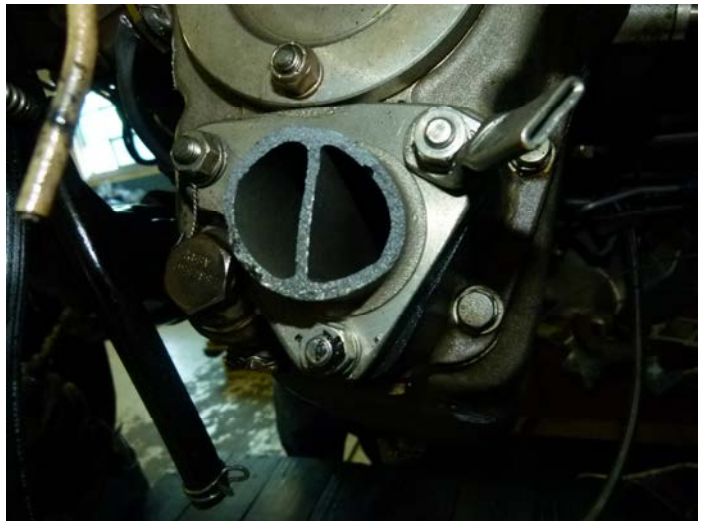
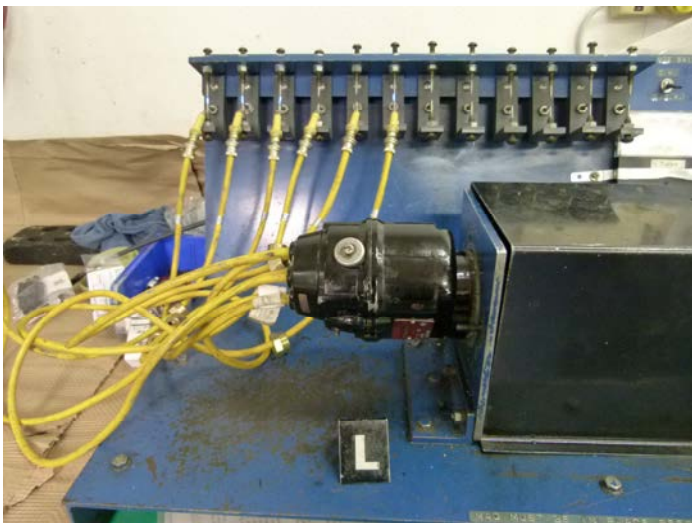
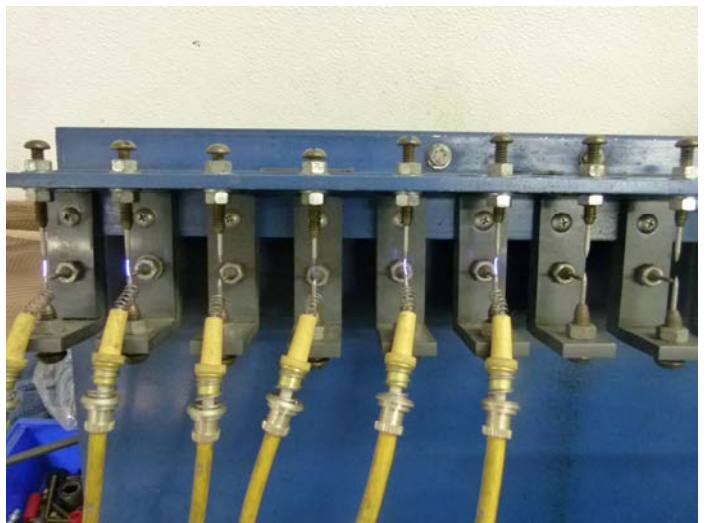
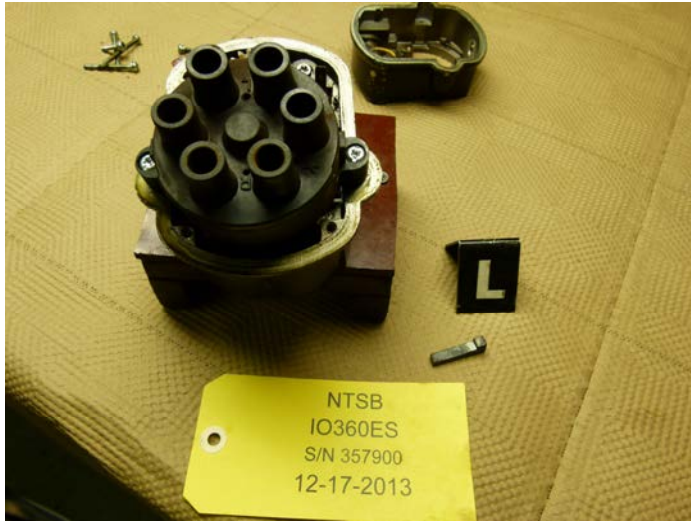
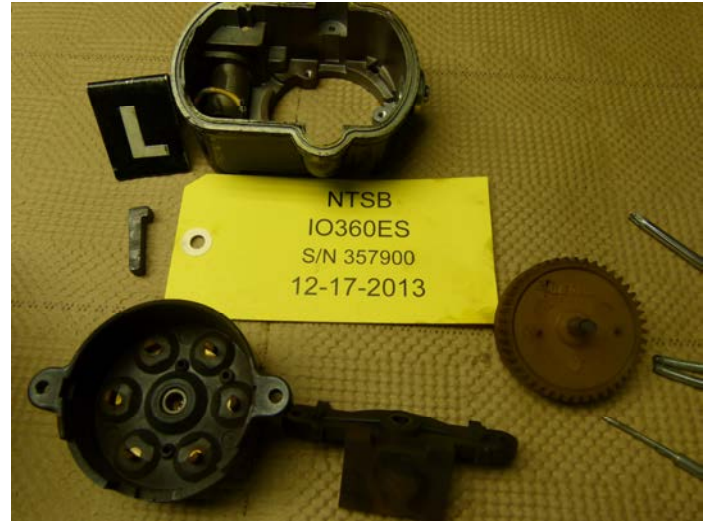
The engine exhibited impact damage concentrated at the bottom rear of the engine. The external surfaces of the engine were impact damaged. The left magneto was replaced for the engine run. The left magneto was tested on the magneto test bench and then disassembled with no anomalies noted, with the exception of the impact damage to the flange.

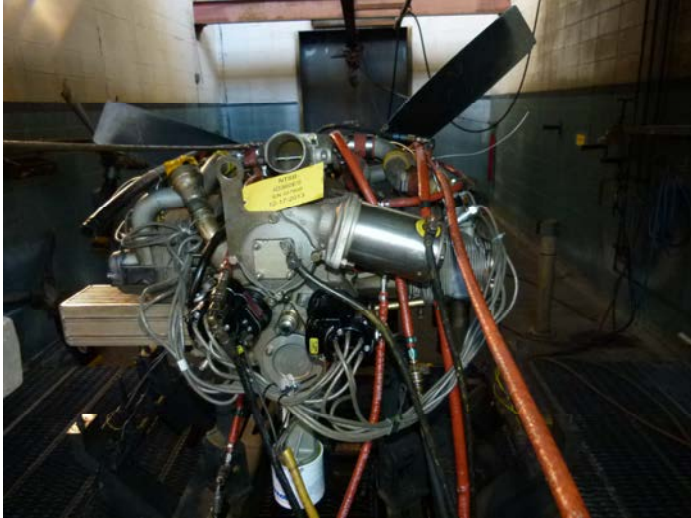
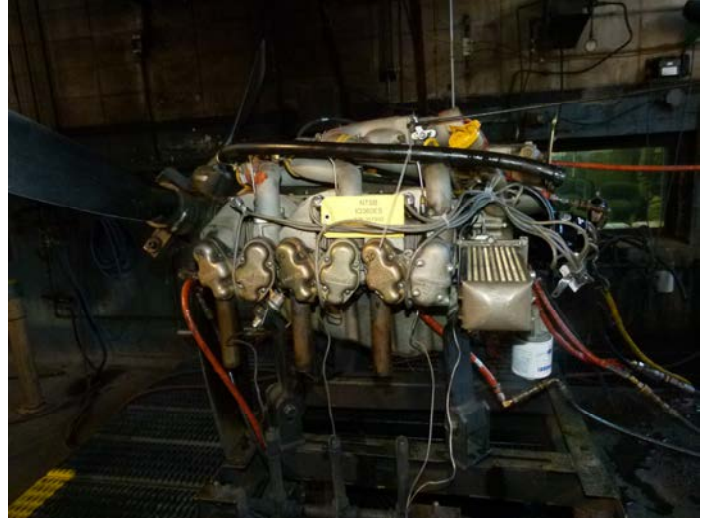
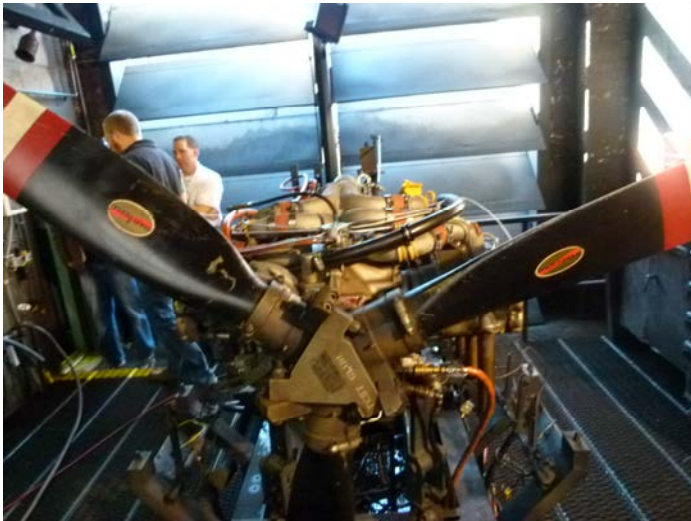
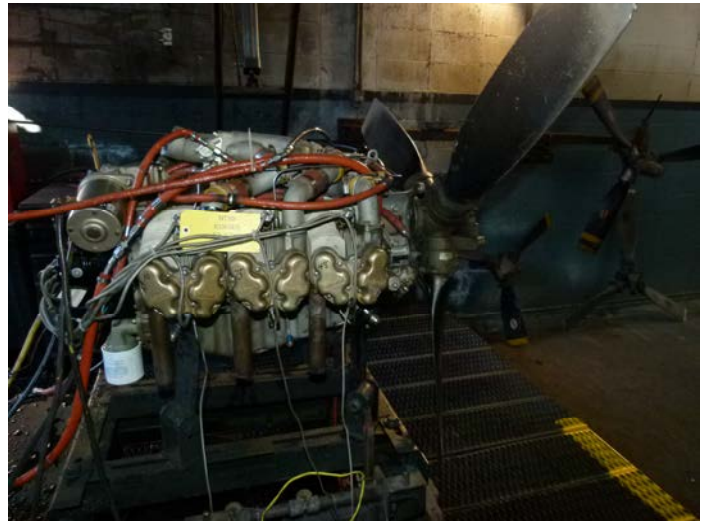
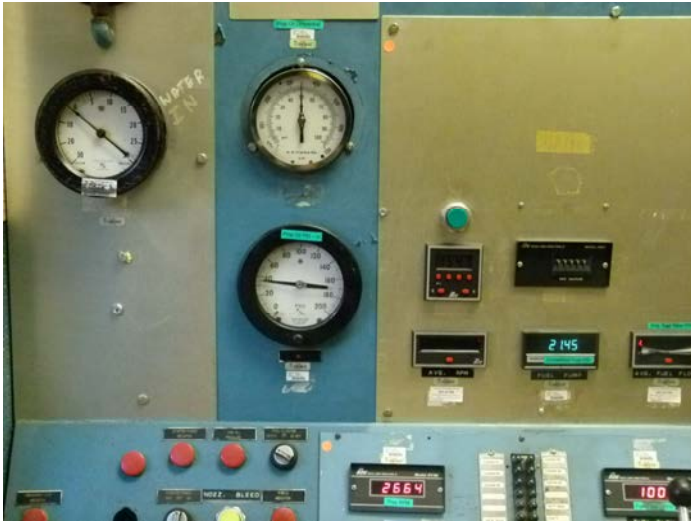
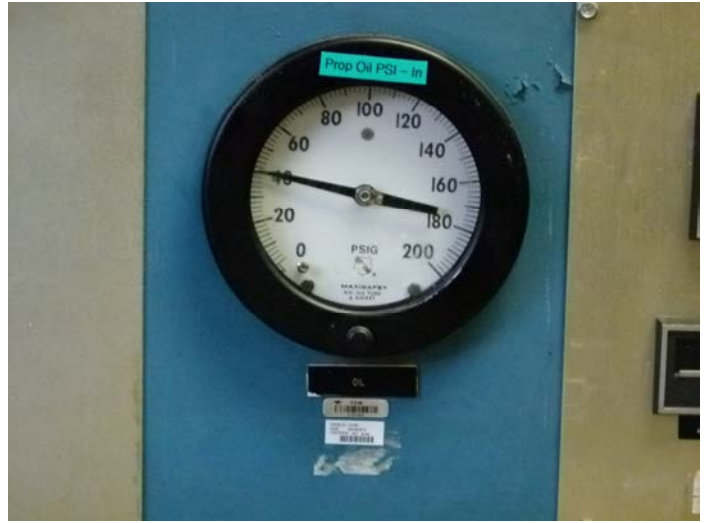
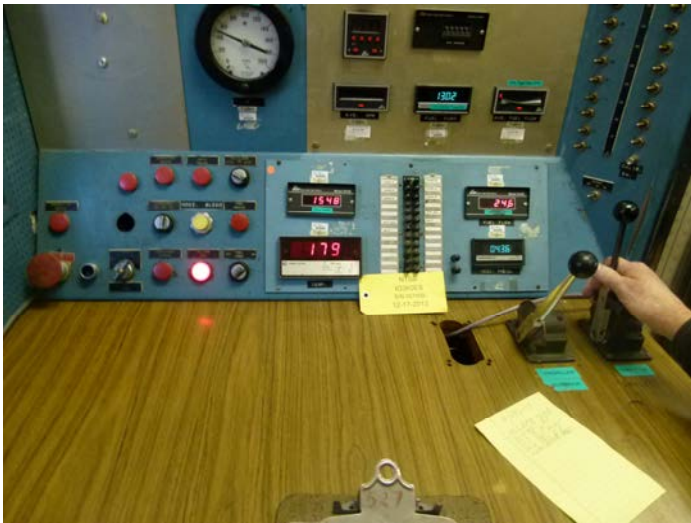
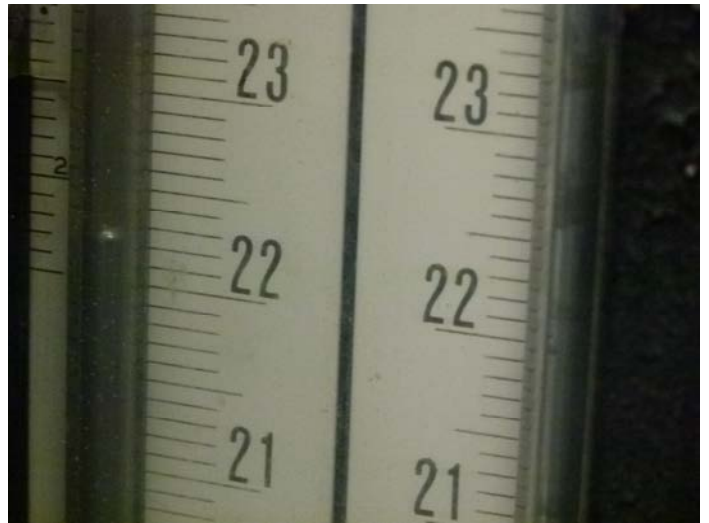
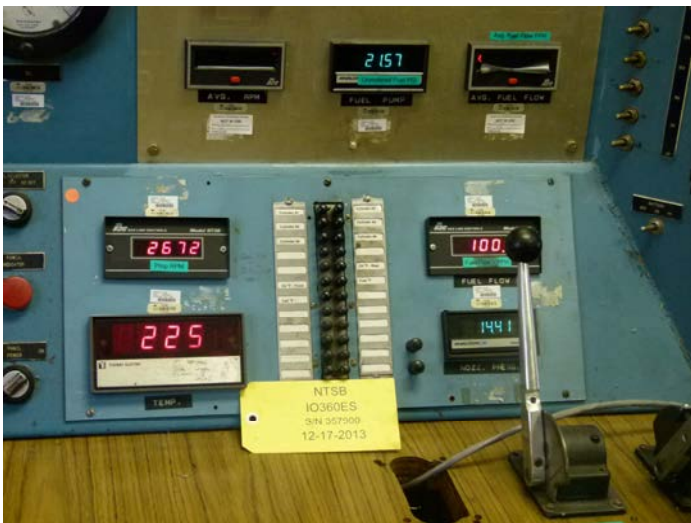
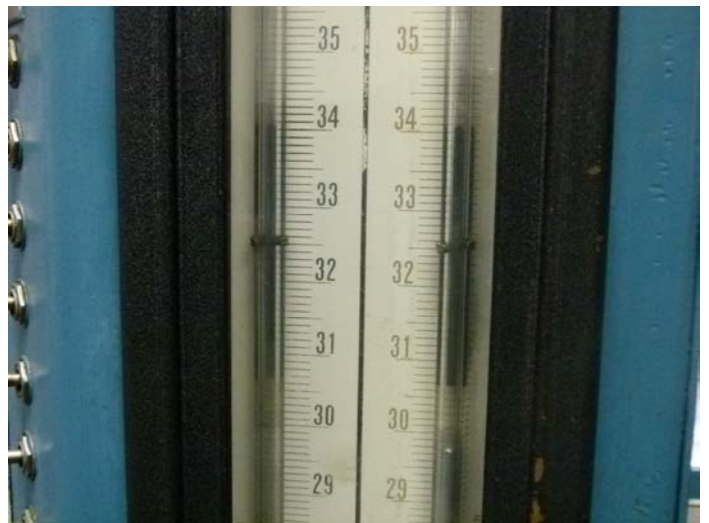
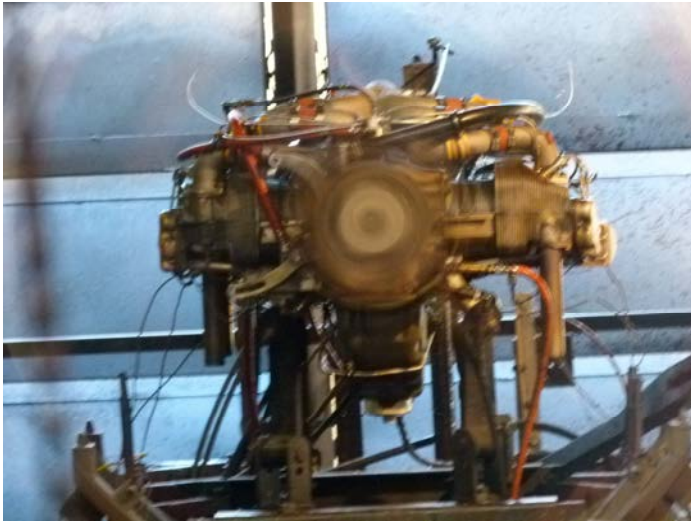
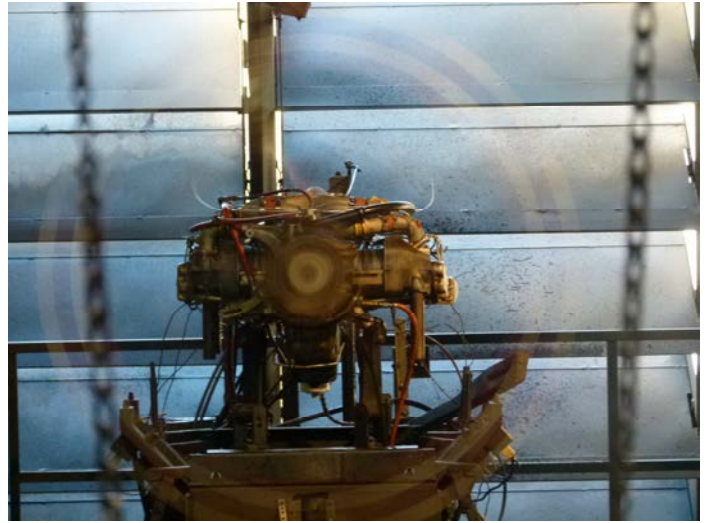
The operation of this engine was normal and did not reveal any abnormalities that would have prevented normal operation and production of rated horsepower.
