NATIONAL TRANSPORTATION SAFETY BOARD

Enhanced Ground Proximity Warning System (EGPWS)

Specialist's Factual Report
by Bill Tuccio, Ph.D.

Location: Teterboro, New Jersey
Date: May 15, 2017
Aircraft: Gates Learjet 35A, Registration N452DA
Operator: Trans-Pacific Air Charter LLC dba Trans-Pacific Jets
NTSB Number: CEN17MA183

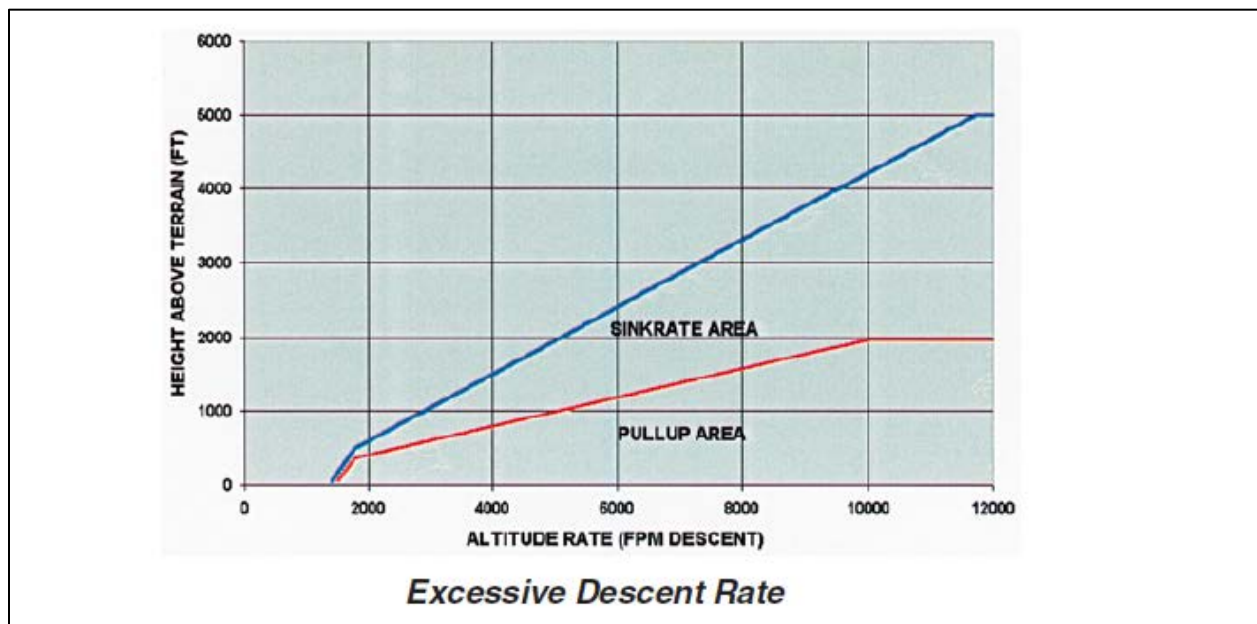
M1SK and M1PU alert warnings are based on an envelope as defined in figure 1. A penetration directly into the “PULLUP AREA” shown in figure 1, without a transition through the “SINKRATE AREA,” will cause a “sink rate” aural alert followed by a “pull up” alert.

Figure 1. Honeywell EGPWS excessive sink rate envelope (figure courtesy of Honeywell).

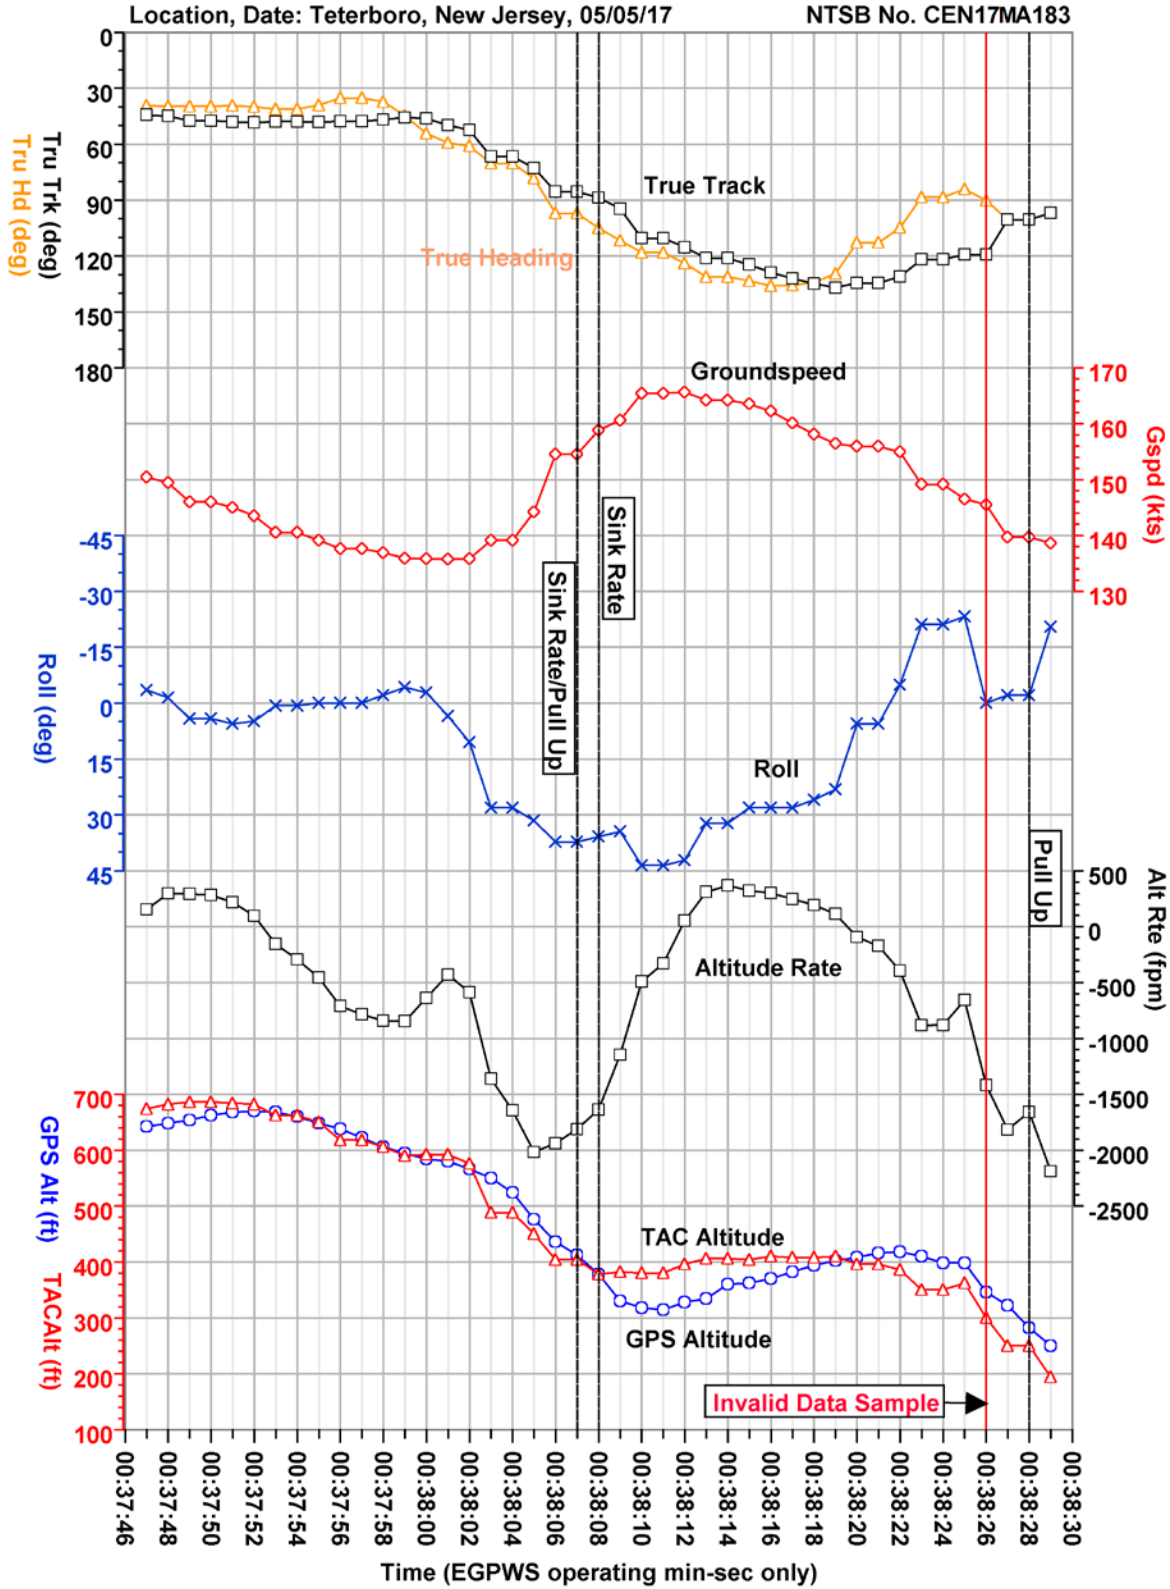
Figure 2 shows a plot of the accident flight recording. The recording began when the aircraft was on a true track of about 48 degrees at a groundspeed of about 150 knots. At about 38:01, the aircraft began to roll right as the groundspeed increased. While the groundspeed increased, altitude began to decrease, reaching a maximum recorded vertical descent rate during this period of 2,017 feet per minute; the recorded GPS altitude reached a minimum of 314 feet; and “sink rate/pull up” and “sink rate” alerts were generated, followed by a decrease of the vertical descent rate.

By 38:12, the groundspeed reached a maximum of about 165 knots, as the altitude was increasing and the roll was 42.2 degrees right (the maximum recorded roll was 43.6 degrees between 38:10 and 38:11).

After 38:12 until the end of the recording, the groundspeed decreased, reaching the last recorded value of 139 knots at a GPS altitude of 250 feet.

At 38:26, the EGPWS software identified the data sample as invalid. This point is included in the plot as it generally aligned with the trends of the surrounding data samples.

The last EGPWS alert was a “pull up,” 1-second before the end of the recording (38:28) when the aircraft was descending at 1,659 feet per minute. The last EGPWS recorded descent rate at 38:29, was 2,189 feet per minute.

Figure 2. Accident leg 288.

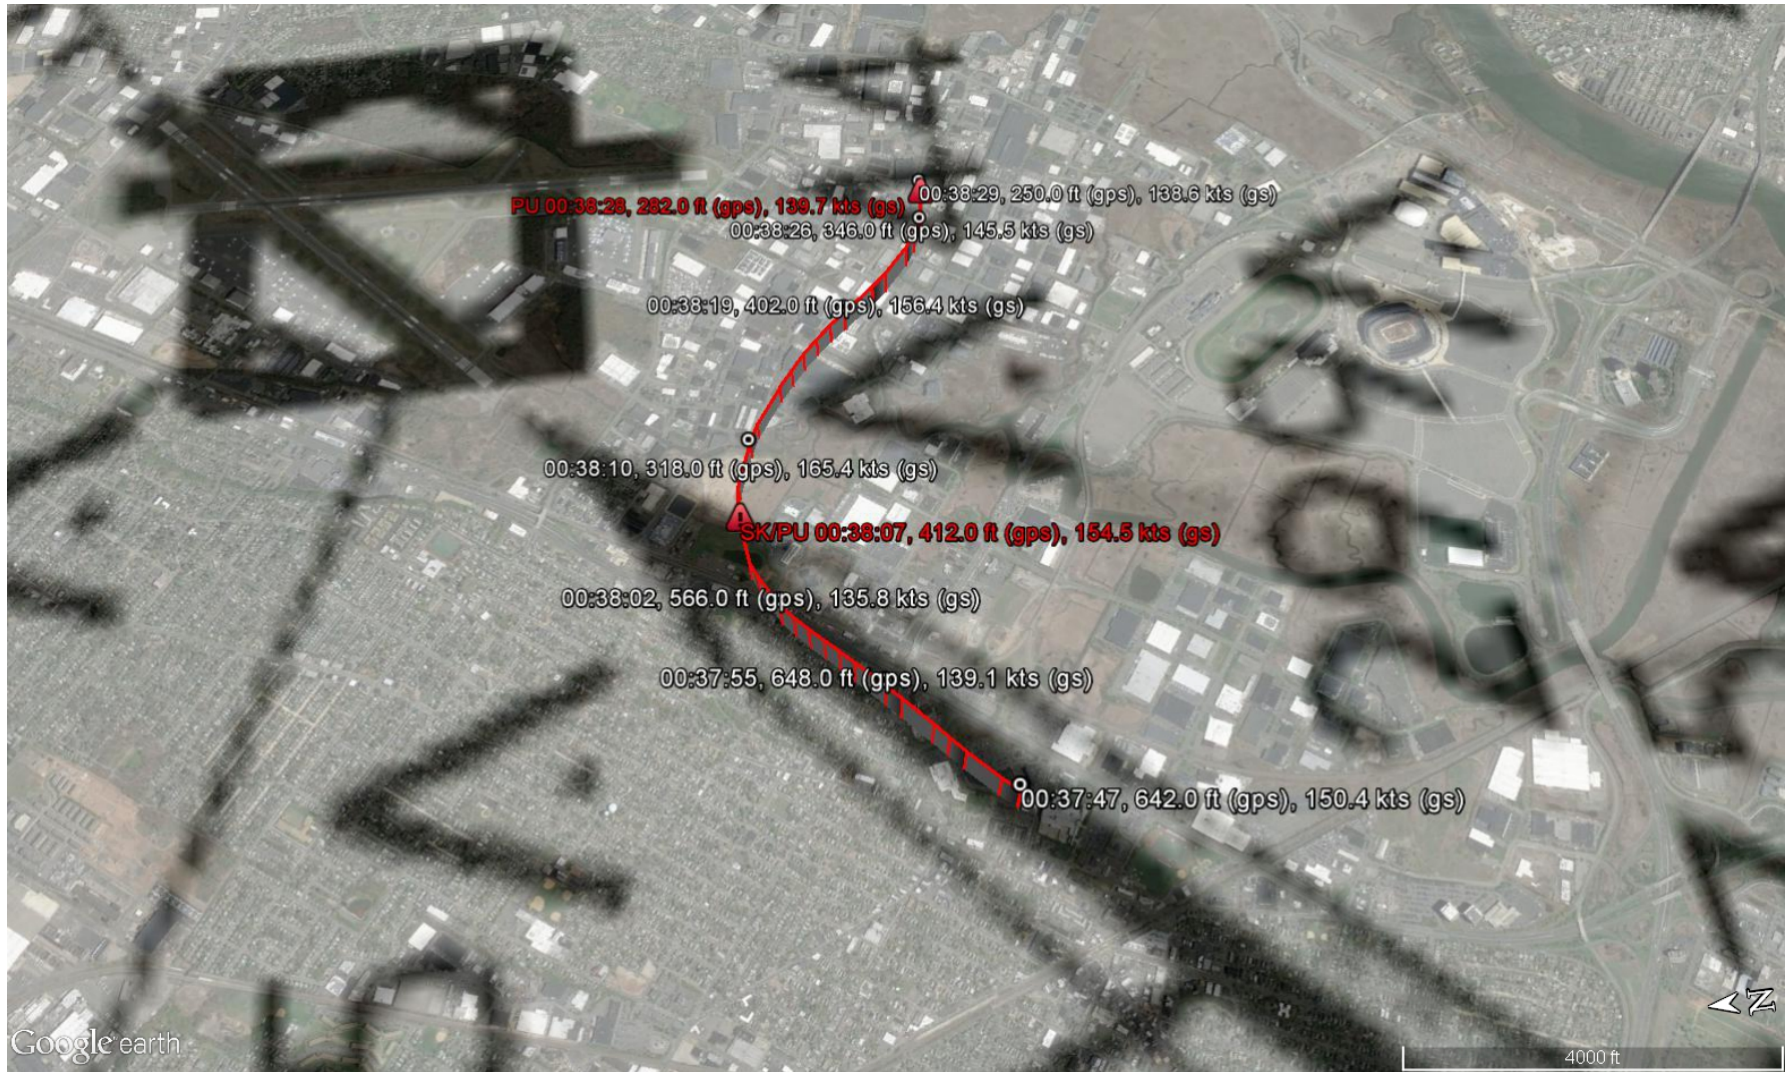
Figure 5. Accident leg 288, FAA ILS 6 approach chart overlay, detail view (select points annotated).

Figures 3 through 8 show geographic overlays of the accident flight recorded data, with select points annotated.

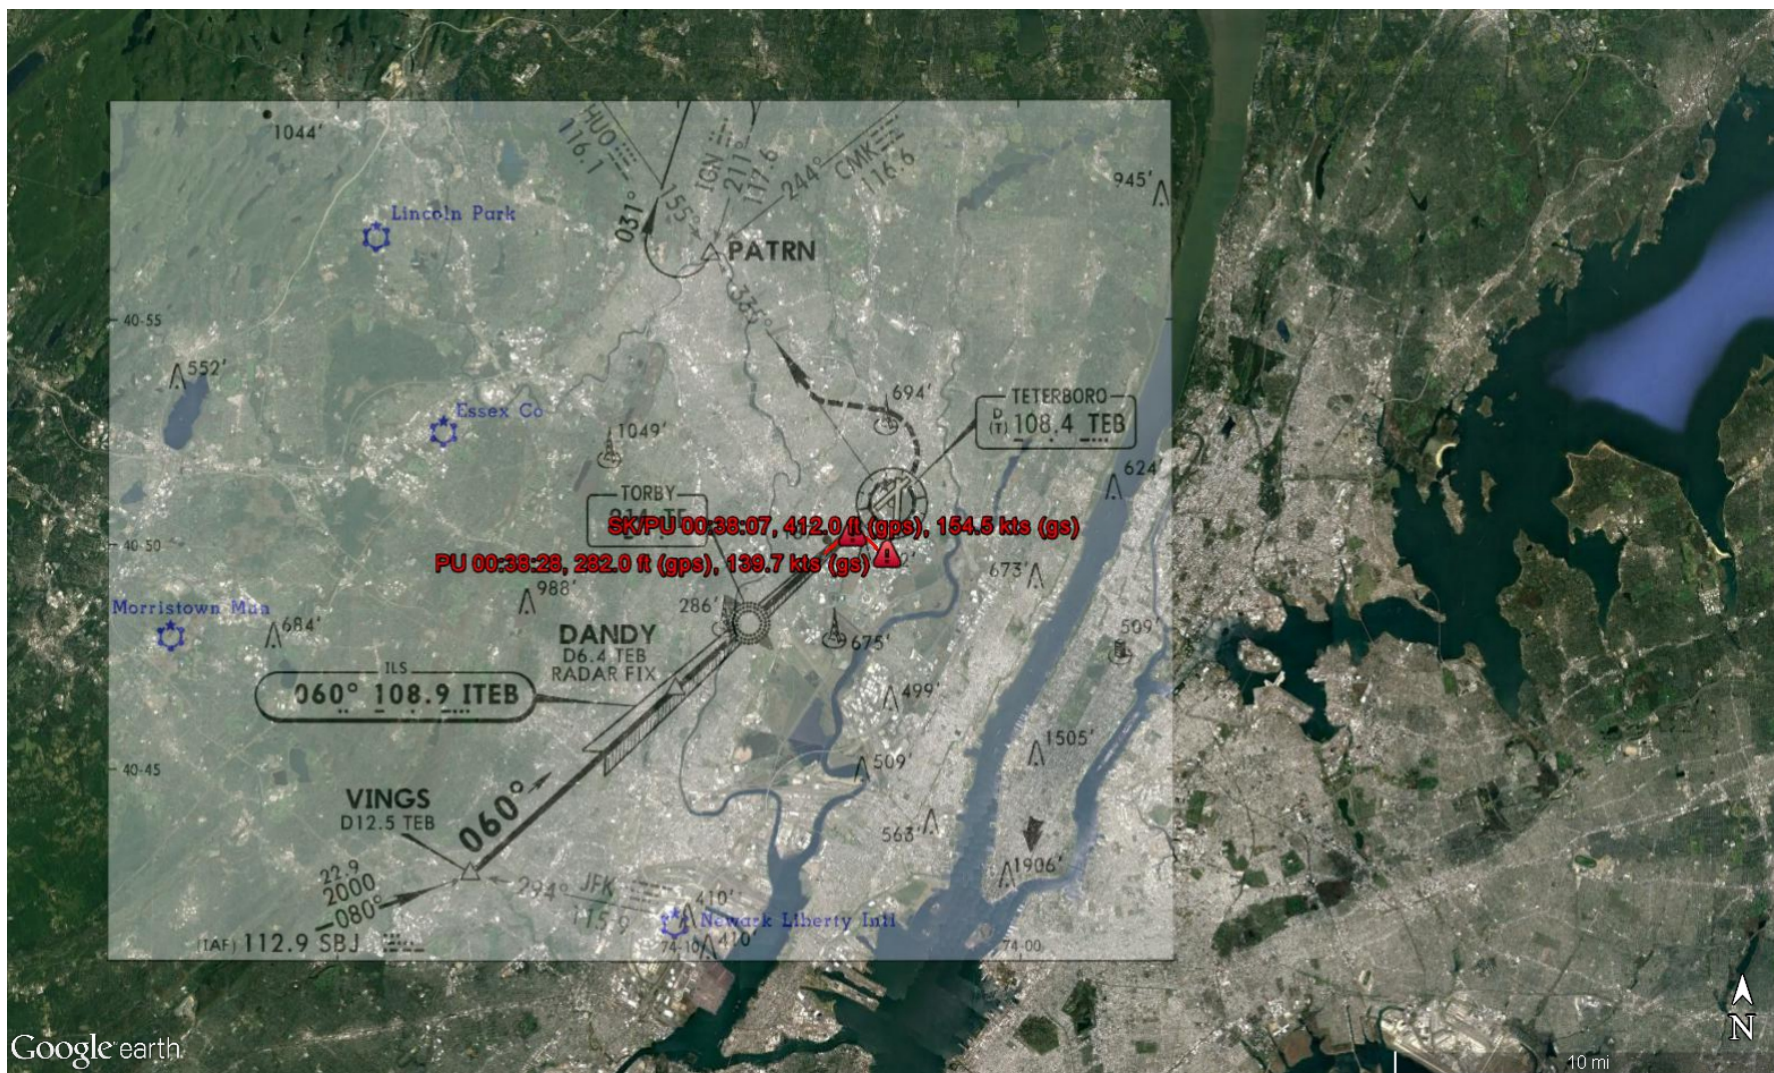
Figure 6. Accident leg 288, Jeppesen ILS 6 approach chart overlay, broad overview (select points annotated).

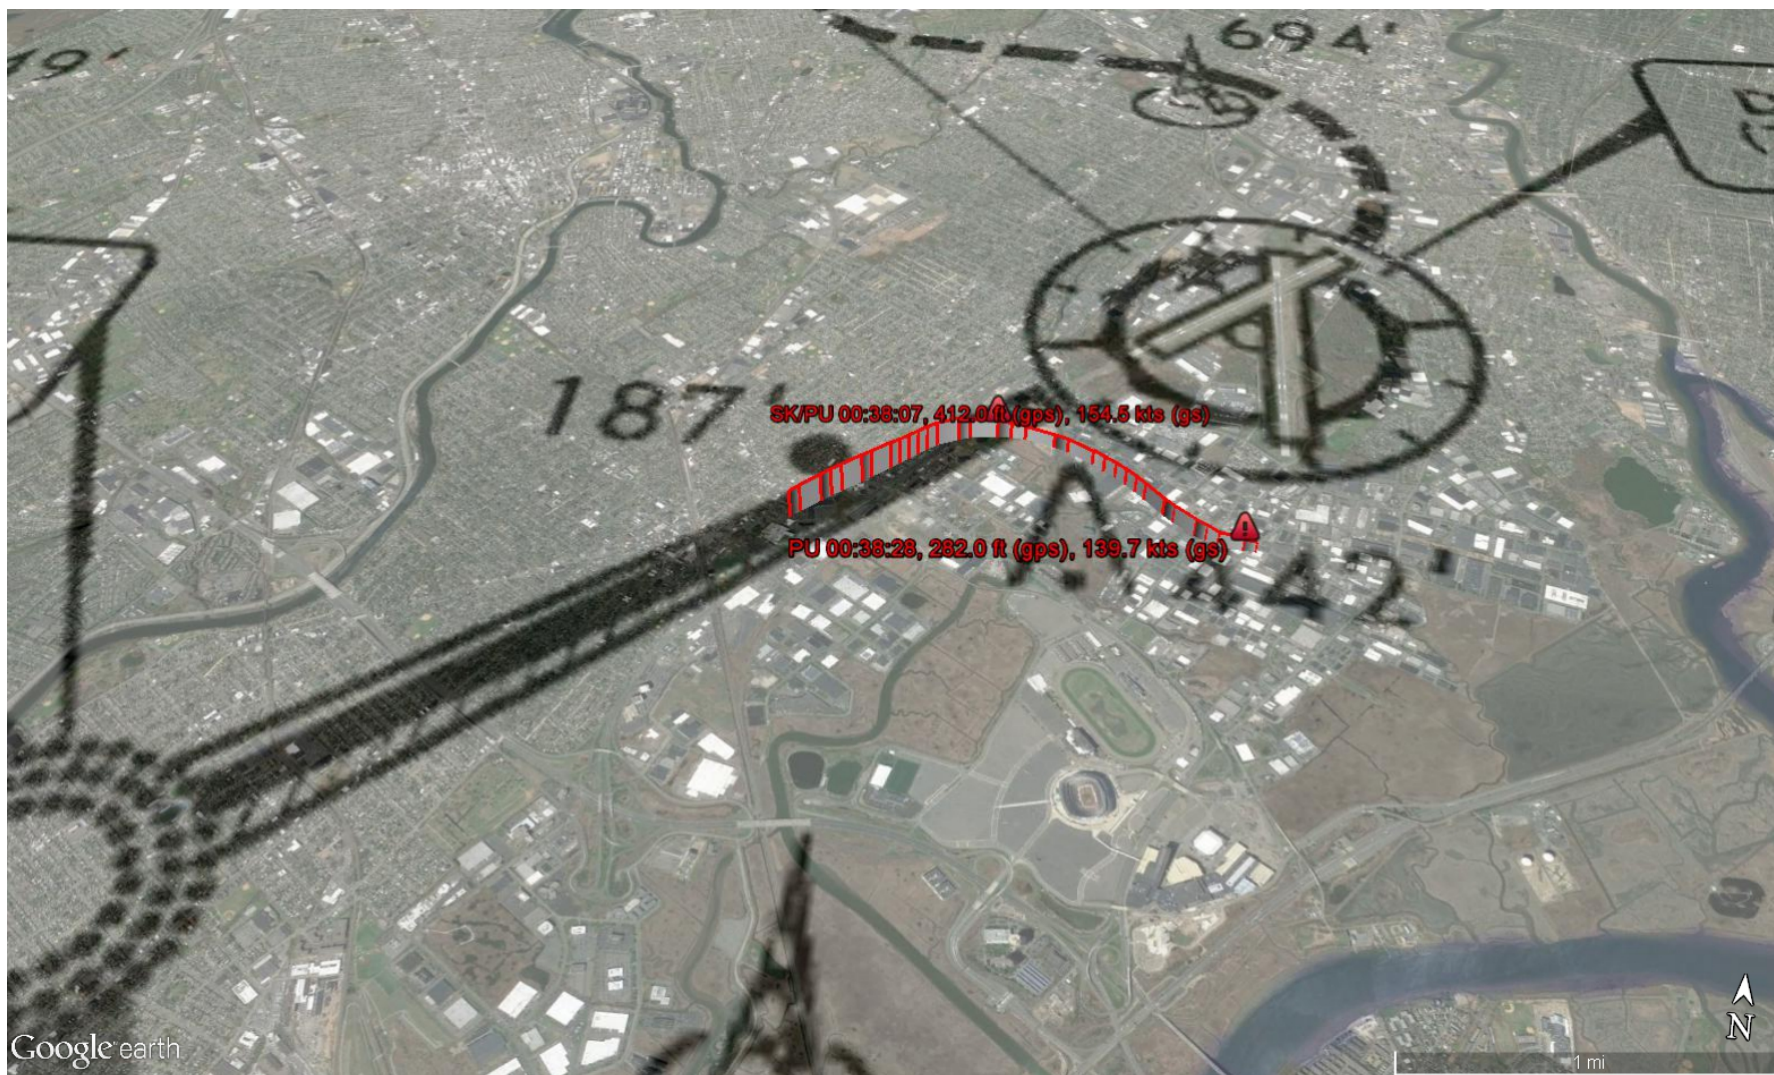
Figure 7. Accident leg 288, Jeppesen ILS 6 approach chart overlay, mid-level zoom (select points annotated).

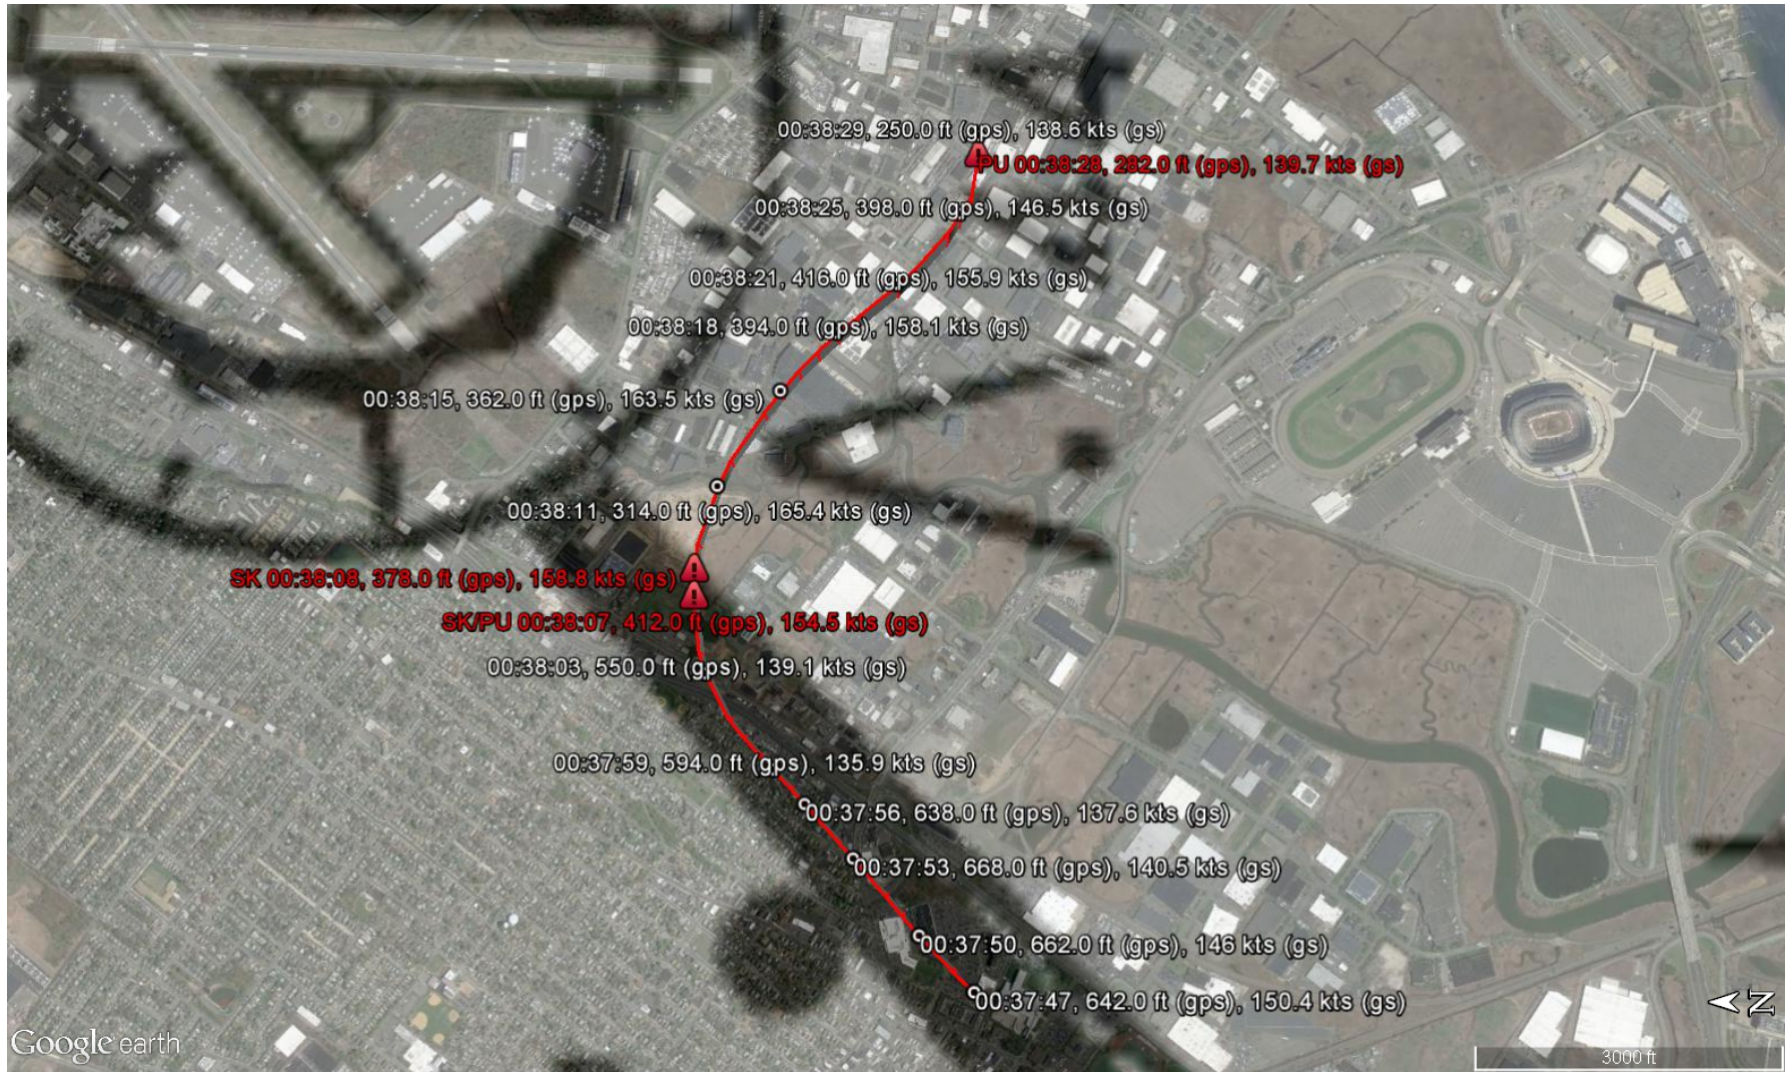
Figure 8. Accident leg 288, Jeppesen ILS 6 approach chart overlay, details (select points annotated).

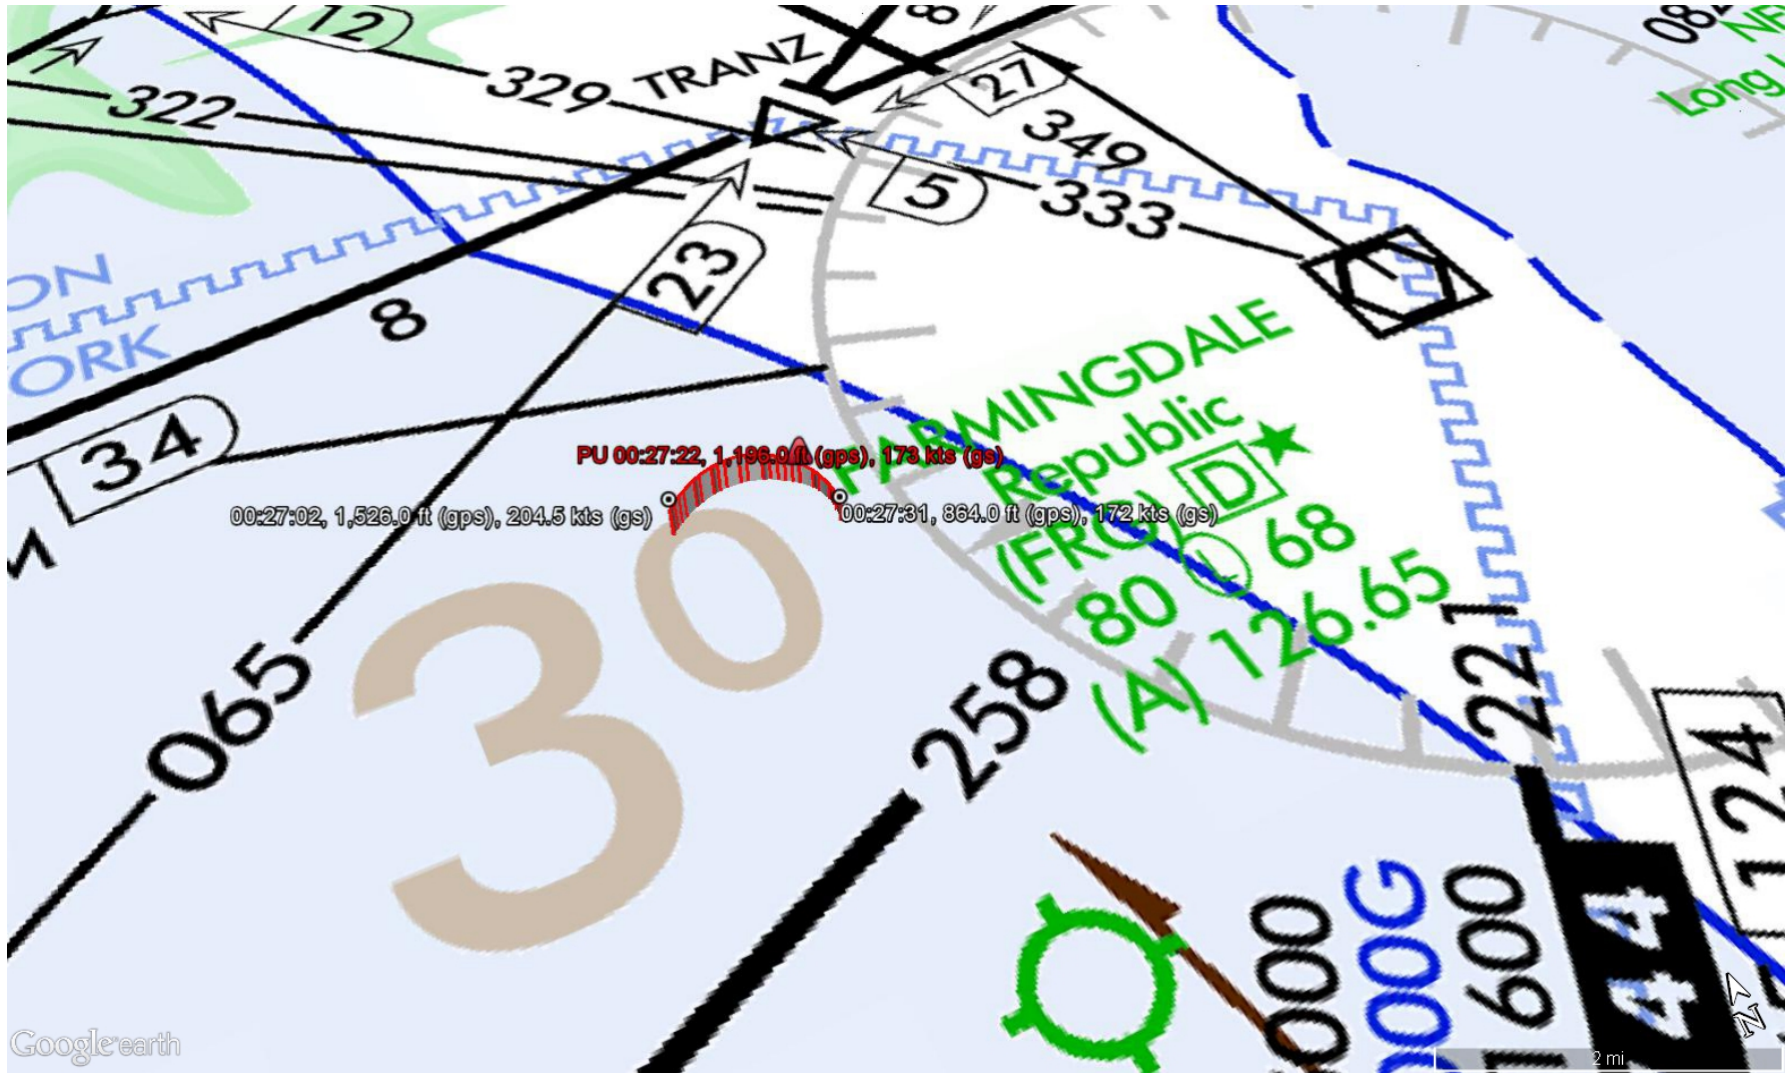
Figure 10. Leg 273, Low altitude IFR enroute chart overlay, first alert (select points annotated).

Figures 9 through 11 show the two prior flights that contained alerts.

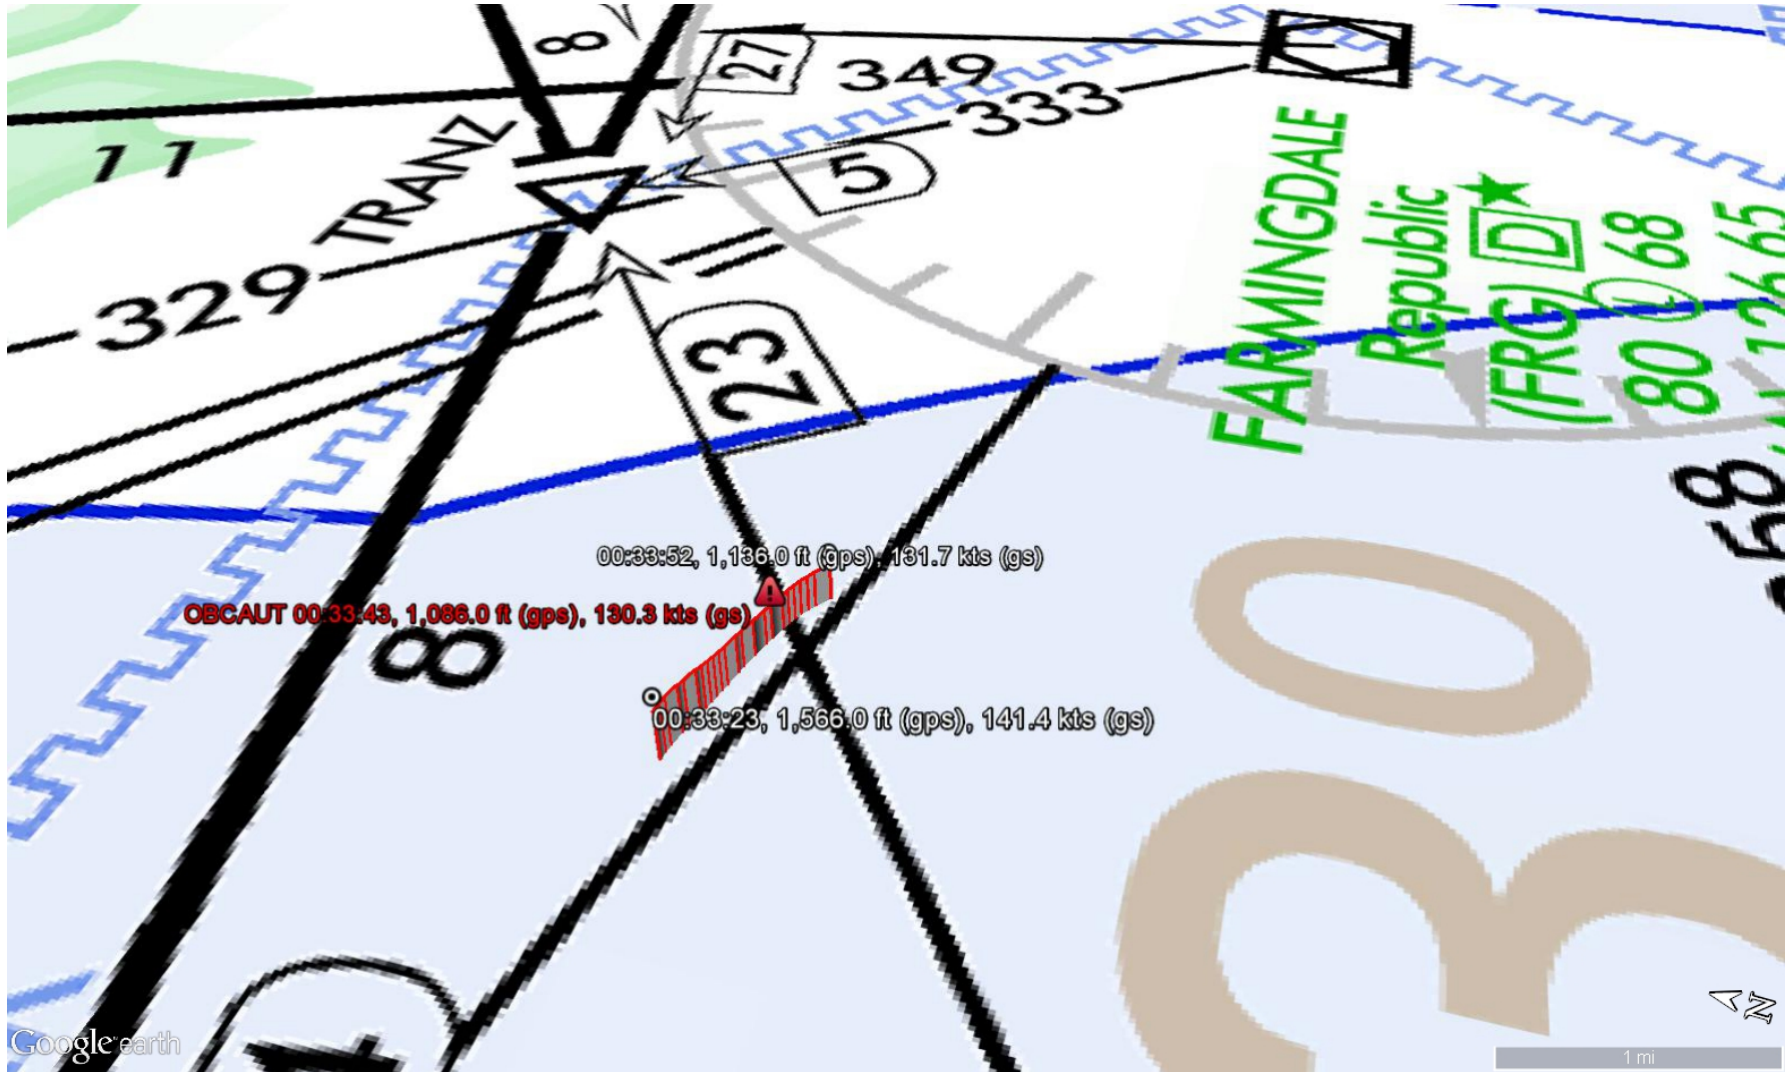
Figure 11. Leg 273, Low altitude IFR enroute chart overlay, second alert (select points annotated).
