NATIONAL TRANSPORTATION SAFETY BOARD

Enhanced Ground Proximity Warning System

Specialist's Factual Report

Location: Amarillo, Texas
Date: December 14, 2012
Aircraft: Beechcraft E-90
Registration: N67PS
Operator: Private
NTSB Number: CEN13FA105

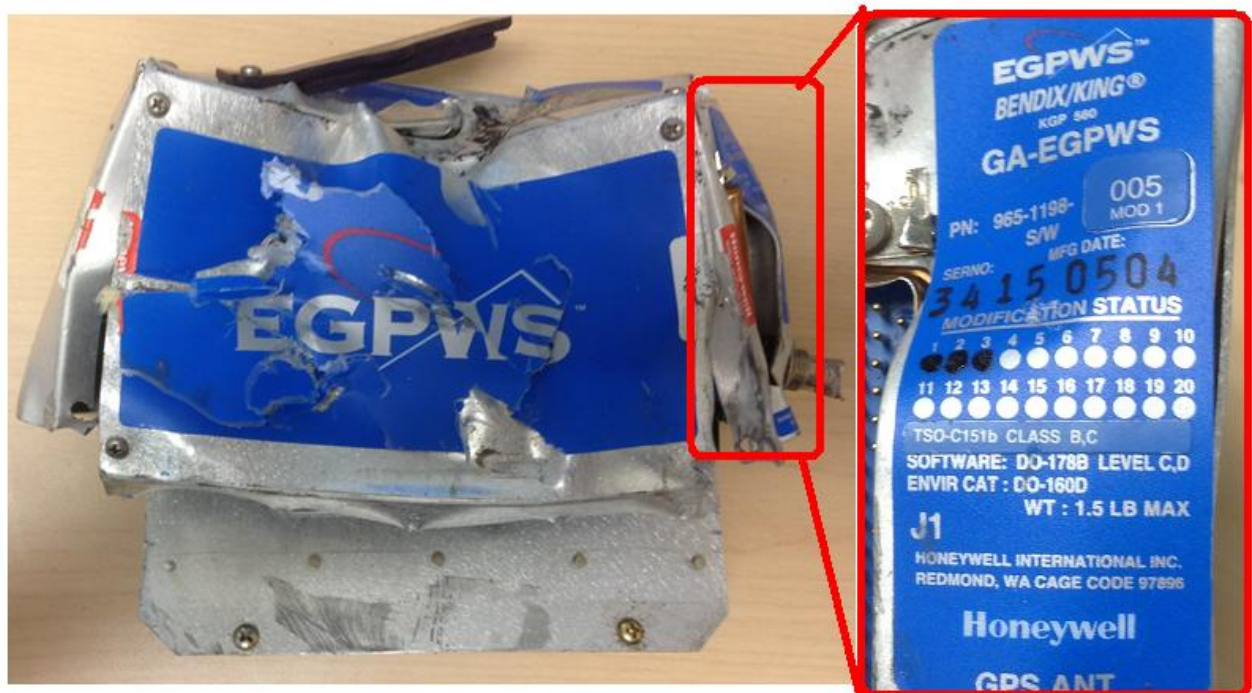
Figure 1. Damaged exterior of EGPWS.

The device was damaged in the event. The extent of the damage is shown in figure 1, with the side data plate expanded. The device was disassembled, and the internal board containing the NVM was found to be intact, as shown in figure 2. Figure 2 also annotates the U8 and U24 NVM chips, which were removed from the internal board and the chips' memory images downloaded by the NTSB for decoding by the EGPWS manufacturer.

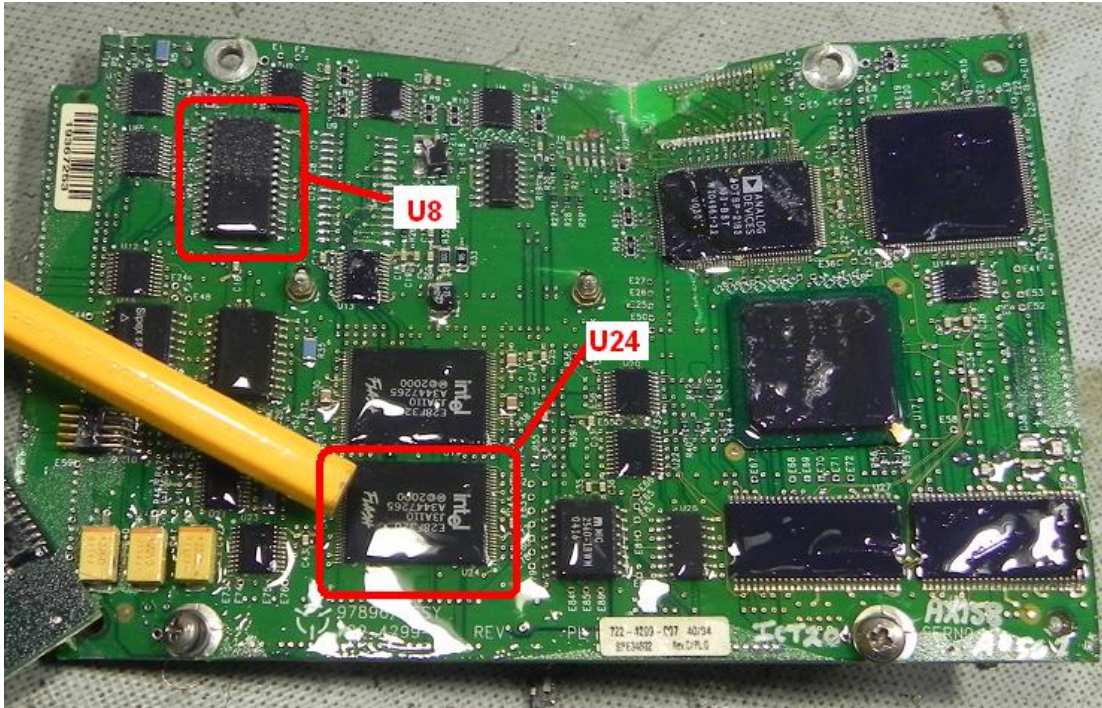
Figure 2. Internal board with NVM chips annotated.

The U8 and U24 memory images were provided to the EGPWS manufacturer for decoding and the decoding process was observed by NTSB personnel. The U8 chip image, which contained configuration information, did not decode properly and was not used by this report. The U24 chip image did decode properly and was used by this report. The decoded files were provided to the NTSB.

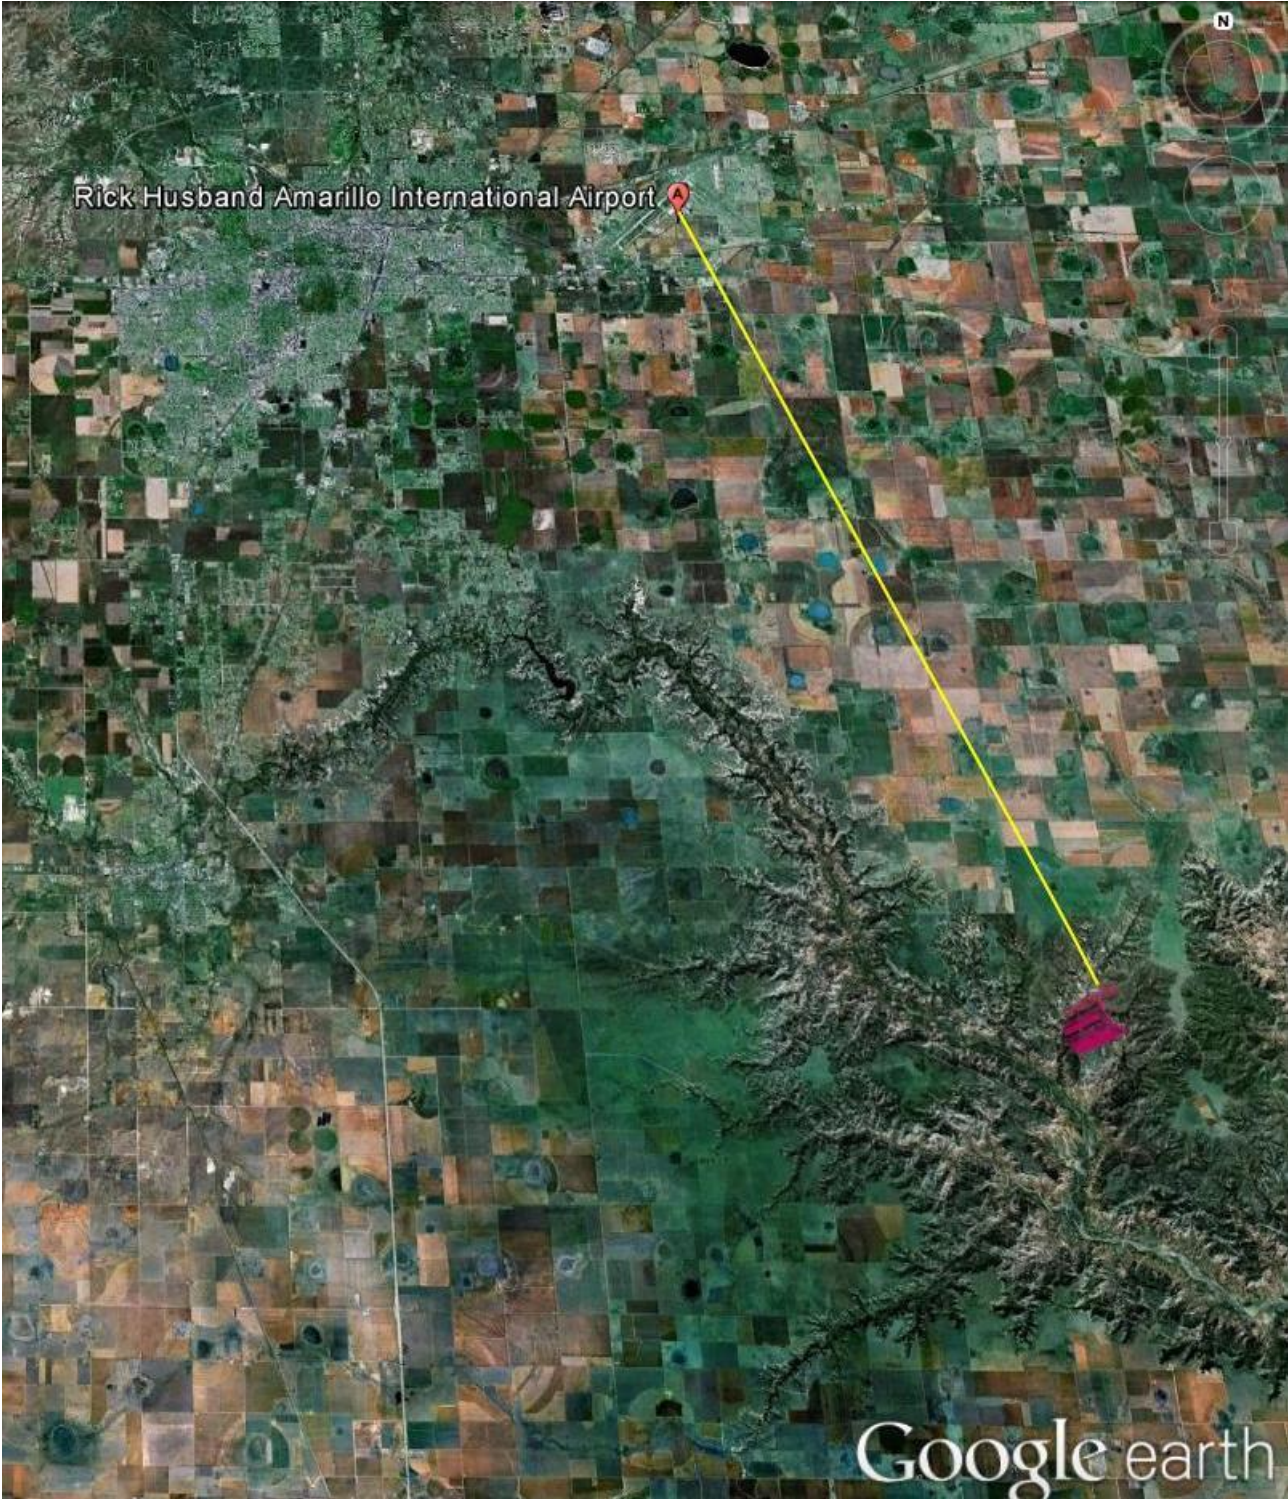
Figure 3. Google Earth overlay – departure airport and EGPWS data.

The overlay in figure 3 shows the relationship of the recorded EGPWS event to the KAMA airport. The recorded data was about 17 nautical miles southeast of the KAMA airport.

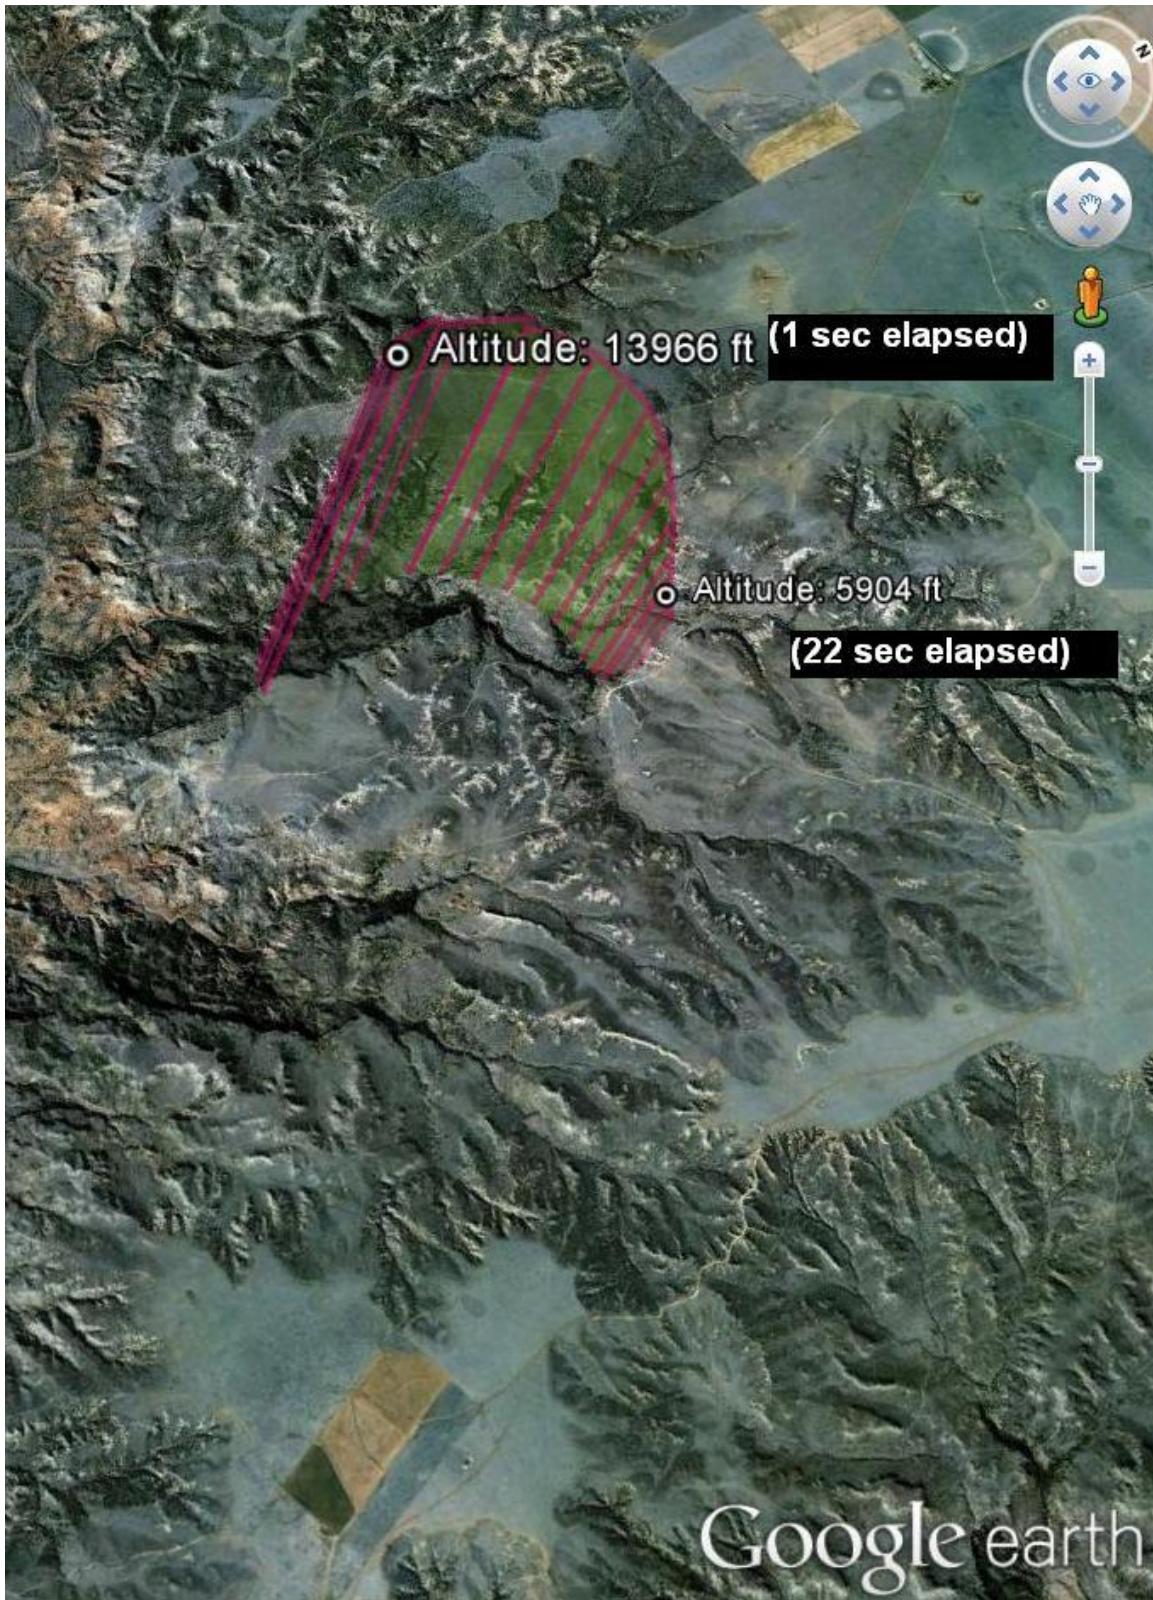
Figure 4. Google Earth overlay of EGPWS data from accident flight.

Figure 4 shows 22 seconds of recorded data in the descent. The aircraft descended from 13,966 feet to 5,904 feet, while the track turned to the right.

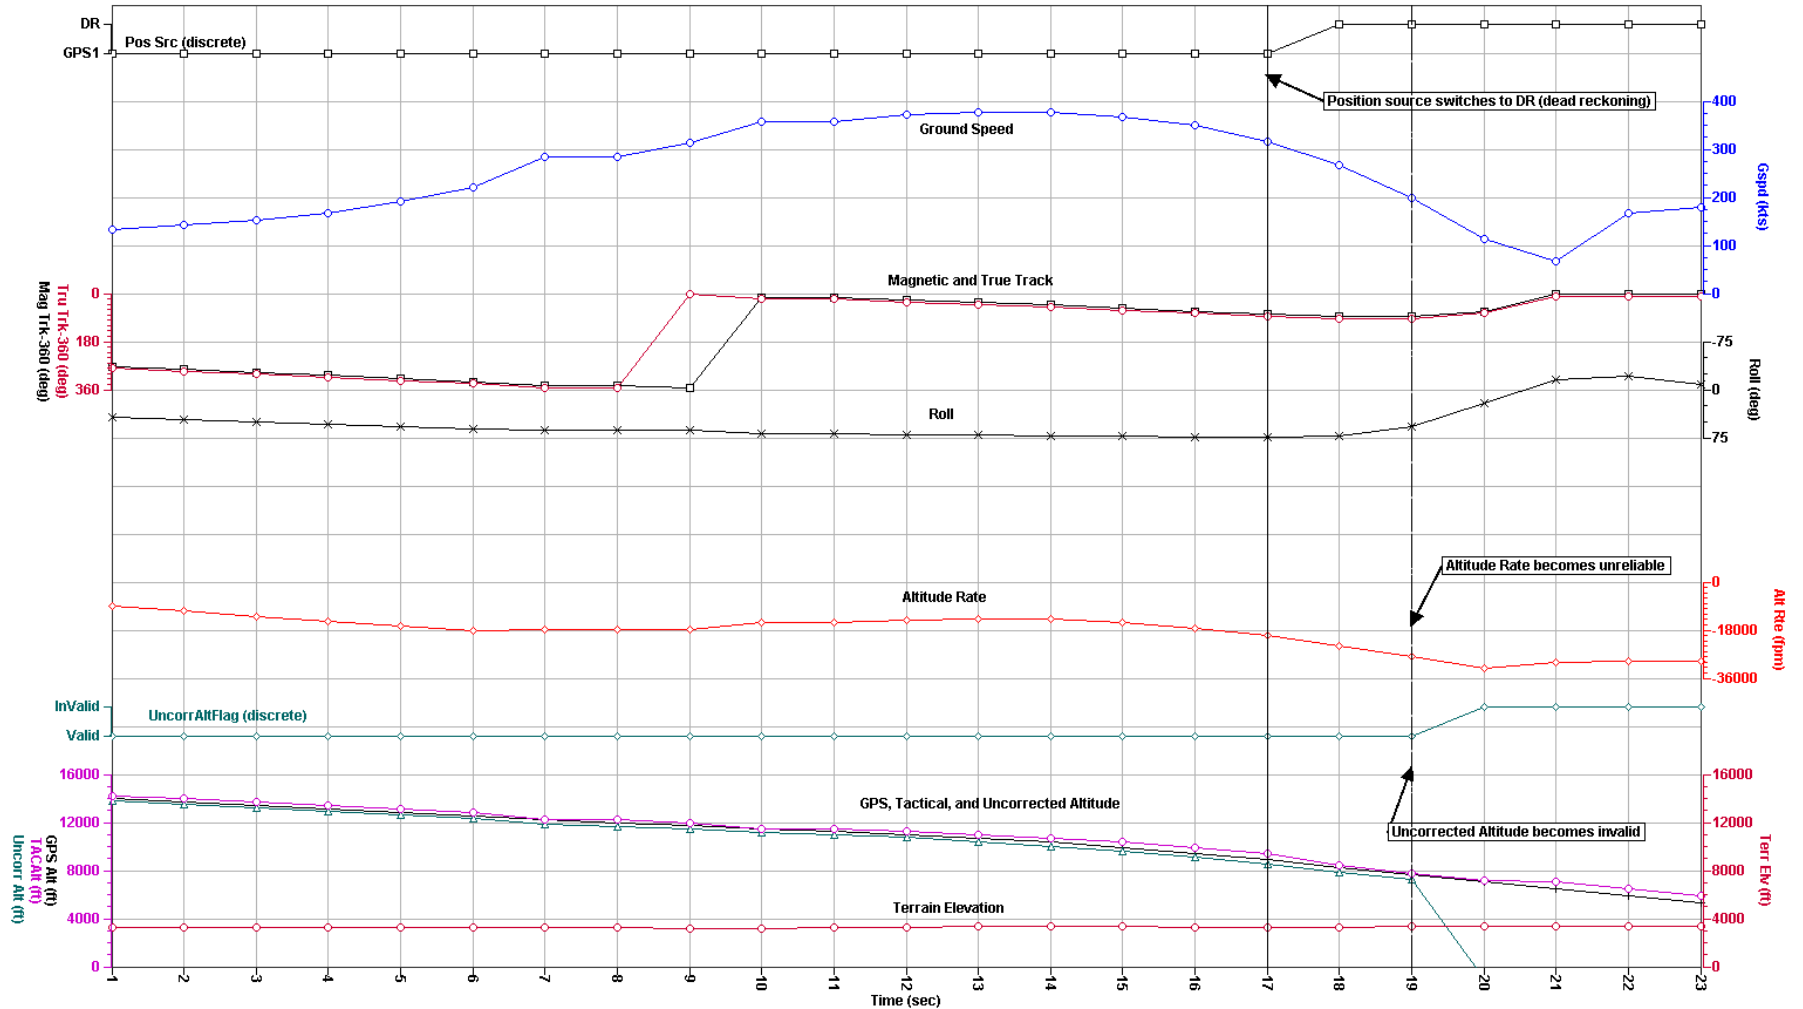
Figure 5. Plot of EGPWS data – accident flight.

Figure 5 shows a plot of the EGPWS recorded data. The aircraft descent rates were in excess of 18,000 fpm, and after 19 seconds, the descent rate exceeded the approximate 32,000 fpm limit of the EGPWS Altitude Rate parameter.
