NATIONAL TRANSPORTATION SAFETY BOARD
Vehicle Recorder Division
Washington, D.C. 20594

Locomotive Event Recorders

Specialist's Factual Report By Sean Payne

Location: Cayce, South Carolina
Date: February 4, 2018
Company: Amtrak/ CSX Transportation
Train ID/Locomotive: Amtrak Train 91/Locomotive 47/Lead¹
Train ID/Locomotive: CSXT Train F777 03/Locomotive 130/Lead²
Train ID/Locomotive: CSXT Train F777 03/Locomotive 36/2nd behind lead Locomotive³
NTSB Number: RRD18MR003
Summary: Refer to the Accident Summary report, within this docket.

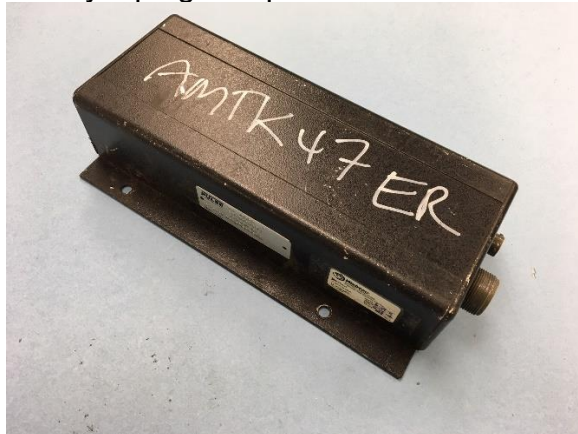
Figure 1. The event recorder from Amtrak 47.

The recorders for Amtrak 47 and CSXT 36 were in good condition. The recorder for CSXT 130 was damaged from impact. Figure 1 shows the recorder from Amtrak 47, figure 2 shows the

The data from Amtrak 47 were extracted normally using the Wabtec Railway Electronics Event Recorder Data Analysis Software and Amtrak equipment at an Amtrak facility in Raleigh, North Carolina on February 5th, 2018.

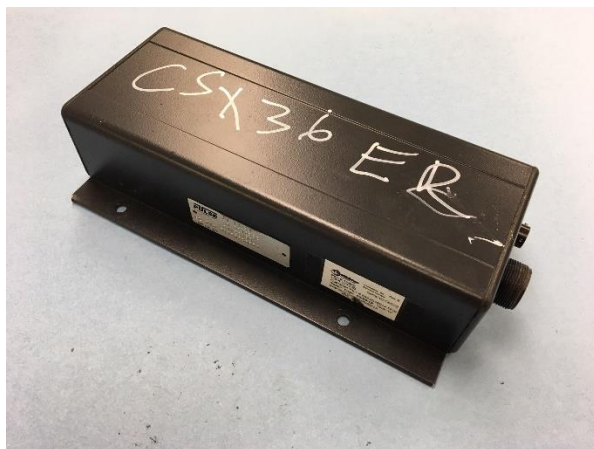
Figure 2. The event recorder from CSXT 36.

The data from CSXT 36 were extracted normally using the Wabtec Railway Electronics Event Recorder Data Analysis Software and CSX equipment on-scene by a CSX employee on February 4th, 2018. Later, the recorder was re-downloaded and the initial data verified by an NTSB specialist at an Amtrak facility, using Amtrak equipment in Raleigh, North Carolina on February 5th, 2018.

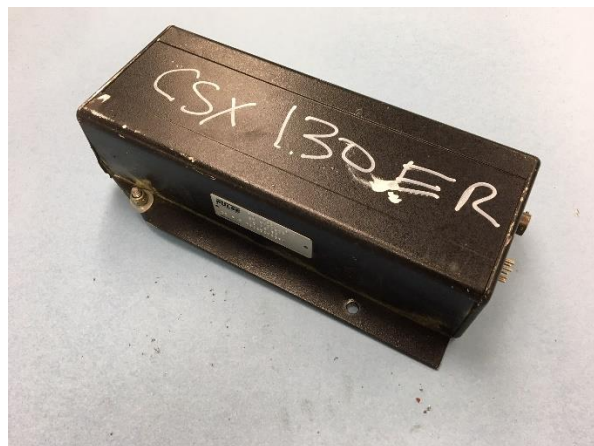
recorder from CSXT 36, and figure 3 shows the recorder from CSXT 130. Note in figure 3 the damage to CSXT 36's cannon style plug receptacle.

Figure 3. The event recorder from CSXT 130.

The recorder from CSXT 130 was extracted from the destroyed locomotive. The recorder was found bolted in it's normal mounting position (aft of the engineer's station), however, most of the cab area and other electronics around the recorder were destroyed. The recorder's canon plug was broken, but individual electrical pins associated with the canon plug remained. Individual pins were able to be inserted into the manufacturer's download cable for the device. The data from CSXT 130 were extracted normally using the Wabtec Railway Electronics Event Recorder Data Analysis Software on February 5th, 2018.

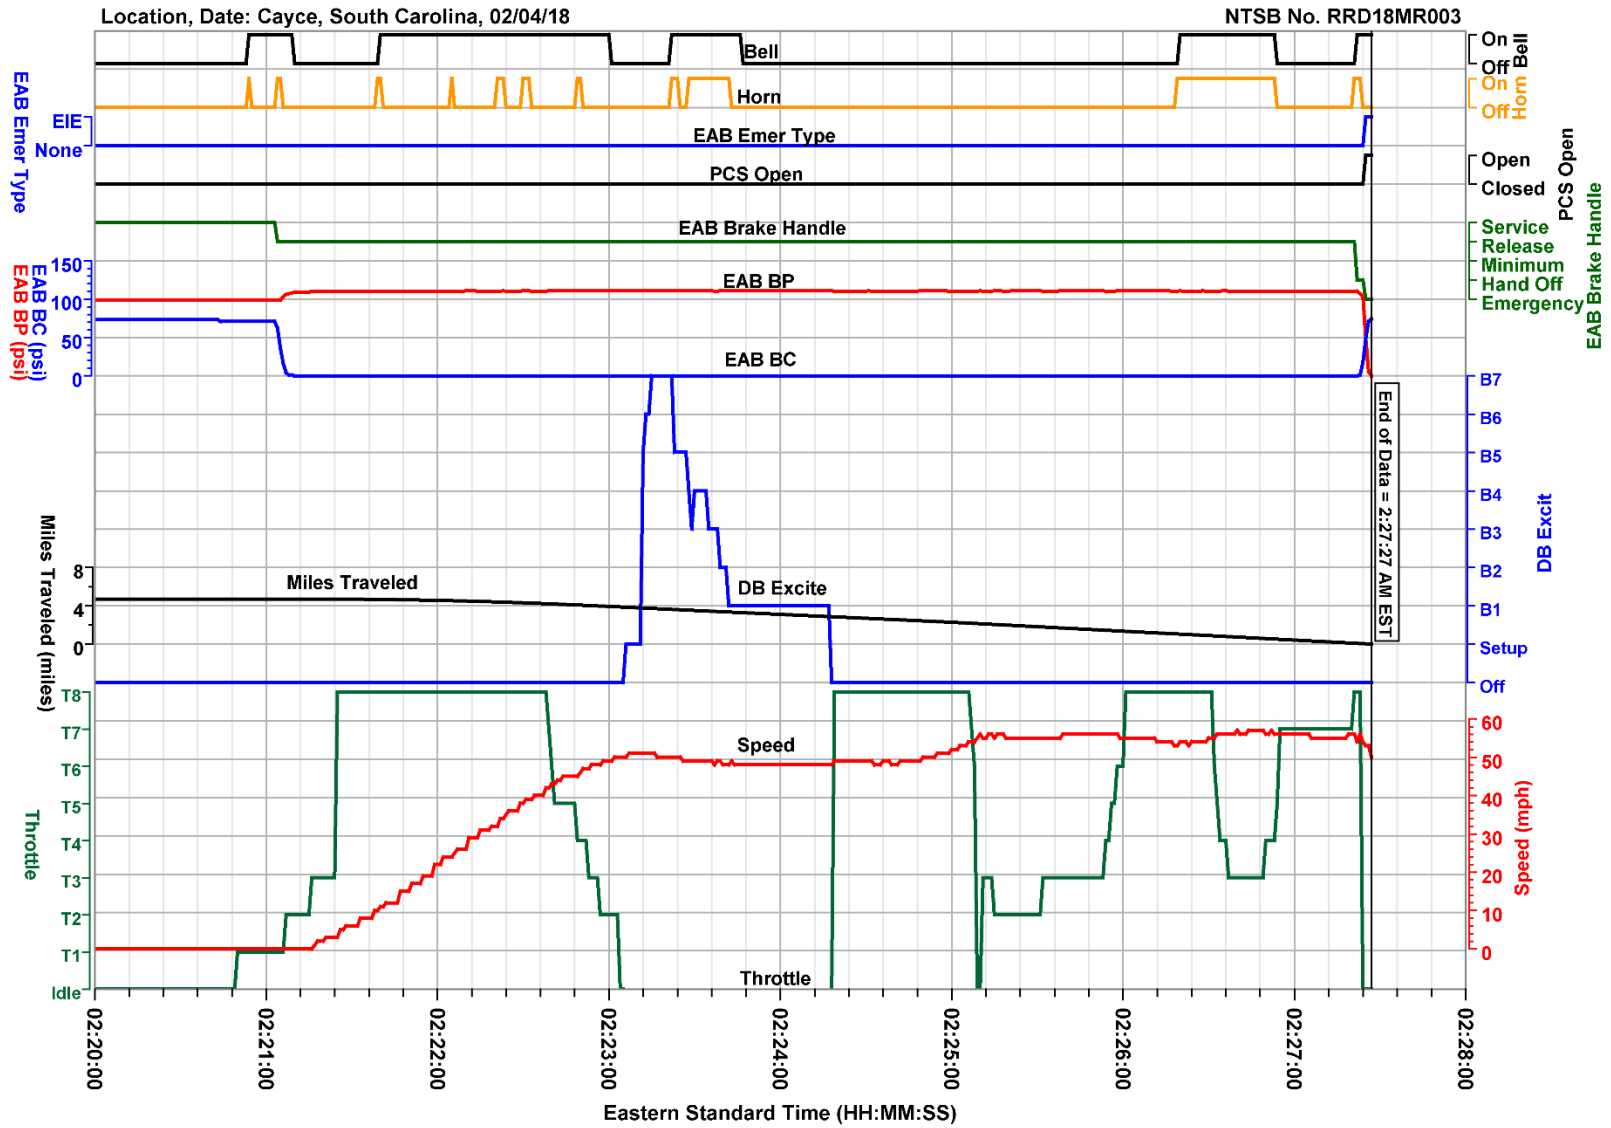
Figures 4 to 6 contain locomotive event recorder data from Amtrak 47. Figure 4 covers 30 minutes of data from 2:00:00 A.M. EST to 2:30:00 A.M. EST. Figure 5 covers 8 minutes of data from 2:20:00 A.M. EST to 2:28:00 A.M. EST. Figure 6 covers 30 seconds of data from 2:27:00 A.M. EST TO 2:27:30 A.M. EST.

Figure 5: Amtrak 47 event recorder parameters from 02:20 AM EST to 02:28 AM EST

- The event recorder showed the train departing Columbia Passenger Station 2:03:42 A.M.
- The train came to a stop at 2:09:17 A.M. at milepost 362.42.
- The train began movement again at 2:21:17 A.M. at milepost 362.42. Milepost began increasing toward the accident site.
- The train reached a maximum speed of 57 miles per hour (mph) around milepost 366.5.
- At 2:27:21 A.M., the train's horn transitioned from off to on. At this time, the train's speed was 56 mph.
- At 2:27:24 A.M., the throttle changed from throttle position 8 (T8) to idle.
- At 2:27:25 A.M., the train entered emergency braking via an "engineer induced emergency" through the EAB handle. The train's speed was 53 mph.
- End of data occurred at 2:27:27 A.M.. The train's speed was 50 mph as the train's air braking system was approaching maximum braking effort. The last milepost was 367.12.

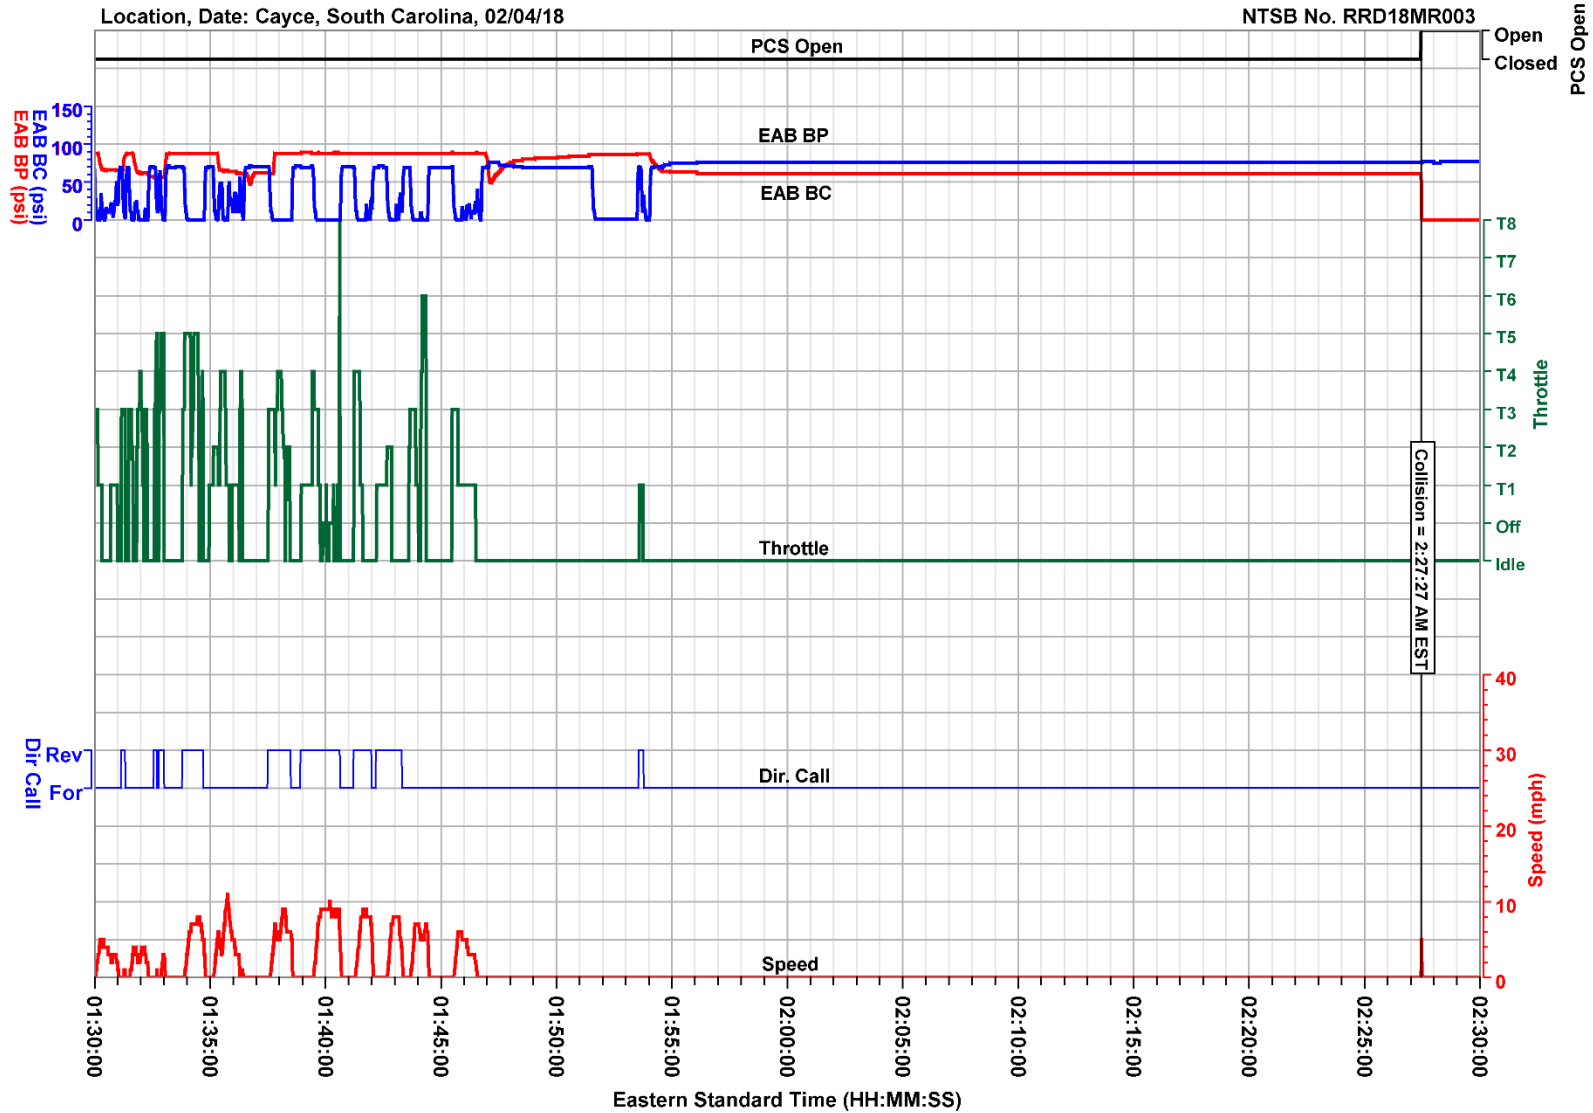
Figure 8 contains locomotive event recorder data from CSXT 36 and covers 1 hour of data from 1:30:00 A.M. EST to 2:30:00 A.M. EST on February 4, 2018.

Figure 8: CSXT 36 event recorder parameters from 01:30:00 A.M. EST to 02:30:00 A.M. EST on February 4, 2018.

At 01:30 A.M. EST, the locomotive was still performing series of moves near milepost 367. Movement continued until 1:46:27 A.M. at which time the train came to a stop after a reversing move. The train was idle for the next 41 minutes. At 2:27:27 A.M., the recorder indicated that the pneumatic control switch (PCS) opened and electronic air brake - brake pipe pressure (EAB BP) dropped quickly to 0 pounds per square inch (psi). A 2 mph and 5 mph sample were recorded within the next two seconds, though the value for milepost remained unchanged. The event recorder continued to record without any other remarkable changes.
