# NATIONAL TRANSPORTATION SAFETY BOARD

## Event Recorders Report

Specialist's Factual Report

Location: Jesup, GA  
Date: February 20, 2014, 04:30 P.M. EST (Eastern Standard Time)  
Company: CSX Transportation  
Train: CSX Train Q12519  
NTSB Number: DCA14FR005

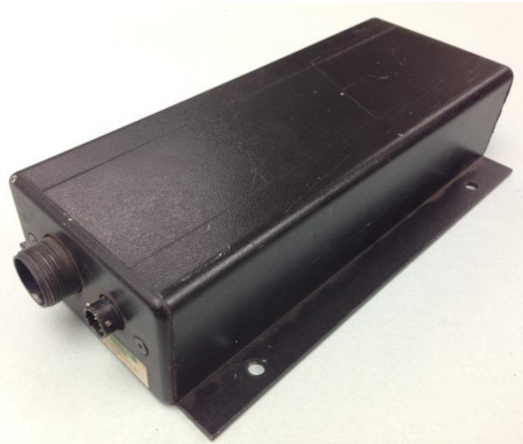
**Figure 1. Wabtec/Pulse recorder from lead locomotive CSX 372.**

Two event recorders were sent to the NTSB laboratory for read out and evaluation. The lead<sup>1</sup> locomotive, CSX 372, contained a Wabtec/Pulse recorder (Figure 1) that recorded approximately 17 parameters. The DPU<sup>2</sup> locomotive, CSX 7921, contained a Siemens/Quantum Q1027 recorder (Figure 2). Both recorders were downloaded in the lab without difficulty using the manufacturer's recommended procedure. Data from both recorders captured the accident sequence in its entirety. For this report, only data from the lead locomotive CSX 372 was used to create plots in Section 5.1 and 5.2. The raw data from CSX 372 is included in this report as Attachment 1. Recorder download activities are summarized in Table 1 on the following page.

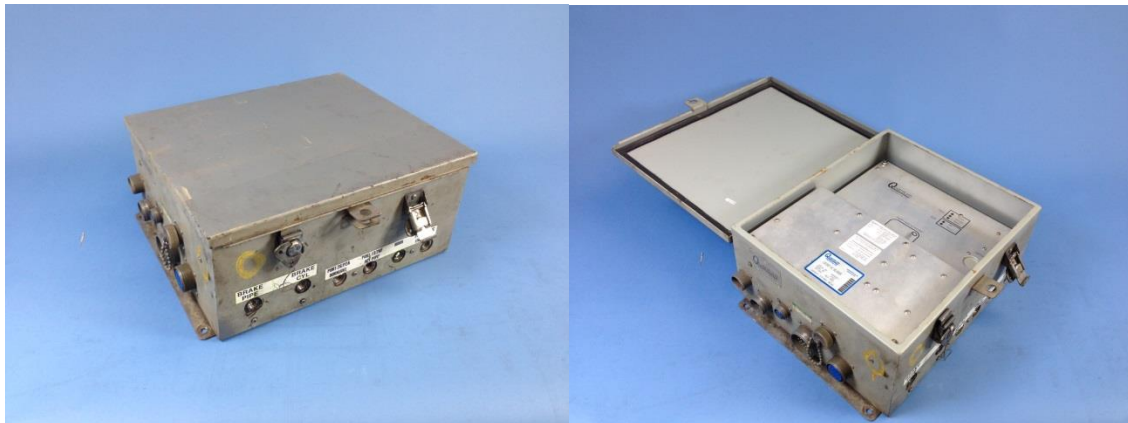
**Figure 2. Siemens/Quantum Q1027 recorder from DPU locomotive CSX 7921.**

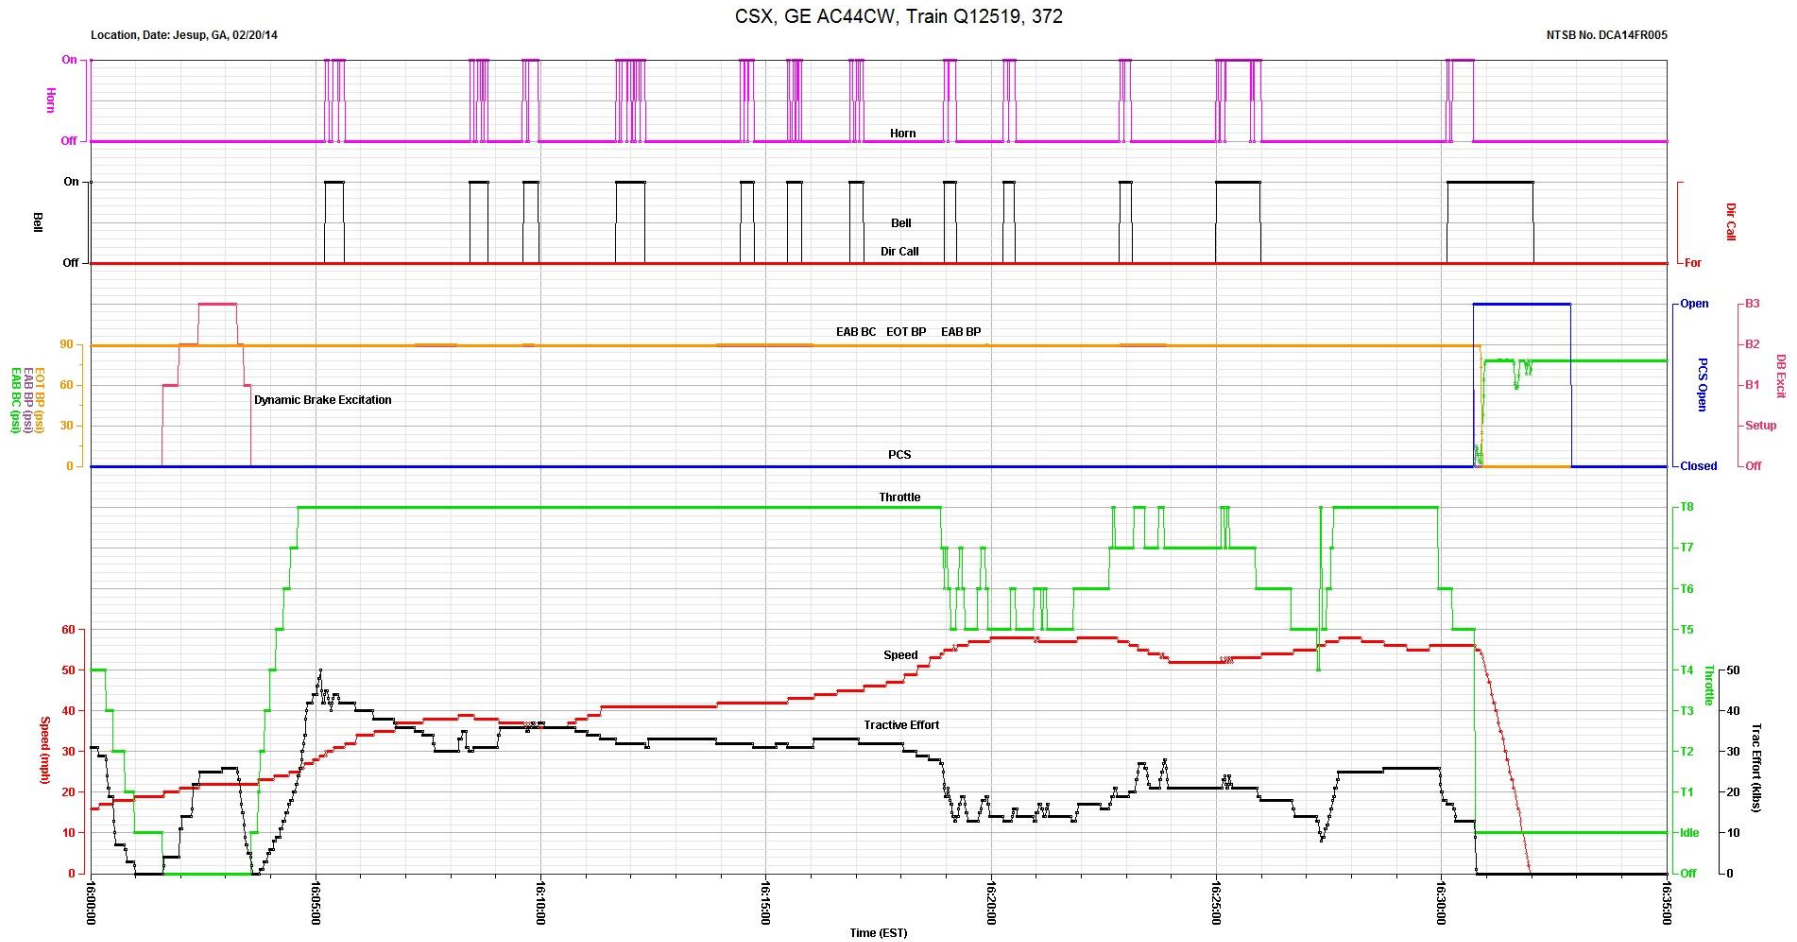
# Plot 1: Train Q12519 – Locomotive 372 - 04:00 P.M. (EST) to 04:35 P.M. (EST)

### **5.1 Train Q12519 – Locomotive 372 - 04:00 P.M. (EST) to 04:35 P.M. (EST)**

Event recorder data shows the train traveling northbound with all systems operating in a normal state. The data shows the train increasing speed from about 15 mph until it reached just under 60 mph around 04:20 P.M. (EST) for the plotted time interval. The horn and bell were activated at various times during the plotted period of time. The throttle position was changed multiple times between positions T4 and T8 as the operator maintained a speed of between 50 and 60 mph. A minor reduction in throttle position was noted around a minute prior to Emergency Brake application at 04:30:43 P.M. (EST). After Emergency Brake application, the train came to rest at 04:31:58 P.M. (EST).

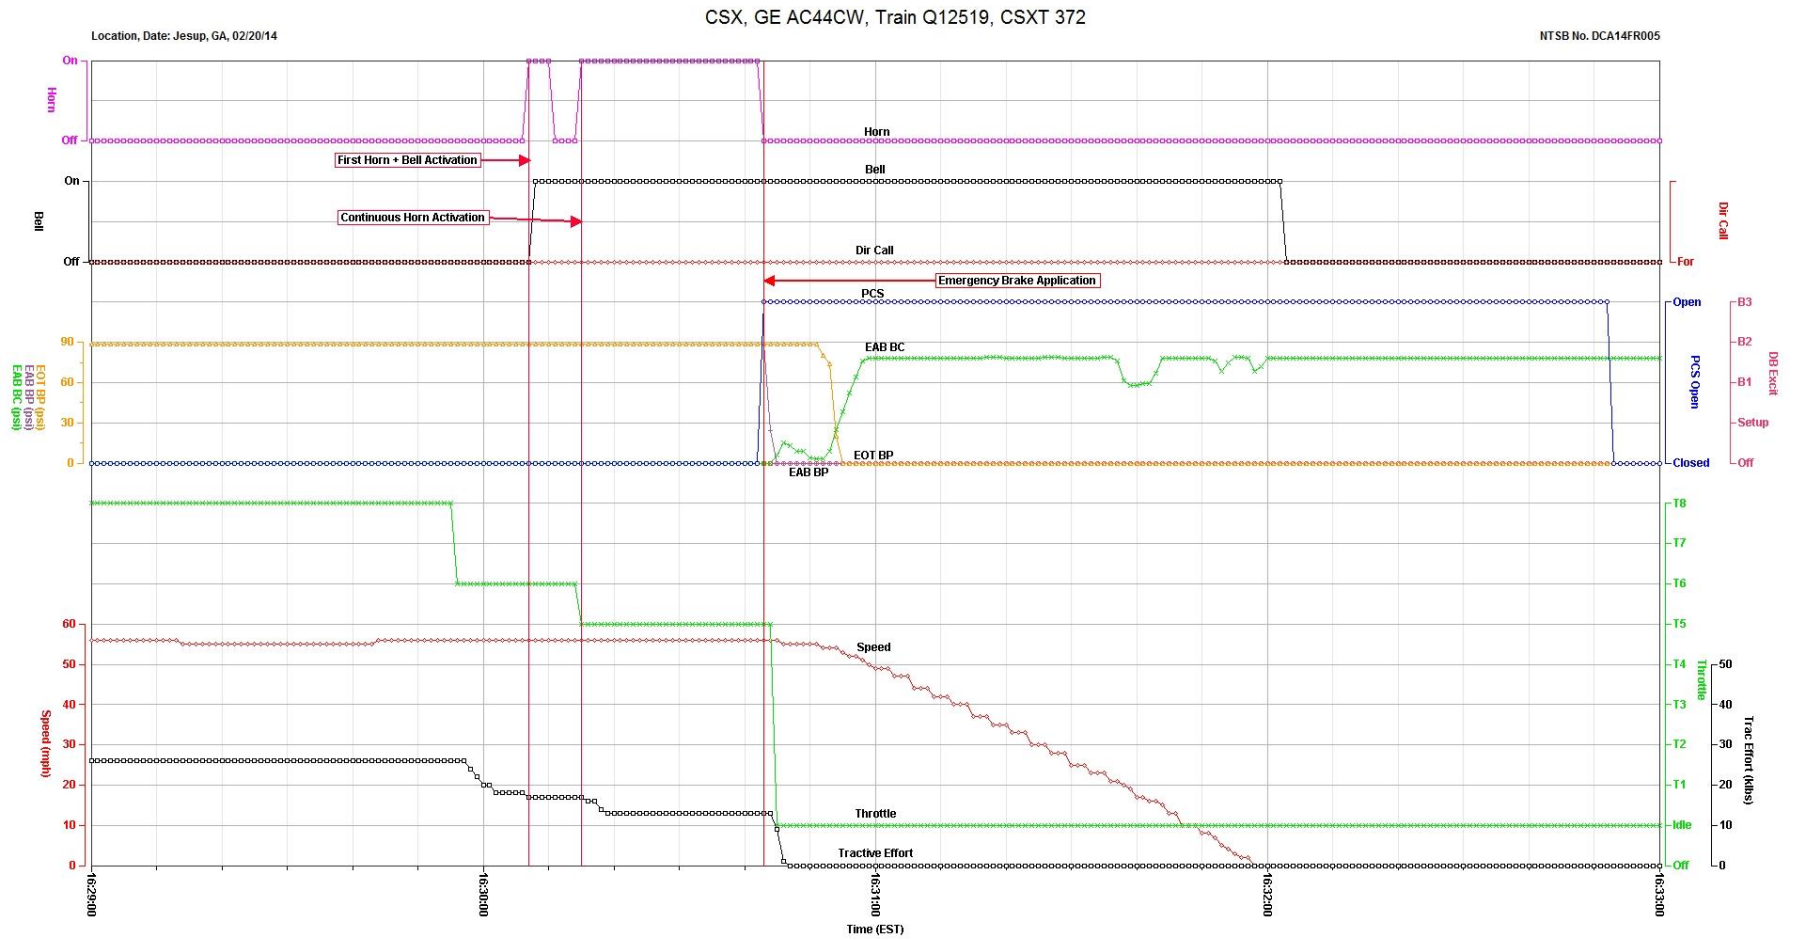
## Plot 2: Train Q12519 – Locomotive 372 - 04:29 P.M. (EST) to 04:33 P.M. (EST)

### **5.2 Train Q12519 – Locomotive 372 - 04:29 P.M. (EST) to 04:33 P.M. (EST)**

The train was traveling at 56 mph in throttle setting T8 as it neared the accident location at 04:29 P.M. (EST). At 04:29:56 P.M. (EST) the throttle is reduced to position T6. At 04:30:07 P.M. (EST) the horn was first activated followed by the bell one second later at 04:30:08 P.M. (EST). At 04:30:15 P.M. (EST) the throttle was further reduced to position T5 and the horn was activated continuously from this time until Emergency Brake application at 04:30:43 P.M. (EST). The Emergency Brake application comes via PCS and data shows a subsequent rapid decrease in Brake Pipe Pressure and corresponding increase in Brake Cylinder Pressure in the immediate seconds following. The throttle was reduced to Idle two seconds later at 04:30:43 P.M. (EST) and the train came to rest at 04:31:58 P.M. (EST).
