**NATIONAL TRANSPORTATION SAFETY BOARD**  
Vehicle Recorder Division  
Washington, D.C. 20594

## **Event and On-Board Image Recorders**

### **Group Chairman's Factual Report By Bill Tuccio, Ph.D.**

Location: Cimarron, Kansas  
Date: March 14, 2016  
Vehicle: Train Amtrak 4: Locomotive AMTK 153 and 152  
Operator: Amtrak  
NTSB Number: DCA16MR004

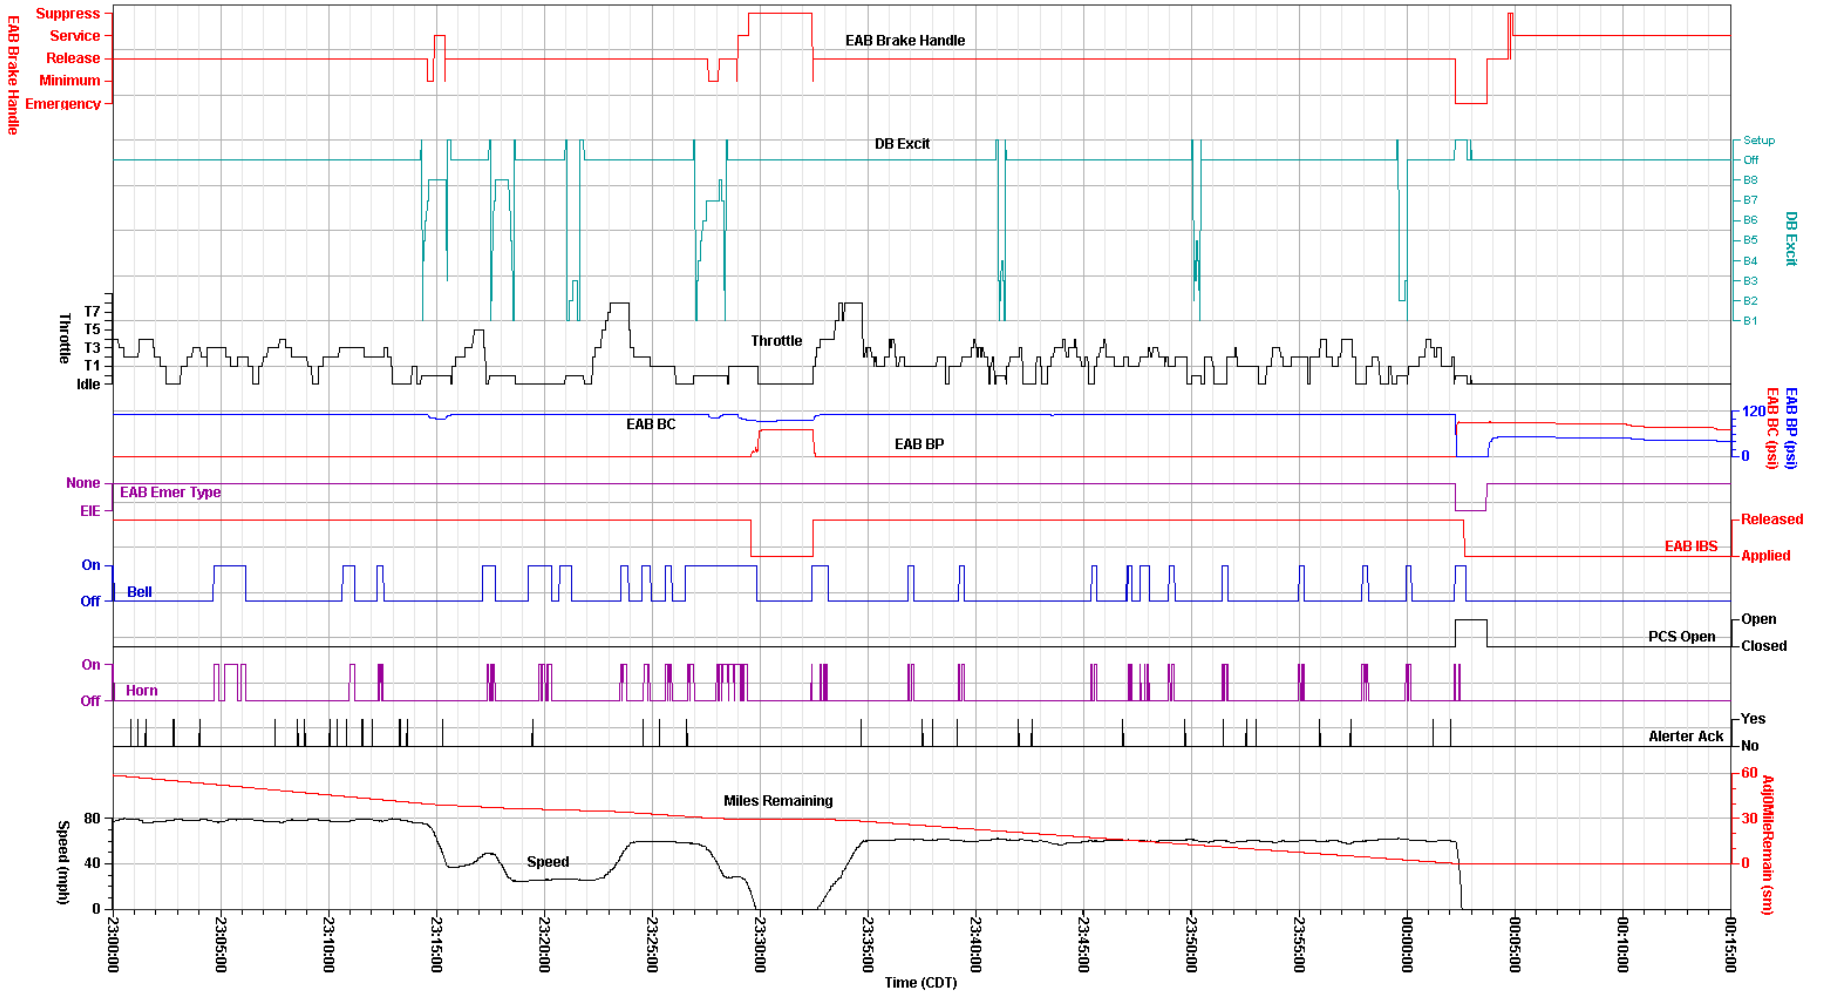
Figure 1: Select parameters from AMTK153 event recorder (from 2300:00 to 0015:00 CDT).

Figures 1 and 2 contain event recorder data as described in table 1. All parameters listed in table A-1 were plotted.

From 2300 CDT until the derailment event, active changes of throttle, alerter, horn, and bell parameters occurred, as shown previously in figure 1.

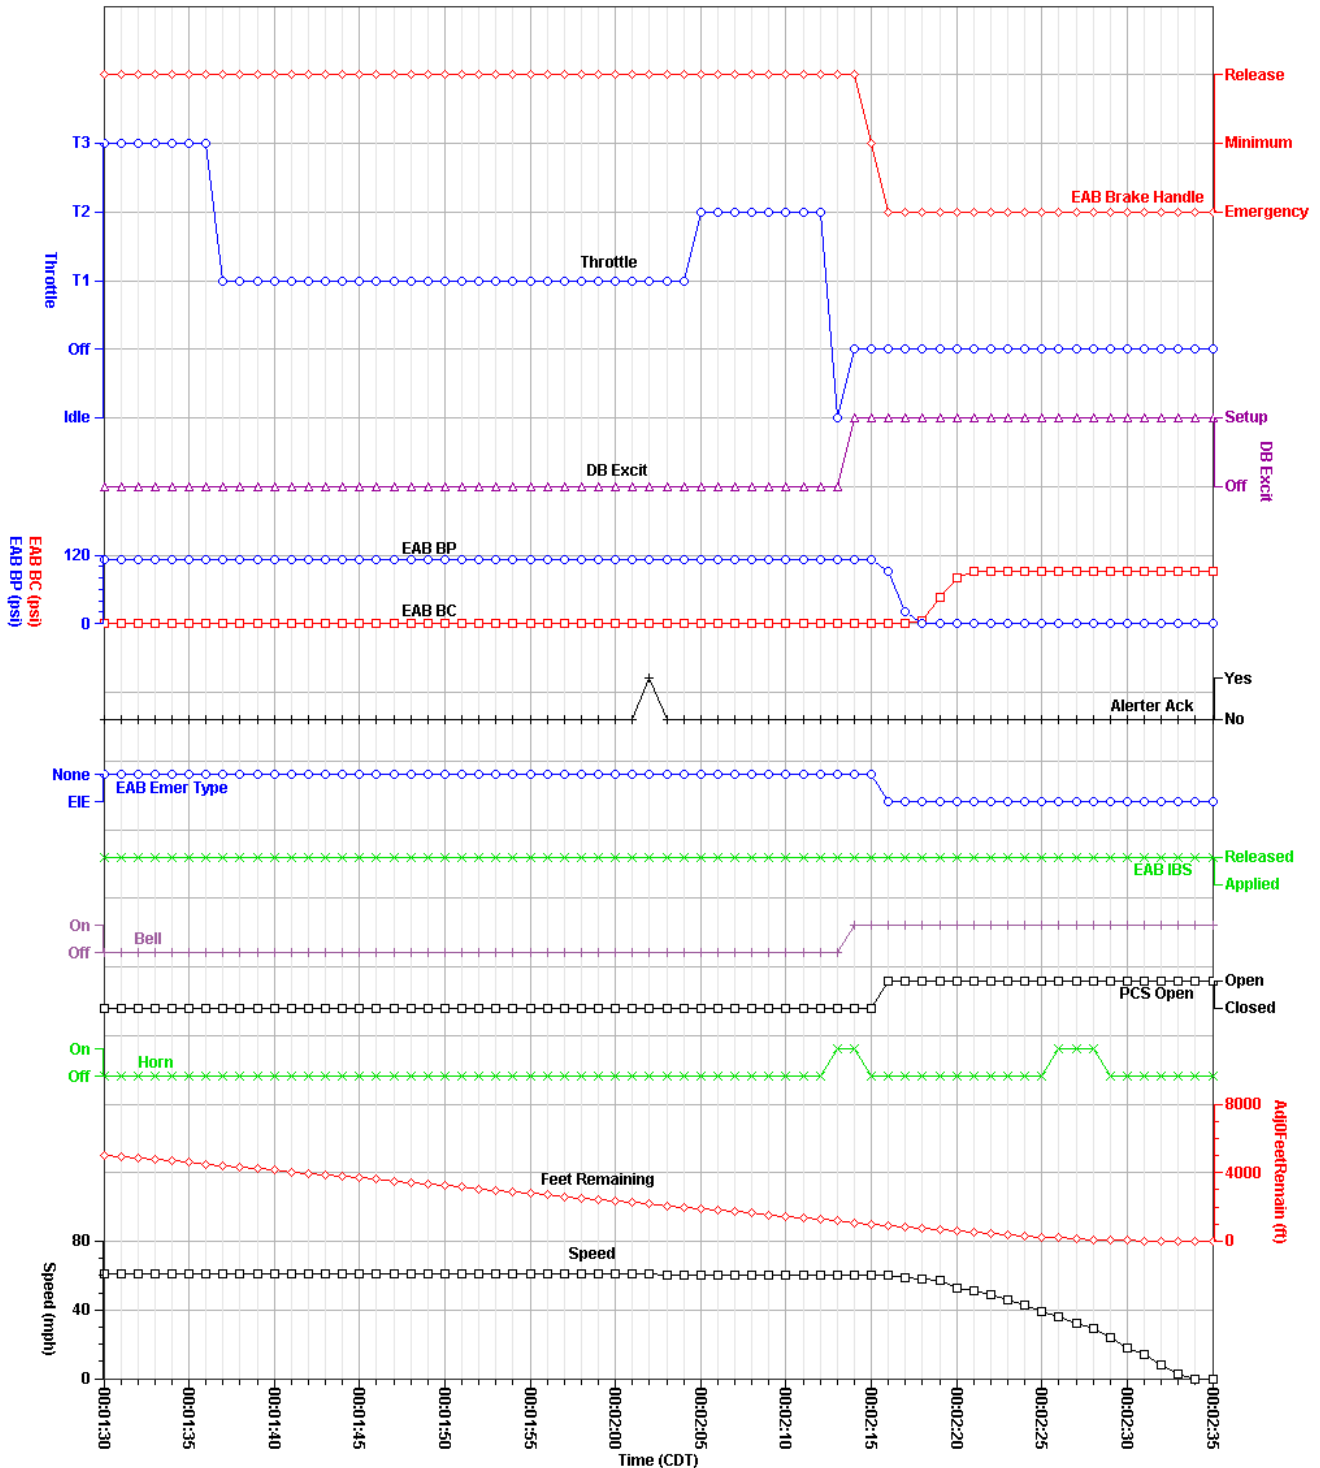
Figure 2: Select parameters from AMTK153 event recorder (from 0001:30 to 0002:35 CDT).

At 0002:14 CDT, AMTK153 swayed right, then left. Also, the bell began and continued until the end of the recording.

At 0002:15 CDT, the Electronic Air Brake (EAB) Handle changed state from "Release" to "Minimum." By 0002:16 CDT, the EAB Handle changed state to Emergency and remained so for the remainder of the derailment event. Coincident with the EAB Handle in Emergency, EAB Pressure began to reduce from a prior value of 111 pounds per square inch to 0 by 0002:18 CDT.

At 0002:26 CDT, the horn was activated for three seconds.

From the time the EAB Handle was first taken out of "Release" until the train stopped, AMTK153 traveled 1,095 feet in 19 seconds.

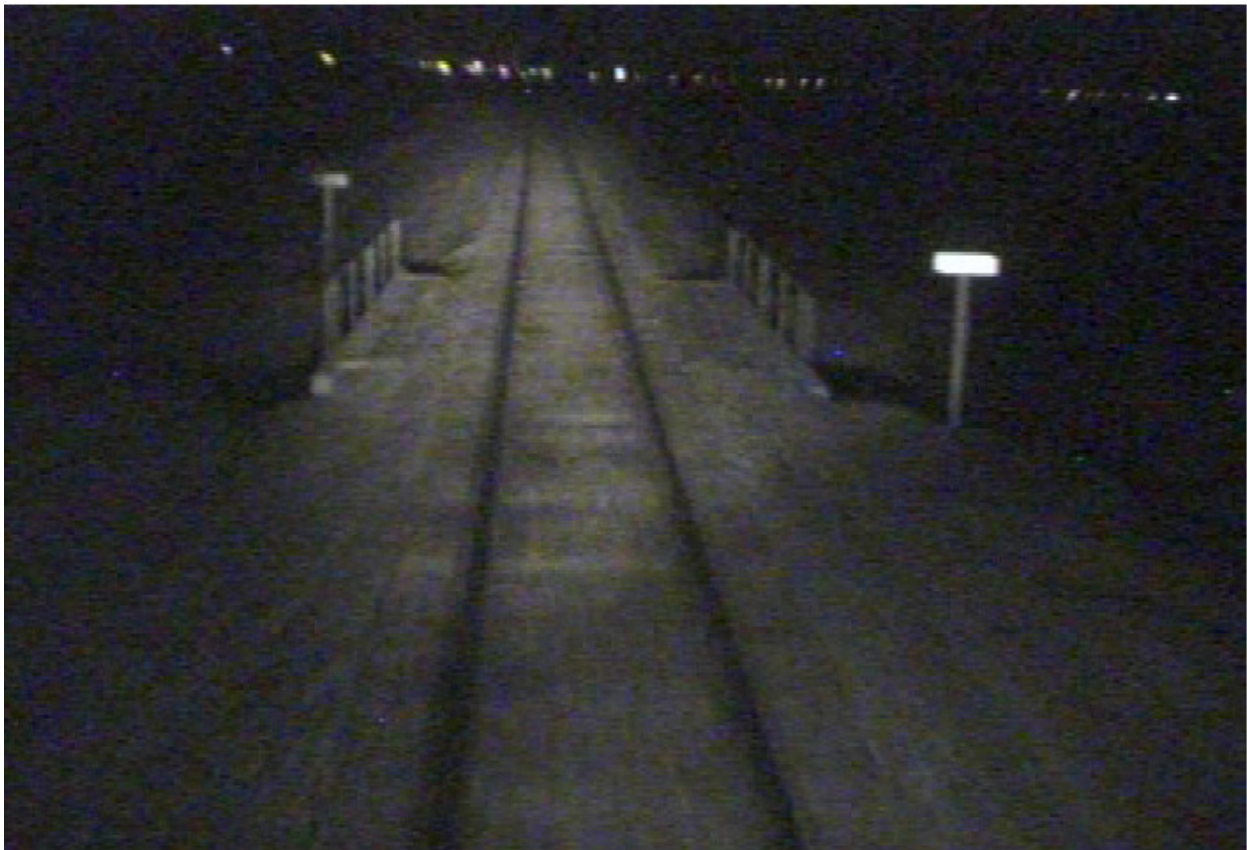
**Figure 3. AMTK153 at 0001:57 CDT.**

At 0001:57 CDT, AMTK153 crossed over a small bridge, as shown in figure 3. At this time, AMTK153 was traveling 61 mph, and was about 1,697 feet from the Engineer Induced Emergency (EIE) event.

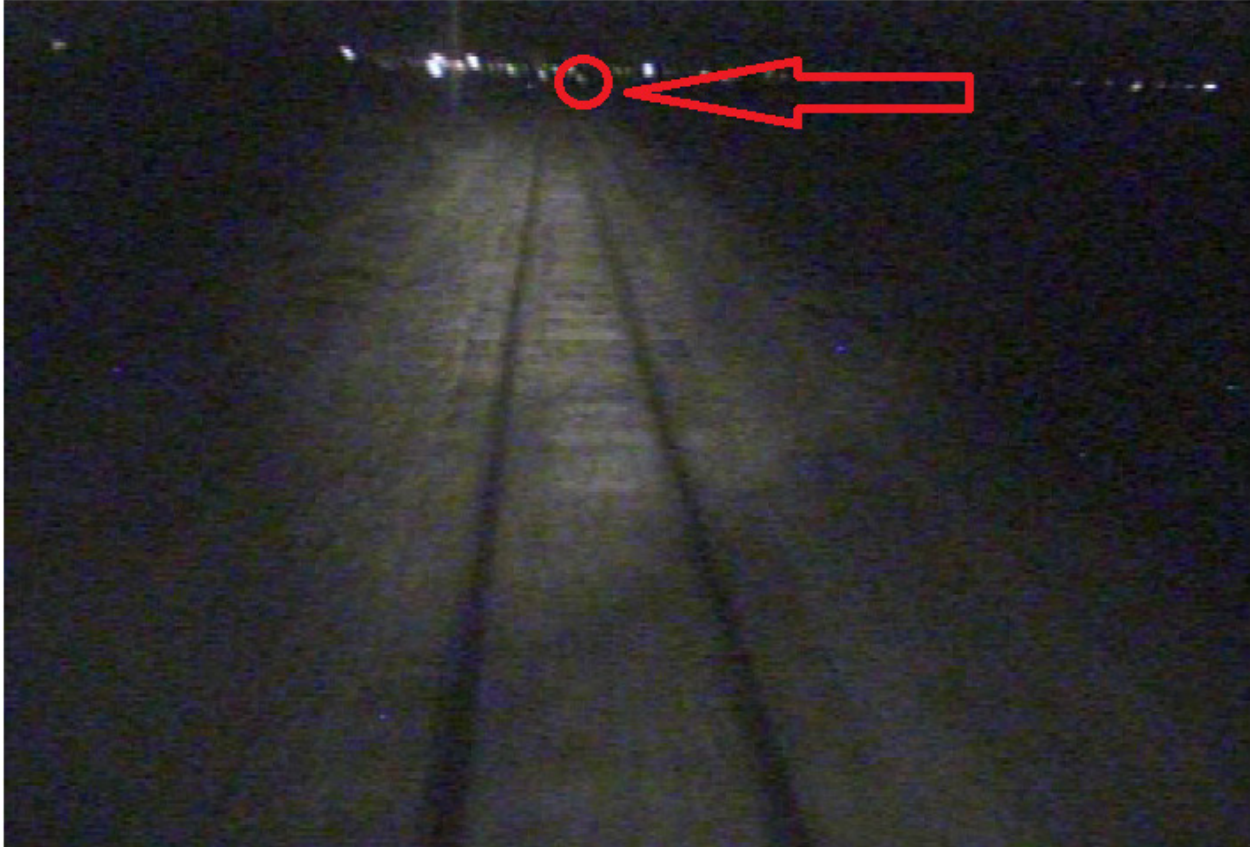
**Figure 4. AMTK153 at 0002:05 CDT.**

At about 0002:05 CDT, the reflective whistle board next to the track anomaly was first visible in the video recording, as shown by the annotation in figure 4.

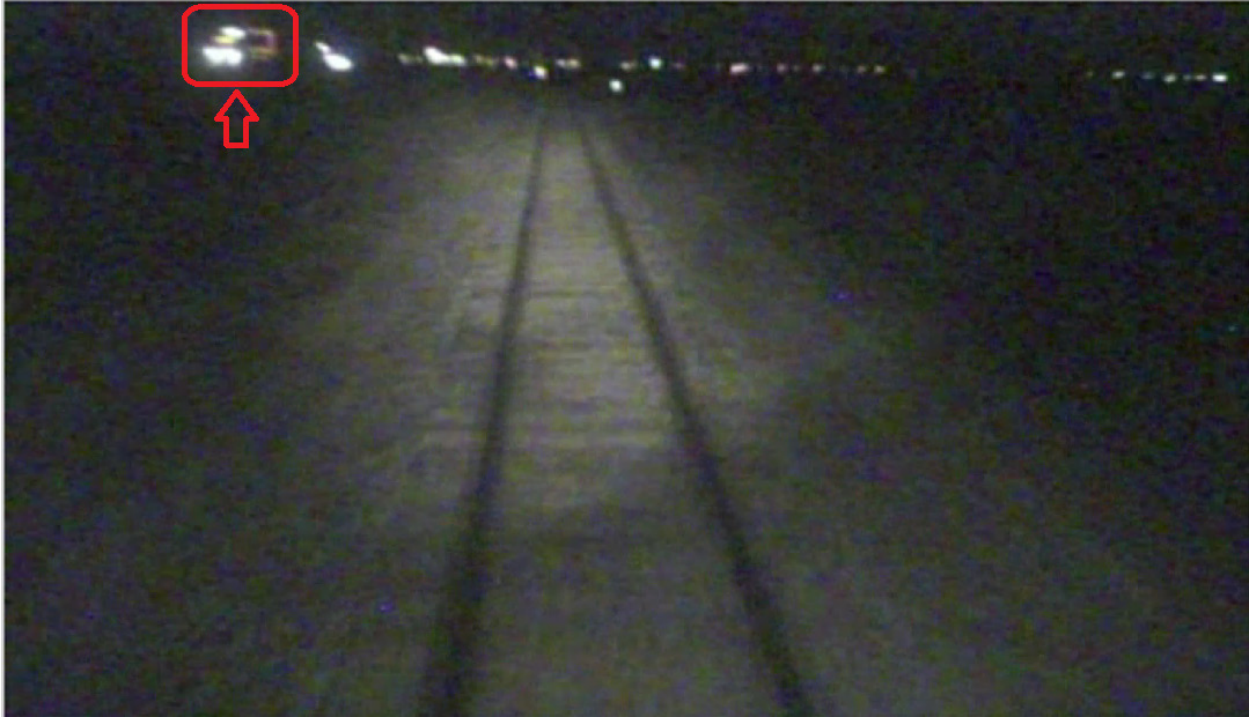
**Figure 5. AMTK153 at 0002:10 CDT.**

At about 0002:10 CDT, a semitrailer truck passed in the opposite direction on the highway to the left, as shown in annotated figure 5.

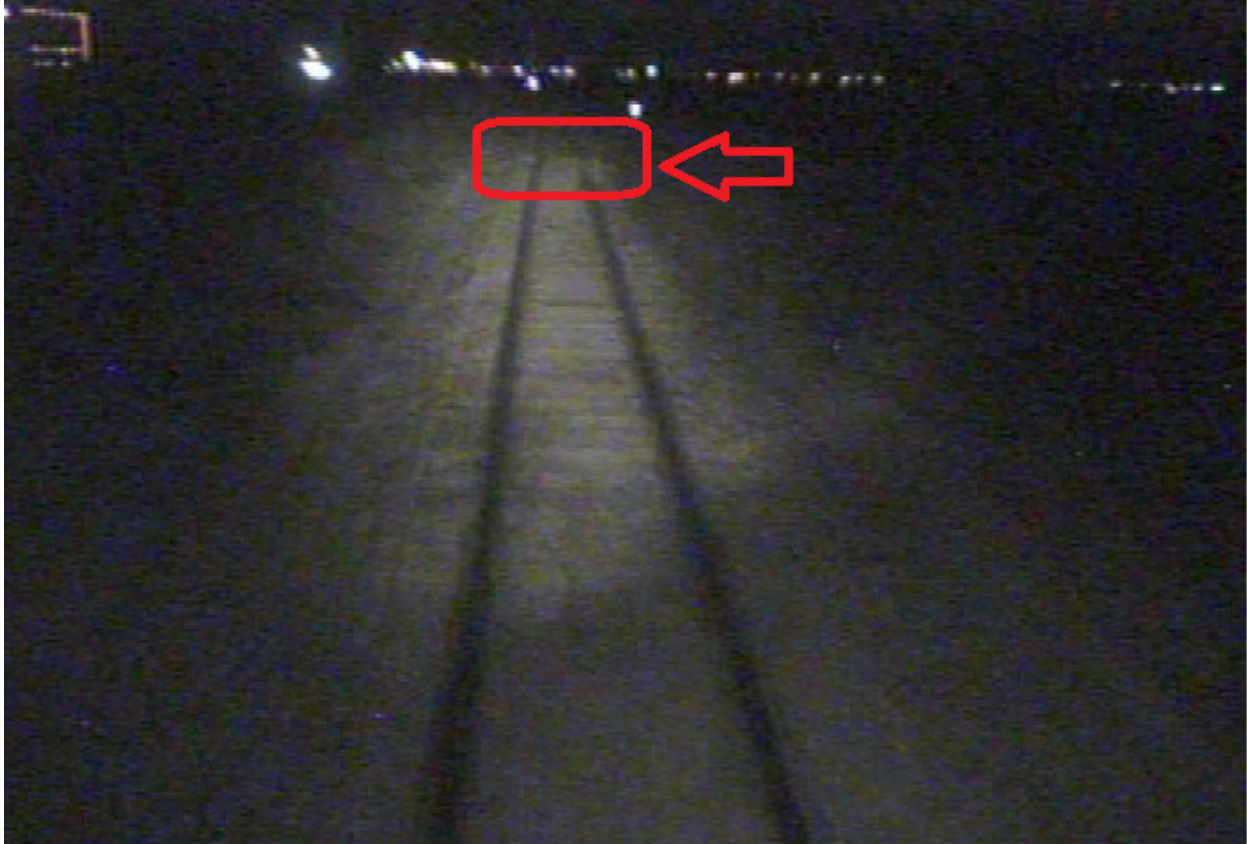
**Figure 6. AMTK153 at 0002:12 CDT.**

At 0002:12 CDT, the track anomaly was first visible in the recorded video, as shown by the annotation in figure 6. At this time, AMTK153 was traveling 60 mph, and was about 1,364 feet from the EIE event. The semitrailer truck from figure 5 is shown in the upper left hand corner of figure 6.

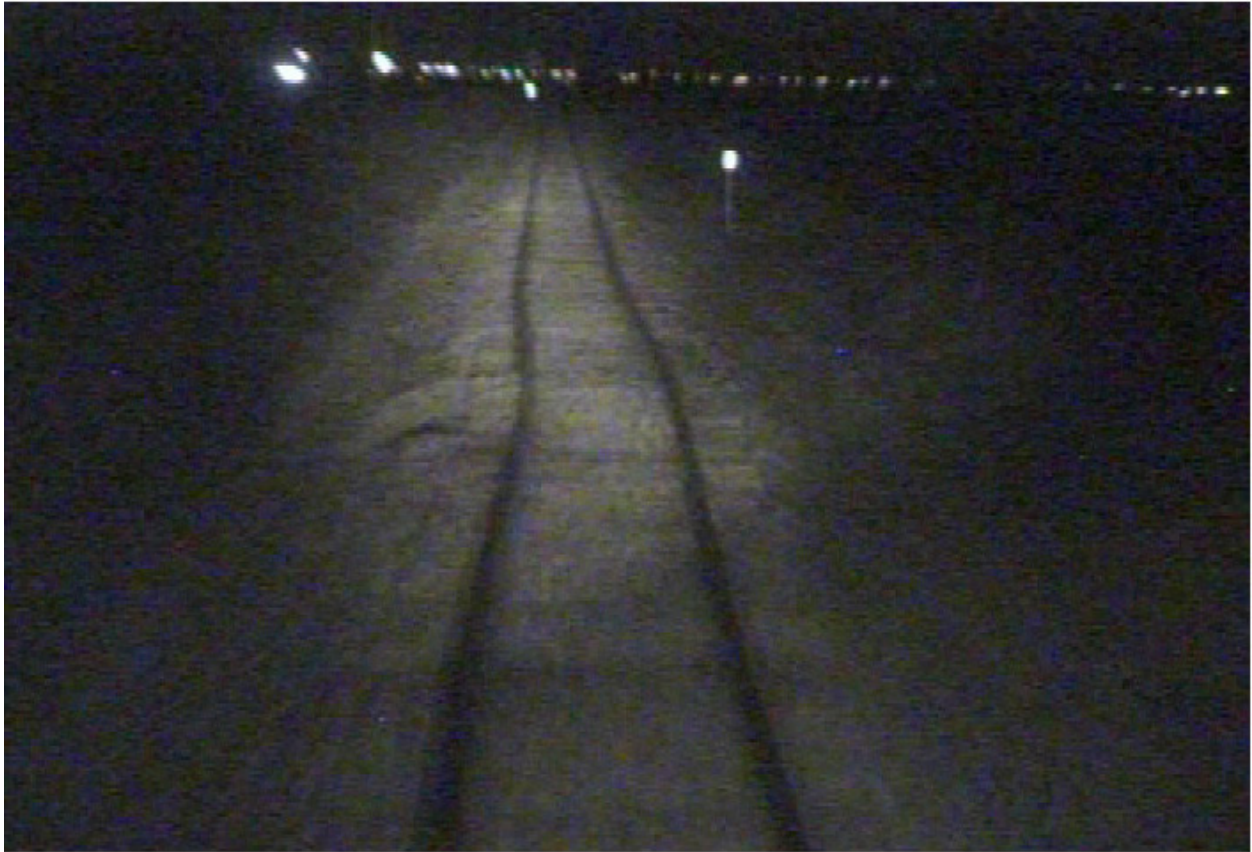
**Figure 7. AMTK153 at 0002:13 CDT.**

Figure 7 shows the track anomaly at 0002:13 CDT from AMTK153.

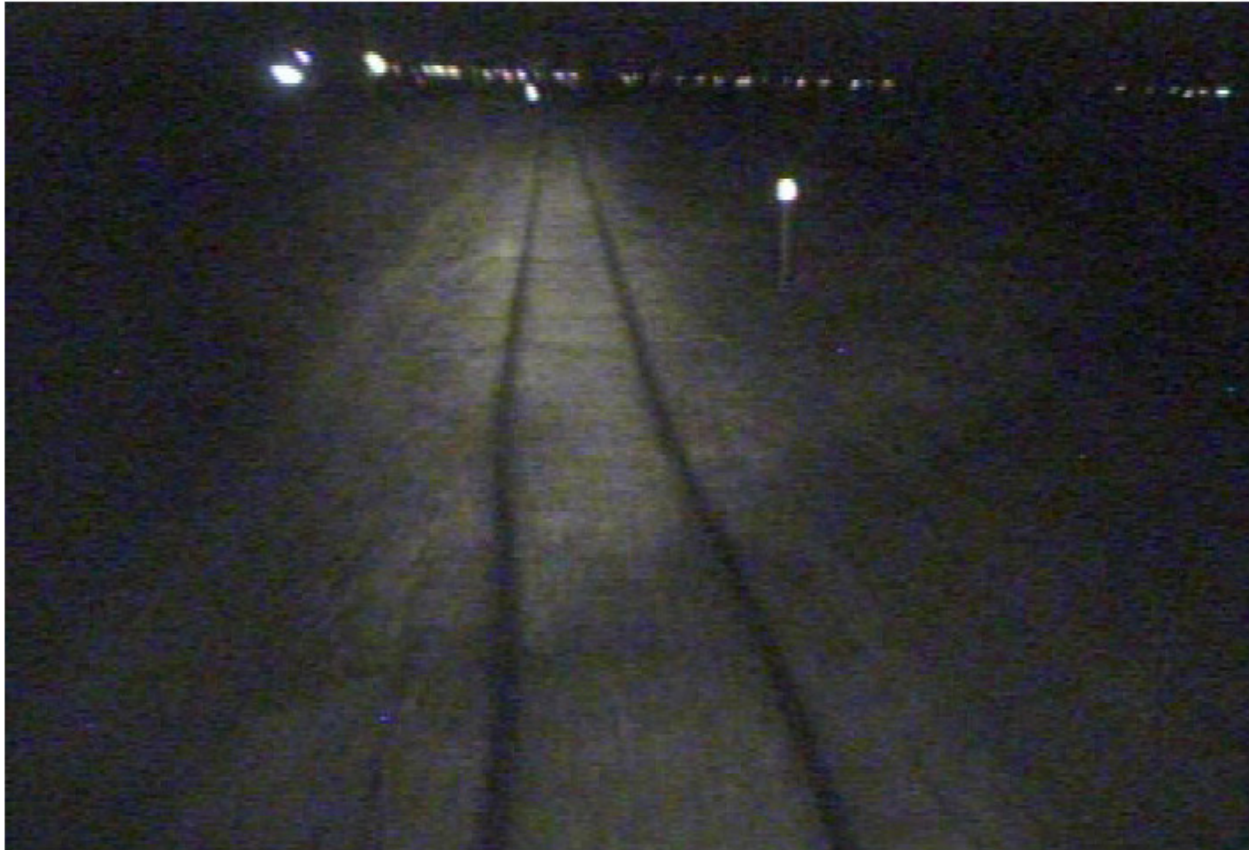
**Figure 8. AMTK153 at 0002:13 (+.2) CDT.**

At 0002:13 CDT (about 0.2 seconds after the image in the figure 7), the horn sounded on the train. At the time the horn sounded, AMTK153's video recorded the image shown in figure 8.

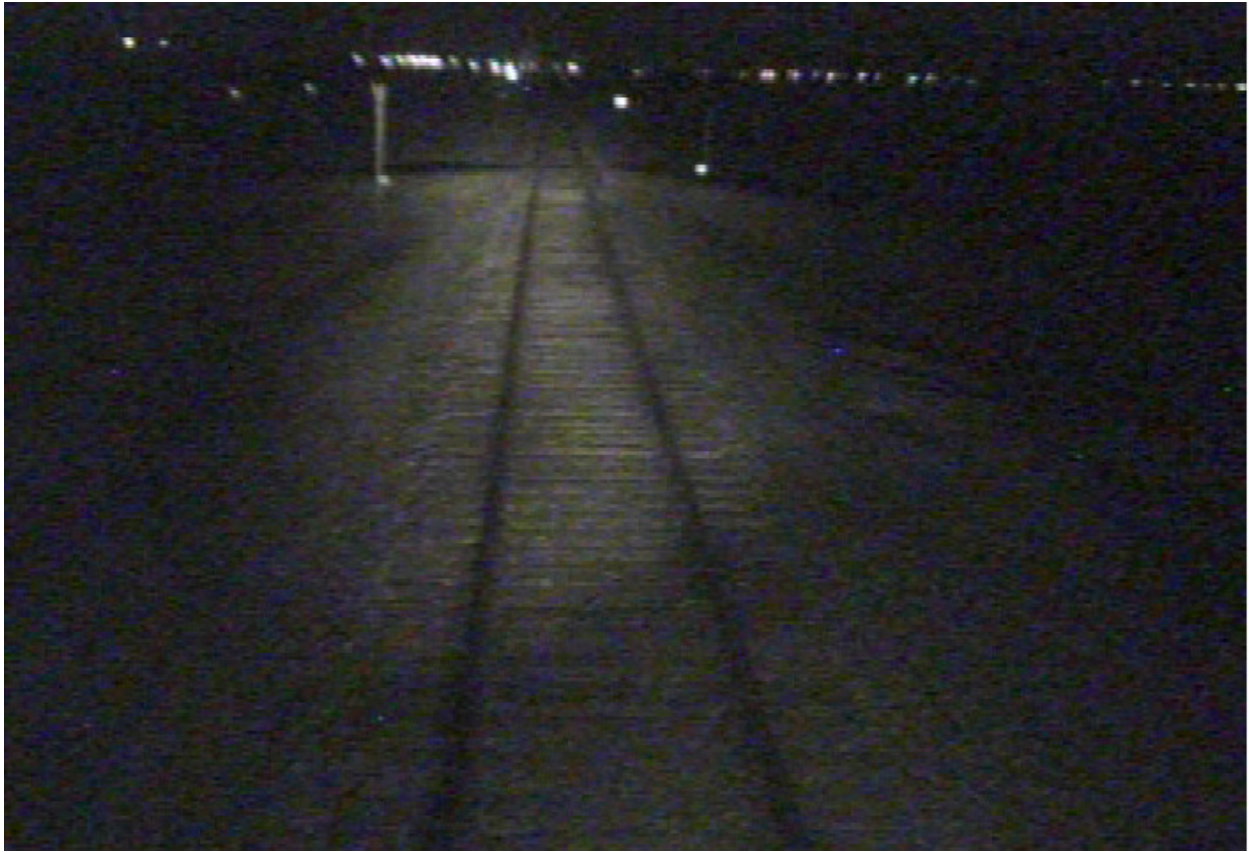
Figure 9. AMTK153 at 0002:34 CDT.

At 0002:34 CDT, AMTK153 came to a stop, as shown in Figure 9. A grade crossing was visible ahead of the locomotive.

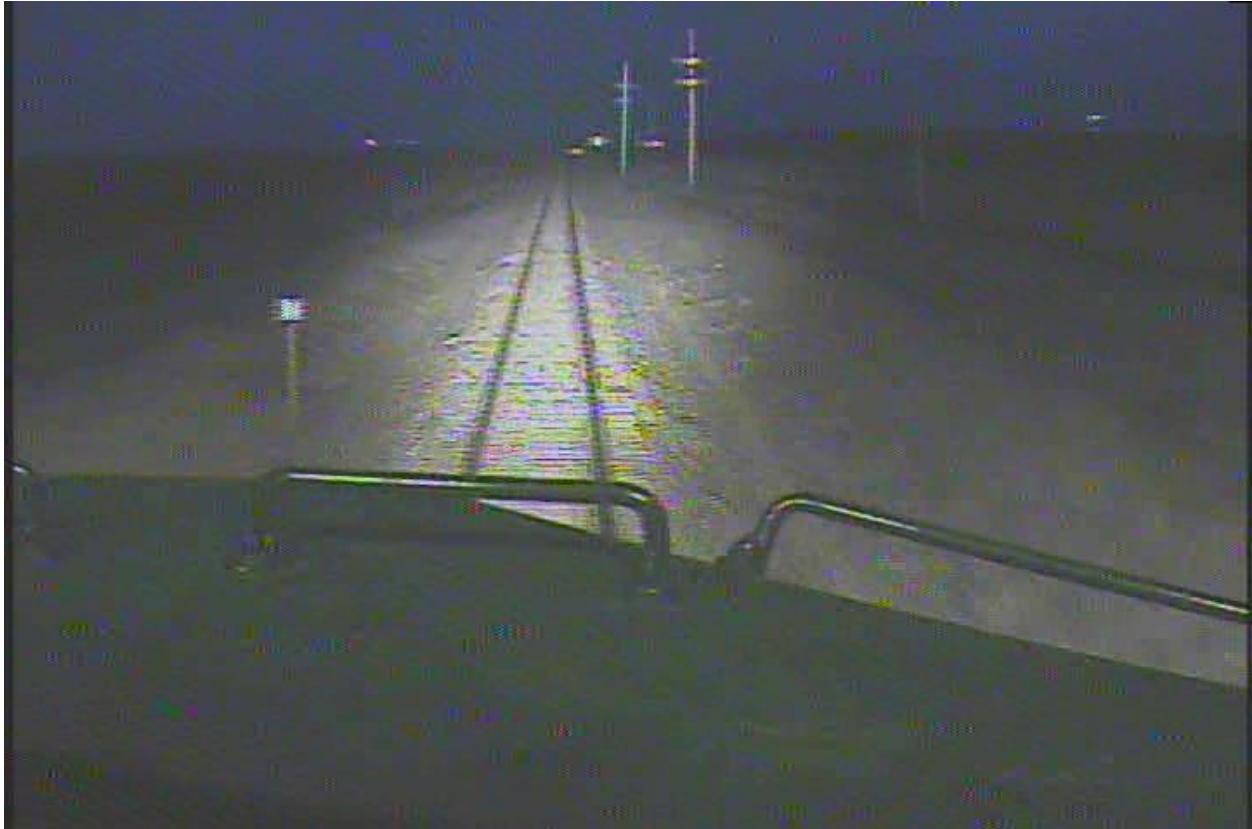
Figure 10. BNSF3917 at 0726 CDT.

At about 0726 CDT on March 13, 2016, BNSF 3917 passed over the location of the track anomaly (shown previously in figure 7) in the opposite direction relative to AMTK153. No track anomaly was observed, as shown in figure 10.
