# NATIONAL TRANSPORTATION SAFETY BOARD

## Electronic Devices - Passengers

### Specialist's Factual Report By Sean Payne

Location: Lockhart, Texas  
Date: July 30, 2016  
Aircraft: Balony Kubicek BB85Z  
Registration: N2469L  
Operator: Heart of Texas Hot Air Balloon Rides  
NTSB Number: DCA16MA204

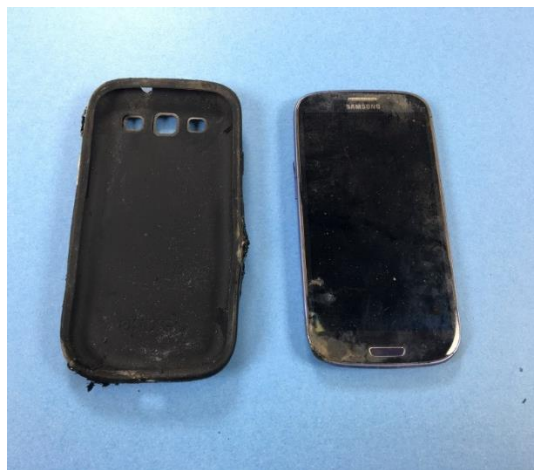
**Figure 1.** Photo of front of device.

Later, the device was examined in the lab. The soft rubber case was removed and phone was examined. Figure 1 shows the front of the device and the case. Figure 2 shows the rear of the device and the rear of the case.

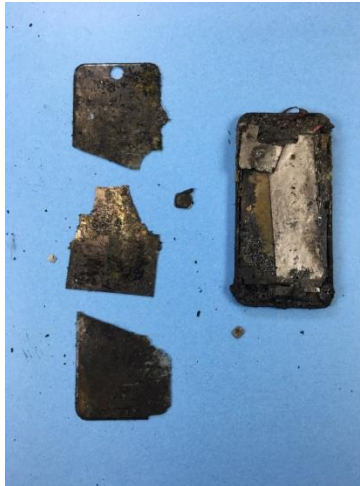
**Figure 3.** Photo of front of device.

The condition of the device is shown in figure 3. The device's screen fell free from the phone's chassis. The rear of the device is shown in figure 4. The area containing the IMEI number was cleaned and the IMEI number was visible. The device was opened and examined (figure 5). The memory board was removed (figure 6). It was determined that data recovery with a surrogate device would not be possible due to extensive thermal damage.

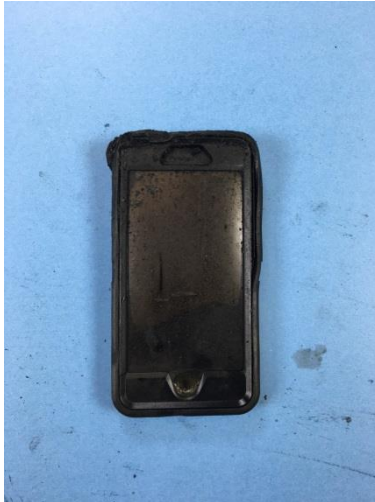
The iPhone was received in a hardened plastic case that showed evidence of fire damage (figure 7). The hardened plastic case was removed and the device was found to be in functional condition (figure 8). Power was applied to the device and the device began to function. The device was found to be password protected with a six digit pin. At the time of writing, the PED could not be accessed due to the password and no data was retrieved from the device.

**Figure 7.** The iPhone 6 as received.

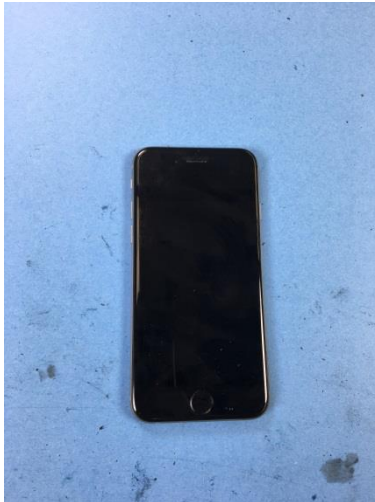
**Figure 8.** The iPhone after being removed from the case and cleaned.

Upon power up, the device was locked with a six digit pin. At the time of writing, the NTSB is working with cellular providers to determine the device's owner. Upon positive identification of the device's owner, the NTSB will attempt to access the device with assistance from the owner's family regarding the passcode.

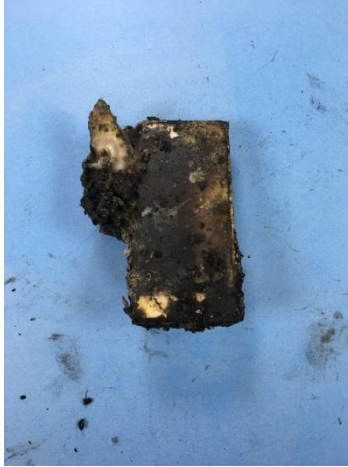
The device was covered in an unknown material that was melted to the exterior of the device (figure 9 – front, figure 10 - rear). The melted structure was removed. The device was cleaned in an attempt to recover the device's IMEI number. The IMEI number could not be identified. The device was opened and was determined to be an iPhone 6 (figure 11). The internal memory board was inspected and was determined to be thermally destroyed. Due to extensive thermal damage, the device could not be recovered using a surrogate.

**Figure 9.** The front of the iPhone as received.

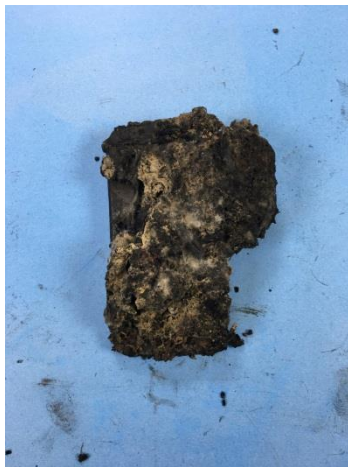
**Figure 10.** The rear of the iPhone as received.

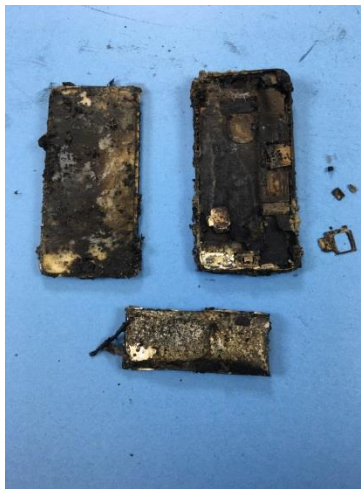
**Figure 11.** The iPhone after being opened. The internal memory board was thermally destroyed.

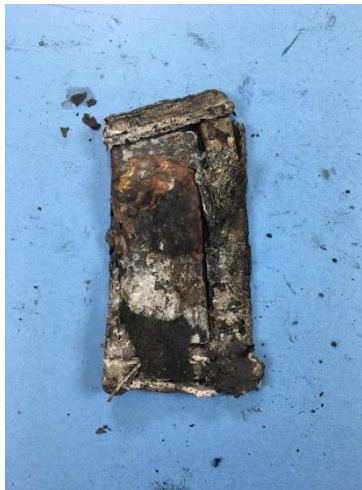
The device exhibited severe thermal damage (figure 12). The device was opened and the internal memory was determined to be thermally destroyed (figure 13). The internal memory board indicated the device was an iPhone 6s. Due to extensive thermal damage, the device was unable to be recovered using a surrogate. The IMEI number was unable to be read from the device.

**Figure 12.** The iPhone 6s as received in the laboratory.

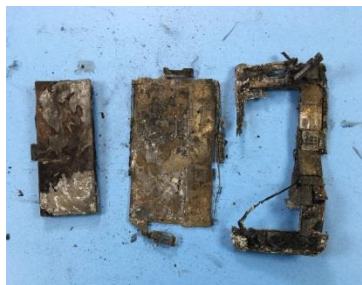
**Figure 13.** The iPhone after being opened. The internal memory board was thermally destroyed.

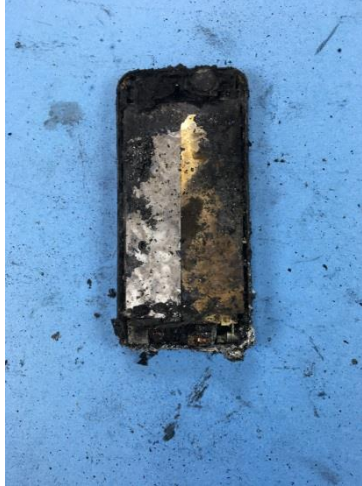
The device exhibited severe thermal damage (figure 14). The device was opened and the internal memory was determined to be thermally destroyed (figure 15). The SIM card was removed and examined (figure 15). The SIM card was destroyed and the network service provider could not be determined. It could not be determined whether the device was an iPhone 6 Plus or iPhone 6s Plus. Due to extensive thermal damage, the device was unable to be recovered using a surrogate. The IMEI number was unable to be read from the device.

**Figure 14.** The iPhone after being opened. The internal memory board was thermally destroyed.

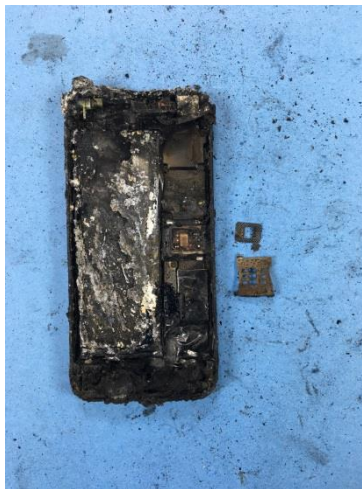
**Figure 15.** The iPhone after being opened. The internal memory board was thermally destroyed.

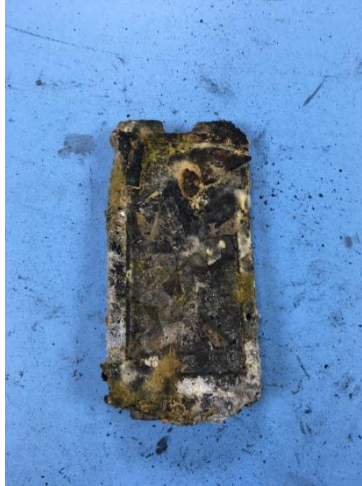
The device exhibited thermal destruction and was covered in mold (figure 16). The device was opened and inspected (figure 17). The internal board was determined to be thermally destroyed and a recovery with a surrogate was not attempted. No serial numbers or identification markings were able to be read from the device. The device contained an inductive charging unit.<sup>7</sup> The type of device could not be determined.

**Figure 16.** The device before being opened.

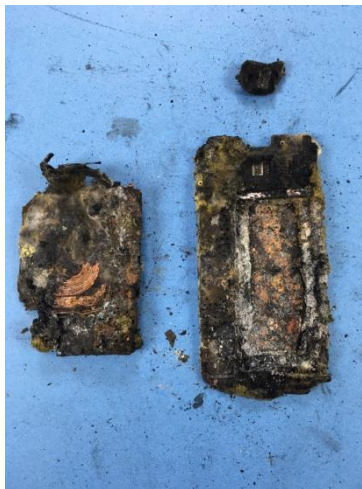
**Figure 17.** The device's internal components after being opened.

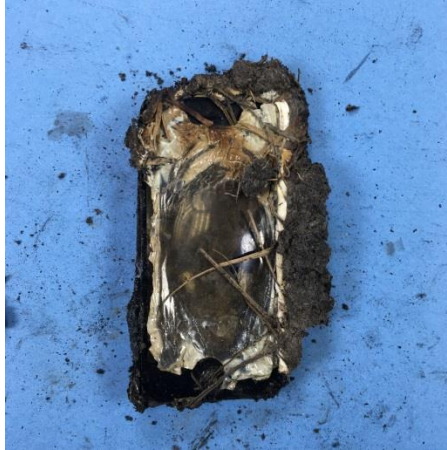
The device was enclosed in a hardened plastic case (figure 18). The hardened plastic case was removed and the device was exposed. The device was found to be thermally damaged. The device was opened (figure 20). The device's internal memory board was determined to be thermally destroyed. The IMEI number could not be determined.

**Figure 18.** The device enclosed in a hardened plastic case.

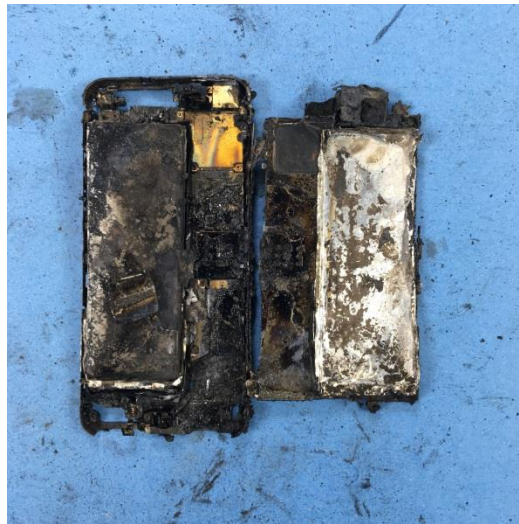
**Figure 19.** The device after being opened.

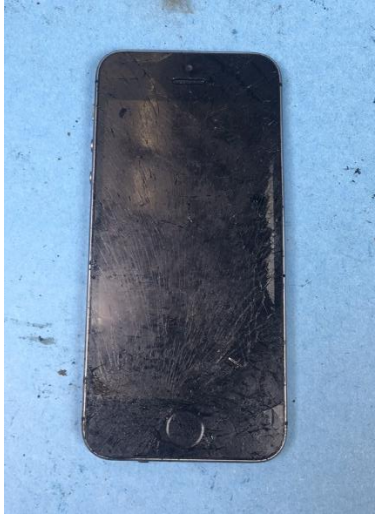
The device was not enclosed in a case. The screen was cracked throughout the front face of the device. The aluminium chassis of the device was slightly bent. Figure 20 shows the device as received. The device was opened and the main board was removed and inspected (figure 21). The main board appeared to be undamaged after a visual inspection. The main board was placed in a surrogate device. The surrogate device was able to power and the device booted (figure 22). The phone was locked with a four digit passcode. At the time of writing, the PED could not be accessed due to the password and no data was retrieved from the device.

**Figure 20.** The device as received.

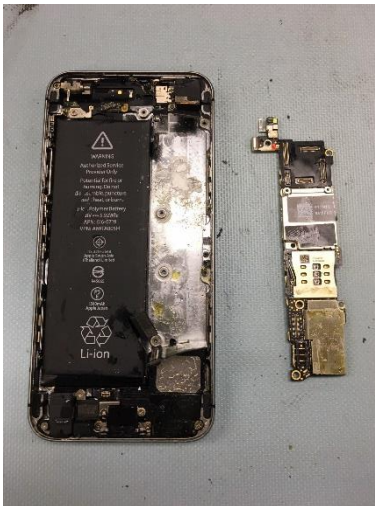
**Figure 21.** The device opened with the main board removed.

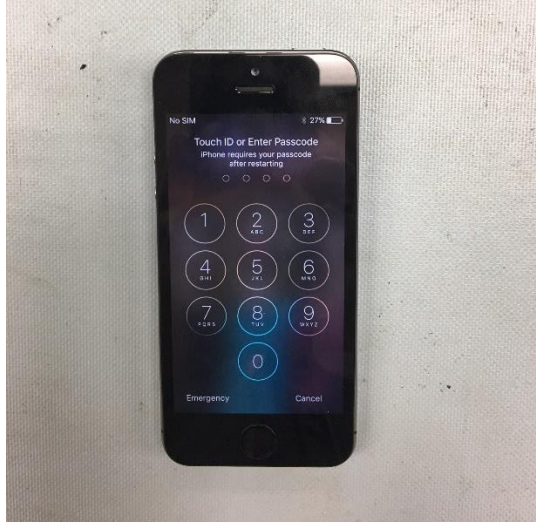
**Figure 22.** The device powered with a surrogate.

Upon power up, the device was locked with a four digit pin. At the time of writing the NTSB is attempting to access the device with assistance from the owner's family regarding the passcode.

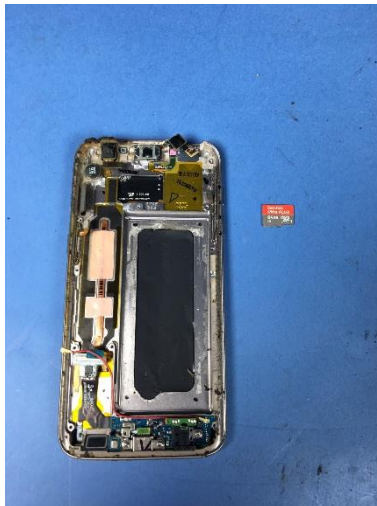
The device was received in a soft rubberized pink case. The device showed signs of significant thermal damage throughout (figure 23). The case was removed and the device was opened (figure 24). The SIM card and microSD card chassis initially could not be removed due to the device's metal chassis being thermally affected in that area. The main board could not be removed without first removing the SIM/SD card chassis. The main board had to be damaged in order to remove the SIM/SD card chassis. The main board was lifted and the SIM/SD card chassis was removed. The SIM and microSD card appeared undamaged (figure 25). The microSD card was read normally using a forensic write blocker.

**Figure 25.** The device and the associated microSD card.

The device's microSD card was downloaded and produced 79 images and 9 video files taken on the day of the accident. These files are discussed in detail in the "Onboard Image Recorder Factual Report" available in the public docket for this accident investigation.

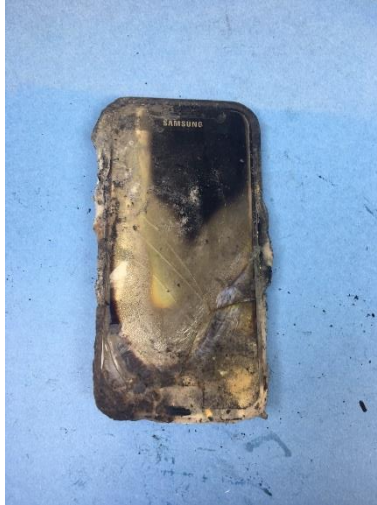
The device was received in a soft rubberized black case. The device showed signs of significant thermal damage throughout (figure 26). The case was removed and the device was opened. The device's internal components appeared undamaged. The device's SIM/microSD card chassis was then removed. The main board could then be removed. The SIM and microSD card appeared undamaged. Figure 27 shows the device with the above internal components extracted. The microSD card was read normally using a forensic write blocker.

**Figure 26.** The device as received.

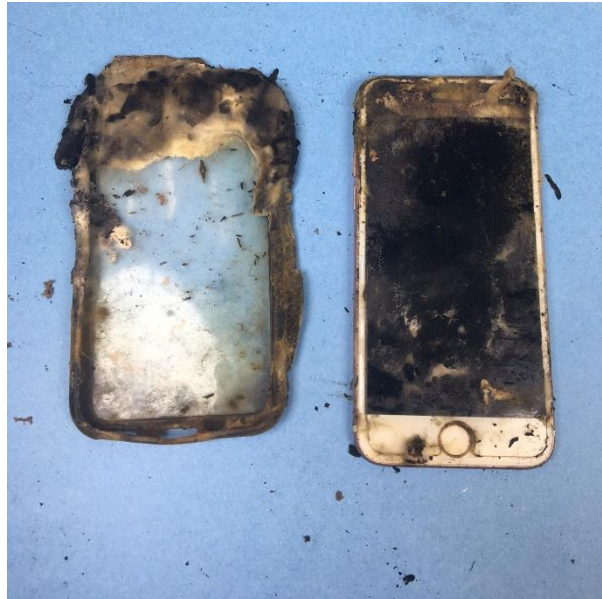
The device arrived to the lab in a rubberized case. The rubberized case was removed and the device was inspected (figure 28). The device showed evidence of light thermal damage. The device was opened and its internal components were inspected. The main

**Figure 28.** The device as received.

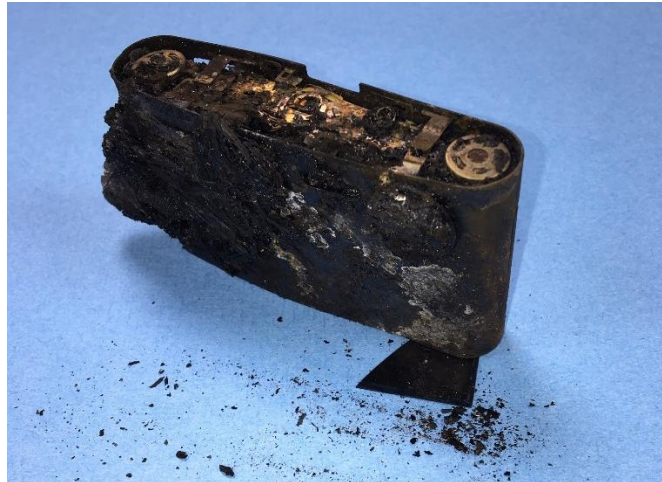
The device exhibited extensive thermal damage (figure 31). Pieces of material were flaking off the device as it was handled. The device's microSD card was located (figure 32). The device's microSD card was removed and determined to be unrecoverable due to thermal damage. Figure 33 shows the microSD card. The card was nonfunctional.

**Figure 31.** The device as received.

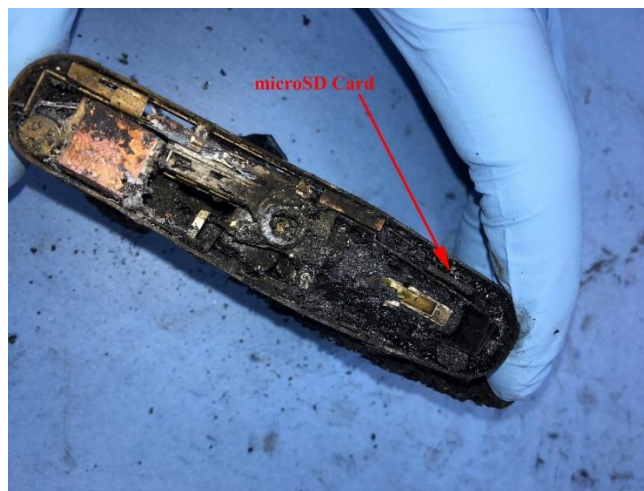
**Figure 32.** The device shown with an arrow indicating the microSD card's position.

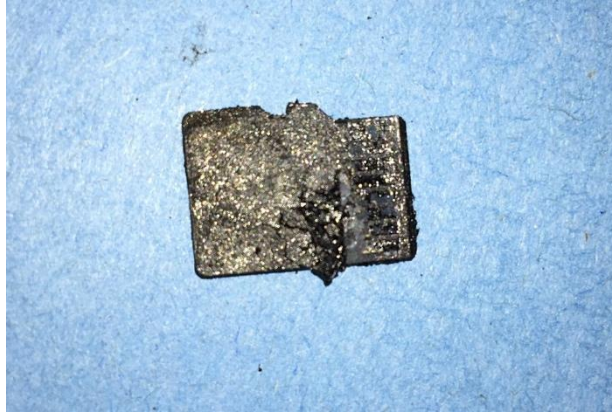
**Figure 33.** The device's microSD card.

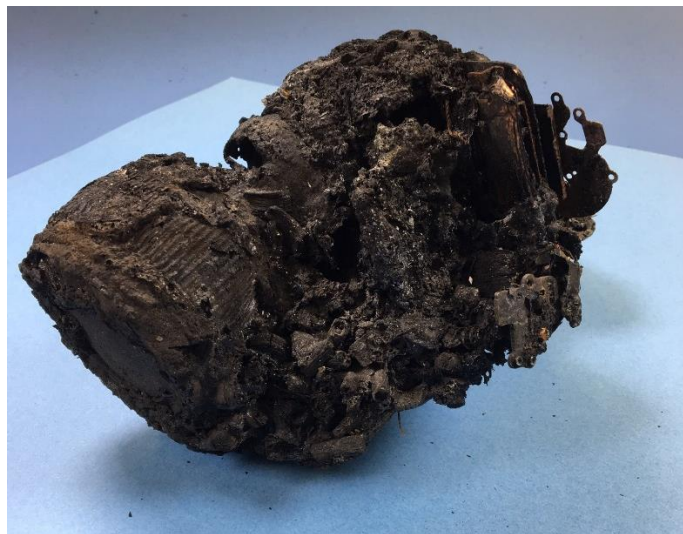
The device exhibited extensive thermal damage (figure 34). The device's SD card was located (figure 35). The device's SD card was removed and determined to be unrecoverable due to thermal damage. Figure 36 shows the SD card. The card was nonfunctional.

**Figure 34.** The device as received.

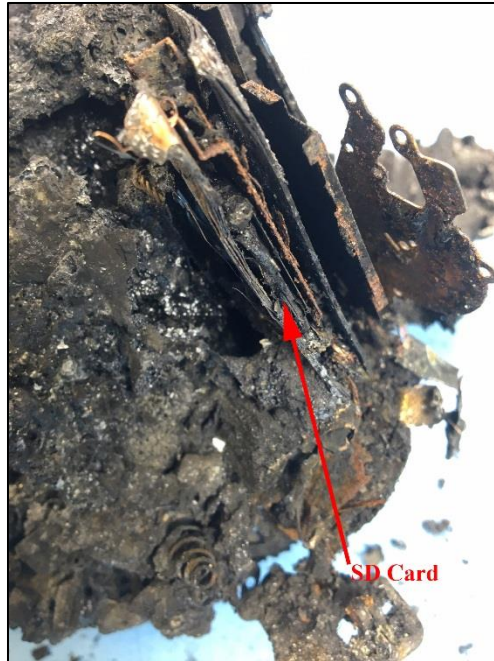
**Figure 35.** The device shown with an arrow indicating the SD card's position.

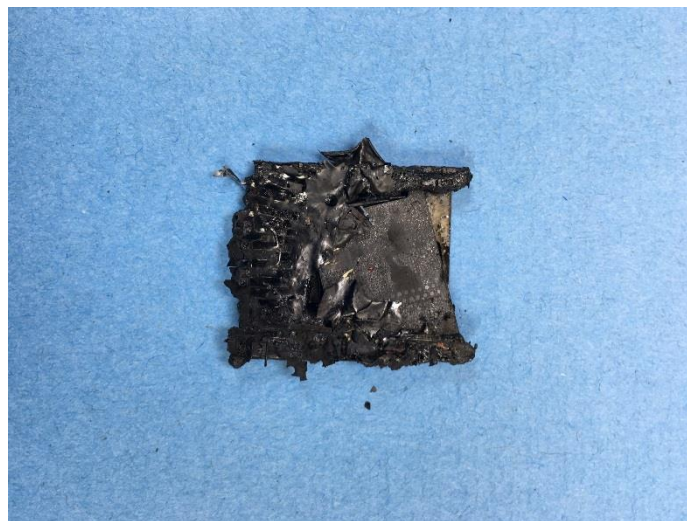
**Figure 36.** The device's SD card.

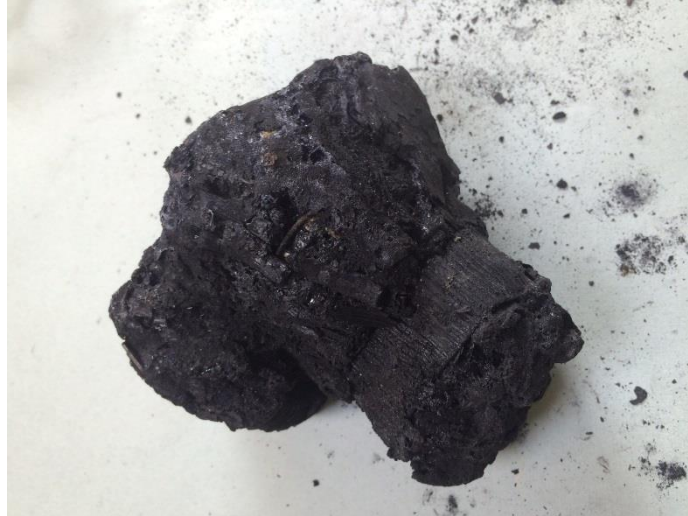
The device exhibited extensive thermal damage (figure 37). The device's SD card was located (figure 38). The SD card was melted to the camera's battery compartment area. The area around the battery compartment was cut away and the SD card was extracted. The device's SD card was removed and determined to be unrecoverable due to thermal damage. Figure 39 shows the SD card. The card was nonfunctional.

**Figure 37.** The device as recovered.

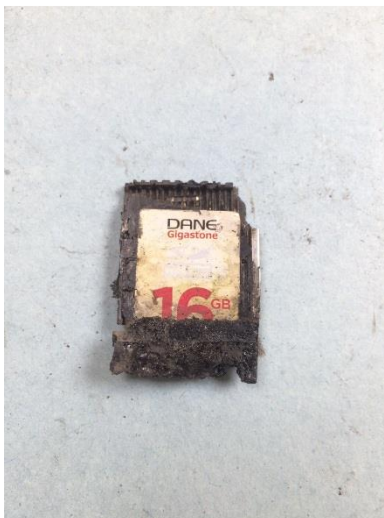
**Figure 39.** The device's SD card.
