NATIONAL TRANSPORTATION SAFETY BOARD

Meteorology – Factual Report

Group Chairman's Factual Report

ANC17MA001

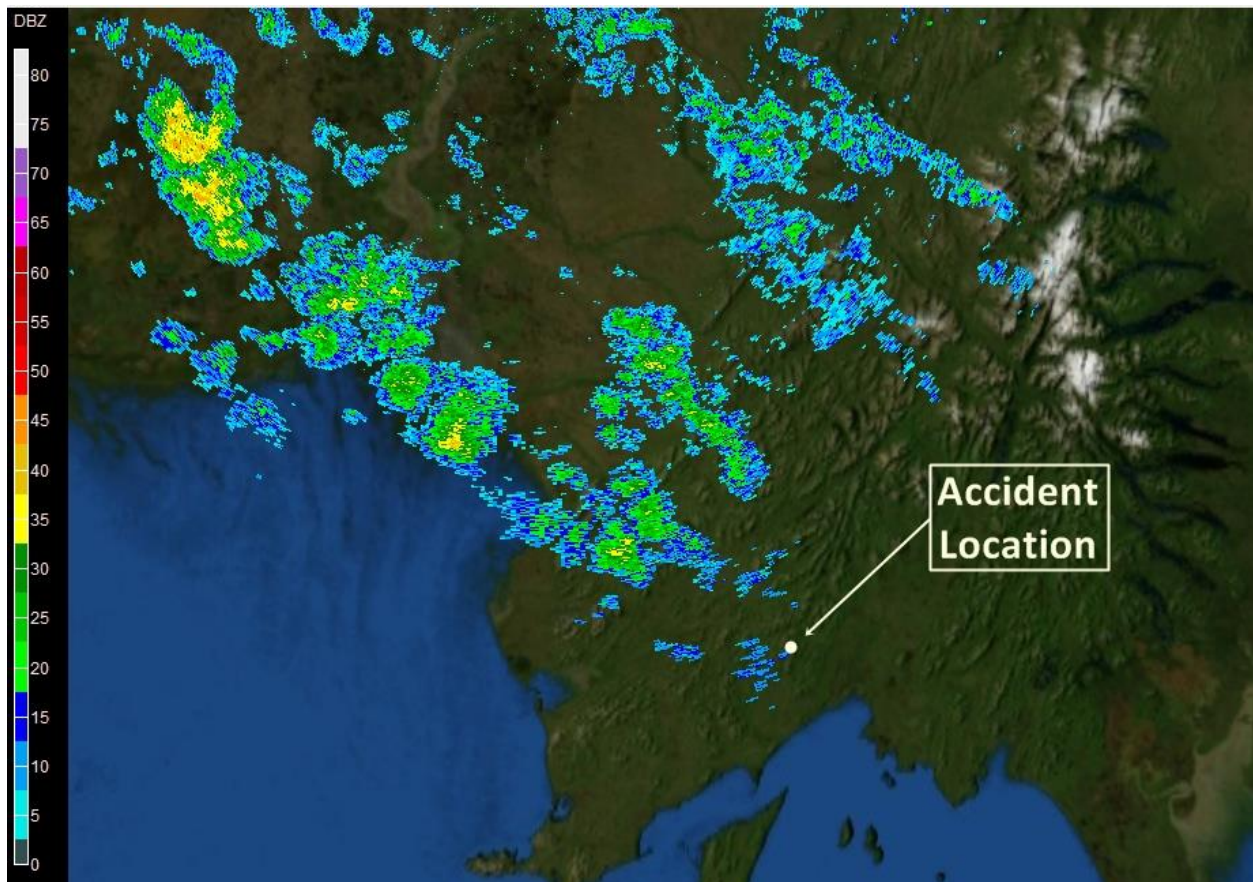
WSR-88D Level-II weather radar imagery from Bethel, Alaska (PABC), is presented in figure 2. PABC was located approximately 104 miles north of the accident site at an elevation of about 162 feet. Assuming standard refraction and considering the 0.95° beam width for the WSR-88D radar beam, the PACG 0.527° tilt would have “seen” altitudes between about 7,900 and 18,400 feet above msl at the accident location. There were areas of light reflectivity ($\leq 15\text{dBZ}$) near the accident location.

Figure 2 – PABC 0.527° Level-II reflectivity product from 1152 AKDT.

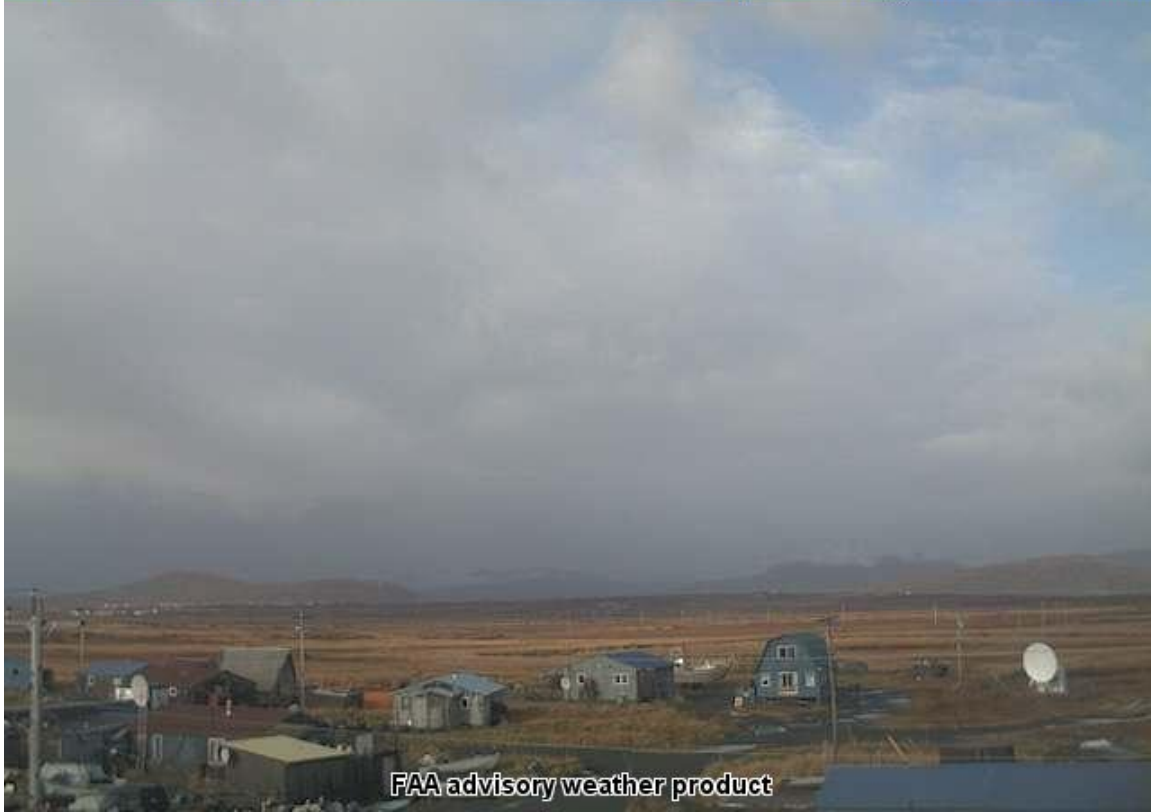
Figure 8 – West-facing Togiak camera image at about 1106 AKDT.

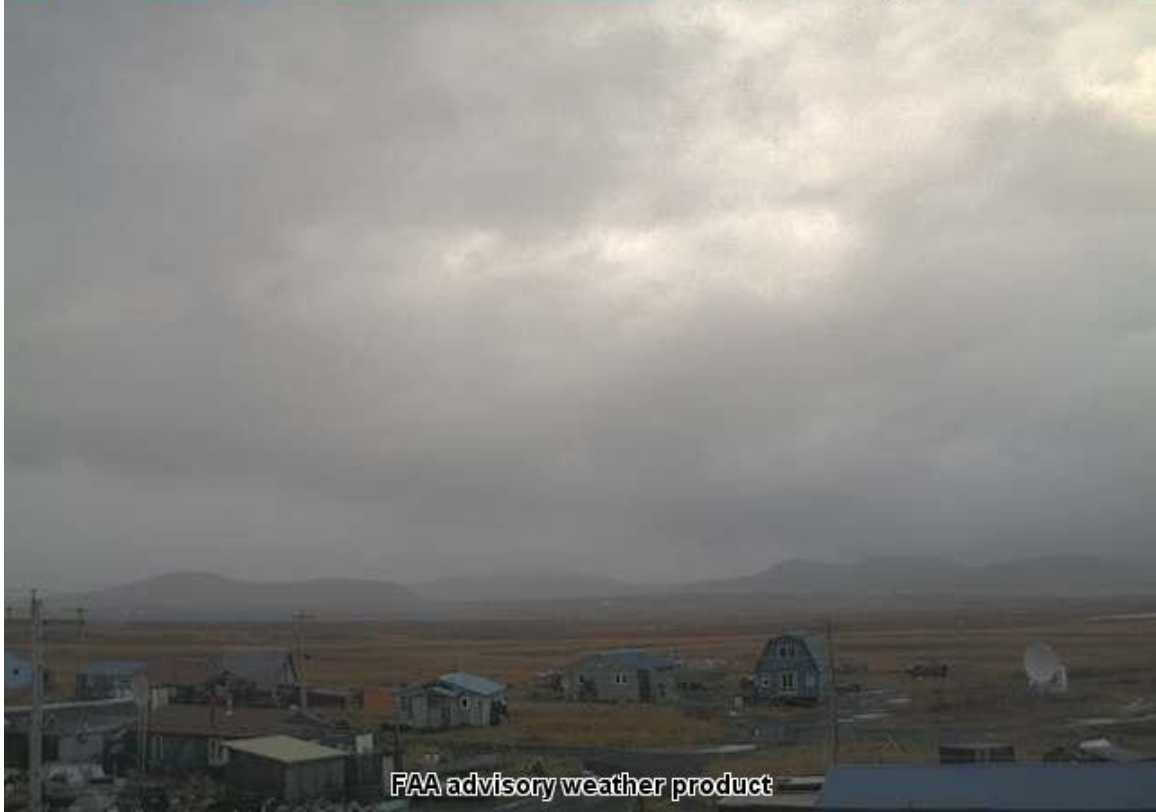
Figure 13 – West-facing Togiak camera image at about 1156 AKDT.

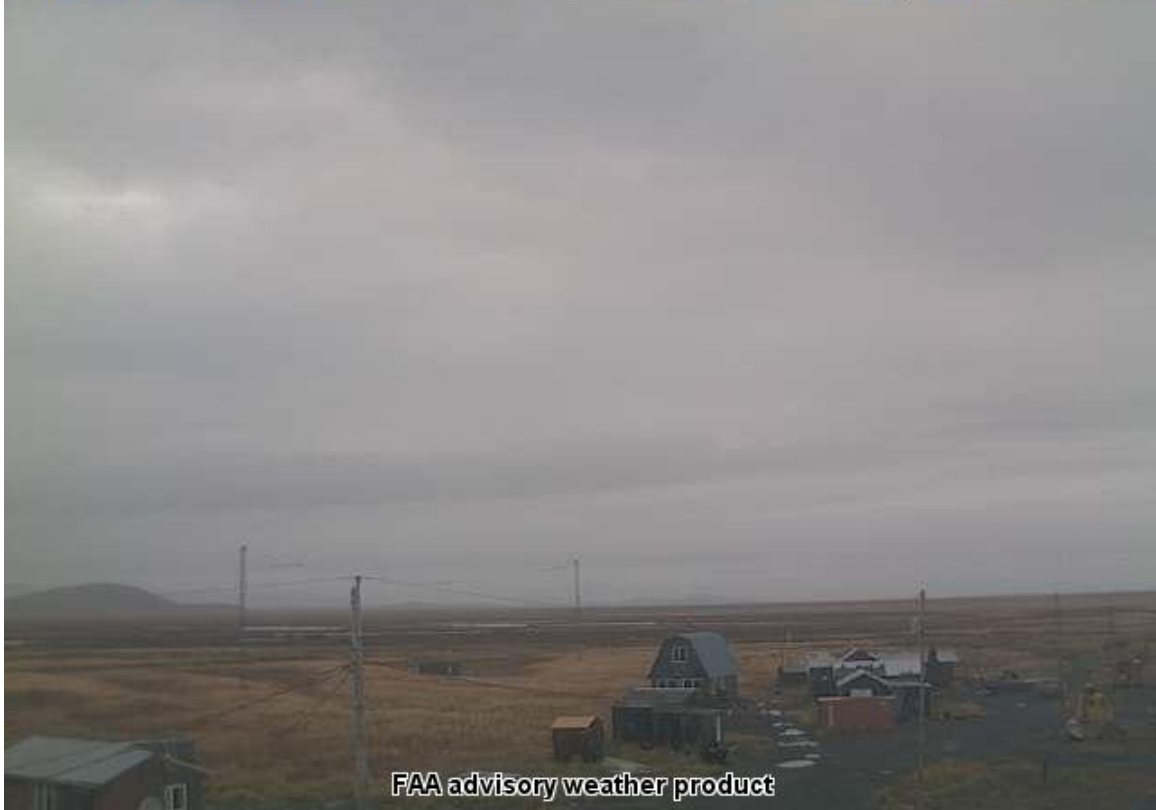
Figure 21 – North-facing Togiak camera image at about 1149 AKDT.
