Washington Metropolitan Area Transit Authority Metrorail train 302 that encountered heavy smoke in the tunnel between the L'Enfant Plaza Station and the Potomac River Bridge on January 12, 2015

GROUP	B
EXHIBIT	
7

**Security Video Recorders
Factual Report**

DCA15FR004

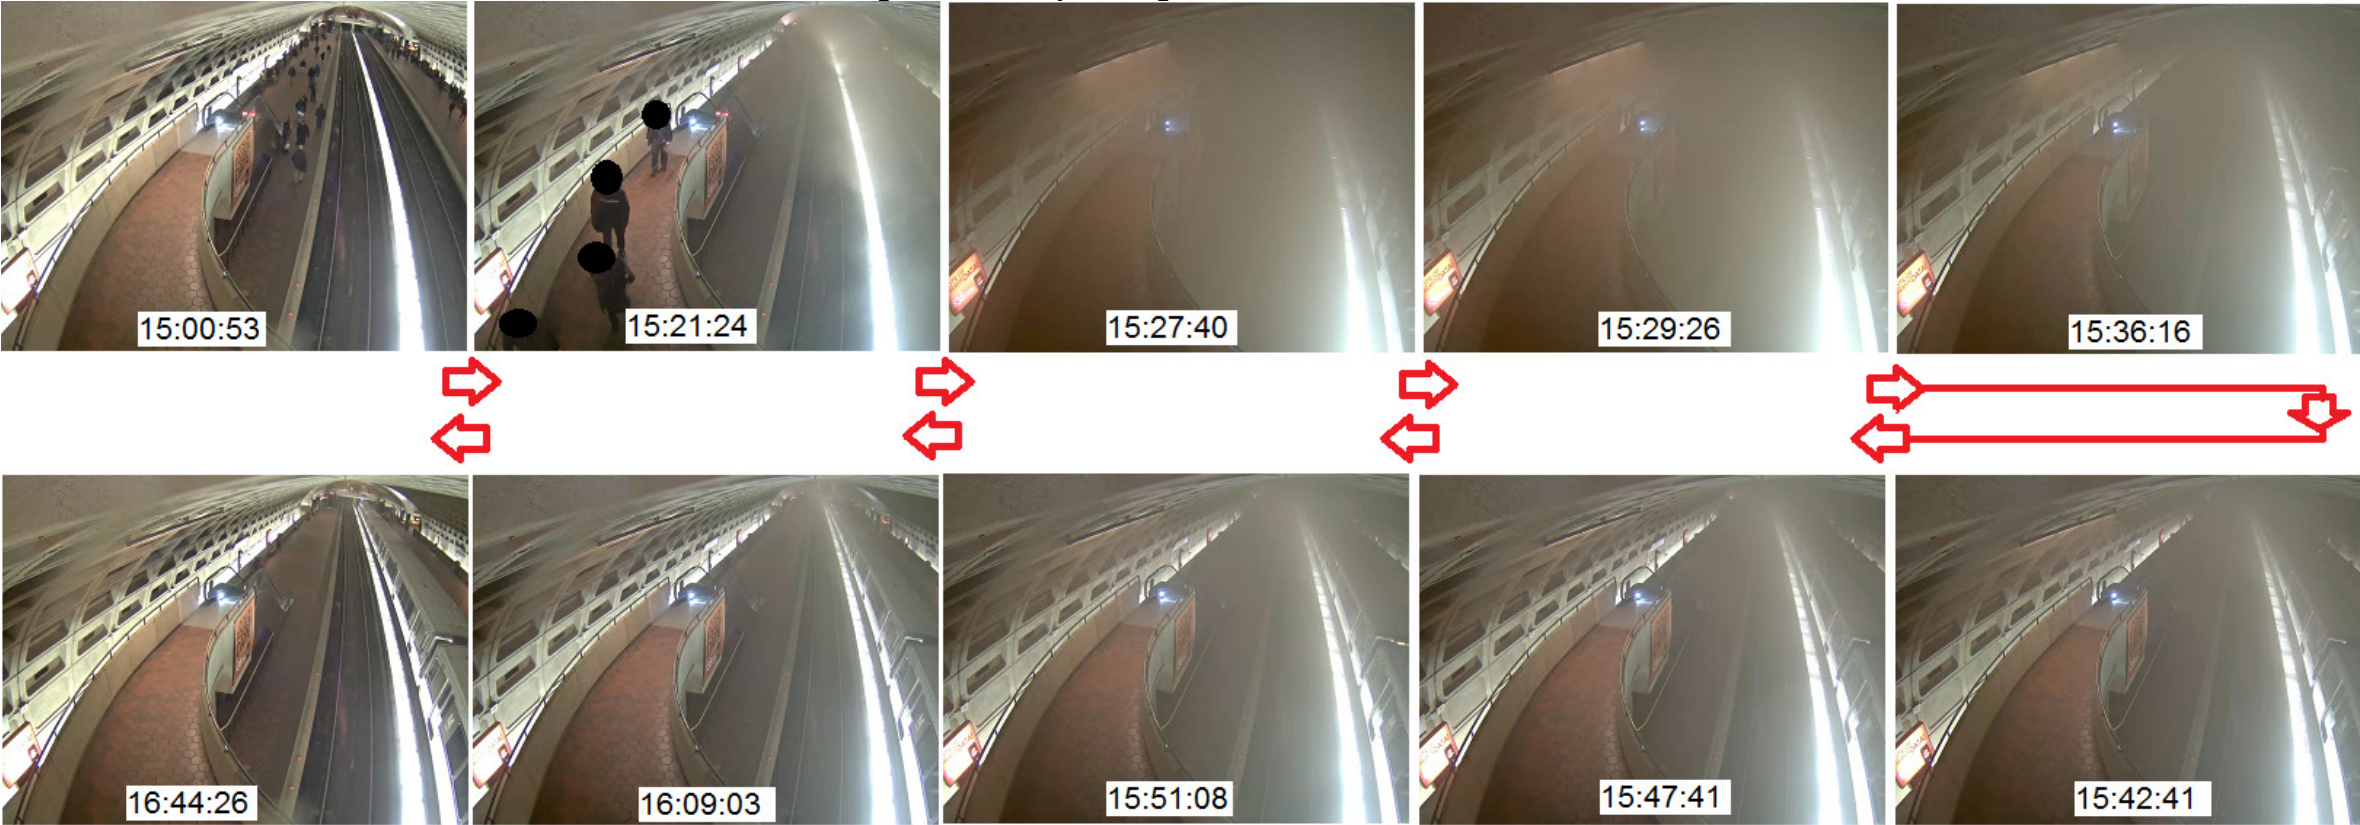
Figure 2. Time-lapse images of L'Enfant Plaza station.

Figure 2 shows time-lapse imagery of the build-up of smoke in L’Enfant Plaza station’s green/yellow line level, as viewed from a camera located in the northeast corner of the station, on the walkway above the green/yellow line north portal. The image at 15:00:53 EST shows the station without any smoke; 15:21:24 EST shows how smoke had filled the station; 15:36:16 EST shows the smoke beginning to dissipate; and subsequent images show the continued dissipation of the smoke.

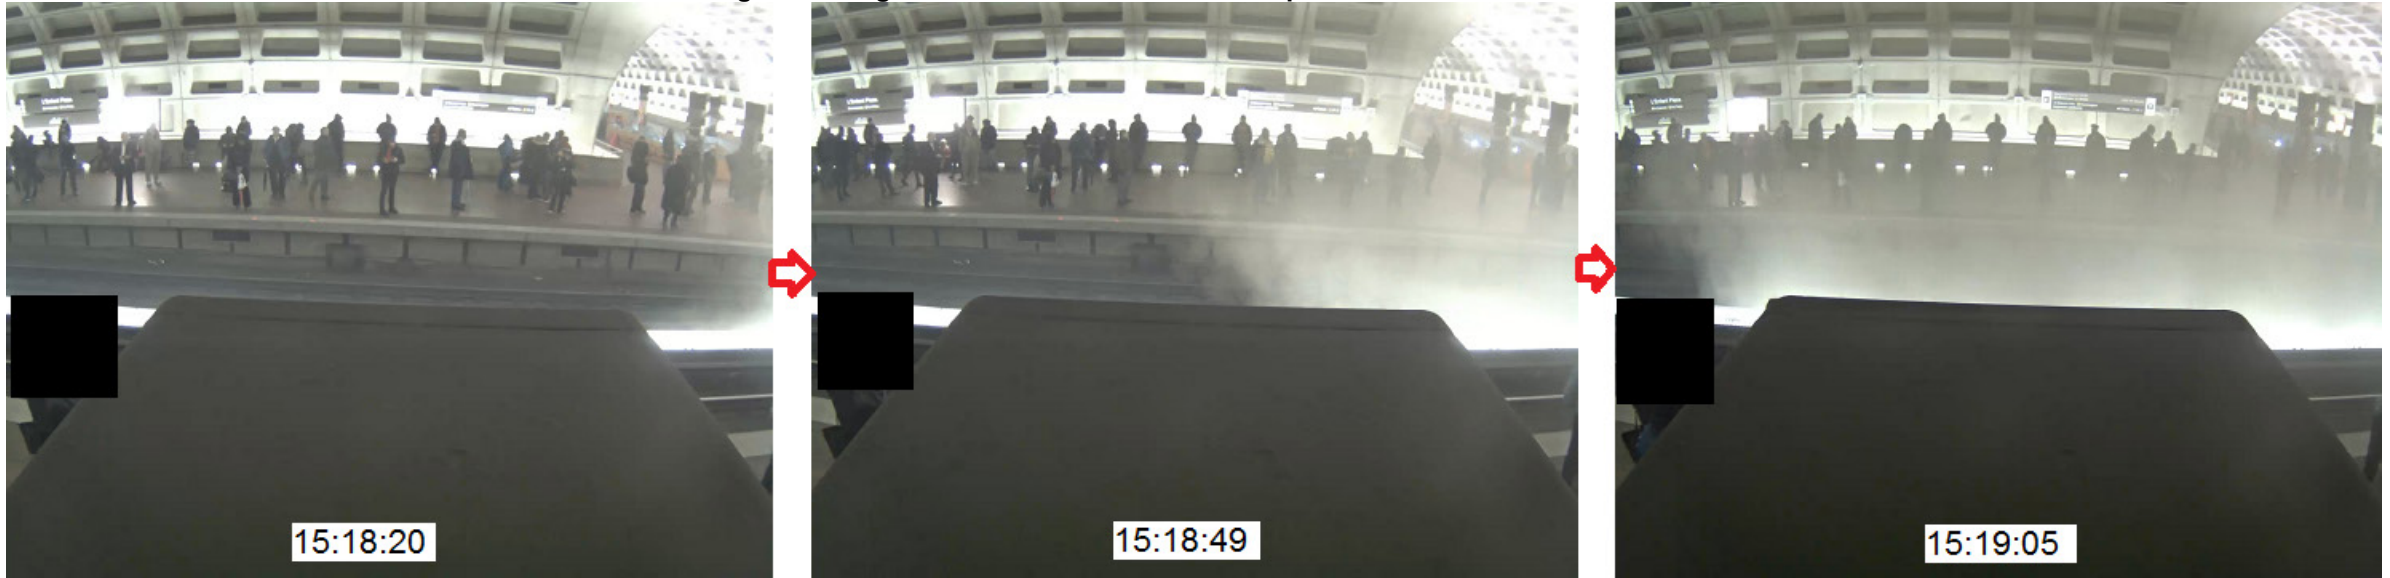
Figure 3. Progression of smoke near the mid-point of L'Enfant Plaza station.

Figure 3 shows a time-lapse view from west to east, looking across the green/yellow line trackbed. At 15:18:20 EST, wisps of smoke were first observed in the right (south) of the image field of view. By 15:18:49 EST, the smoke had progressed to the midpoint of the image field of view. By 15:19:05 EST, the smoke had progressed to the left (north) of the image field of view.

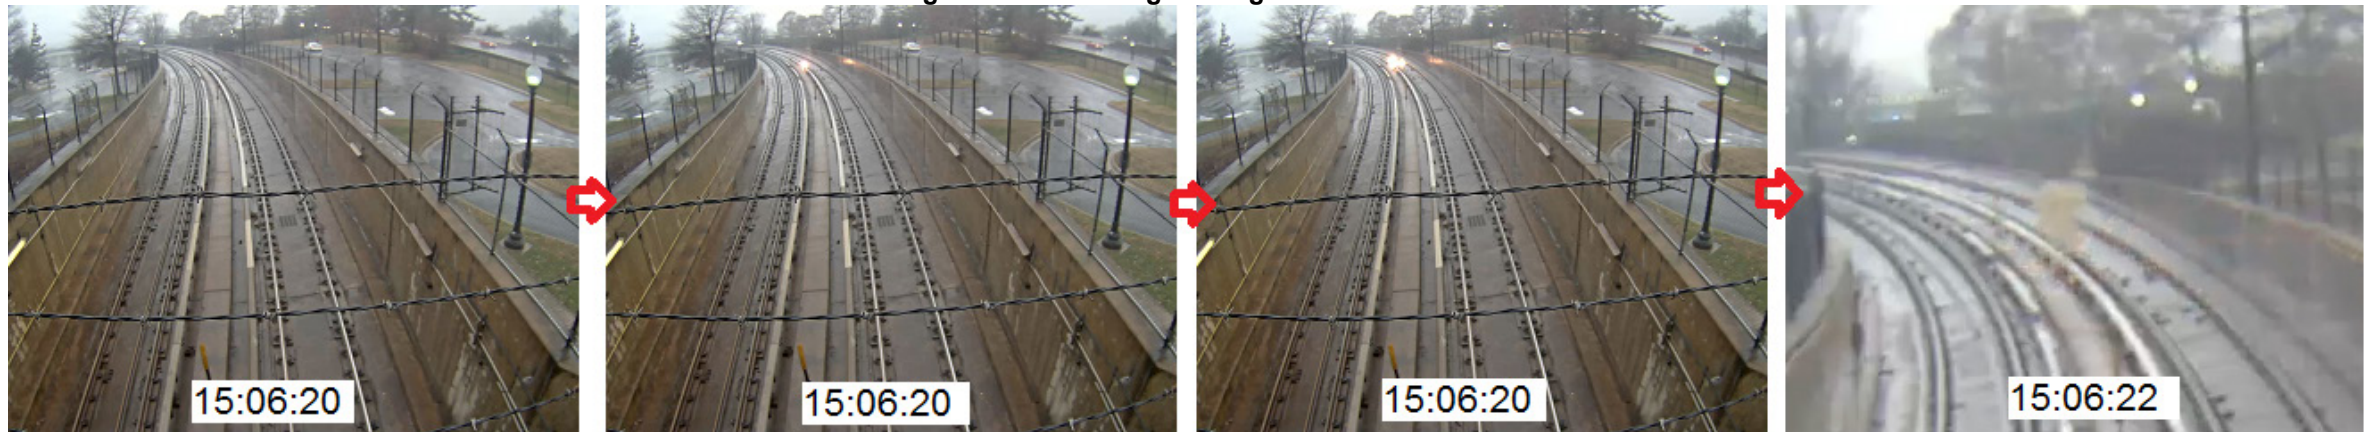
Figure 4. L-line bridge arcing event.

Figure 4 shows a time-lapse view of an arcing event observed on the L-line bridge near the Potomac River. At 15:02:20 EST a burst of yellow-orange was observed, followed by smoke. The smoke quickly dissipated.

Note: Image at 15:06:22 uses a different camera than the prior three images.

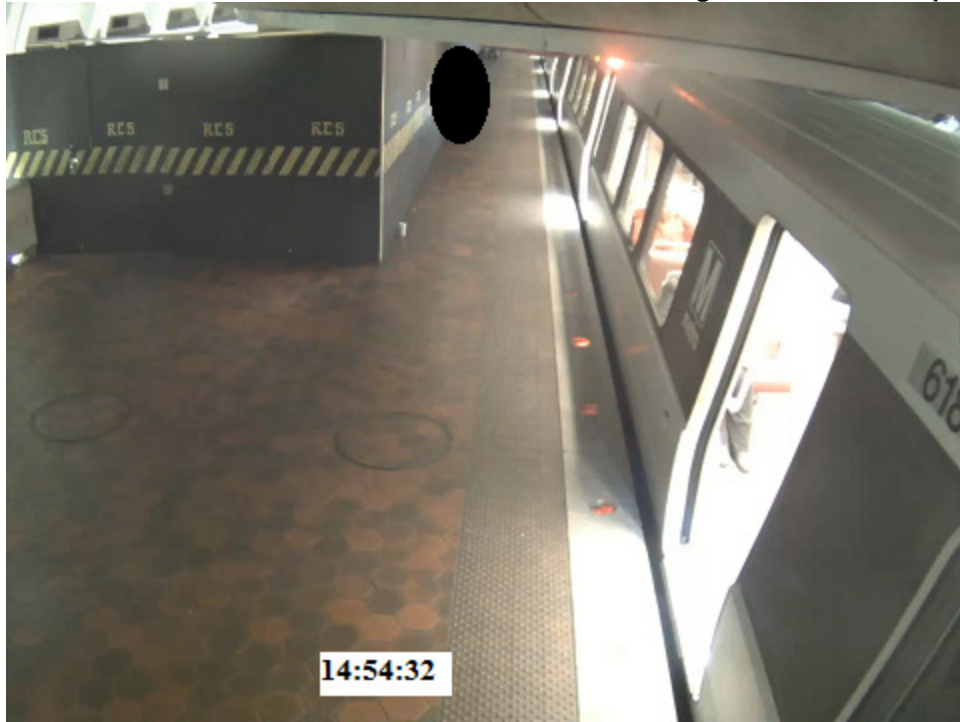
Figure 5. Southwest portal visibility comparison.

Figure 5 compares the normal visibility near the southwest portal to the visibility near the peak of the event at 15:23:13 EST. At 15:23:13 EST, the platform lights and the yellow and black construction sign were barely visible.
