Washington Metropolitan Area Transit Authority Metrorail train 302 that encountered heavy smoke in the tunnel between the L'Enfant Plaza Station and the Potomac River Bridge on January 12, 2015

1988 Water Intrusion in Underground
Structures Report

**WATER INTRUSION
IN
UNDERGROUND STRUCTURES**

**FINAL REPORT
OCT. 1988**

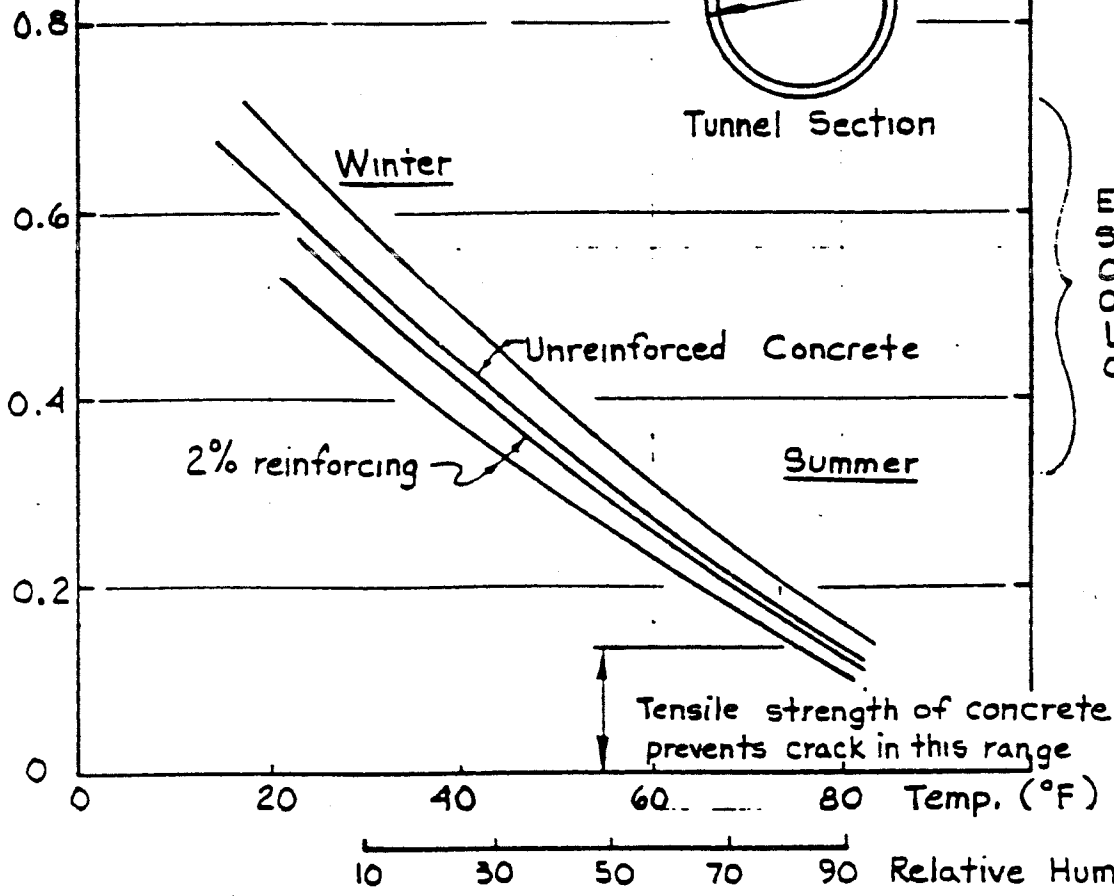
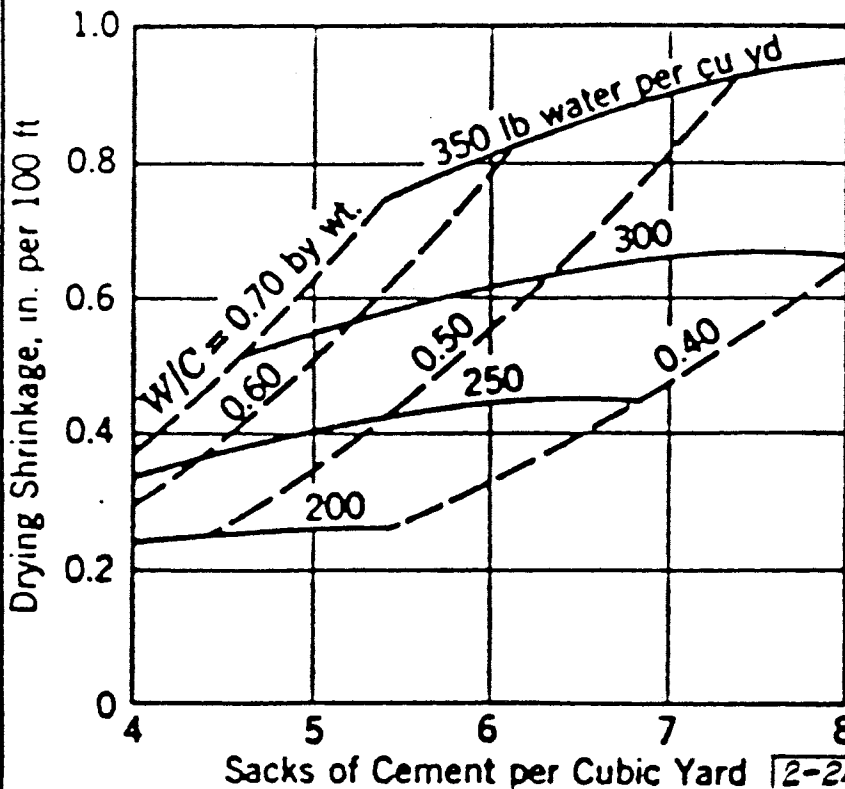
COMPONENTS OF TUNNEL LINING CRACKS 2-3

TOTAL WIDTH OF CIRCUMFERENTIAL CRACKS PER 100' OF TUNNEL LENGTH (in.)

EFFECT OF SEASONAL CHANGE ON TUNNEL LINING CRACKING

EFFECT OF WATER AND CEMENT ON TUNNEL LINING CRACKING DUE TO CURING DRYING
