N113WS flight path per witnesses

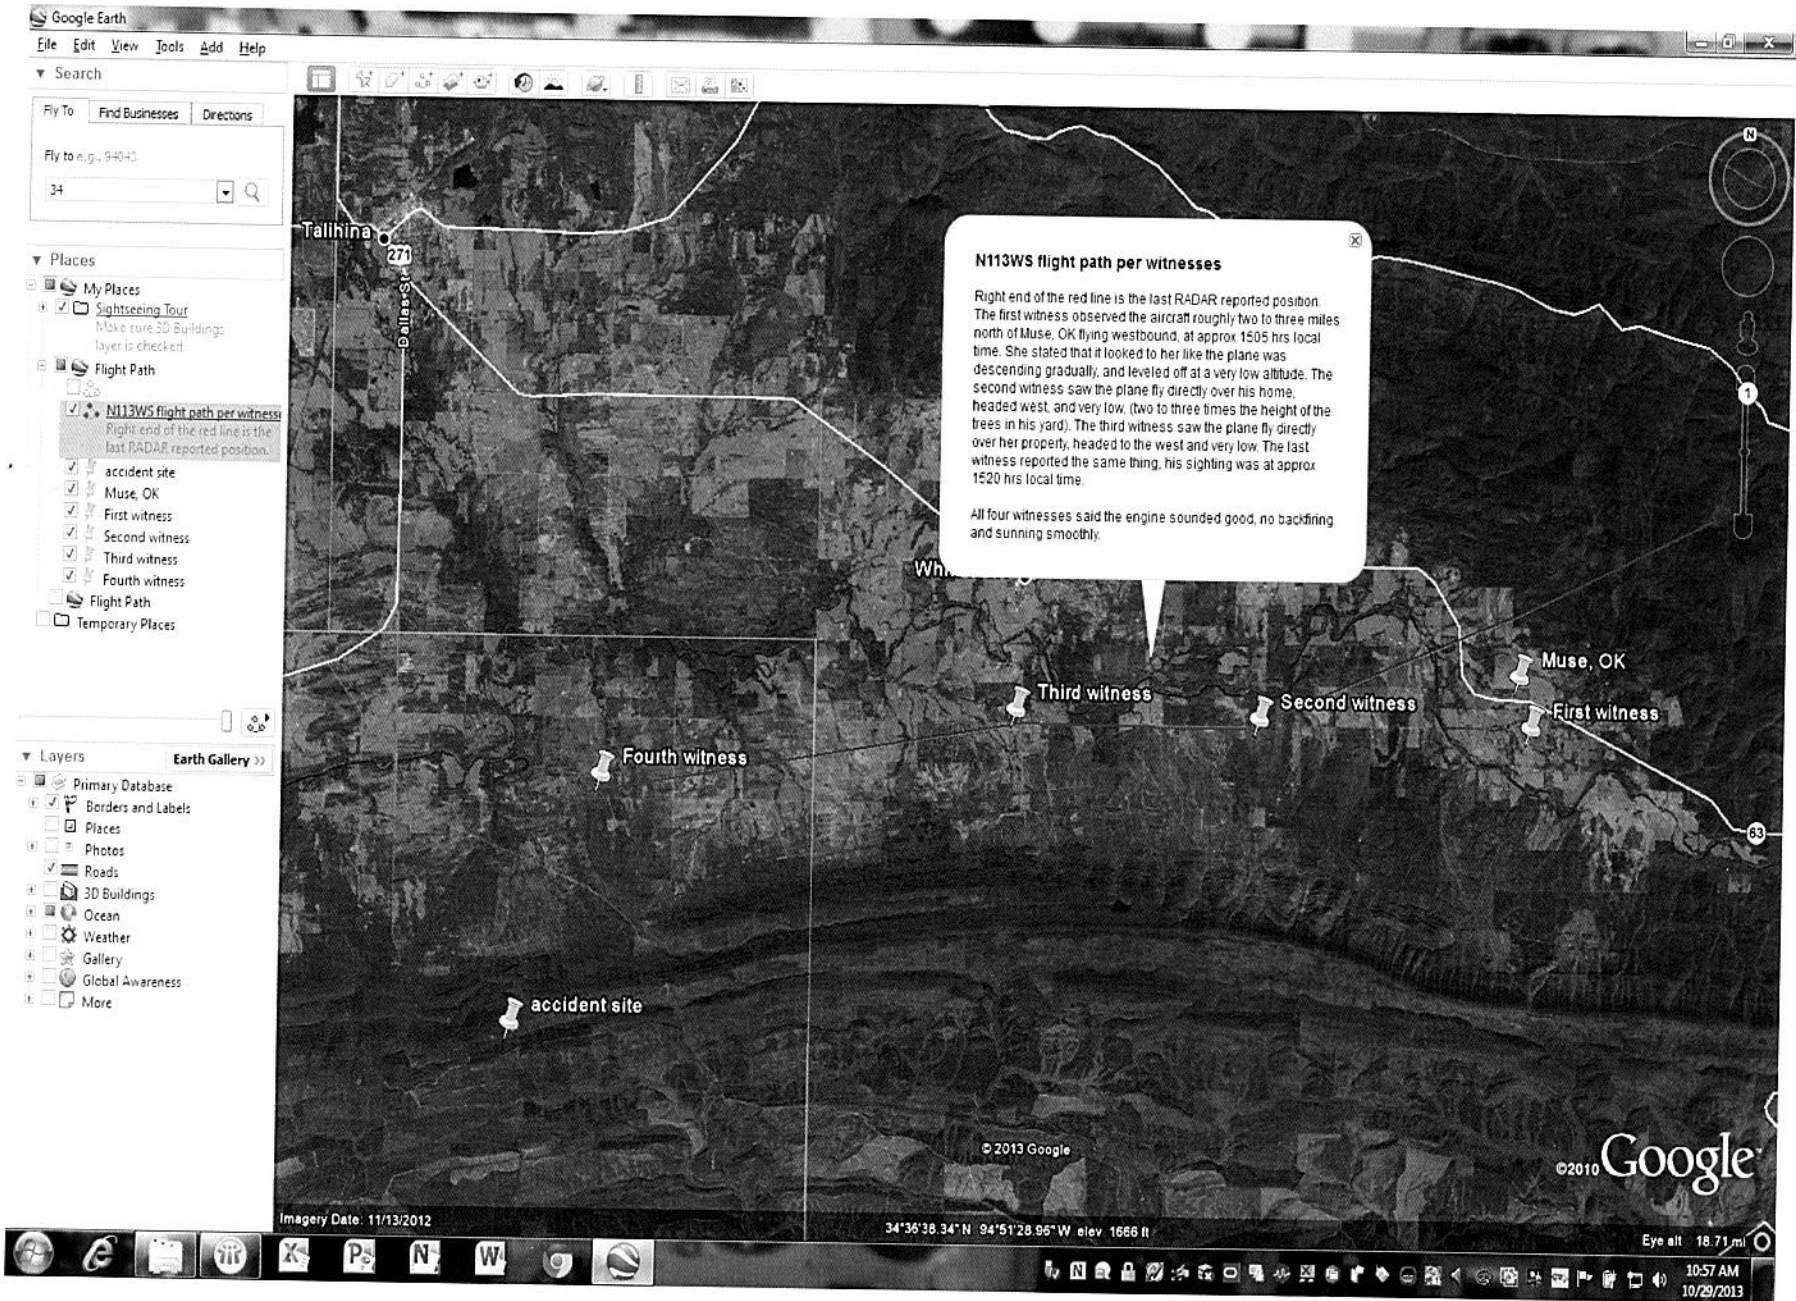
- Places
- My Places
- Sightseeing Tour
Make sure 3D Buildings layer is checked.
- Flight Path
- N113WS flight path per witness
Right end of the red line is the last RADAR reported position.
- accident site
- Muse, OK
- First witness
- Second witness
- Third witness
- Fourth witness
- Flight Path
- Temporary Places

Right end of the red line is the last RADAR reported position. The first witness observed the aircraft roughly two to three miles north of Muse, OK flying westbound, at approx 1505 hrs local time. She stated that it looked to her like the plane was descending gradually, and leveled off at a very low altitude. The second witness saw the plane fly directly over his home, headed west, and very low, (two to three times the height of the trees in his yard). The third witness saw the plane fly directly over her property, headed to the west and very low. The last witness reported the same thing, his sighting was at approx 1520 hrs local time.

All four witnesses said the engine sounded good, no backfiring and sunning smoothly.
