**FEDERAL HIGHWAY ADMINISTRATION
TURNER-FAIRBANK HIGHWAY RESEARCH CENTER REPORT**

*Finite Element Modeling of I-35W Bridge Collapse
Final Report*

OCTOBER 2008

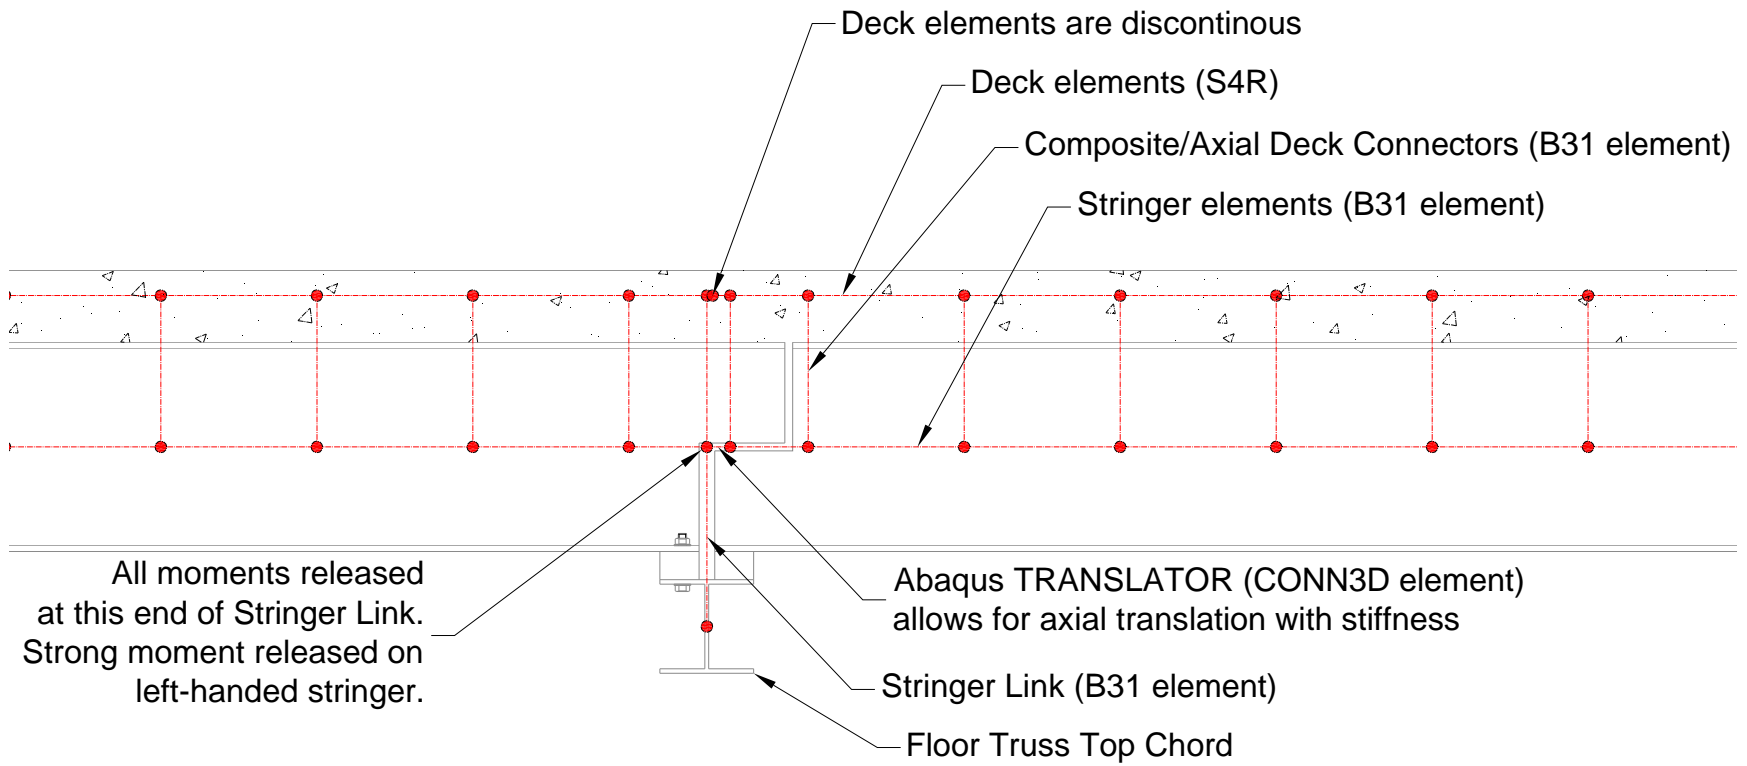
Figure 11. Idealization of deck and stringer structural system.

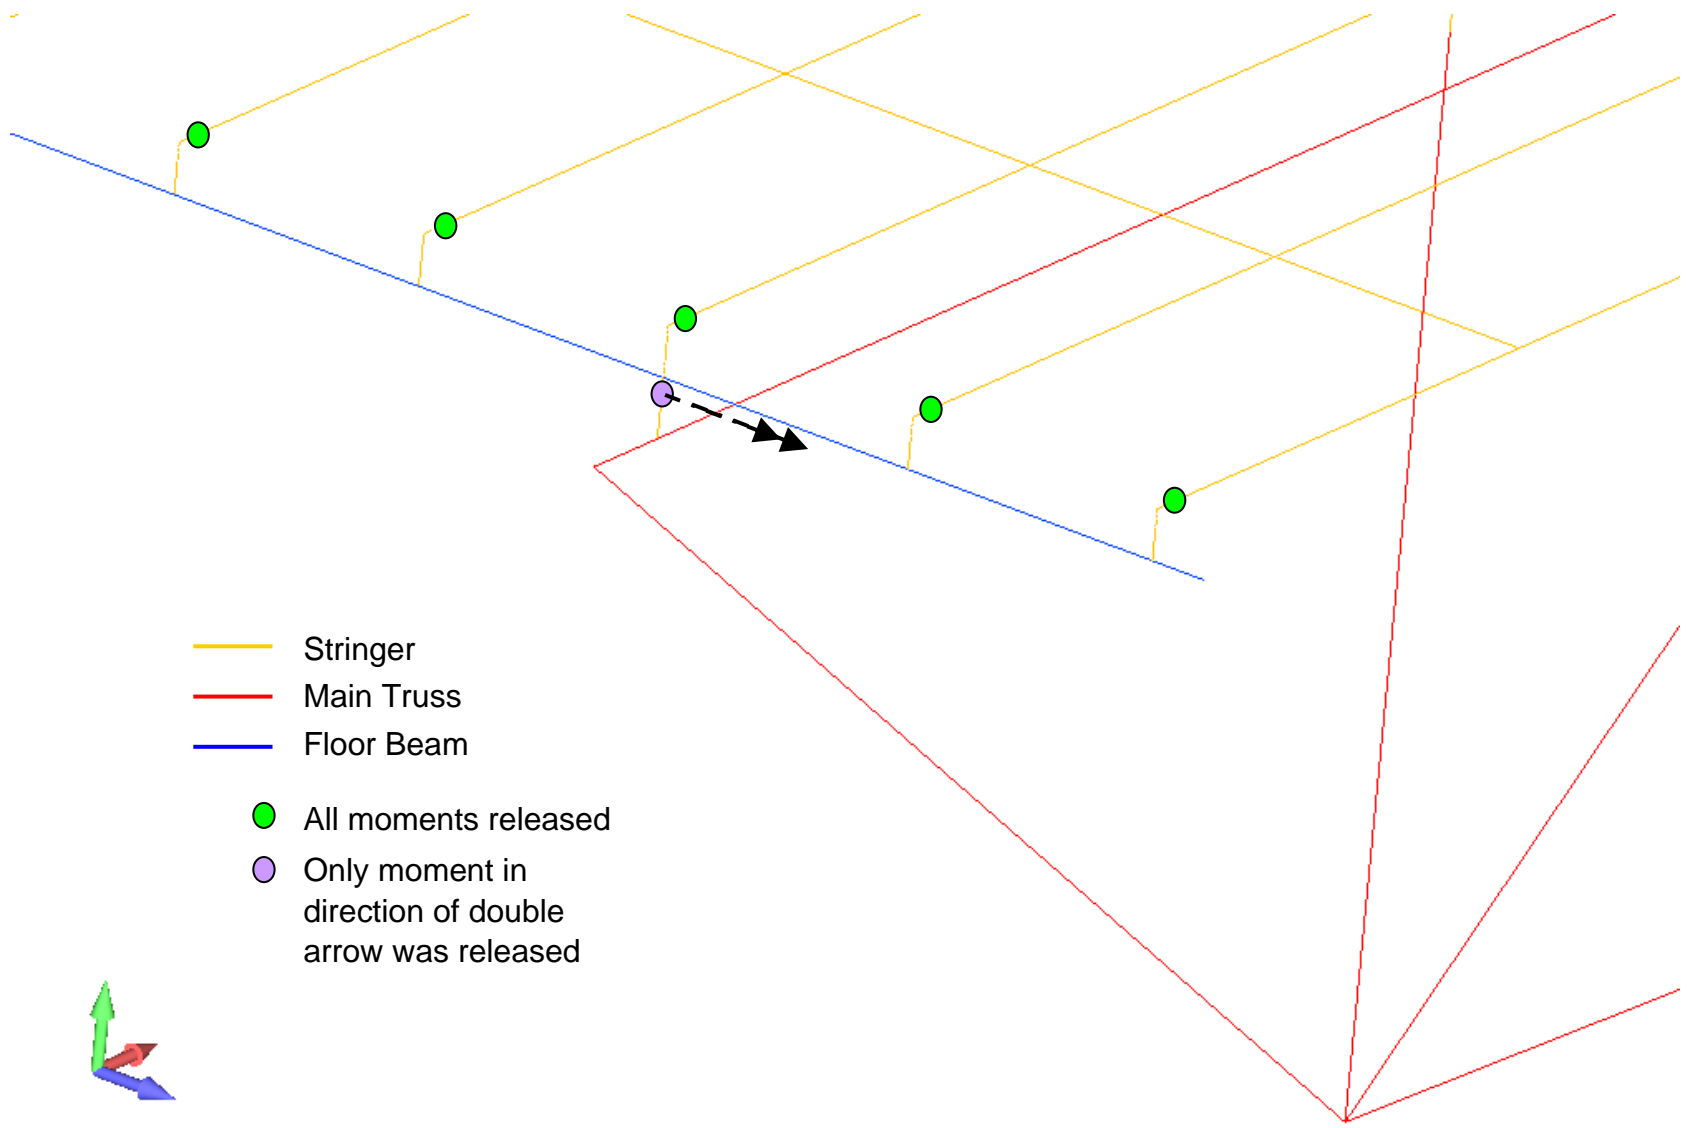
Figure 12. Illustration of moment releases near the floor beams.

There were two deep floor beams at the north and south ends of the bridge to transfer stringer reactions out to the two main trusses. Later into the investigation when the model was being used to actually model the collapse condition, Abaqus ran into convergence issues with some of the floor beam elements. The convergence issue arose because as the bridge deflected, the support bearings would move as the bridge elongated. This motion caused the stringers to put out-of-plane force on the floor beams that was causing lateral-torsional buckling. Since this failure mode was fictitious (because it was occurring in the model at loads less than present on the bridge at the time of collapse), moment releases were added to alleviate this issue. Shown in Figure 12 is a partial view of the north floor beam from the model. The first fix was to release all three moments from the stringer elements at the end they frame into the floor beam links. The second fix was to provide one moment release on the top end of the link between the main

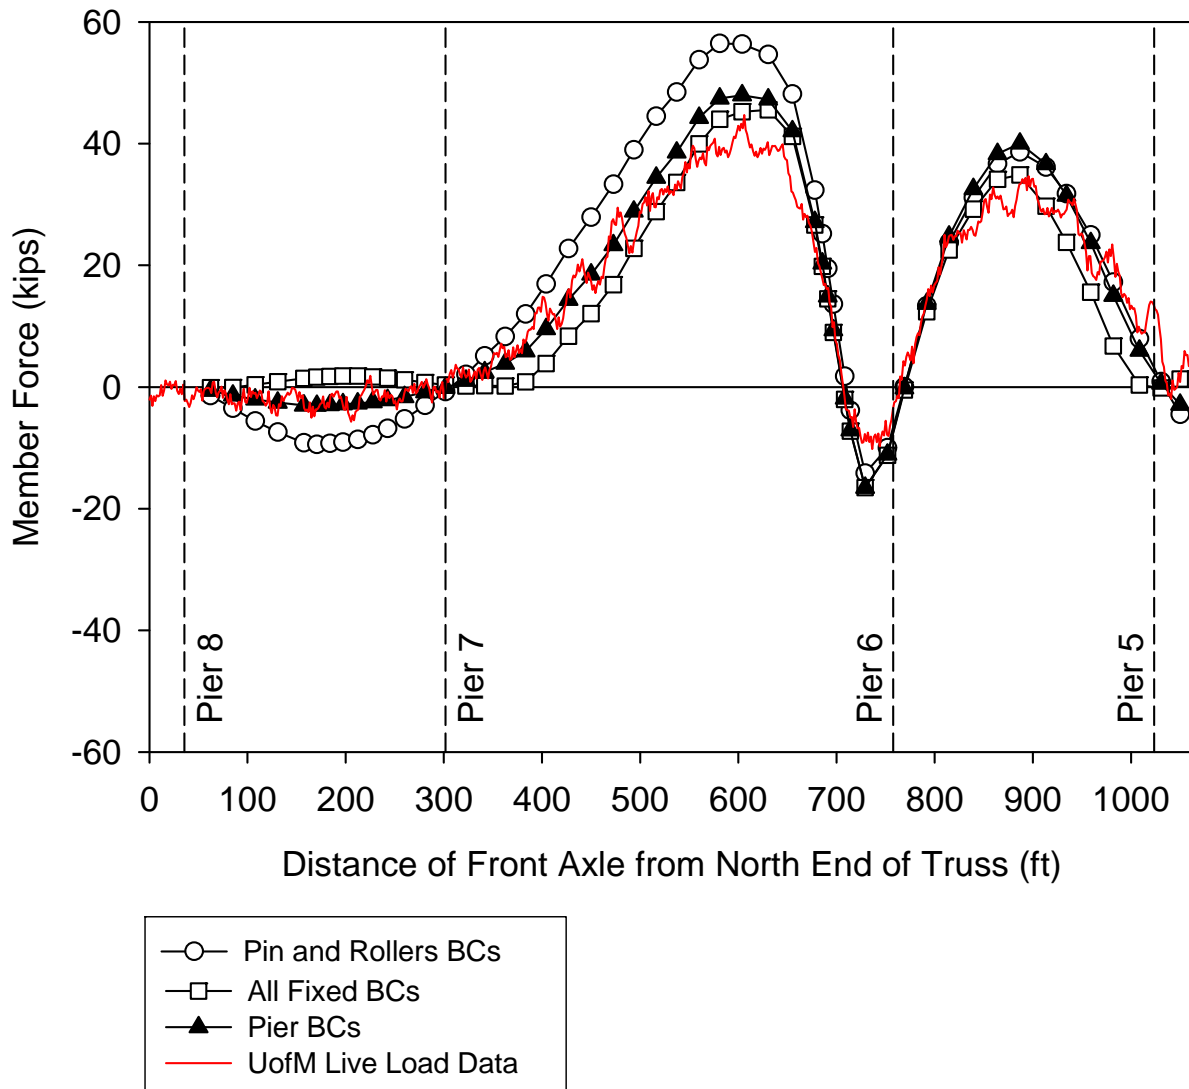
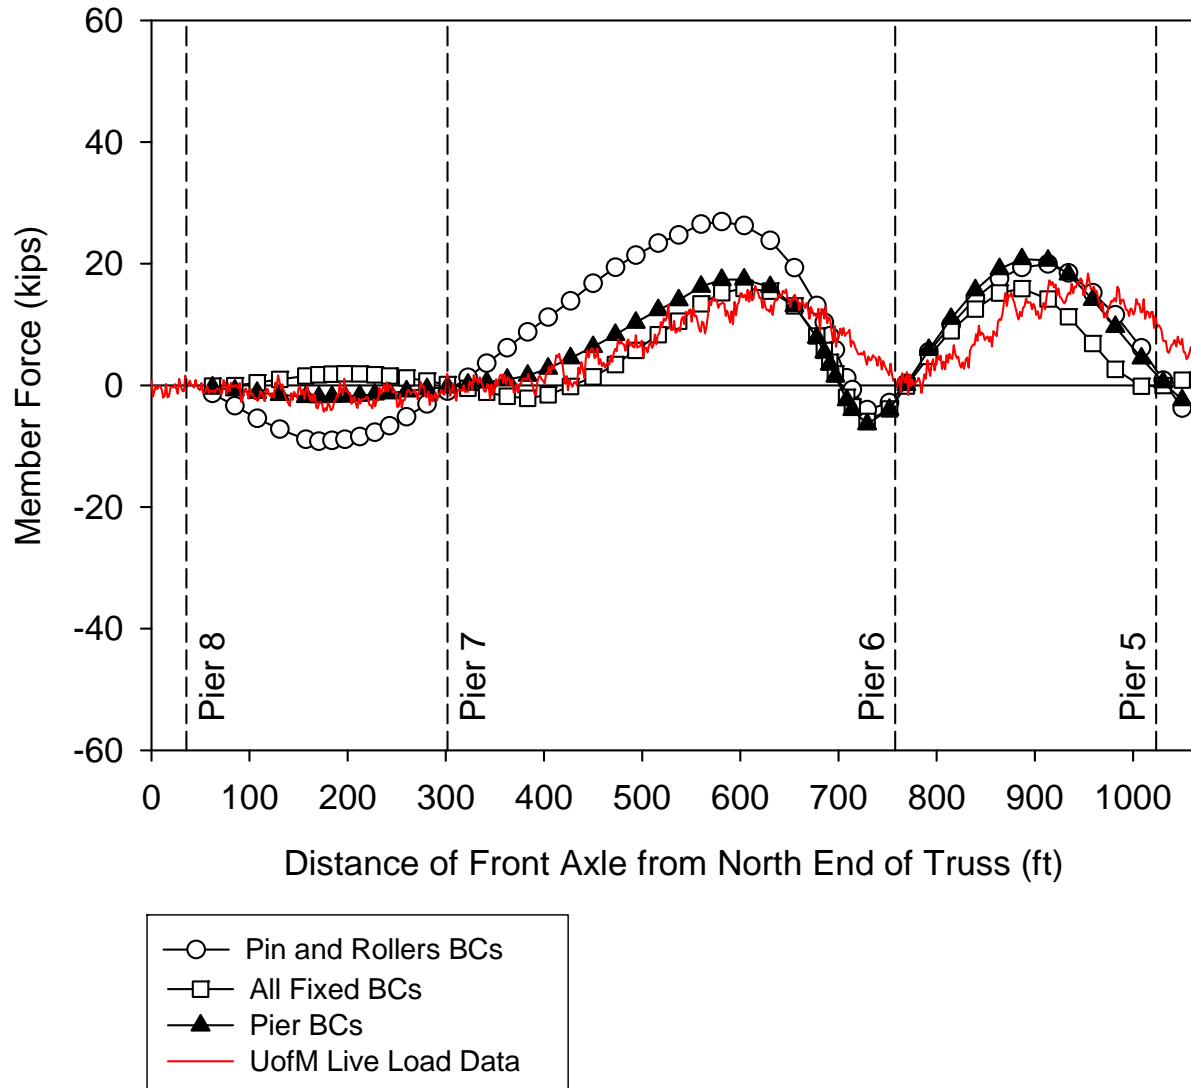
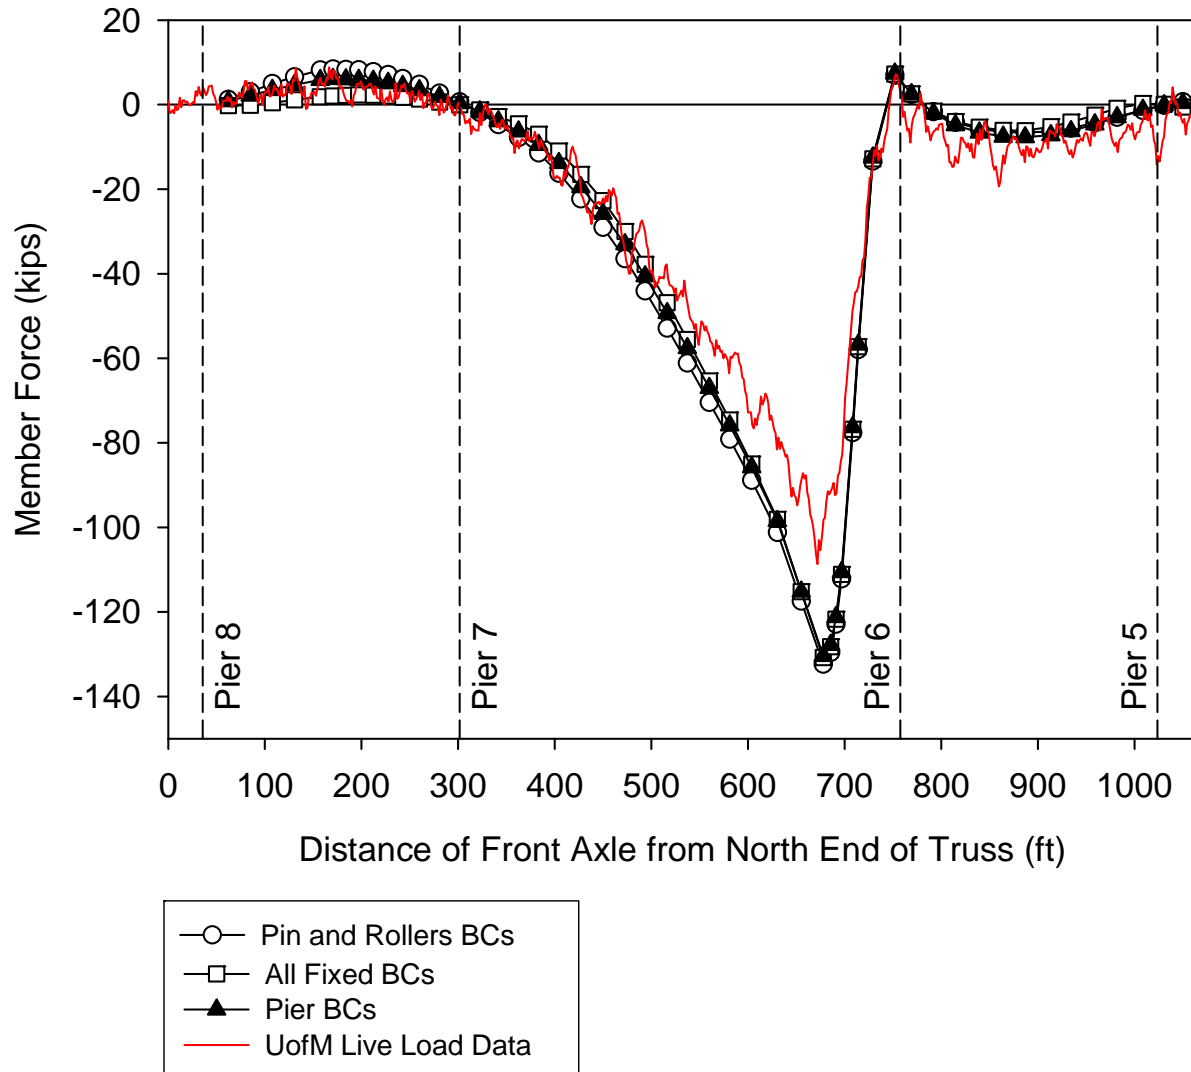
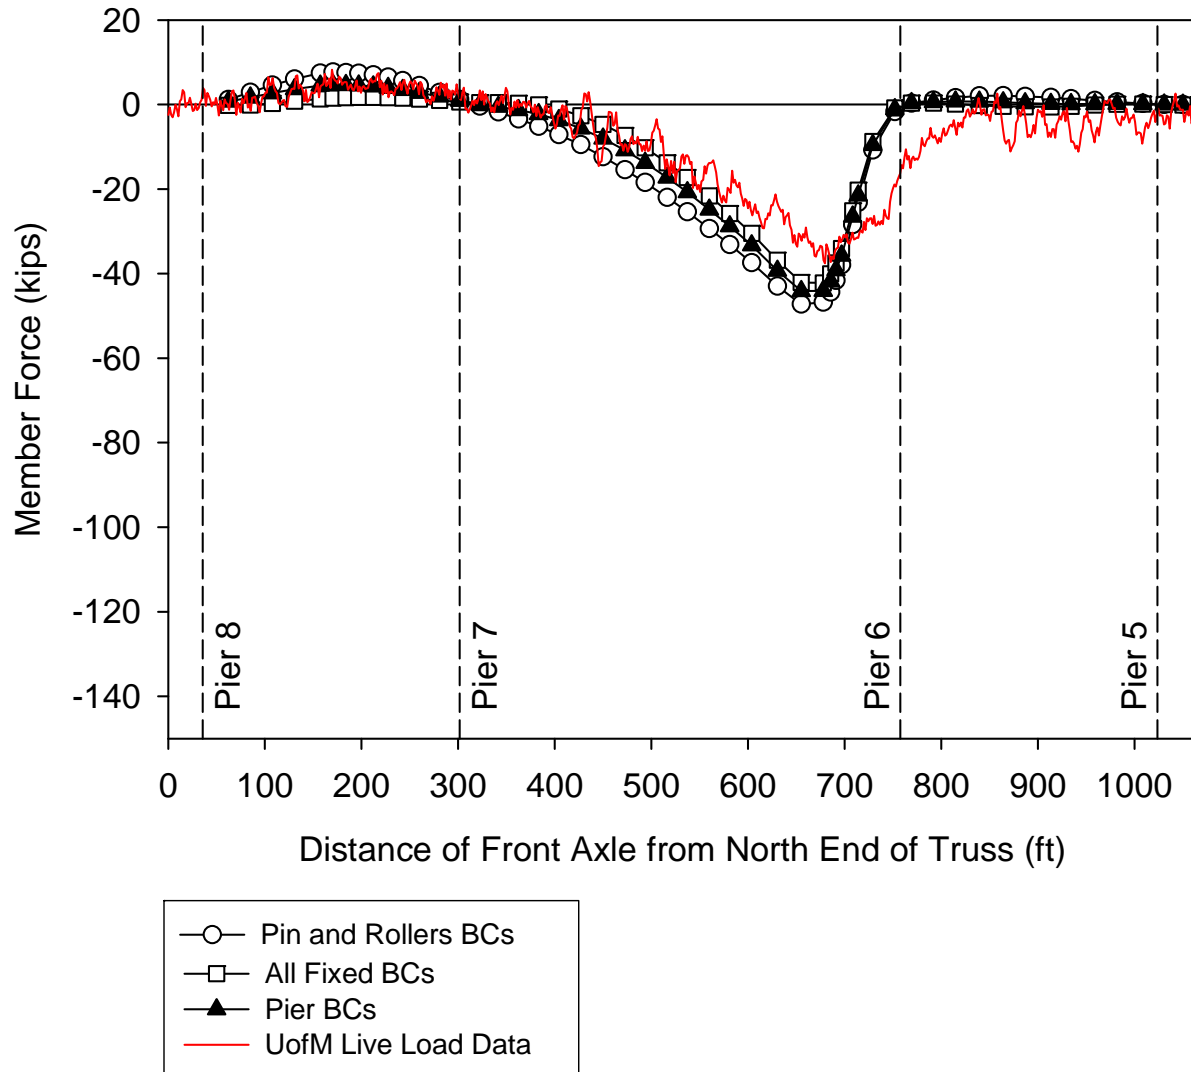
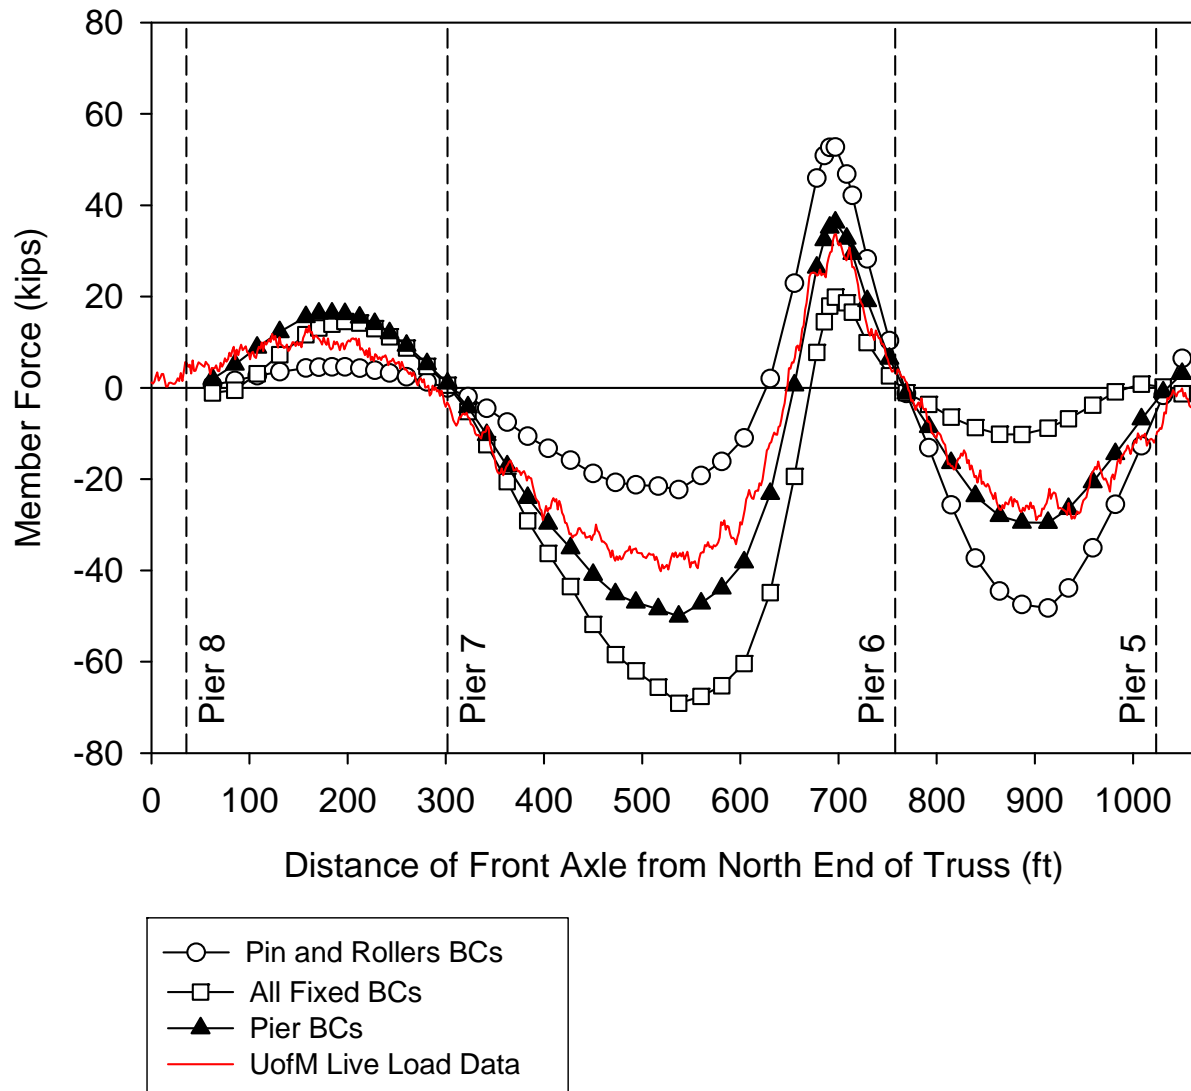
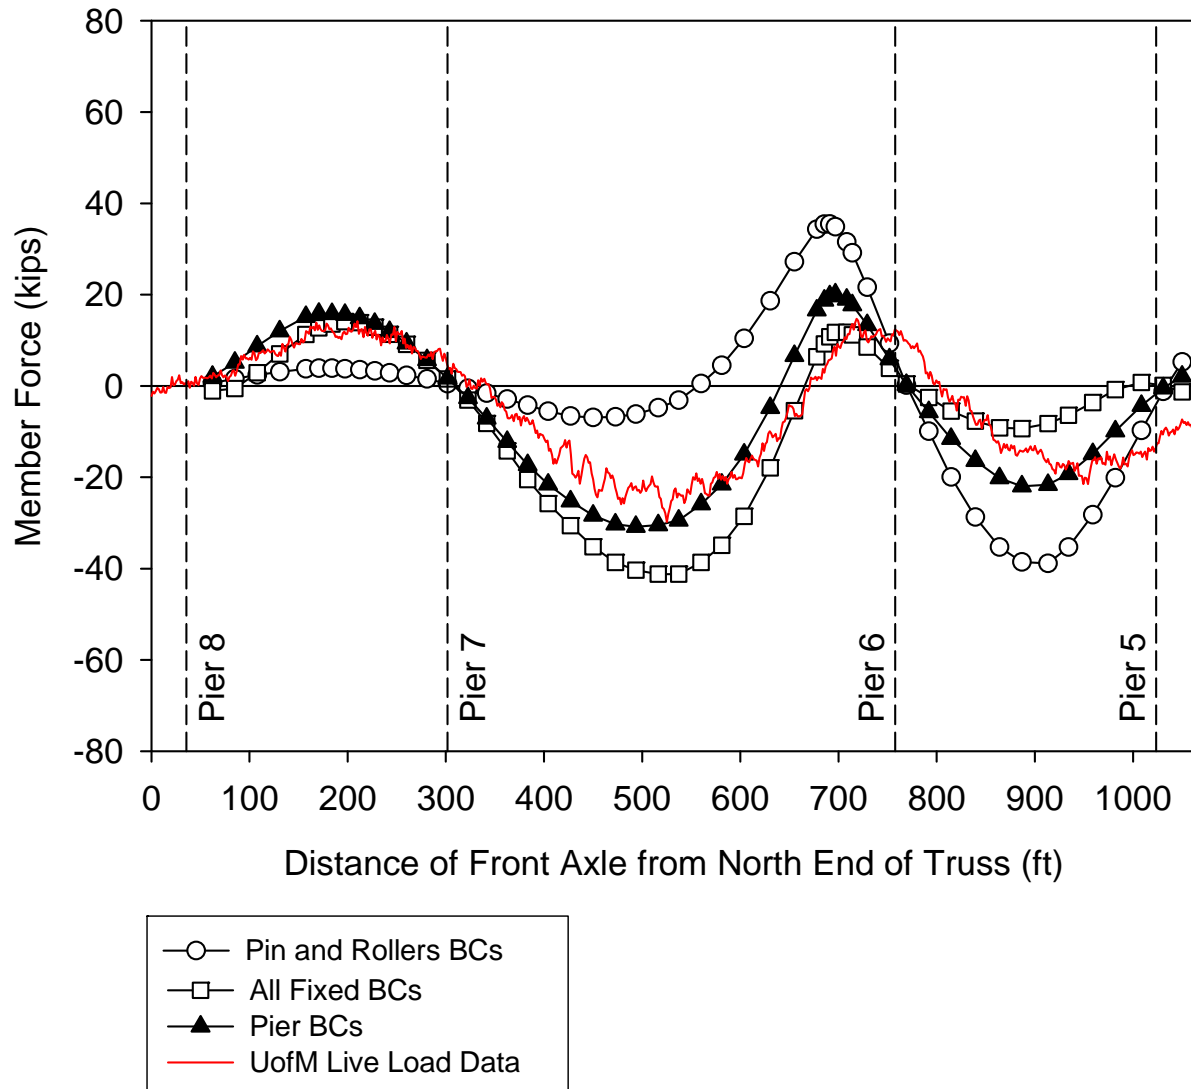
Figure 14. Influence lines from calibration for west truss upper chord member U10-U9.

Figure 15. Influence lines from calibration for east truss upper chord member U10-U9.

Figure 16. Influence lines from calibration for west truss diagonal member U10-L9.

Figure 17. Influence lines from calibration for east truss diagonal member U10-L9.

Figure 18. Influence lines from calibration for west truss lower chord member L10-L9.

Figure 19. Influence lines from calibration for east truss lower chord member L10-L9.

The final conclusion found through the calibration showed that the live load data fell in-between the assumption of ideal and completely fixed boundary conditions. As the graphs show, once the

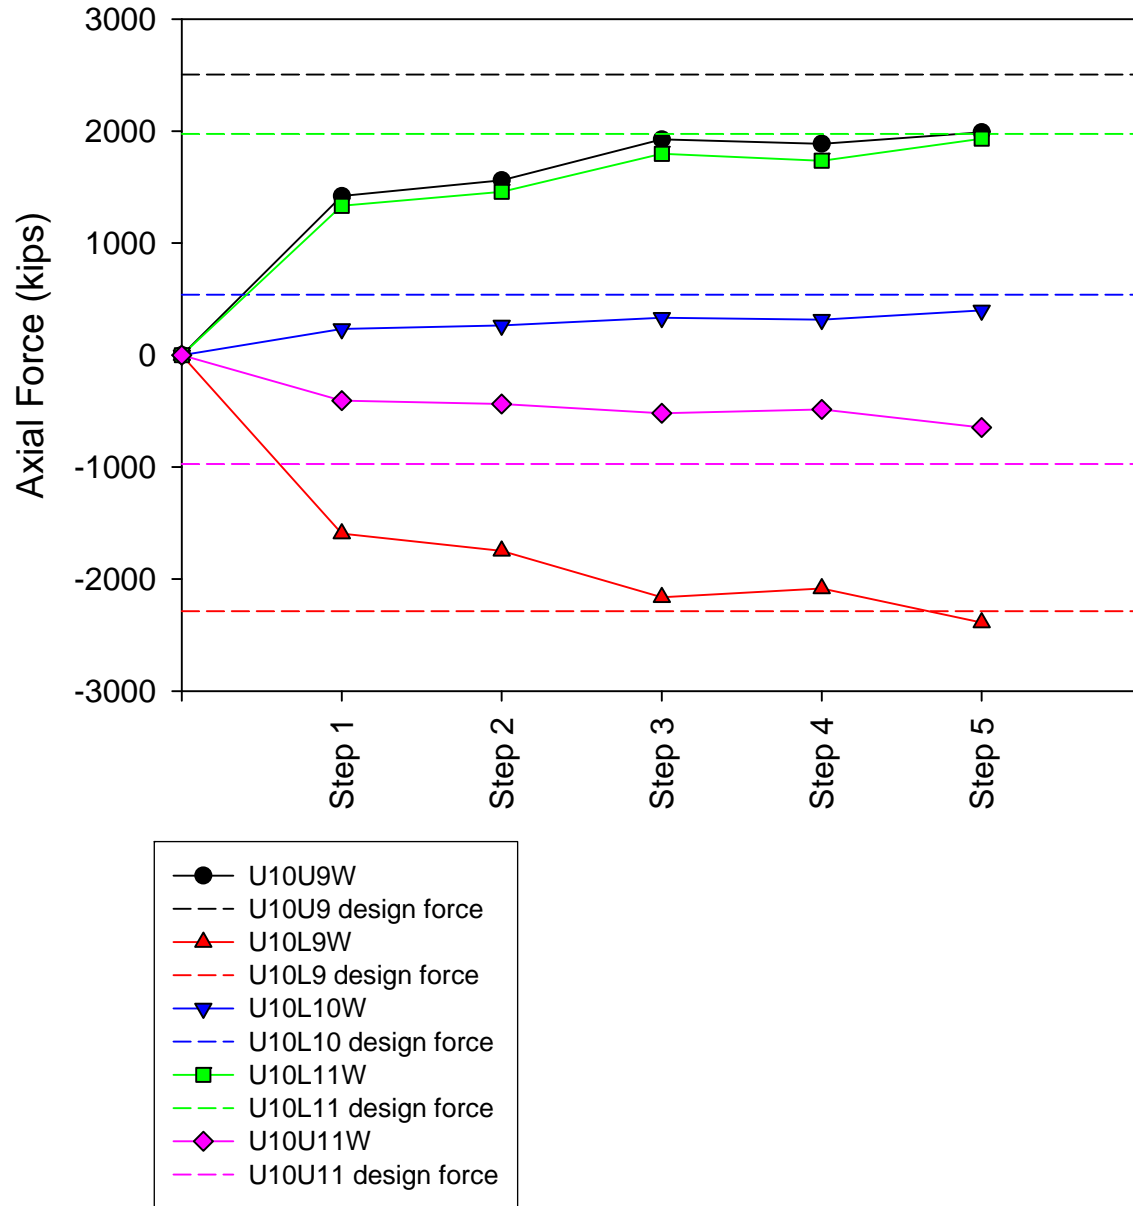
Figure 20. Axial force traces of U10 members.

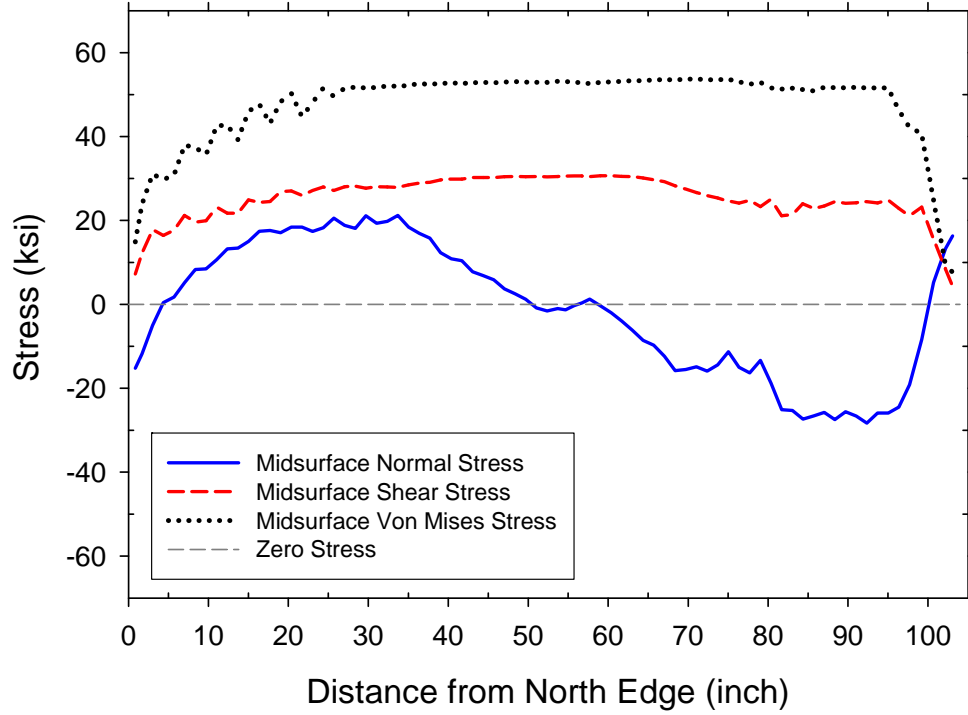
Figure 29. Mid-thickness normal and shear stresses on A-A plane for U10W-west plate.

Figure 30. Mid-thickness normal and shear stresses on A-A plane for U10W-east plate.

Figure 31. Mid-thickness normal and shear stresses on A-A plane for U10E-west plate.

Figure 32. Mid-thickness normal and shear stresses on A-A plane for U10E-East plate.

expected, shear being applied to the A-A plane appears to dominate the capacity of the U10 connection.

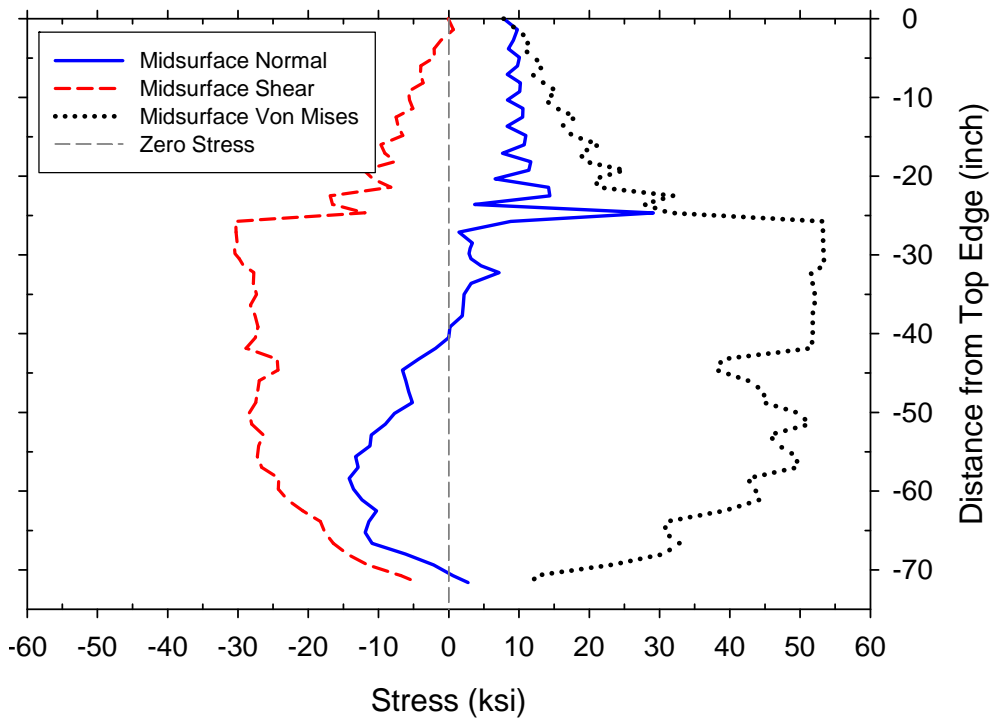
Figure 33. Mid-thickness normal and shear stresses on B-B plane for U10W-west plate.

Figure 34. Mid-thickness normal and shear stresses on B-B plane for U10W-east plate.

Figure 35. Mid-thickness normal and shear stresses on B-B plane for U10E-west plate.

Figure 36. Mid-thickness normal and shear stresses on B-B plane for U10E-east plate.

Figures 33-36 show similar plots along the B-B free-body section plane. There are two distinct regions of behavior along this section plane. The top region of the gusset serves primarily as a chord splice plate and additional internal splice plates share a portion of the total force. In the lower region, all of the member forces flow through the gusset plates. The shear stress below the top chord is close to the 29.9 ksi shear yield strength over a significant portion of the plate. The shear stress is lower in the top chord splice region since the internal splice plates take a portion of the load. Similarly, the normal stress distribution shows two distinct regions of behavior. A relatively uniform axial stress distribution can be observed in the top chord splice region. There appears to be more of a bending stress distribution across the lower portion of the plate. This illustrates the complexity involved with gusset plate design.

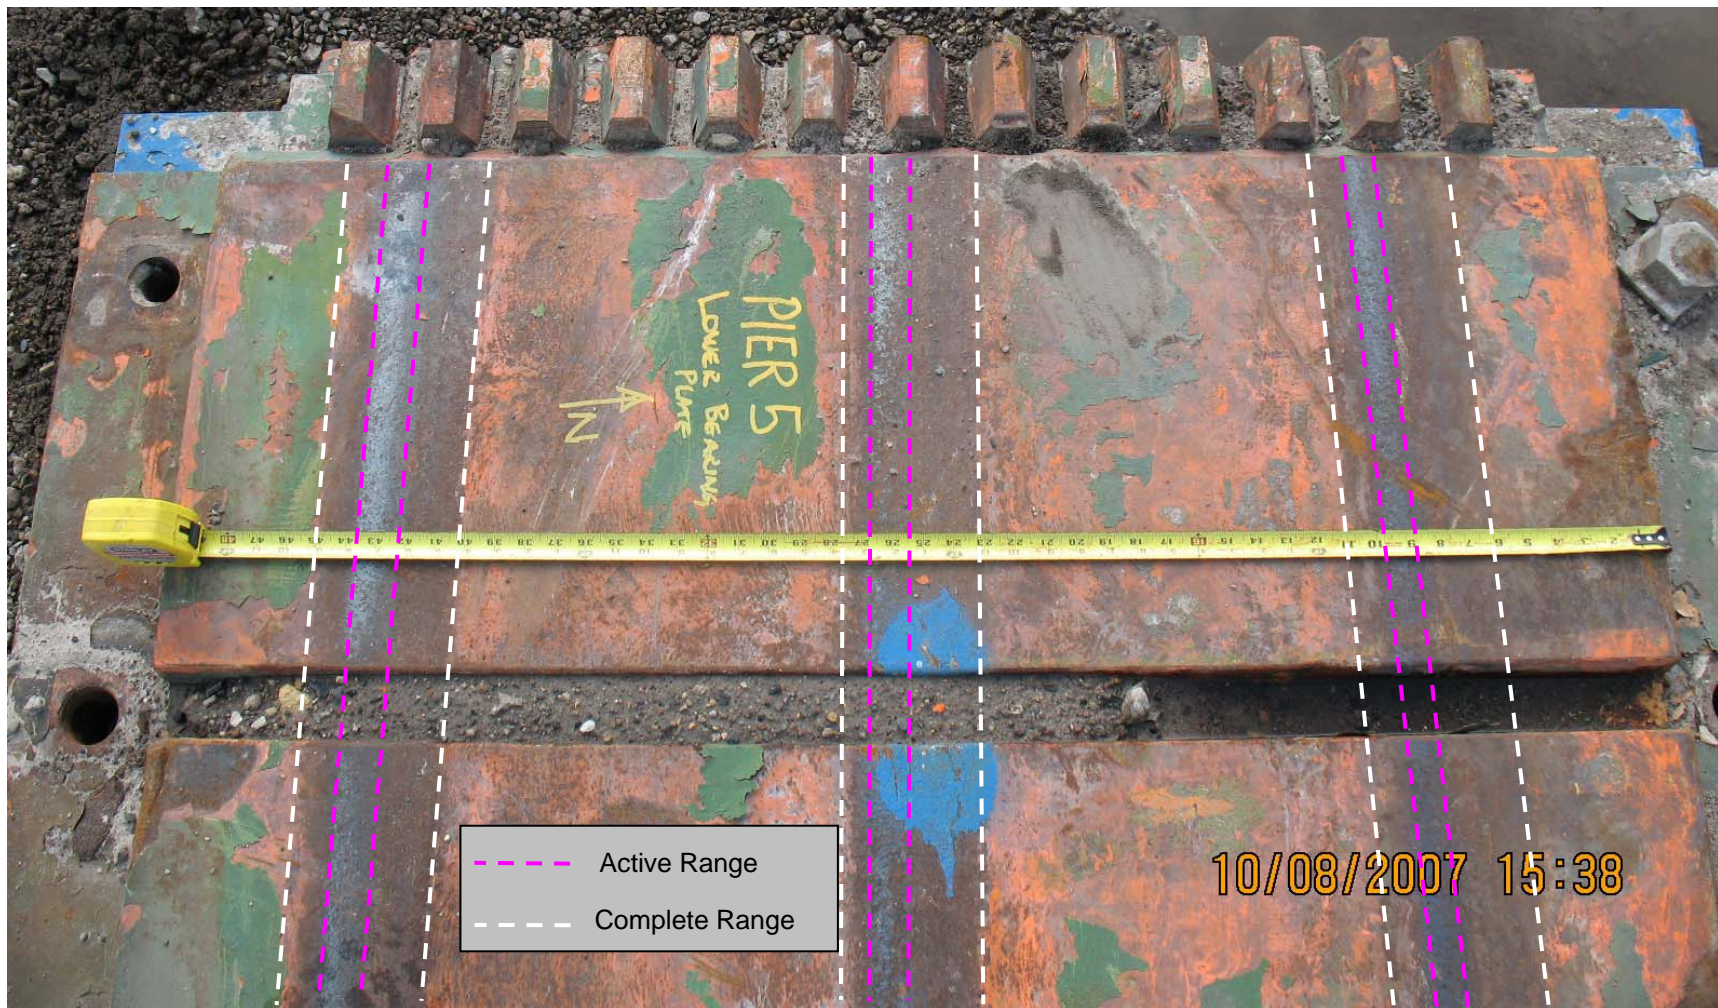
Figure 45. Roller wear indications in the lower bearing sole plate at Pier 5.

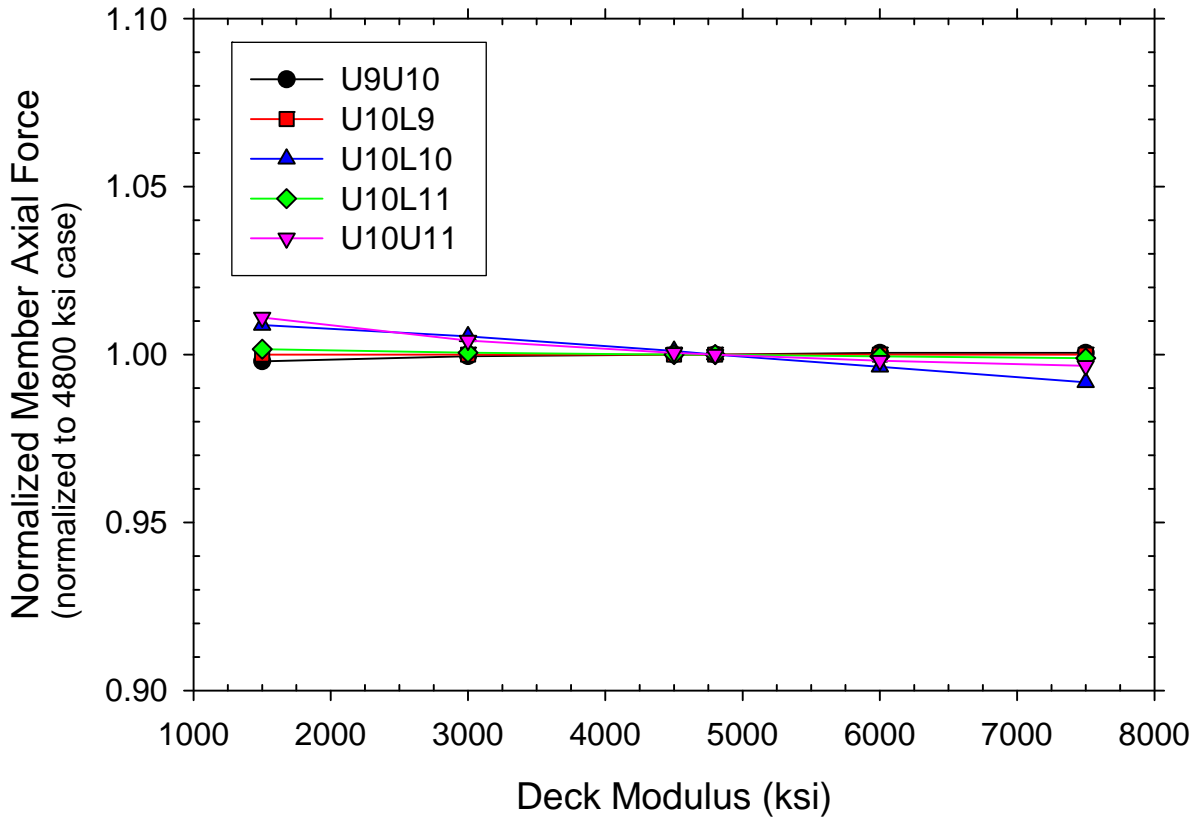
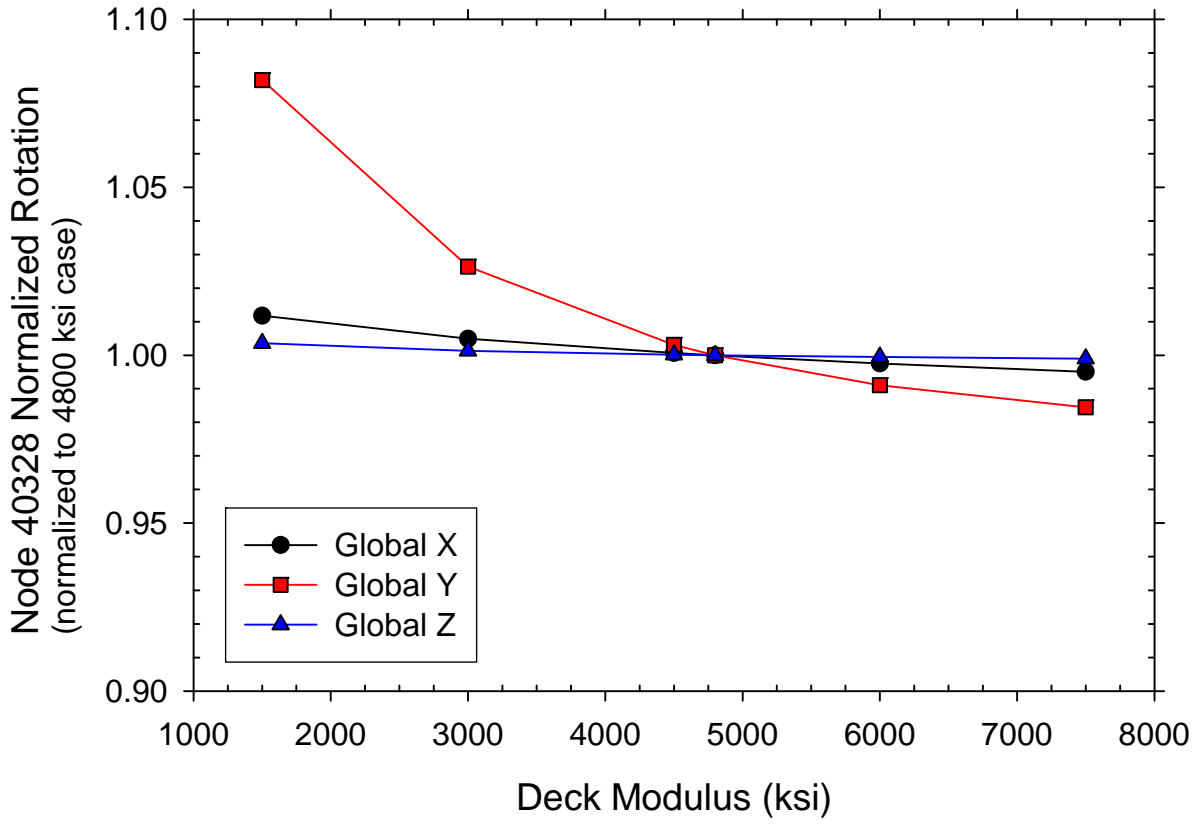
Figure 58. Effect of deck modulus on U10W member axial forces.

Figure 59. Effect of deck modulus on Node 40328 translation.

Figure 60. Effect of deck modulus on node 40328 rotation.
