**FEDERAL HIGHWAY ADMINISTRATION
TURNER-FAIRBANK HIGHWAY RESEARCH CENTER REPORT**

*Finite Element Modeling of I-35W Bridge Collapse
Final Report*

OCTOBER 2008

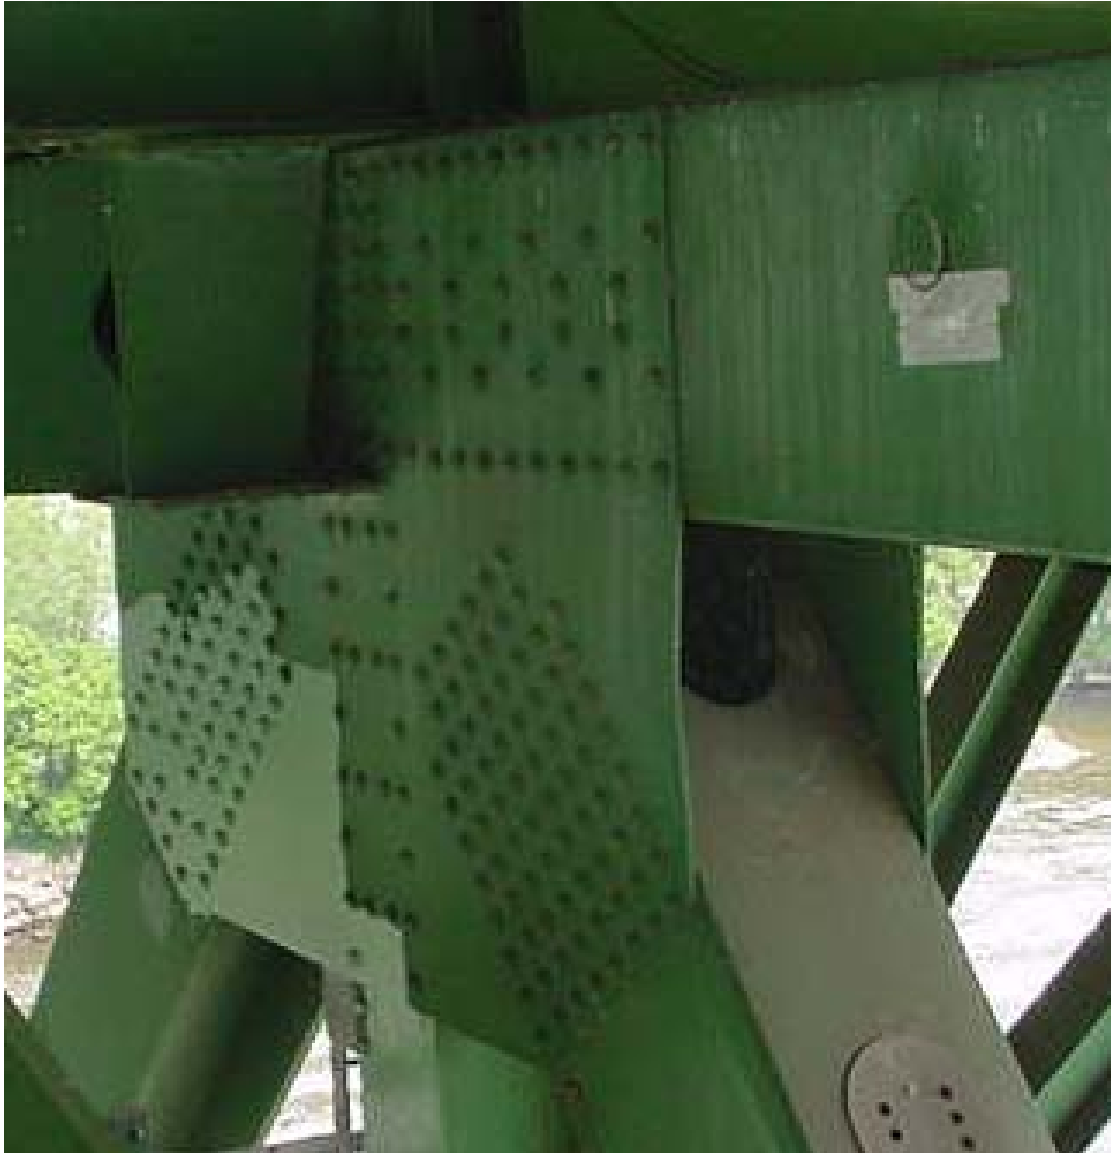
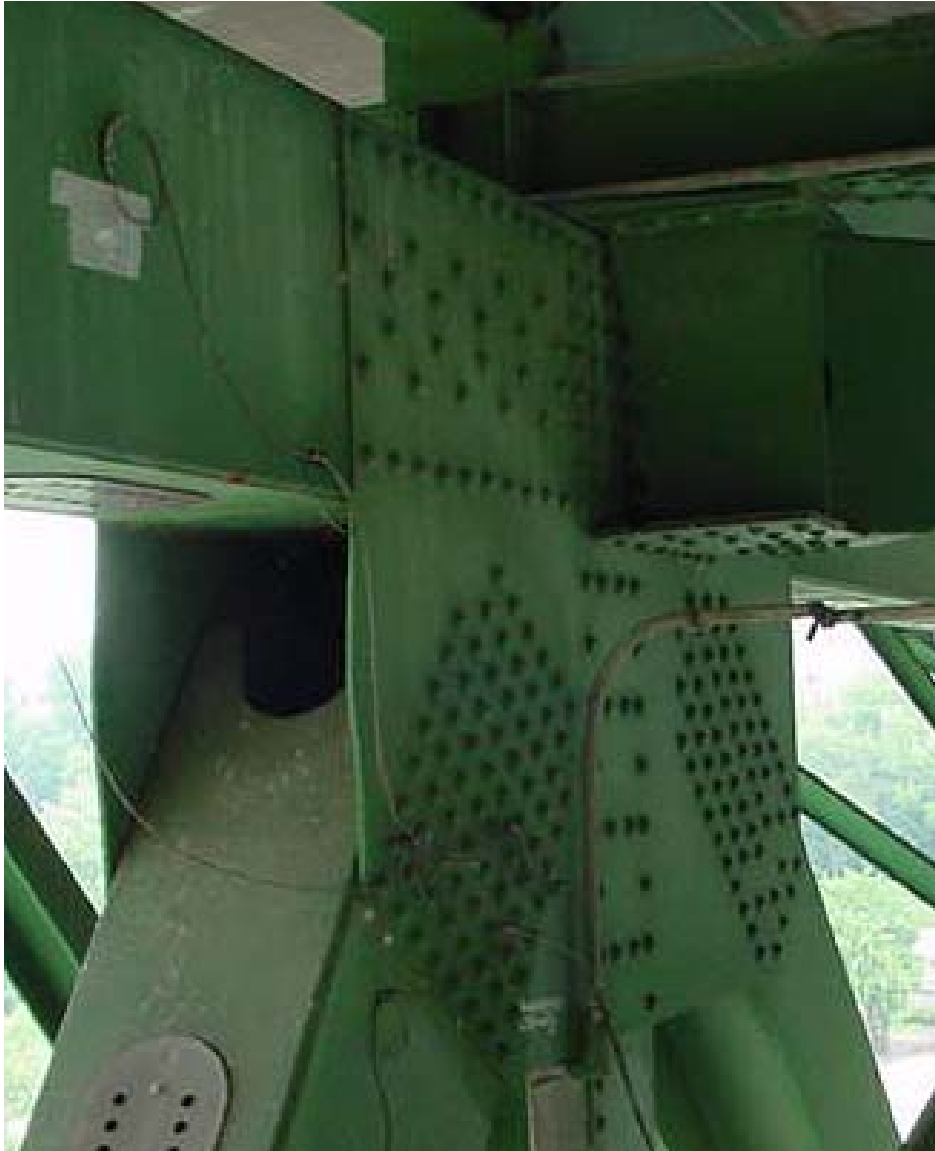
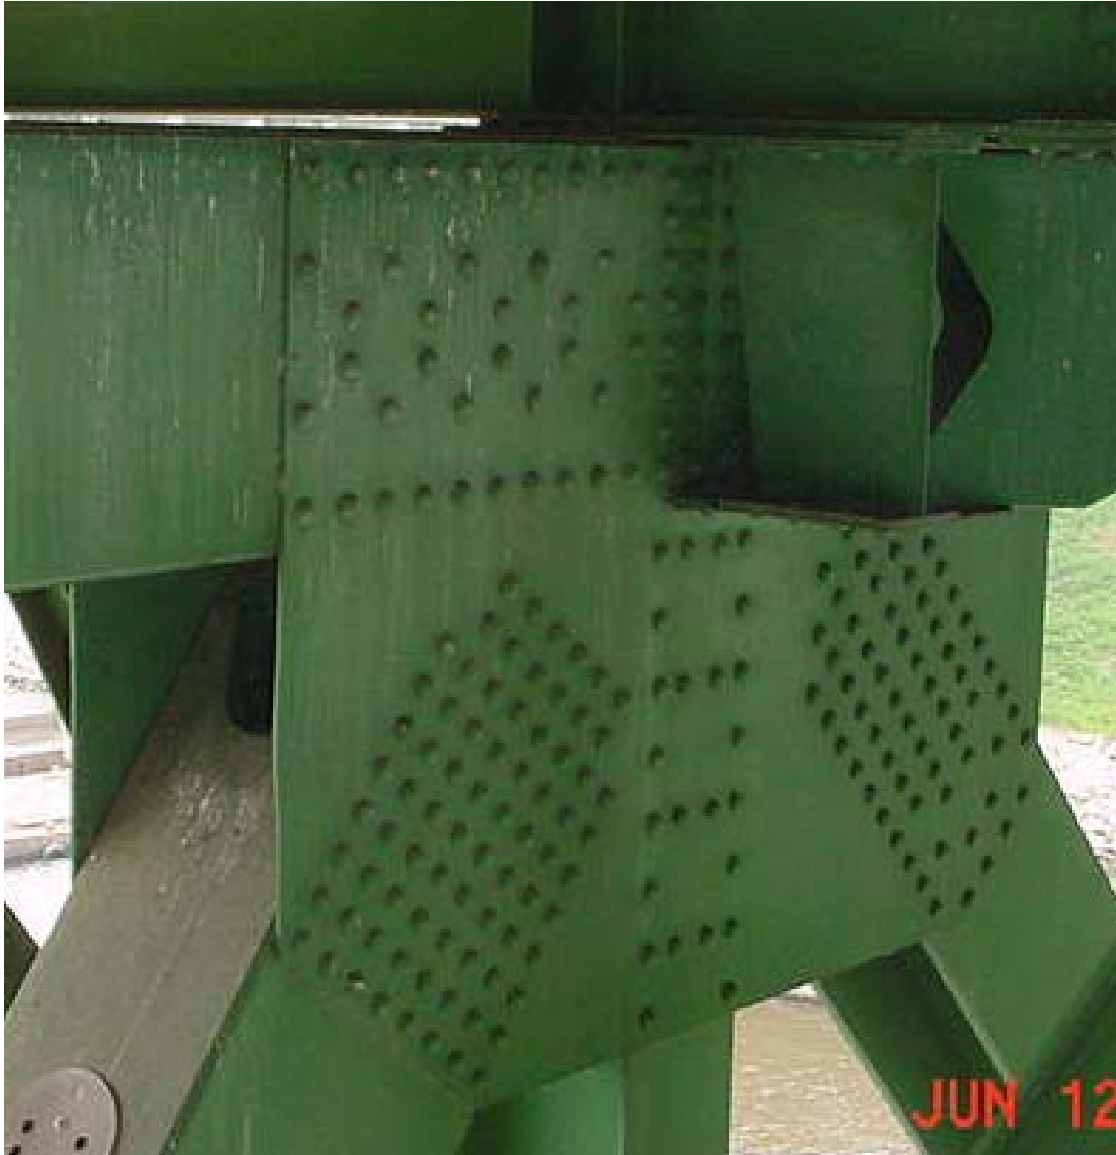
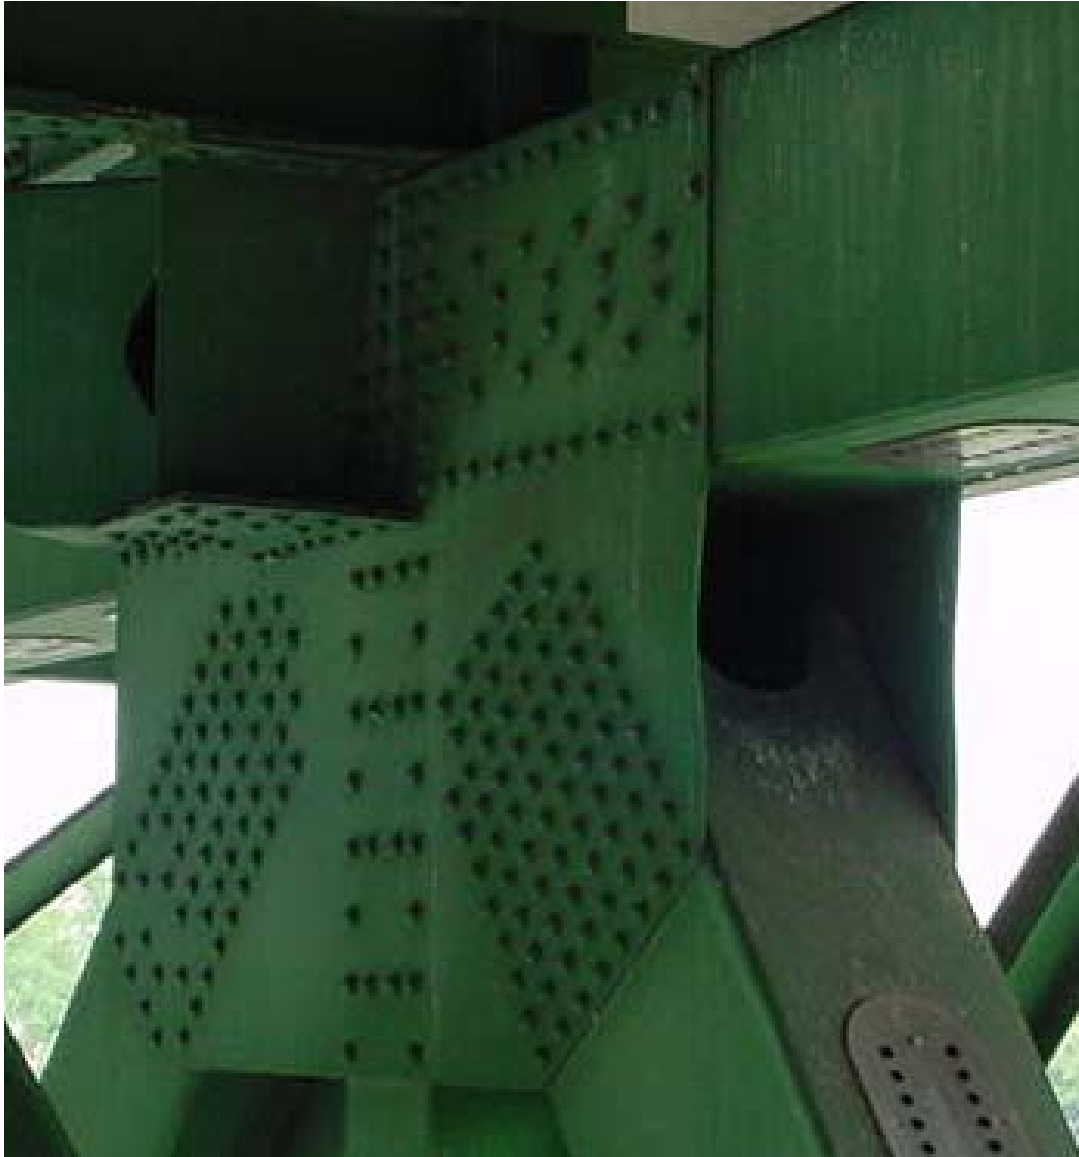
Figure 61. Picture of U10E connection taken on 12 June 2003.

Figure 62. Picture of U10W connection taken on 10 June 2003.

Figure 63. Picture of U10'E connection taken on 12 June 2003.

Figure 64. Picture of U10'W connection taken on 10 June 2003.

Connection	Direction of Initial Imperfection
U10East (see Figure 61)	Upstream (west)
U10West (see Figure 62)	Upstream (west)
U10'East (see Figure 63)	Downstream (east)
U10'West (see Figure 64)	Downstream (east)

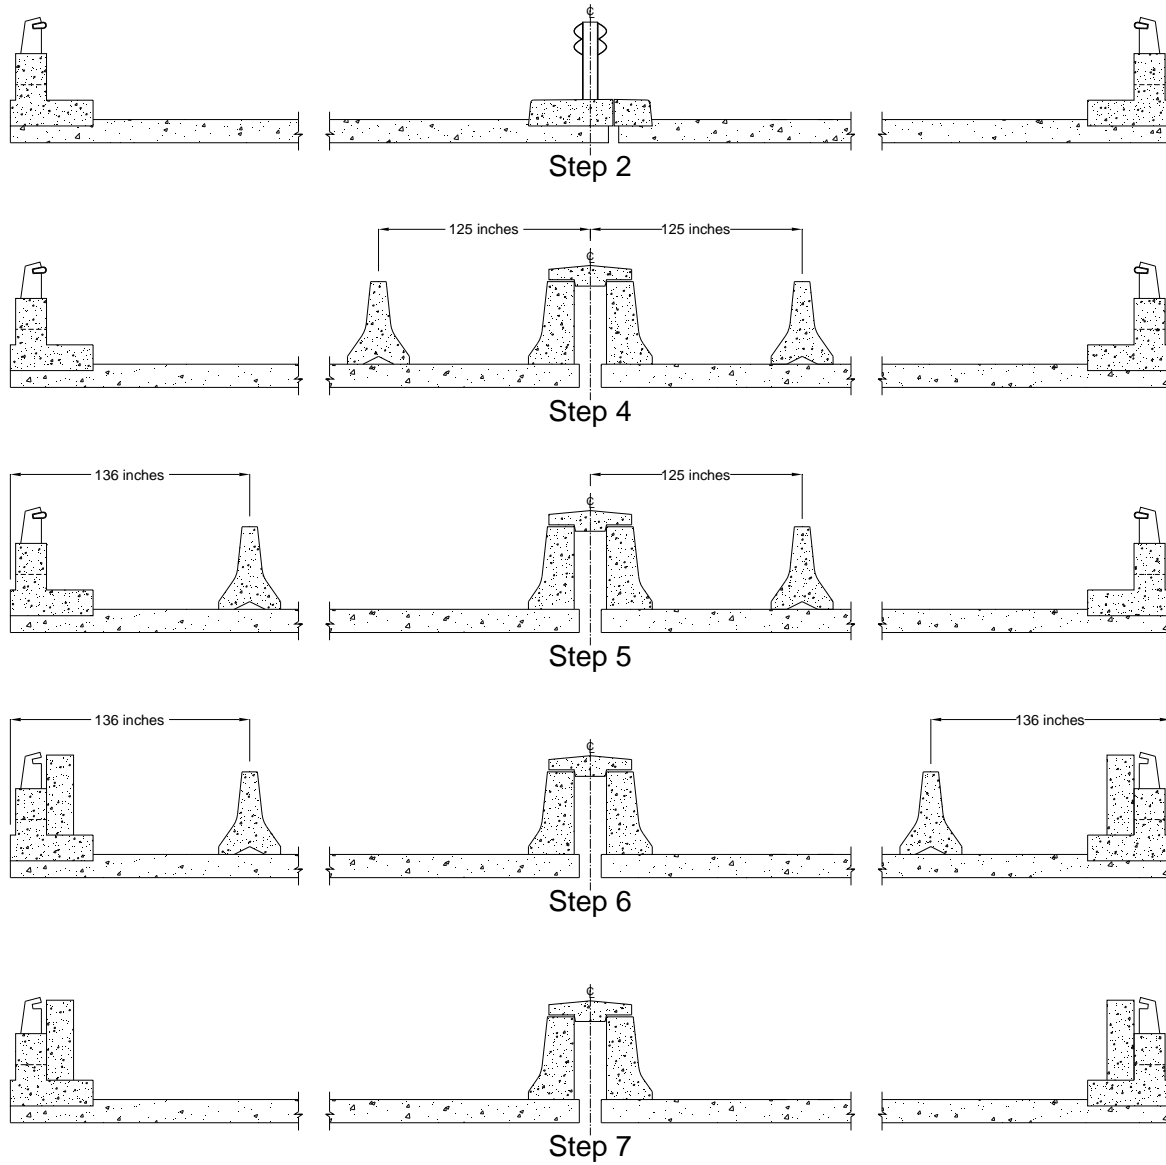
Figure 78. Schematic of loading steps for temporary barrier scenario. View looking North.

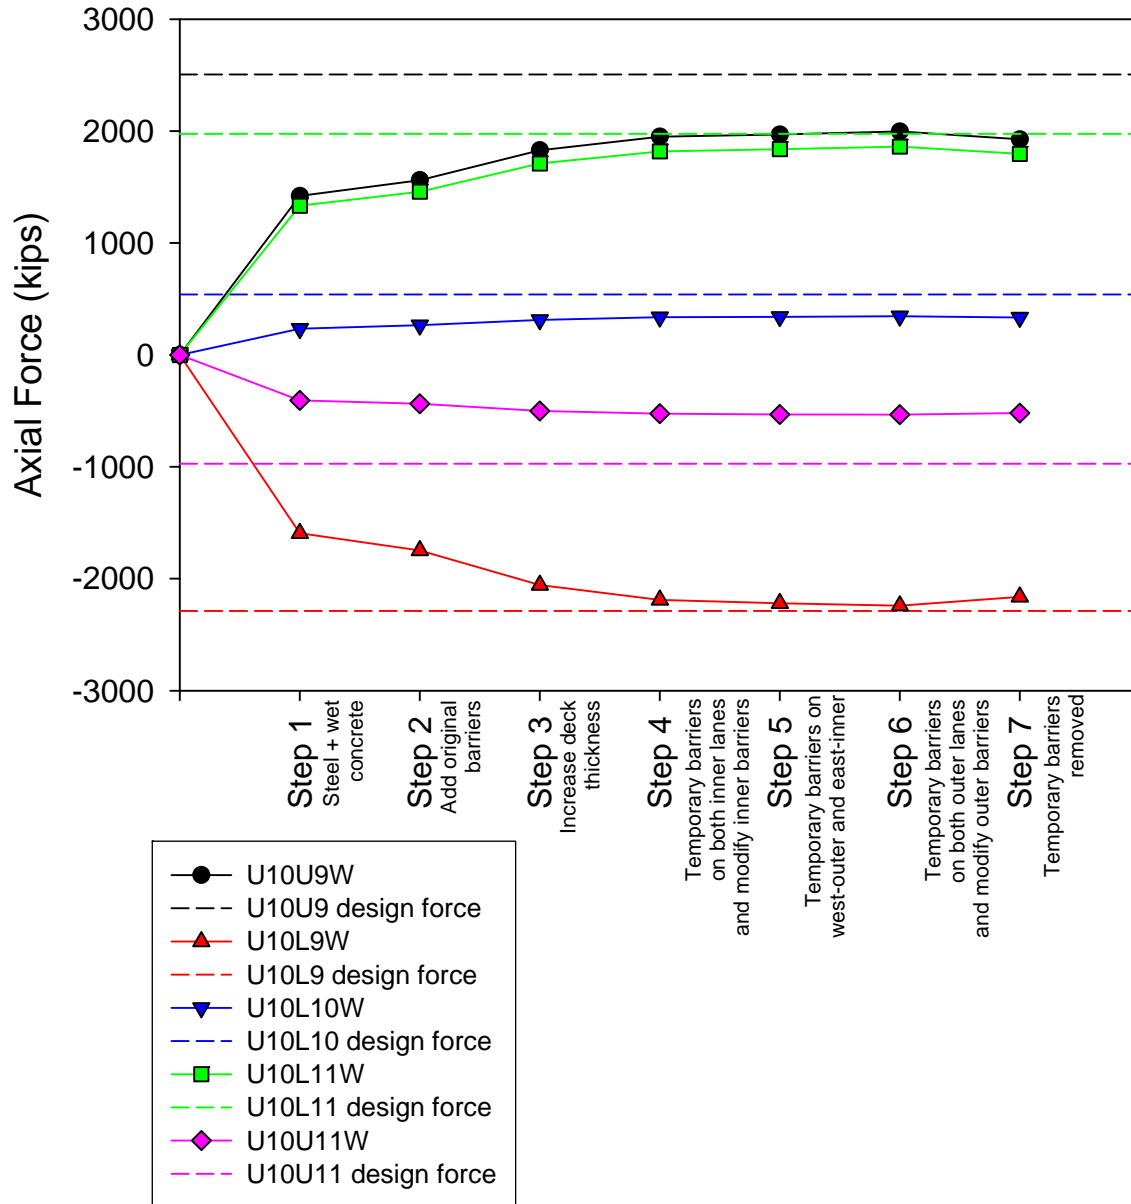
Figure 79. Force point traces of U10W member loads through temporary barrier load scenario.

- 0.029 inches to the west for the U10W-E plate
- 0.058 inches to the west for the U10E-W plate
- 0.041 inches to the west for the U10E-E plate
