# **NATIONAL TRANSPORTATION SAFETY BOARD**

## **Operations and System Safety Factual Report**

**RRD18FR010**

**Dallas, Garland and Northeastern (DGNO) Railroad Conductor Fatality**

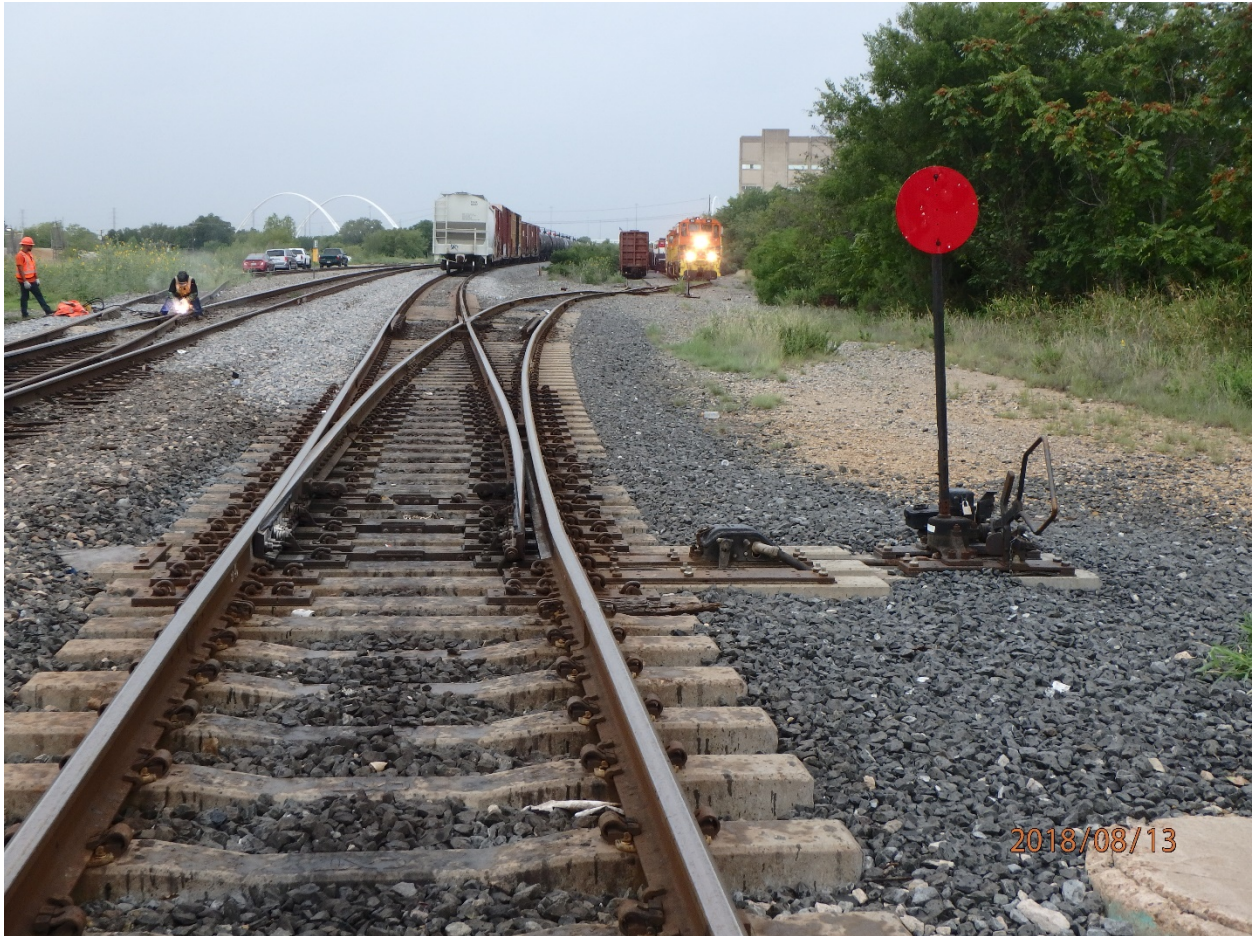
*Figure 2 This is the switch that governs movements into track 400 or for a diverging route into tracks 401 or 402. Photo shows switch target (red) is perpendicular to track 400 indicating that the switch is lined for diverging route for tracks 401 or 402.*

When they arrived at the Main Track switch to enter Cadiz Yard, the conductor stopped the movement via radio and lined the switch from the Main Track into Cadiz Yard tracks. The Conductor then instructed the Engineer to come ahead about 3 cars lengths (continuing West as a shoving movement ).<sup>7</sup> After moving ahead about 1-1/2 car lengths, the conductor told the engineer via radio, he was lined up to come ahead (continue shoving West) about 30 car lengths.<sup>8</sup> The Engineer shoved a few car lengths and the movement came to an abrupt stop and felt that a hard coupling as the movement came against the cars in track 400. The Engineer stated that he never saw any kind of light or other signs from the Conductor to indicate his position relative to the movement he was directing by radio.

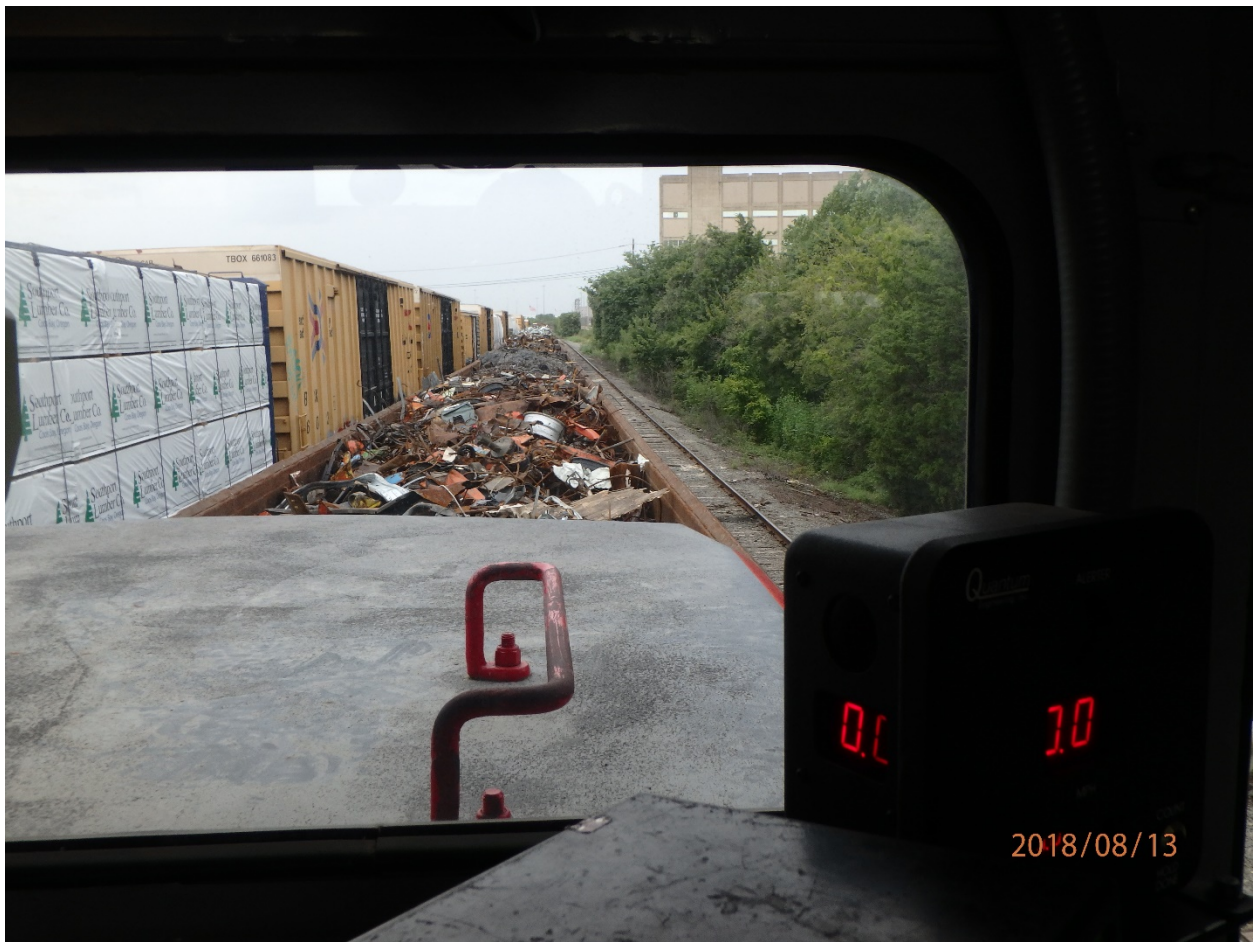
*Figure 3 This is the actual accident train. View is from the righthand side of the locomotive from the engineer controls looking west. There were 9 gondolas cars loaded with scrap iron coupled ahead of the locomotive.*

In direction of travel (west), the Engineer was seated at the controls on the righthand side of the locomotive. There were nine gondola railroad cars attached ahead of the locomotive.

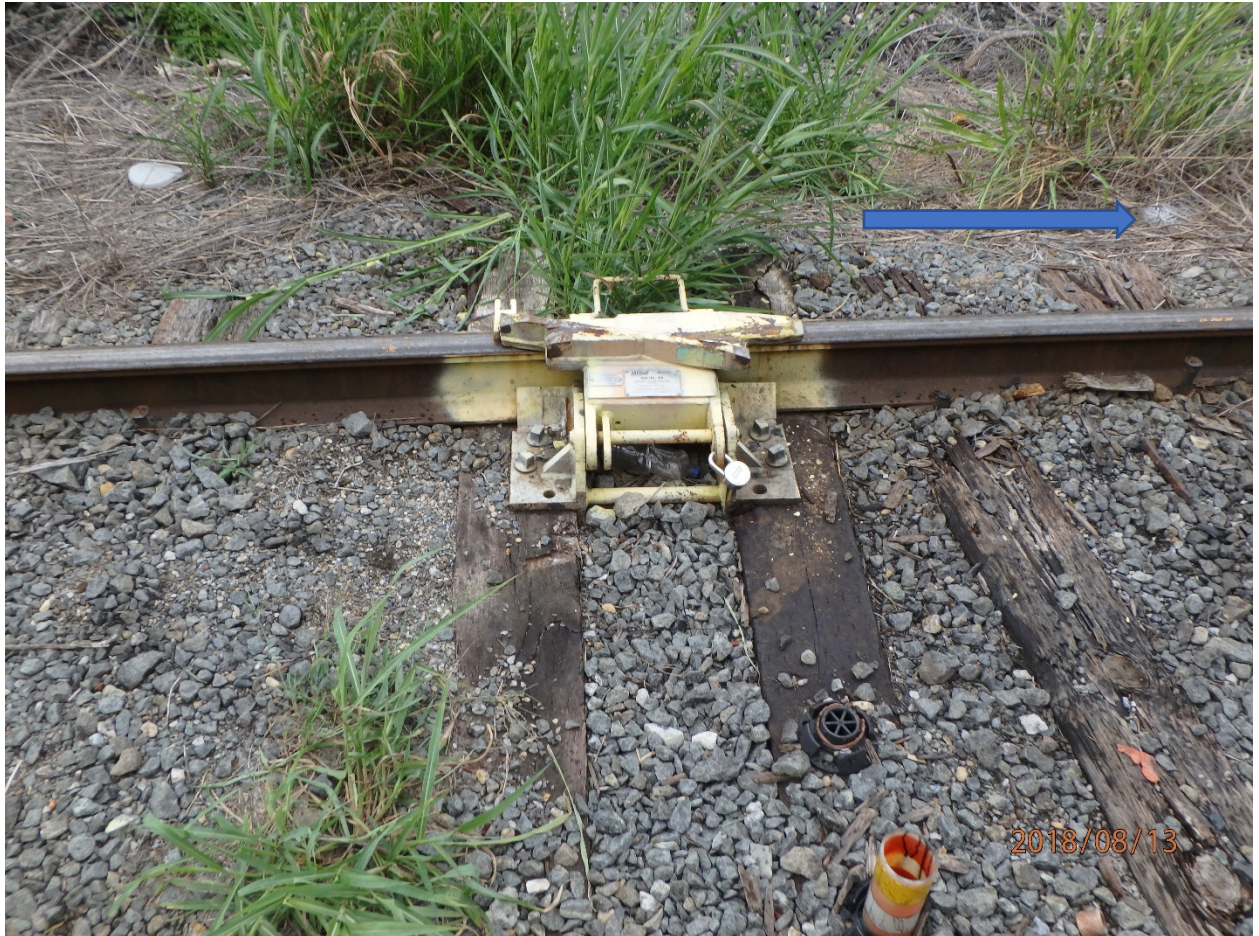
Figure 4 NTSB Photo, on the left is the yellow derail in track 400. The blue arrow points to white paint on the ground, the location where the conductor switch keys were found.

The DGNO General Manager was dispatched to the accident and found the conductor's switch keys and cap near the derail in track 400. The derail was found locked and lined for the

derailing position.<sup>9</sup>
