Motorcoach Run-Off-the-Road and Collision
With Vertical Highway Signpost
Interstate 95 Southbound
New York City, New York
March 12, 2011

NTSB/HAR-12/01
PB2012-916201
Notation 8308A
Adopted June 5, 2012

Highway Accident Report

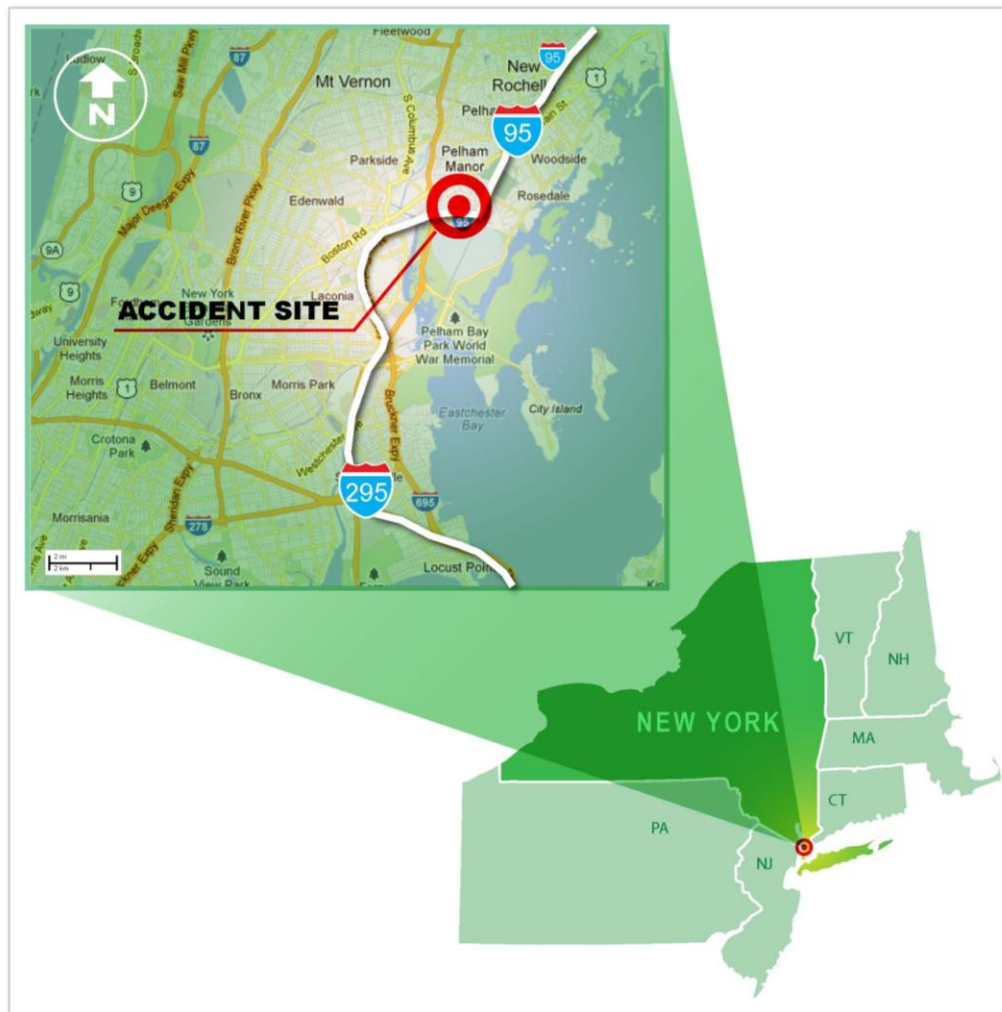
Figure 1. Regional map and view of accident site.

About 5:38 a.m.¹ on March 12, 2011, a 1999 Prevost 56-passenger motorcoach, operated by World Wide Travel of Greater New York (World Wide Travel), was traveling southbound on Interstate 95 (I-95) in the Bronx borough of New York City. (See figures 1–3.) The motorcoach, carrying the driver and 32 passengers, was en route from the Mohegan Sun Casino in Uncasville, Connecticut, to New York City.

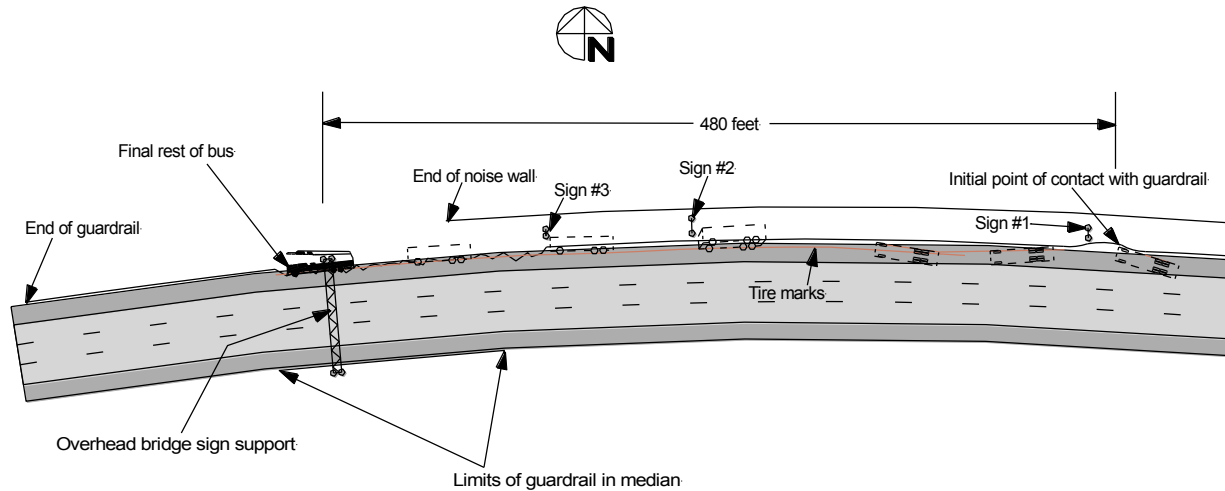
Figure 4. Accident scene diagram.

As the motorcoach approached mile marker 3.2, the vehicle left the roadway and crossed the rumble strip on the 10-foot-wide right shoulder, striking a strong-post blocked-out W-beam guardrail² at 64 mph.³ The motorcoach continued forward along the paved shoulder, sideswiping the guardrail, and then overturned to the right 90° on its longitudinal axis, flattening the guardrail as it continued to slide forward. (See figures 4 and 5.)

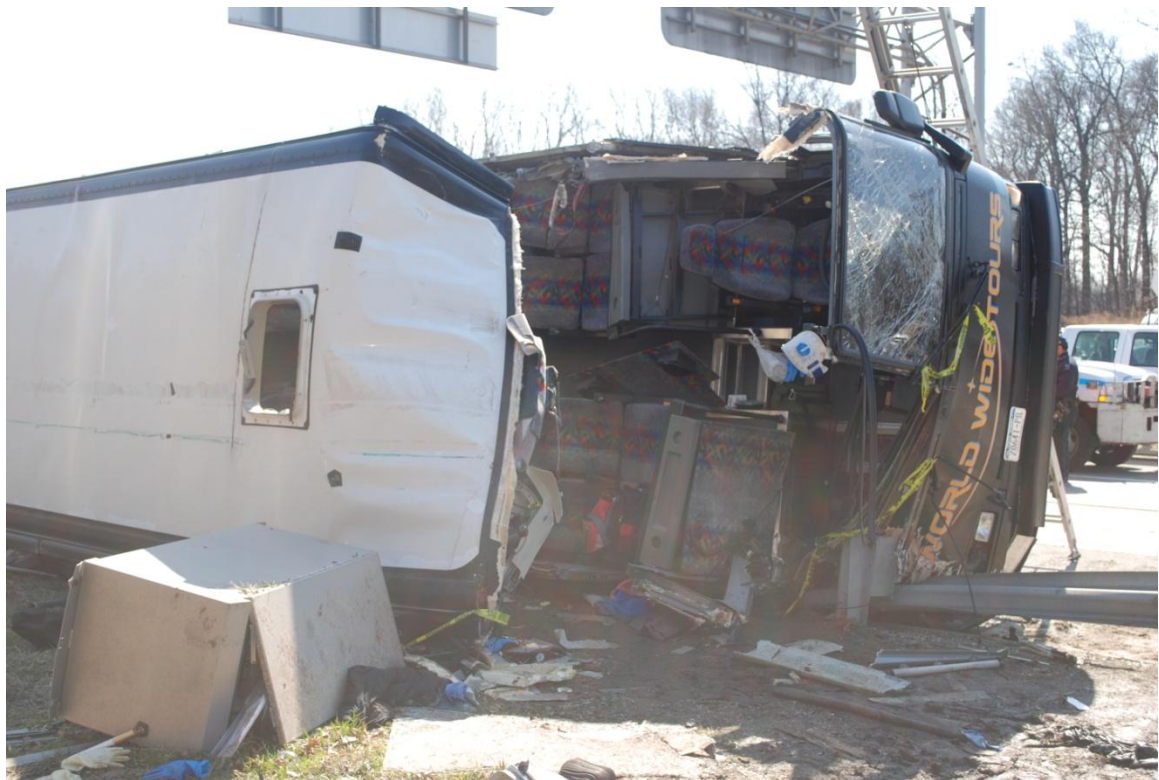
Figure 6. Roof separation due to intrusion of the vertical highway signpost poles.

The front of the motorcoach subsequently collided with an overhead vertical highway signpost, consisting of two vertical 8-inch-diameter steel tubular poles linked by cross-beam diagonal metal supports and an attached steel electrical box.

After the motorcoach's windshield struck this support structure and steel electrical box, the two poles making up the vertical highway signpost entered the passenger compartment along the base of the passenger windows, as the motorcoach slid forward. The impact resulted in the vehicle's roof panel being torn from the bus body for almost the entire length of the bus. (See figure 6.) Fifteen passengers were killed, 17 passengers received serious-to-minor injuries, and the bus driver received minor injuries.

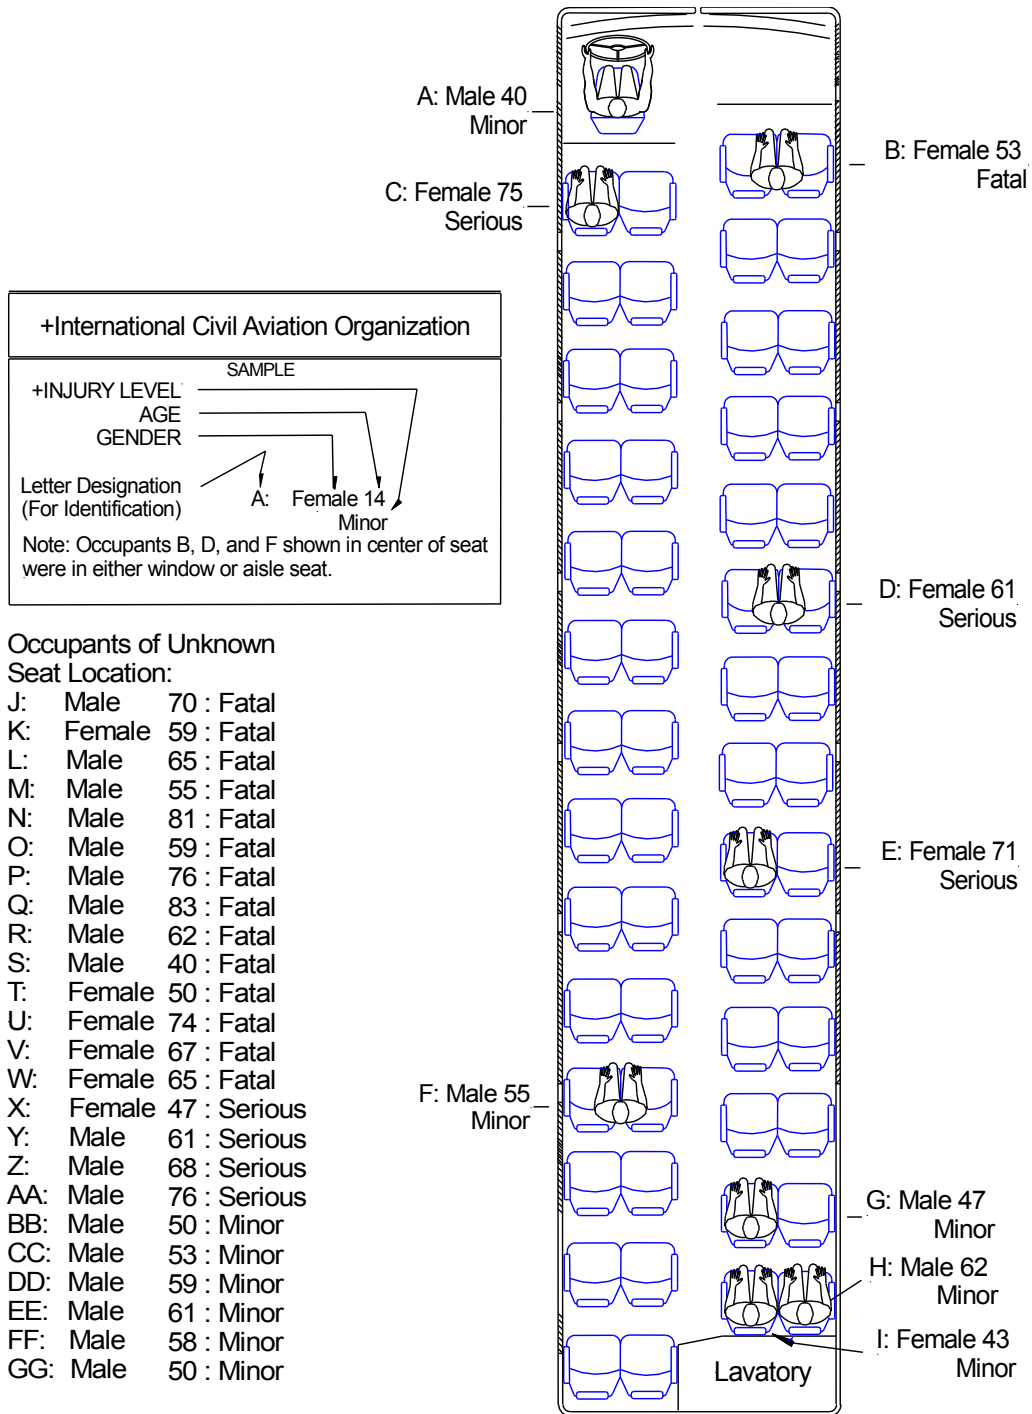
Figure 7. Passenger seating chart, injury, and demographic information.

Passenger interviews provided information on seating positions for 8 of the 32 passengers.⁶ (See figure 7.) The partial seating chart contains the known locations of bus occupants obtained through these interviews. All occupants are assigned a letter designation in the chart for reference; occupants whose seating position before the crash could not be determined are listed by letter designation and injury severity.

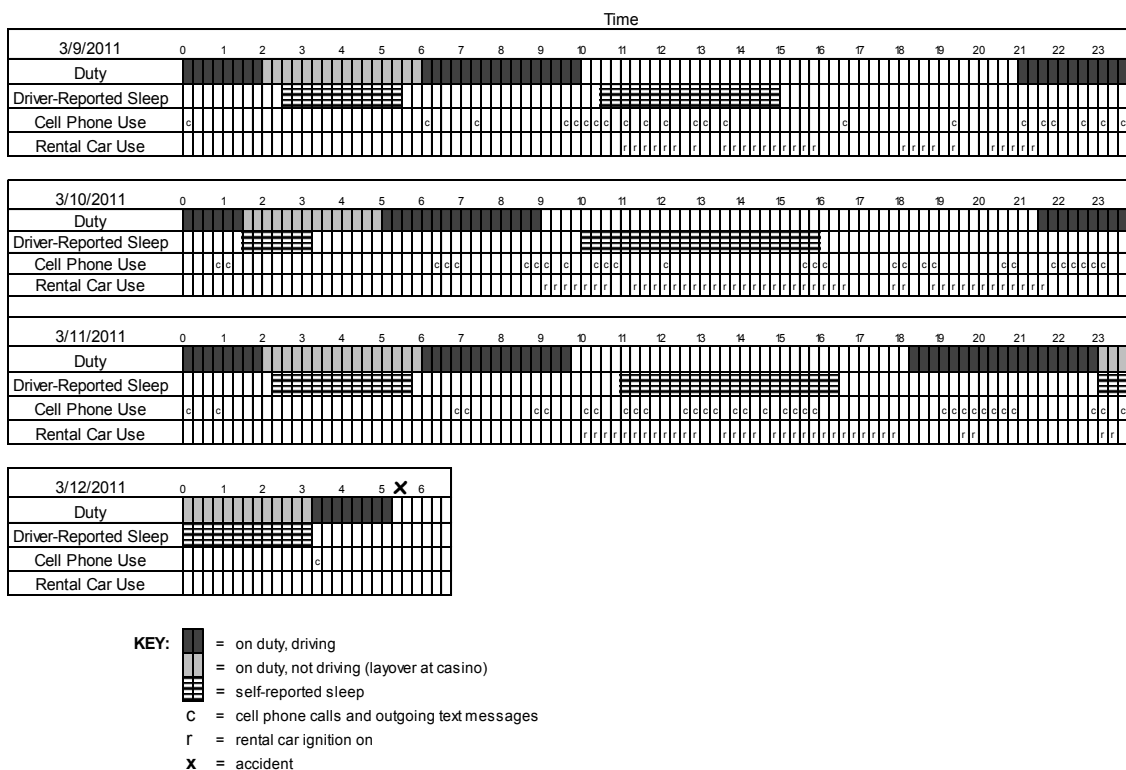
Figure 8. Recent driver activity history.

Figure 8 provides a graphical activity history for the 3 days leading up to the accident and includes information about the driver’s driving/duty status, self-reported sleep times, cell phone use, and rental car use. Each block in the figure represents a 15-minute increment, with the letter “c” in a block representing a period in which the driver’s cell phone was used for calls or outgoing text messages and the letter “r” representing a period when the rental car’s ignition was on. The driver’s work duty status did not show a violation of the commercial hours-of-service regulations. Evidence from the driver’s cell phone records suggests that he was using his cell phone frequently during self-reported off-duty or daytime sleep periods over the 3 days before the accident.¹¹ Additionally, cell phone data obtained by the NYSP show that during the driver’s self-reported sleep period, his cell phone was in use at several locations in New York City and Nassau County, New York. Factoring in the driver’s cell phone use, his opportunity for sleep during off-duty periods would have been limited to short periods of approximately 4 hours or less.

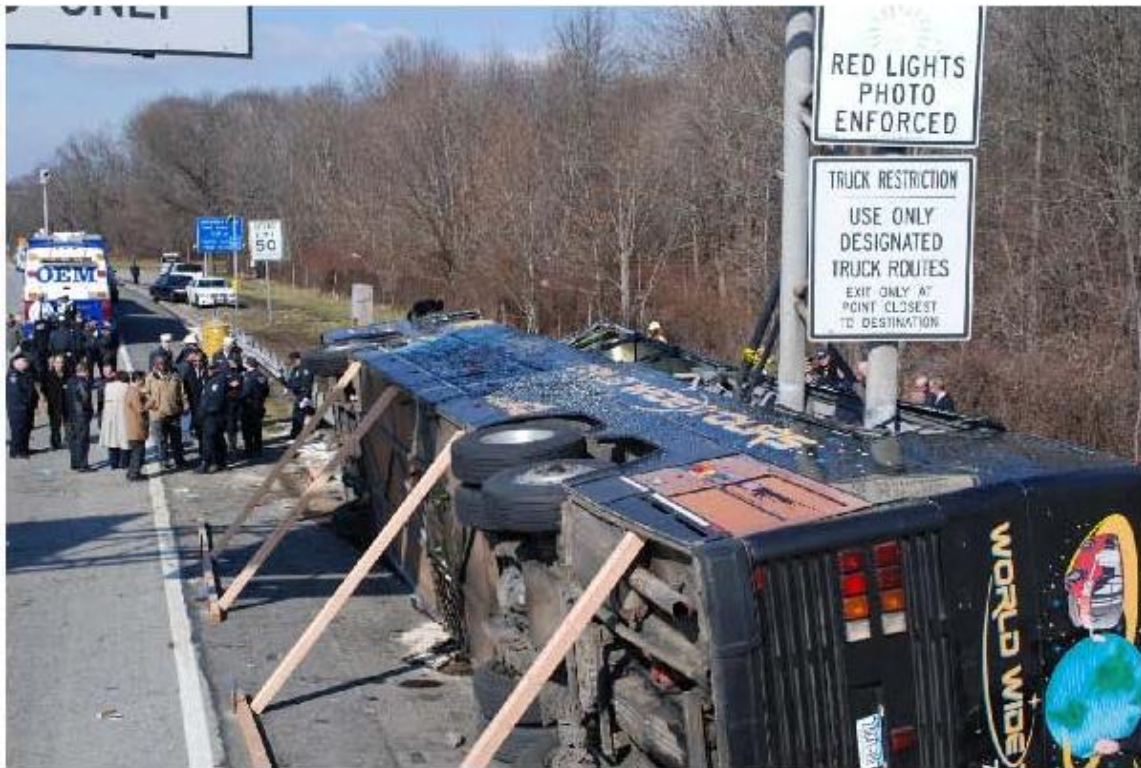
Figure 9. Southbound view of accident motorcoach at rest.

The primary mechanism of physical damage to the motorcoach occurred after the vehicle rolled 90° onto its passenger side and slid forward, striking the vertical highway signpost. The damage was due to the intrusion of the signpost's support poles and cross-beam diagonal metal support and attached steel electrical box, which nearly separated the roof from the motorcoach body at the passenger windows. (See figure 9.)

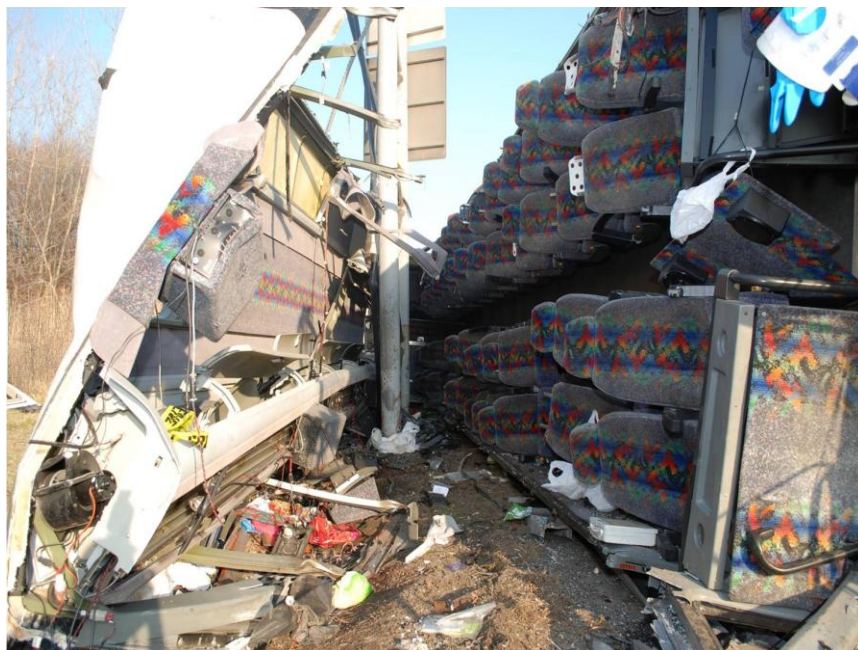
Figure 10. Roof and interior parcel rack damage (shown at left) caused by intrusion of the vertical highway signpost support poles.

The Prevost motorcoach interior was 95 inches wide by 72 inches high, and the vertical distance from the floor to the window base measured 32.7 inches. The passenger compartment had closed bin parcel racks supported by extruded aluminum above the passenger seats. The frame for the passenger side parcel racks remained in place but was heavily damaged, the parcel racks on the driver side and front portion of the bus were displaced, and the parcel racks in the rear half of the motorcoach remained in place. The driver side parcel rack doors were detached and damaged due to intrusion of the vertical highway signpost. (See figure 10.)

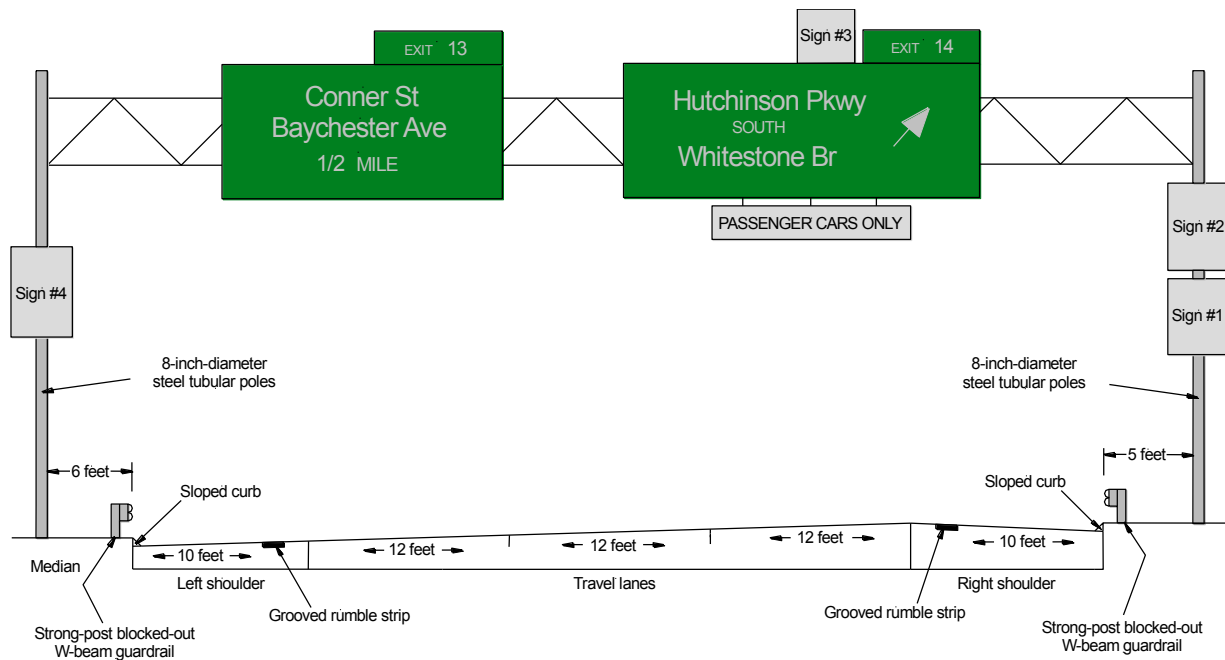
Figure 11. Typical section of I-95 southbound lanes in the vicinity of the accident.

I-95 in the vicinity of the accident, which is classified as an urban principal arterial road, was constructed in the 1950s and reconstructed in 1984. The southbound lanes consist of three travel lanes, each measuring approximately 12 feet wide and separated by evenly spaced white retroreflective pavement stripes 6 inches wide and 10 feet long. A 6-inch solid yellow pavement stripe delineates the inner edge of the roadway from the 10-foot-wide left shoulder, and a 6-inch solid white pavement stripe delineates the outer edge of the right travel lane from the 10-foot-wide right shoulder. (See figure 11).

A sloped (or mountable concrete) curb located at the edge of the 10-foot-wide paved right and left shoulders (see figure 11) had been installed in 1984 to convey stormwater runoff from the travel lanes of I-95 to a closed drainage system. The curb was approximately 5 inches high, as measured from the pavement surface.²³ The strong-post blocked-out W-beam guardrail was offset approximately 3 inches from the back face of the sloped curb. The installation of the curb complied with the NYSDOT *Highway Design Manual* guidance and standard sheet details in force at that time.²⁴

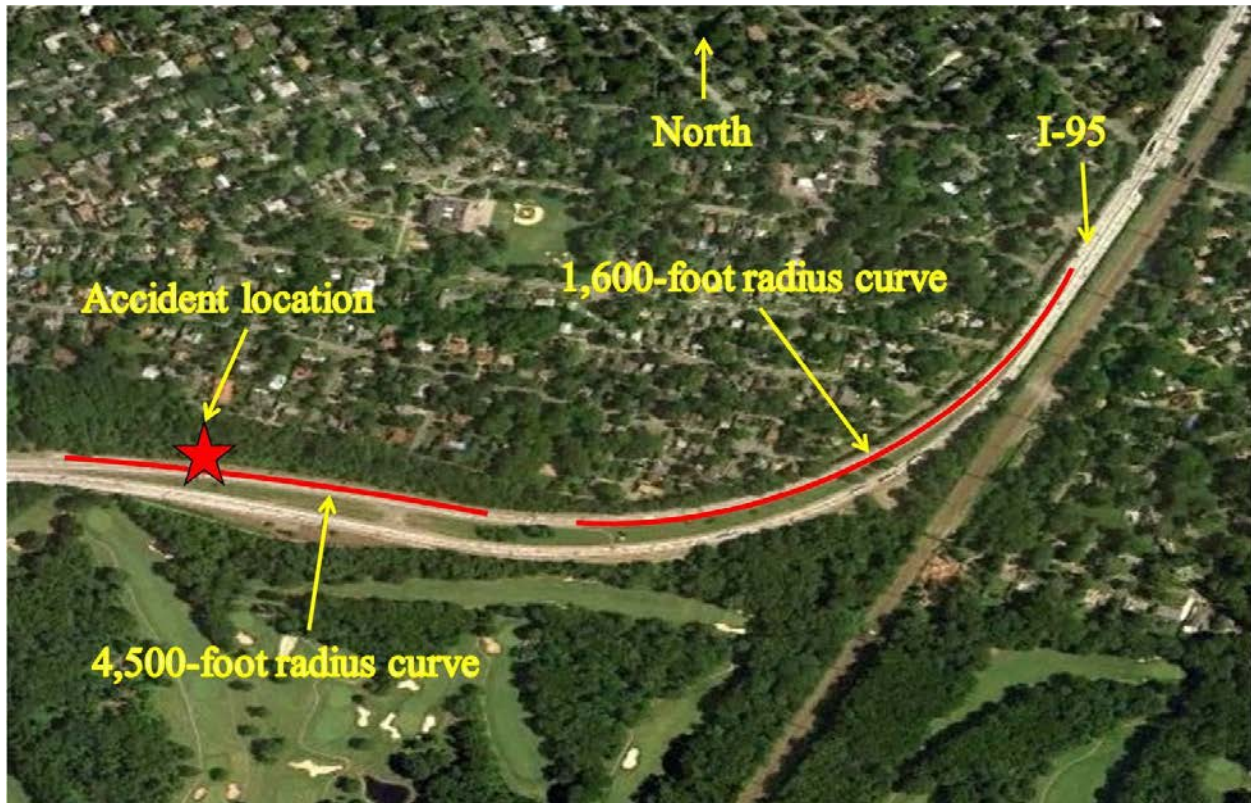
Figure 12. Horizontal curvature of I-95 southbound in the accident vicinity.

770 feet before the accident location and then transitions to a 4,500-foot radius curve that turns to the left in the direction of travel. The accident location was within the 4,500-foot radius curve. Grooved rumble strips (also called shoulder treatment for accident reduction, or STAR) were located on the right and left shoulders of the southbound lanes, along with a sloped curb at the edge of the right and left shoulders. (See figure 12 illustrating the two horizontal curves.)

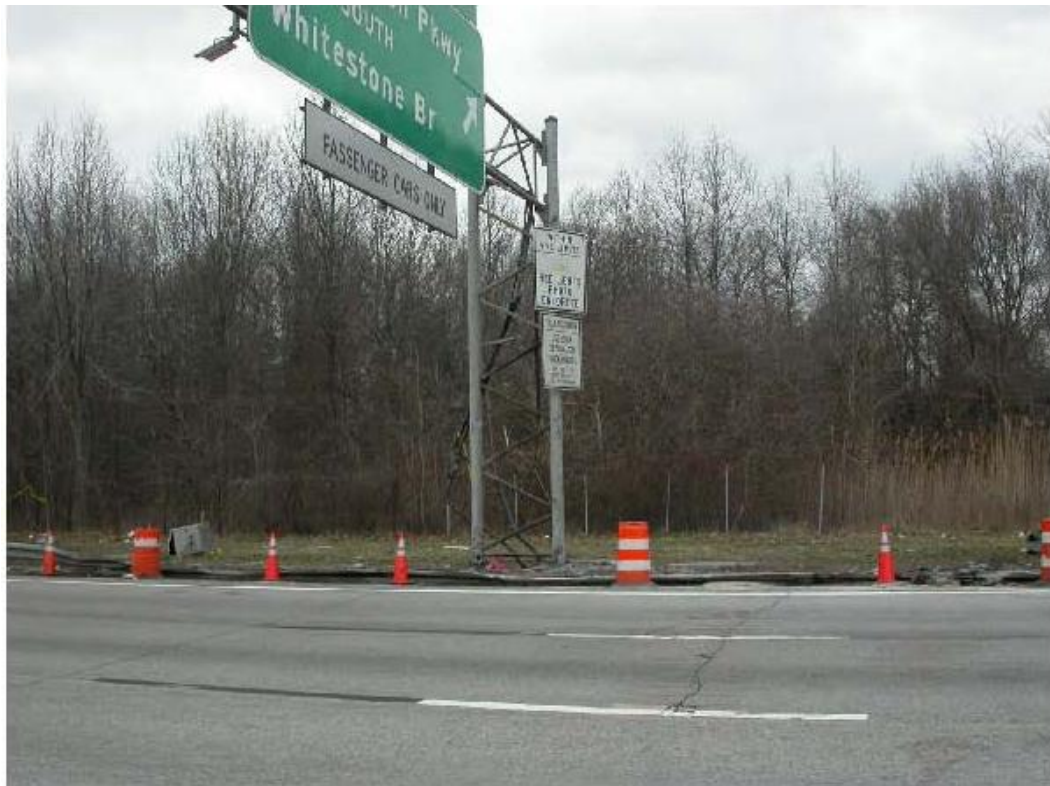
Figure 13. Overhead vertical highway signpost (east and west poles).

The four poles that supported the overhead vertical highway signpost were part of a fixed-base system and, as such, are not designed to yield or break away on impact. The four vertical support poles, two on I-95 northbound and two on I-95 southbound, were 8-inch-diameter steel tubular poles²⁷ with a wall thickness of 0.3125 inch. Each pair of poles was connected with cross bracing and separated by a lateral (parallel to the travel lanes) distance of 5 feet 2 inches. (See figure 13.) Two E-ZPass tag readers, wired to a metal cabinet installed on the cross bracing, were mounted on the overhead sign structure above the travel lanes. In addition, two wire conduits were attached to the vertical highway signpost to feed a variable message system sign above I-95 northbound. NTSB investigators documented accident damage to the two vertical poles, including a hole at the base and an indentation 9 feet above the base on the west pole and multiple scrape marks on the east pole from its base to a height of 9 feet.

The vertical highway signpost support poles were located within the clear zone and offset from the edge of the travel lanes by 15 feet, which consisted of a 10-foot-wide paved shoulder and a 5-foot offset from the face of the W-beam guardrail. (See figure 11.) The clear zone concept, which recommends providing a traversable and unobstructed roadside area beyond the traveled way for use by errant vehicles, is usually set at 30 feet for freeways.²⁸

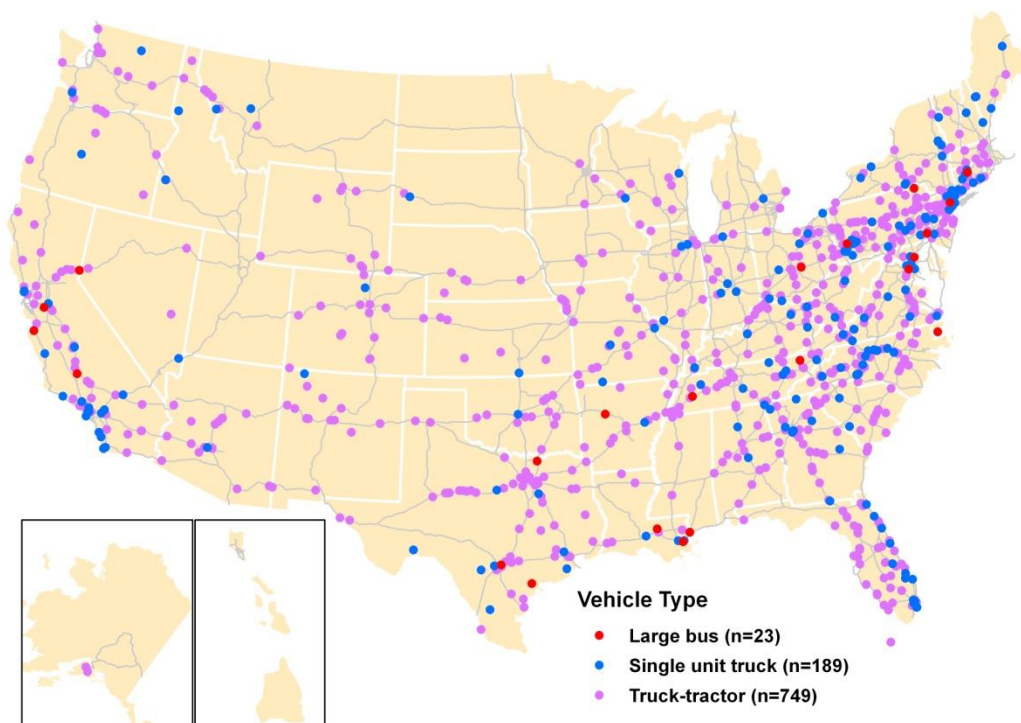
Figure 14. Fatal accident locations involving heavy vehicles colliding with a guardrail on high-speed roadways (2005–2010).

NTSB investigators examined the event sequence of fatal accidents on high-speed roadways involving collisions with guardrails from 2004–2010, using NHTSA Fatality Analysis Reporting System (FARS) data. Figure 14 shows the locations of the accidents involving heavy vehicles. In those accidents, “collision with guardrail” was typically not the first event, indicating that one or more precipitating events led to the interaction with the guardrail. Because most guardrails are set back a distance from the traveling lanes, “ran-off-road” was the event most often cited as the preceding event, similar to the accident described in this report. Also, “collision with guardrail” was rarely recorded as the most harmful event specifically involving large buses and other heavy vehicles. The most likely subsequent event after a vehicle collided with the guardrail was “rollover” for truck-tractors and “ran-off-road” for large buses. On average, very few fatal accidents involved vehicles colliding with guardrails and then subsequently colliding with supports (such as a highway sign, overhead sign, light, or traffic sign).

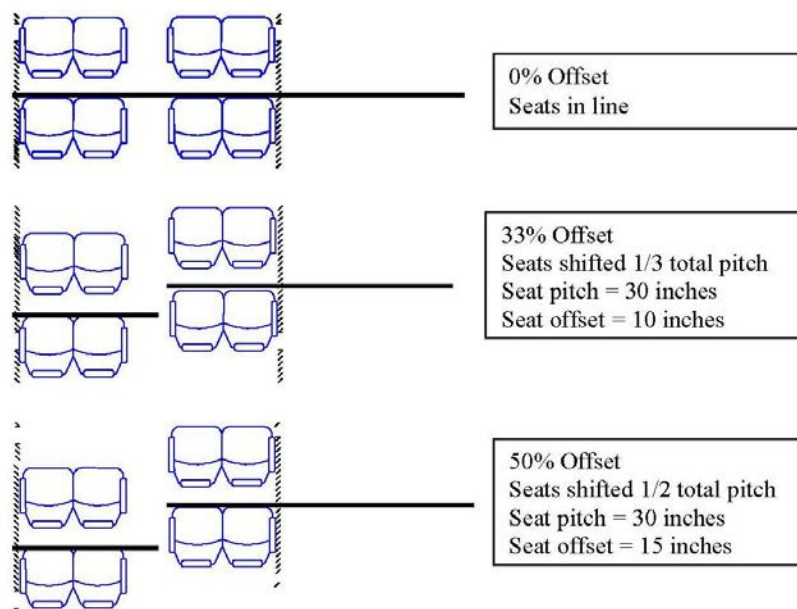
Figure 15. Simulation study seat row alignments and offset row configurations.

Because restraint installation would redefine occupant kinematics in a motorcoach crash and could reduce ejection, secondary impacts, and intrusion factors, the NTSB undertook a simulation study to characterize occupant kinematics with and without passenger lap/shoulder belts.¹⁸⁹ The study focused on two full rows of passenger seats near the bus's CG and included variable occupant density, restraints, and armrest configurations. Offset rows were identified as a factor greatly affecting occupant kinematics and injury predictions for unrestrained passengers in rollover events. As discussed in section 1.5.2, offset rows refer to the seating rows on the driver side of the bus being offset slightly rearward from the same rows on the opposite side of the bus. (See figure 15.)

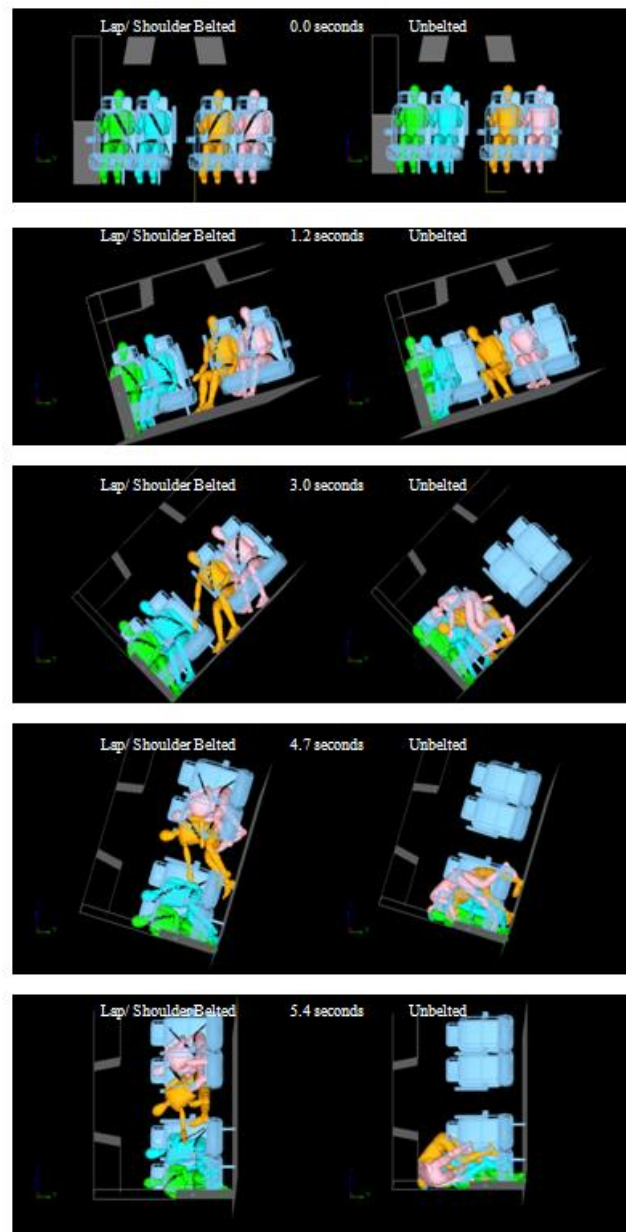
Figure 16. Time history of unrestrained and lap/shoulder-belted occupant kinematics.

The simulation showed that unrestrained occupants were vulnerable to injury during the bus overturn due to impacts with other occupants and interior surfaces. Unrestrained occupants were in close contact with the window and sidewall structure adjacent to the ground toward the end of the simulated accident sequence and were also vulnerable to ejection where window integrity was lost. Simple variations in seating configuration, such as the amount of row offset and armrest position, greatly affected kinematics and injury predictions. After the accident bus overturned, unrestrained occupants were piled on top of one another next to the windows between the seats and the luggage racks. This positioning made them vulnerable to injury, given the intrusion that followed from the secondary impact with the vertical highway signpost.

In the simulation, lap/shoulder-belted occupants were contained within their seating compartments. Occupants seated on the far side of the roll (opposite the side near the ground) were able to partially escape the shoulder harness during the roll sequence, which then placed them in a position closer to the floor of the bus than to the luggage racks, reducing their vulnerability during intrusion of the vertical highway signpost at the window level later in the impact sequence. Near side occupants remained in a more upright position during the simulation, making them potentially more vulnerable to impact and intrusion of the signpost's poles. For all lap/shoulder-belted occupants, the simulation resulted in low predicted injury levels for the motorcoach rollover without intrusion. A comparison of unrestrained occupant kinematics and lap/shoulder-belted occupant kinematics is shown in figure 16.

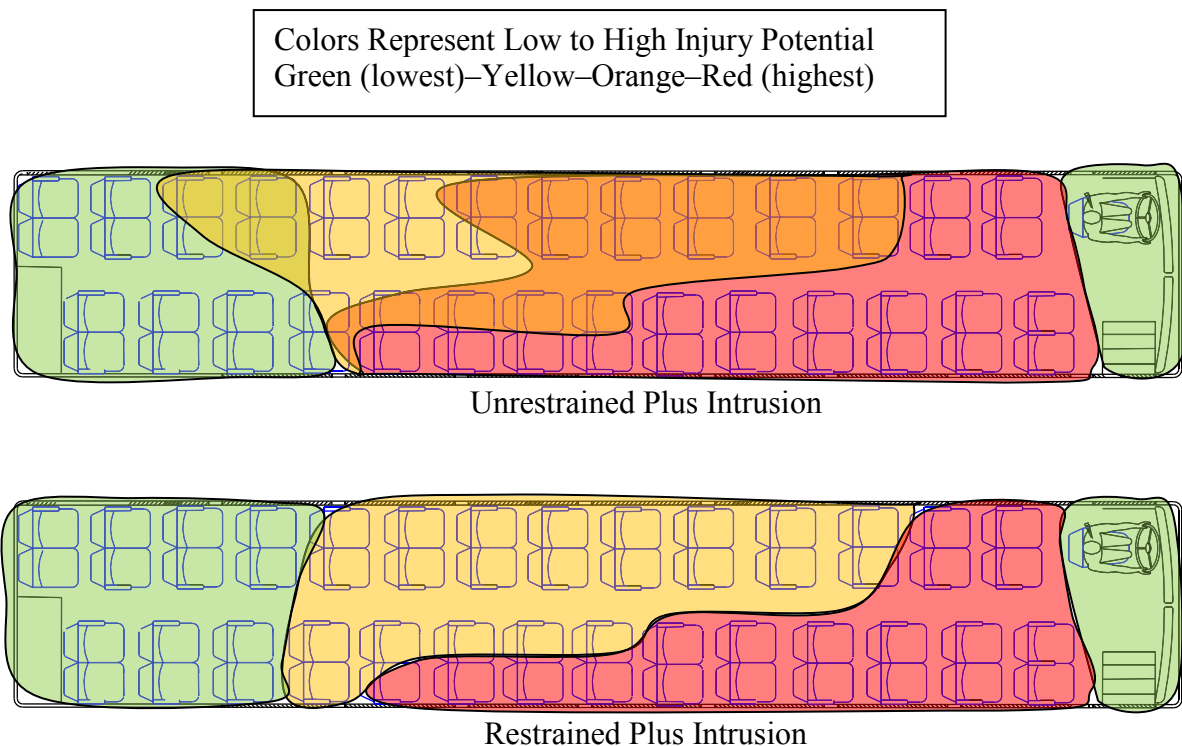
Figure 17. Risk zone approximation using intrusion and occupant study data.

The characteristic motion of the unrestrained occupants compared to the intrusion zone evaluation indicates that the vertical highway signpost's intrusion appears to have caused most of the injuries and all of the fatalities in this accident. The motorcoach's occupant compartment was not compromised before the vertical highway signpost's impact, and the regions of intrusion are clearly identified.

Although the accident dynamics before the vertical highway signpost's intrusion were severe enough to have caused serious injuries for some unrestrained occupants, the fatal injuries did not likely occur prior to the vertical poles' impact. However, passenger lap/shoulder belts on newer motorcoaches may mitigate fatalities and serious injuries for some occupants by reducing injuries during rollover events and reducing exposure to intrusion for some occupants in accidents such as this one. The NTSB concludes that equipping new motorcoaches with passenger lap/shoulder belts, even in the case of accidents such as this one, would likely mitigate serious and fatal injuries for some passengers during a rollover and subsequent impact events.
