Truck-Tractor Semitrailer Rear-End Collision  
Into Passenger Vehicles on Interstate 44  
Near Miami, Oklahoma  
June 26, 2009

NTSB/HAR-10/02  
PB2010-916202

# Highway Accident Report

**Abstract:** About 1:19 p.m. on June 26, 2009, a multivehicle accident occurred on Interstate 44 (I-44) near Miami, Oklahoma, shortly after a minor accident in the vicinity had resulted in a traffic queue. A truck driver operating a Volvo truck-tractor in combination with an empty semitrailer was traveling eastbound in the outside lane of I-44. He did not react to the queue of slowing and stopped vehicles ahead and collided with the rear of a Land Rover sport utility vehicle (SUV). As both vehicles moved forward, the Land Rover struck a Hyundai Sonata and then departed the right lane and shoulder. The Volvo continued forward, struck and overrode the Hyundai Sonata, struck and overrode a Kia Spectra, and then struck the rear of a Ford Windstar minivan. The Volvo overrode a portion of the Windstar while pushing it into the rear of a trailer being towed by a Ford F350 pickup truck. The pickup was pushed into a Chevrolet Tahoe SUV. As a result of the accident, 10 passenger vehicle occupants died, 5 re

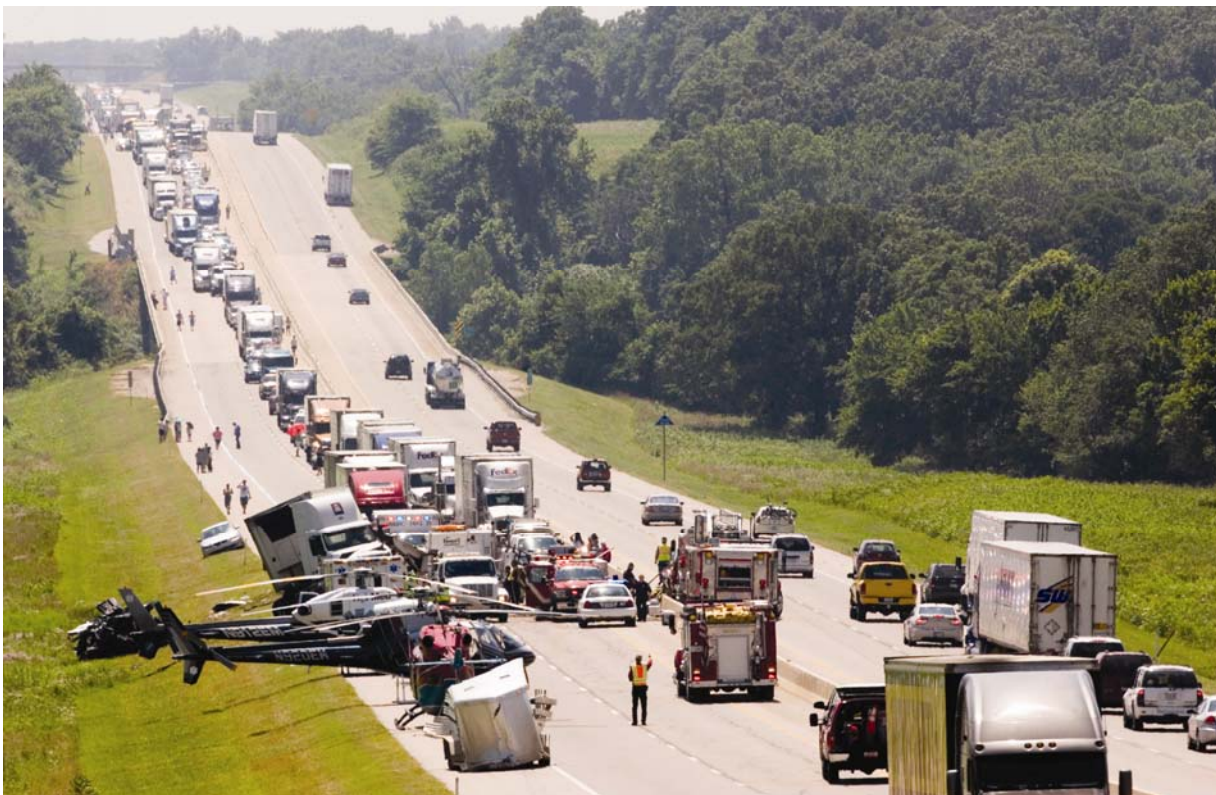
**Figure 1.** View of I-44 (looking west) showing the site of the fatal June 26, 2009, accident. [Photograph courtesy Gary Crow]

About 1:13 p.m.<sup>1</sup> on June 26, 2009, a minor traffic accident involving a Ford Focus occurred on eastbound Interstate 44 (I-44), the Will Rogers Turnpike, near Miami, Oklahoma. Immediately following this minor accident, a queue of traffic formed as the disabled vehicle was pushed from the roadway. Within minutes of the first accident, at approximately 1:19 p.m., a secondary fatal accident occurred when a Volvo truck-tractor semitrailer drove into the traffic queue at approximately 69 mph. (See figures 1 and 2 for postaccident photographs. Figure 3 shows a map of the accident location.)

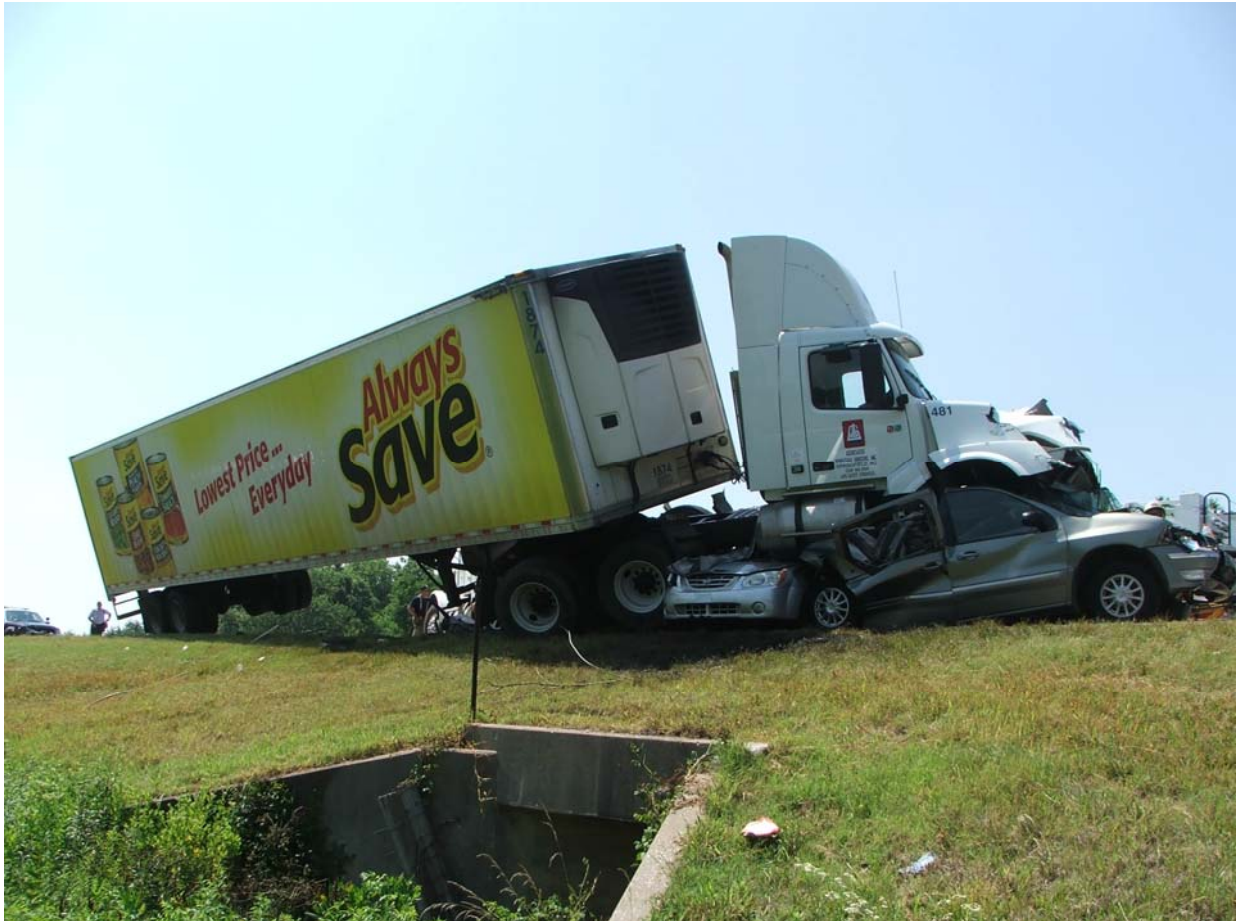
**Figure 2.** Postaccident photograph showing Volvo truck-tractor semitrailer override of passenger vehicles. [Photograph courtesy Oklahoma Highway Patrol]

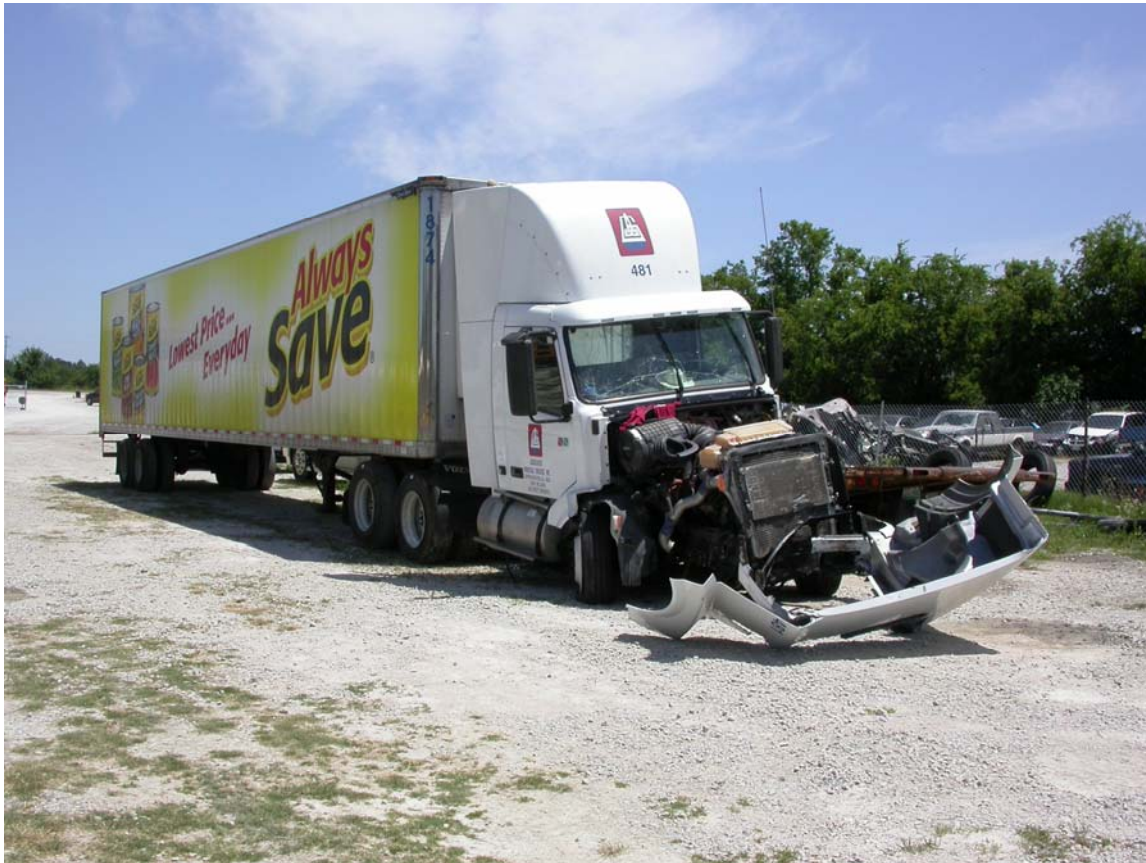
As a result of the second accident, the Volvo truck-tractor sustained extensive damage and its Great Dane semitrailer sustained minor damage. (See figure 5.) The Volvo truck-tractor sustained frontal damage, including windshield damage. The body of the truck-tractor was shifted to the right, and there was right side damage to the front of the frame. Additional damage was located underneath the vehicle. The brake components on the Volvo steer and second axles were damaged as a result of the accident. Near the second axle, damage consisting of gouging and scraping to the driveshaft and axle housing was found, and the second axle brake components were bent. The underside of the right side saddle fuel tank was damaged, and fuel was lost through a hole in the underside of the tank.

**Figure 5.** Collision damage to 2008 Volvo truck-tractor.

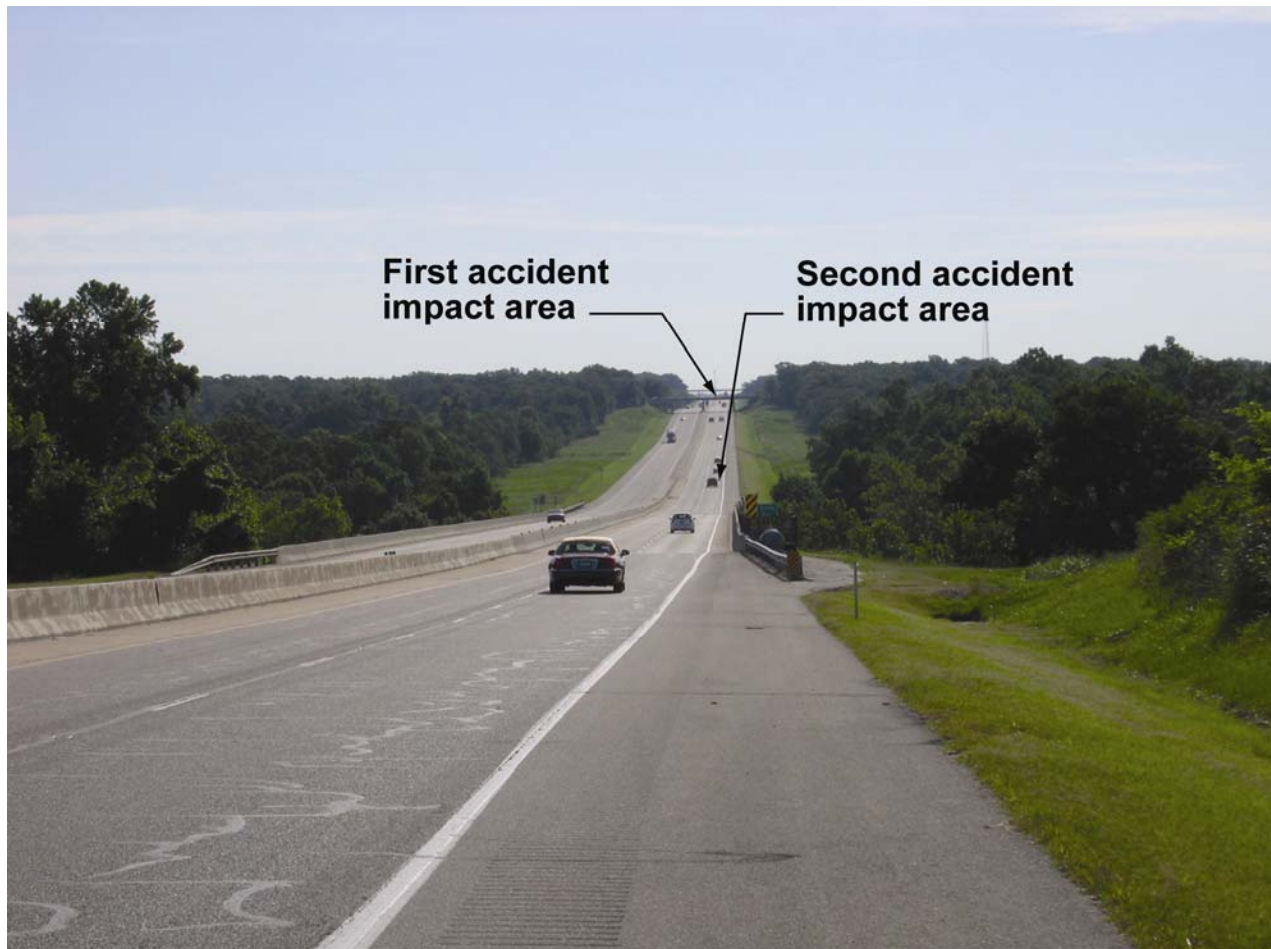
The American Association of State Highway and Transportation Officials (AASHTO) recommends an 820-foot stopping sight distance for a speed of 75 mph.<sup>10</sup> Field measurements showed that when the accident site was viewed from a truck driver's perspective (average seated eye height of approximately 96 inches from the ground), a 2.0-foot-tall (height of a passenger car taillight) object could be seen from the beginning of the hill crest 1,260 feet away.<sup>11</sup> (See figure 6.)

**Figure 6.** View of I-44 eastbound, showing the sites of the June 26, 2009, accidents.

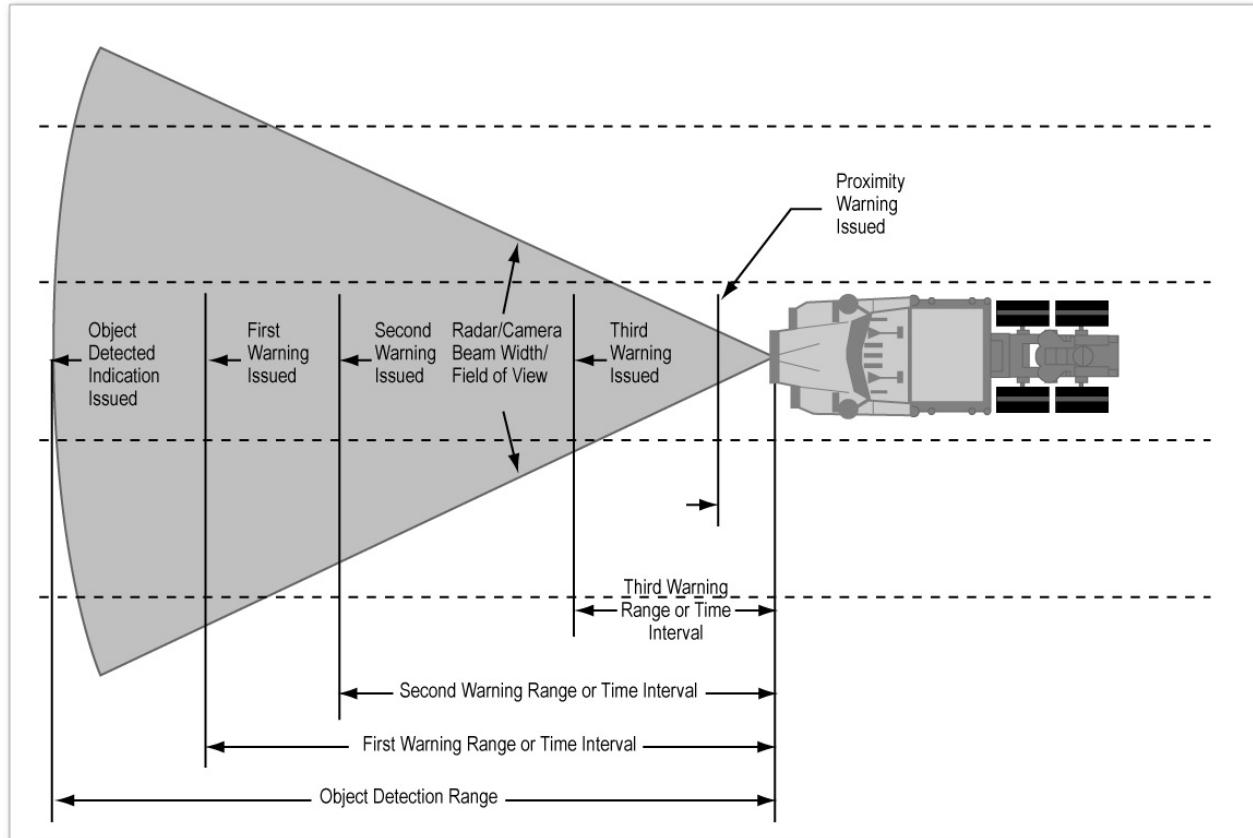
**Figure 8.** FCWS object detection and warning thresholds. [Original source figure, adapted by the NTSB, obtained from the FMCSA.<sup>68</sup>]

Some currently available systems can detect and display warnings at a distance of 350 feet or a following distance period of up to 3.00 seconds. A “collision alert” warning occurs if the following distance closes to less than 0.50 second or the radar detects slow-moving or stopped traffic within 350 feet of the vehicle, at which time the system alerts the driver with three red LED indicators and an audible tone.

Most FCWSs use radar technology mounted to the vehicle, typically within the front bumper assembly. When other vehicles or stationary objects come within predefined distances or closing speeds in the forward path of the host vehicle, audible and visual alerts are communicated to the driver from an in-cab display unit. One add-on to this system is adaptive cruise control (ACC), which uses the same technology to adjust or disengage conventional cruise control if it is in use when a collision risk is detected. Some FCWSs can also engage vehicle braking when an imminent hazard is detected; this is called “active braking” or collision mitigation braking (CMB). When combined with FCWSs, such systems are often called collision mitigation systems.

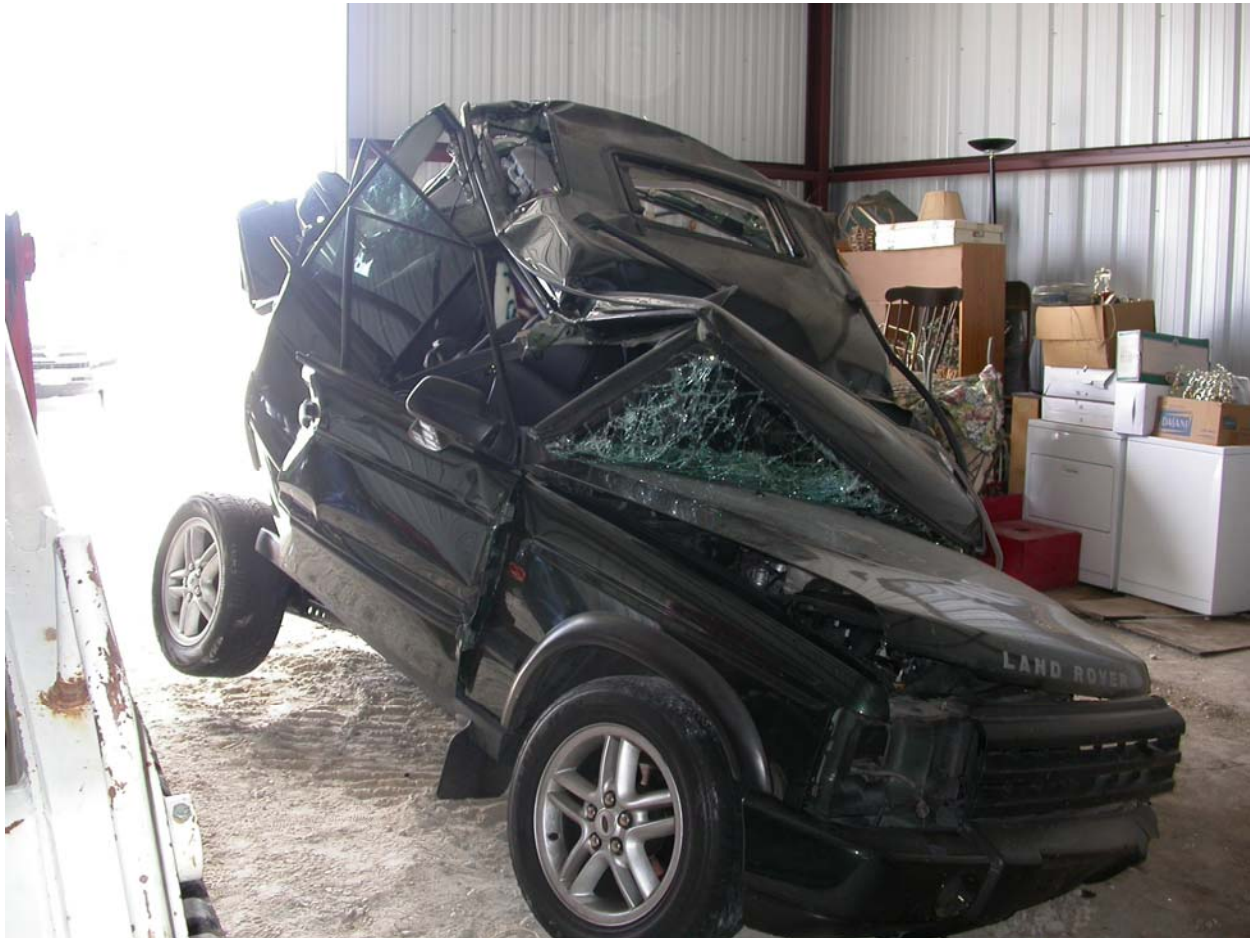
**Land Rover SUV.** Postaccident inspection revealed significant override damage where the Land Rover's left rear bumper corner was crushed 19 inches forward of the rear axle, and the passenger compartment interior was almost two-thirds collapsed toward the front of the vehicle. A small area on the right side of the rear seat had not collapsed. The vehicle also sustained damage to its left front bumper corner and down the left side of its front fender, due to impact with the back of the Hyundai sedan.

**Figure B-1.** Collision damage to 2003 Land Rover SUV.

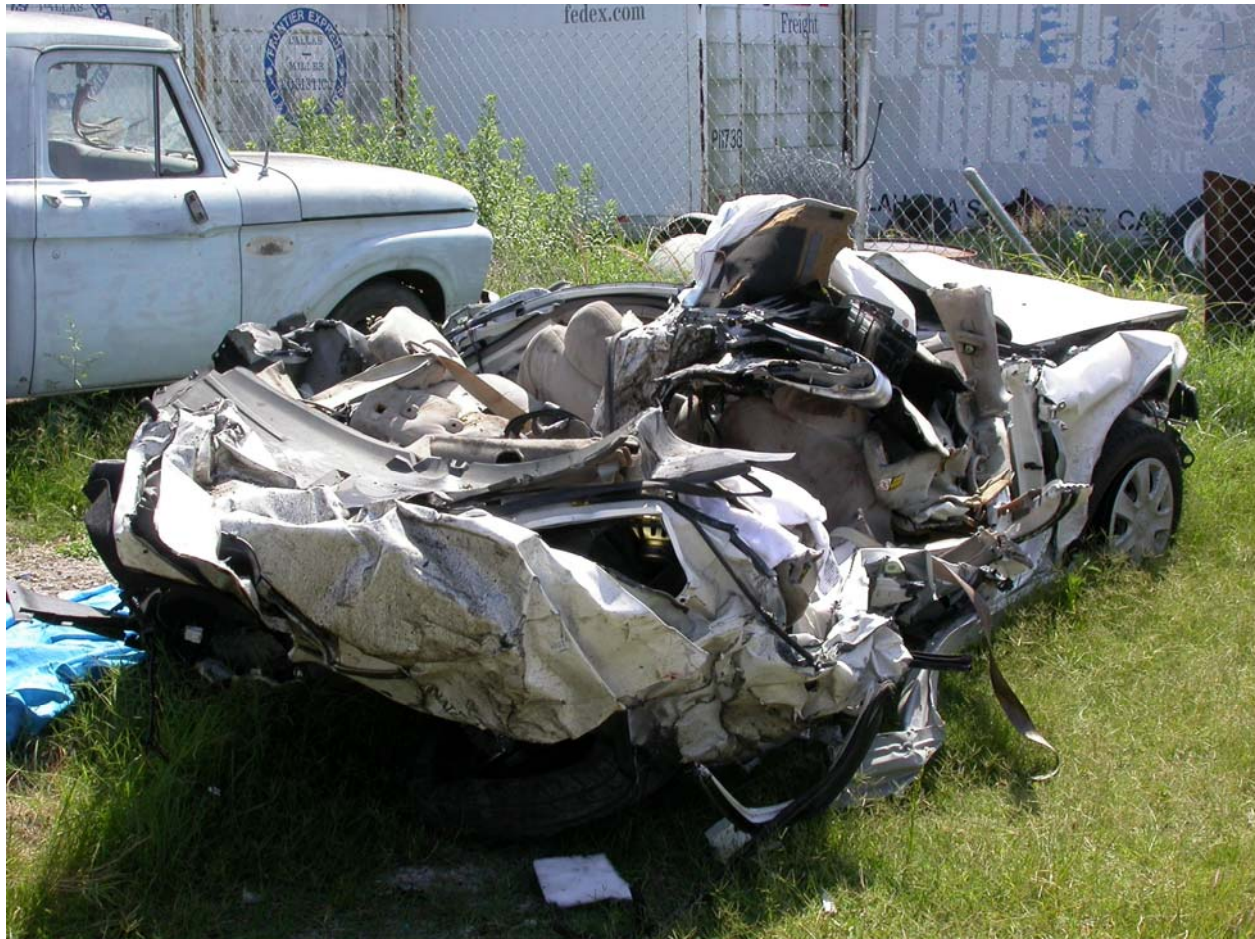
**Hyundai Sonata Sedan.** The Volvo truck-tractor completely overrode the Hyundai and, when all the vehicles came to rest, the Volvo was on top of the Hyundai. Black tire marks were found on the top of the Hyundai's rear center seat and on the driver's headrest. The entire back end of the Hyundai was crushed inward, the roof was crushed downward, the corner of the right rear bumper was crushed forward approximately 36 inches, and the interior of the vehicle was almost totally collapsed downward.

**Figure B-2.** Collision damage to 2003 Hyundai Sonata sedan.

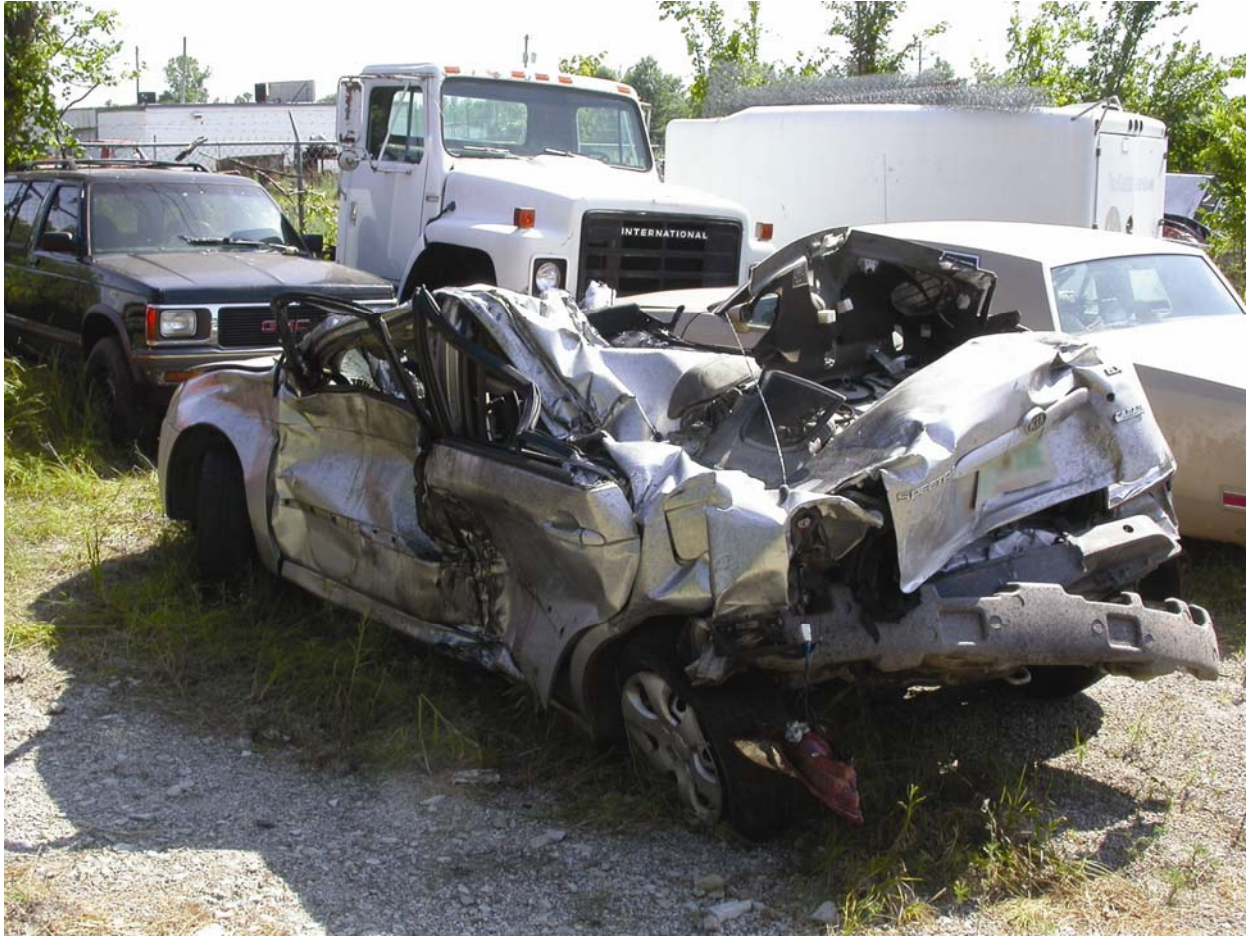
**Figure B-3.** Collision damage to 2004 Kia Spectra sedan.

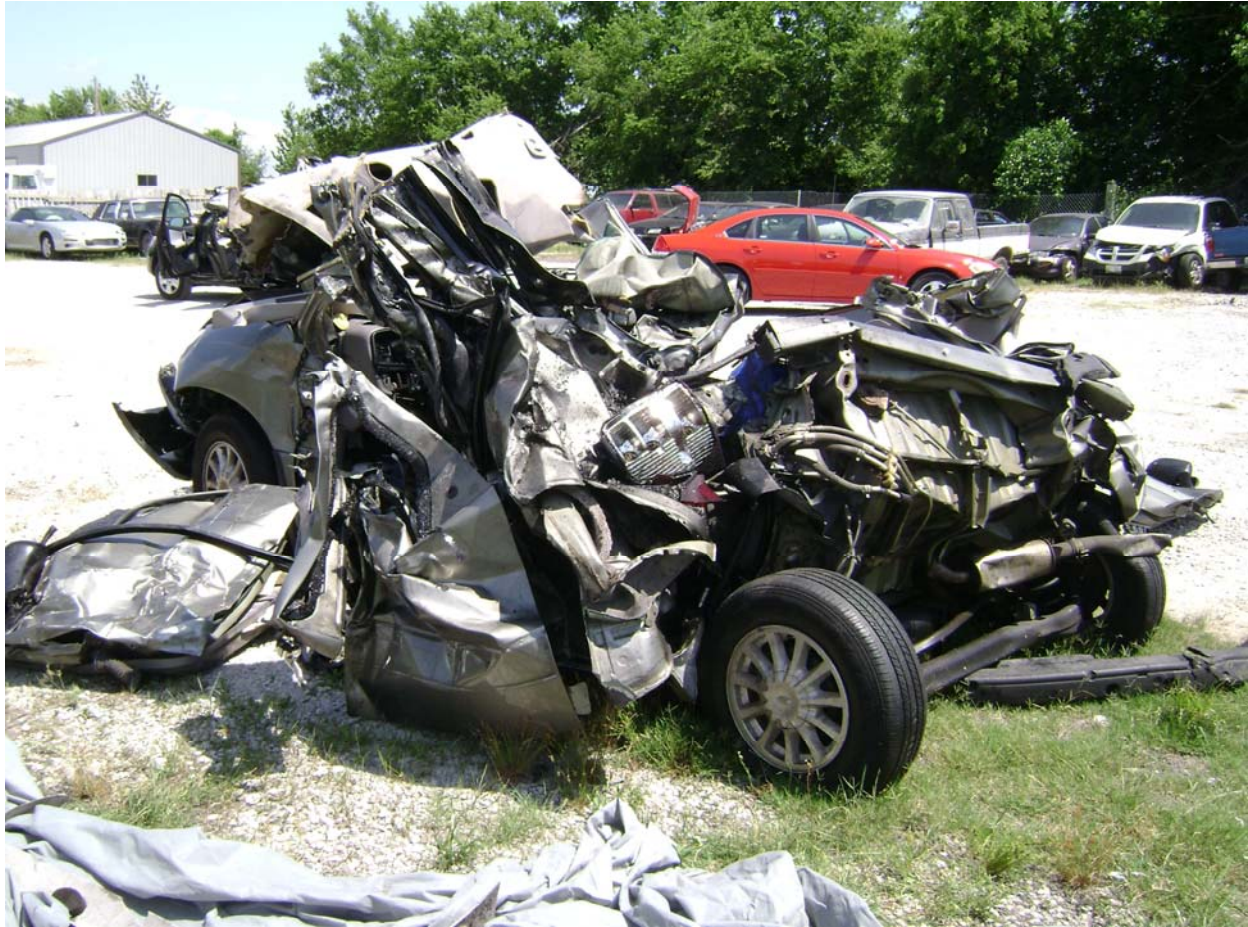
**Ford Windstar Minivan.** The Volvo truck-tractor semitrailer's striking the Windstar resulted in the rear two-thirds of the minivan being trapped underneath the front of the Volvo when all the vehicles came to final rest. The Windstar was crushed forward and upward off the frame, and its roof was bent accordion-style forward and upward at a 90-degree angle and torn away from the D-pillar. The left rear bumper corner was crushed forward to the rear axle, and the vehicle's entire front end sustained moderate damage from striking the livestock trailer being towed by the F350 pickup truck. The interior of the minivan was almost totally collapsed forward, with the exception of the right front passenger seatback.

**Figure B-4.** Collision damage to 2000 Ford Windstar minivan.

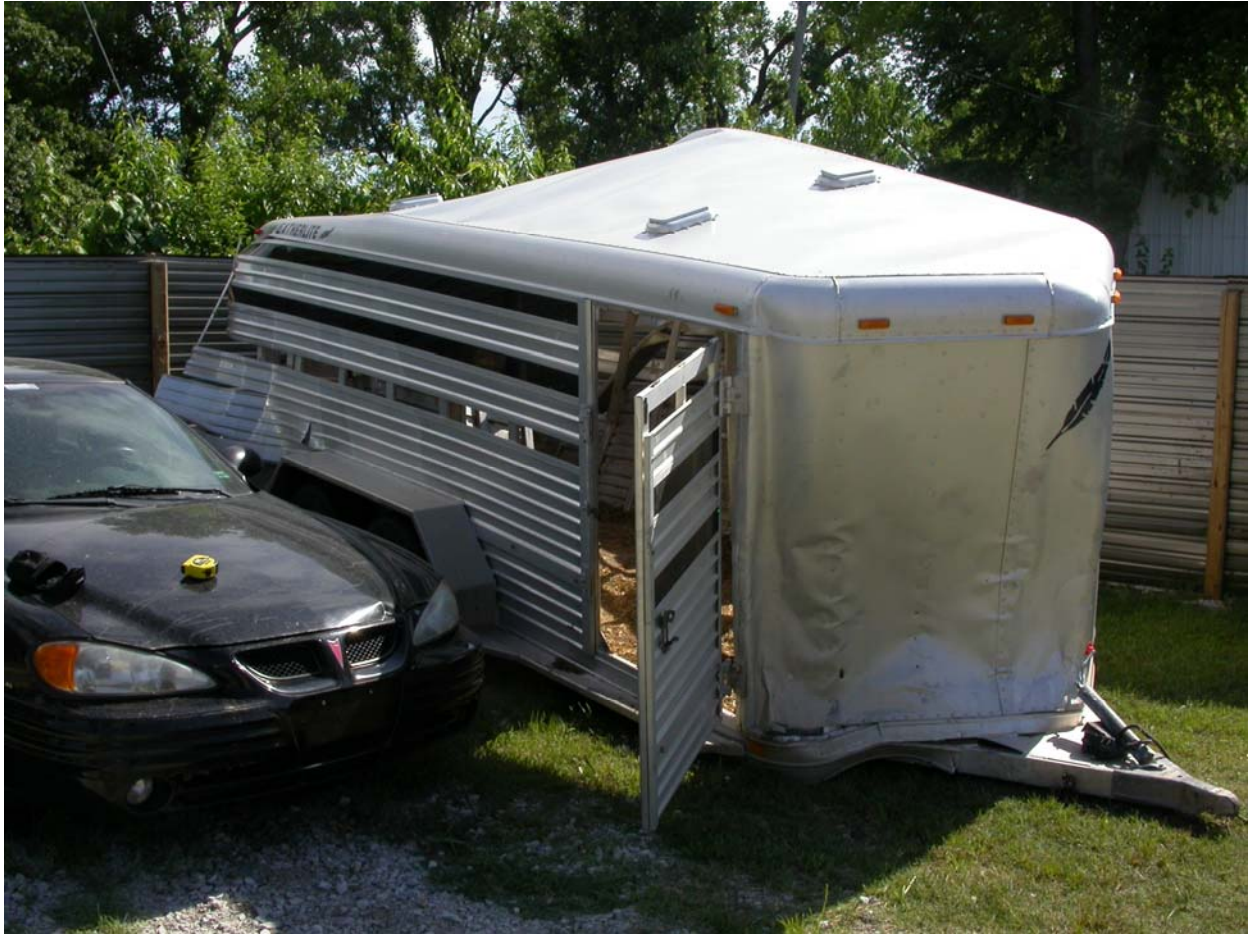
**Figure B-5.** Collision damage to livestock trailer pulled by Ford F350 pickup truck.

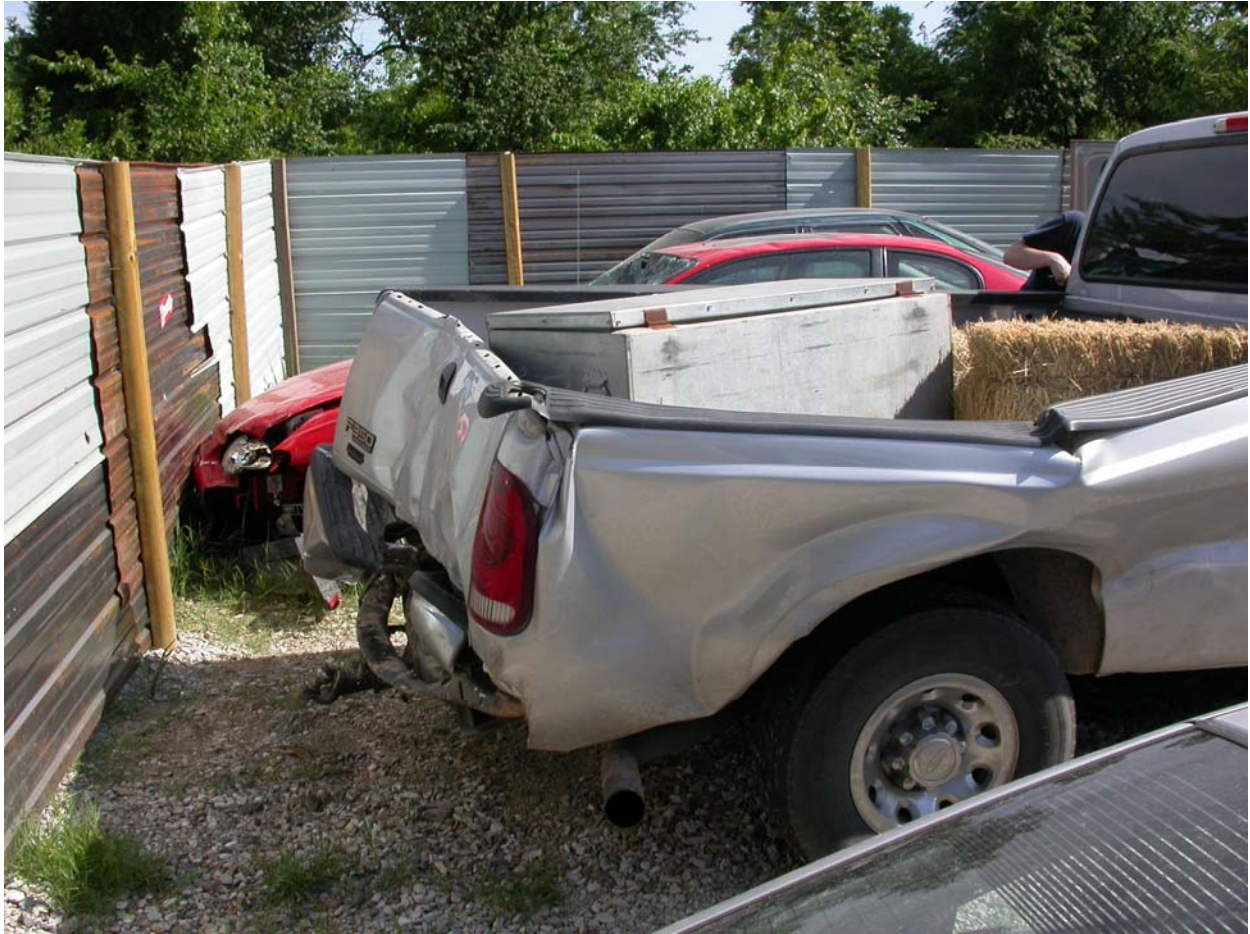
**Figure B-6.** Collision damage to 2004 Ford F350 pickup truck.

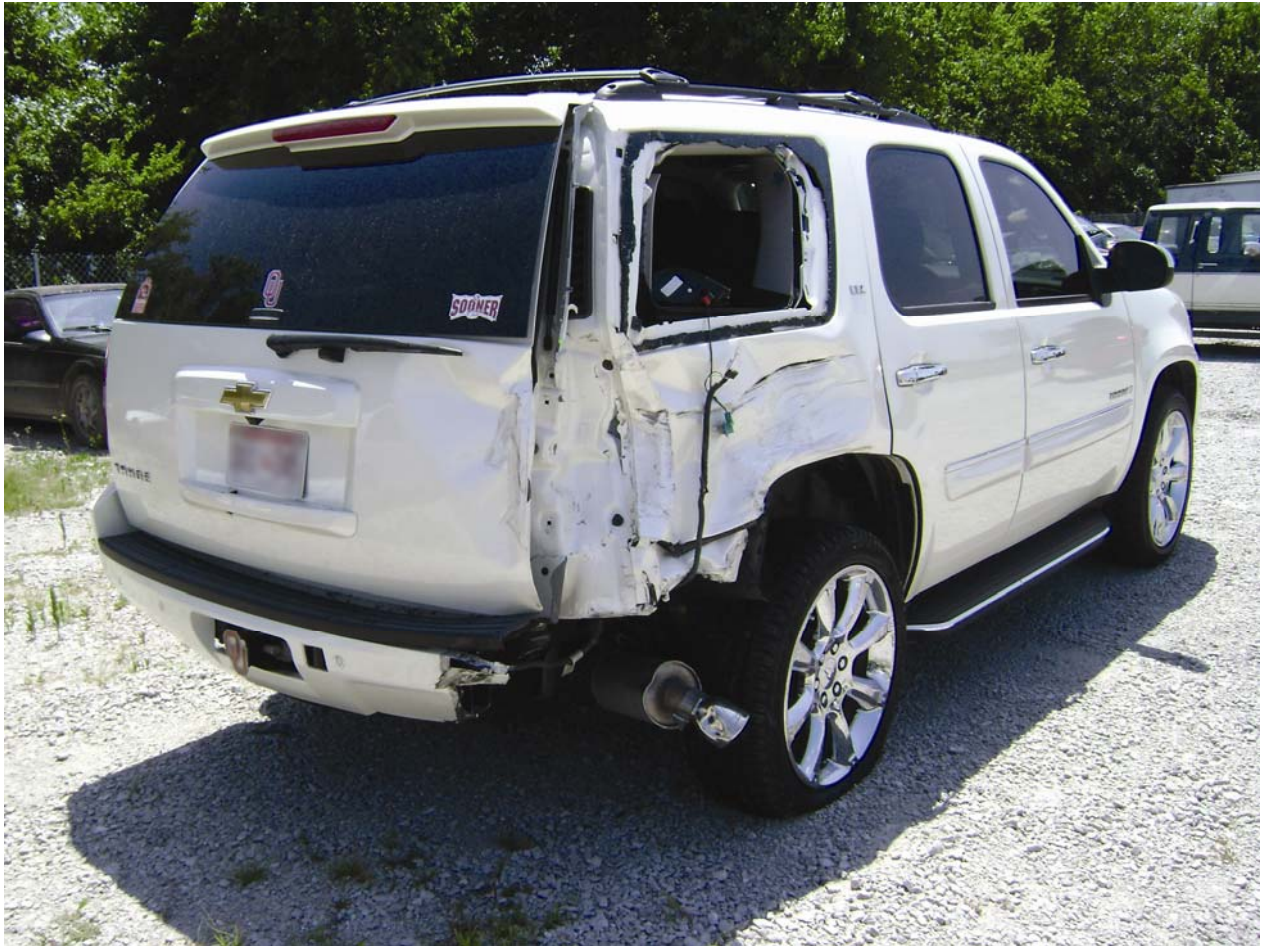
**Chevrolet Tahoe SUV.** This vehicle was struck from behind by the Ford pickup truck, and it came to rest in the left lane. The vehicle exterior sustained moderate damage, consisting of approximately 12 inches of direct contact damage, which continued down the right rear fender and caused the right rear window to shatter. The interior of the vehicle sustained no damage.

**Figure B-7.** Collision damage to 2008 Chevrolet Tahoe SUV.
