NATIONAL TRANSPORTATION SAFETY BOARD

FINITE ELEMENT MODELING STUDY REPORT

Place : Casselton, North Dakota
Date : December 30, 2013
Vehicle : BNSF Grain Freight Car, G-RYLRGT9-26A
NTSB No. : DCA14MR004
Investigator : Richard Hipskind

Finite element modeling to examine local stress concentration due to void defect in wheelset axle.

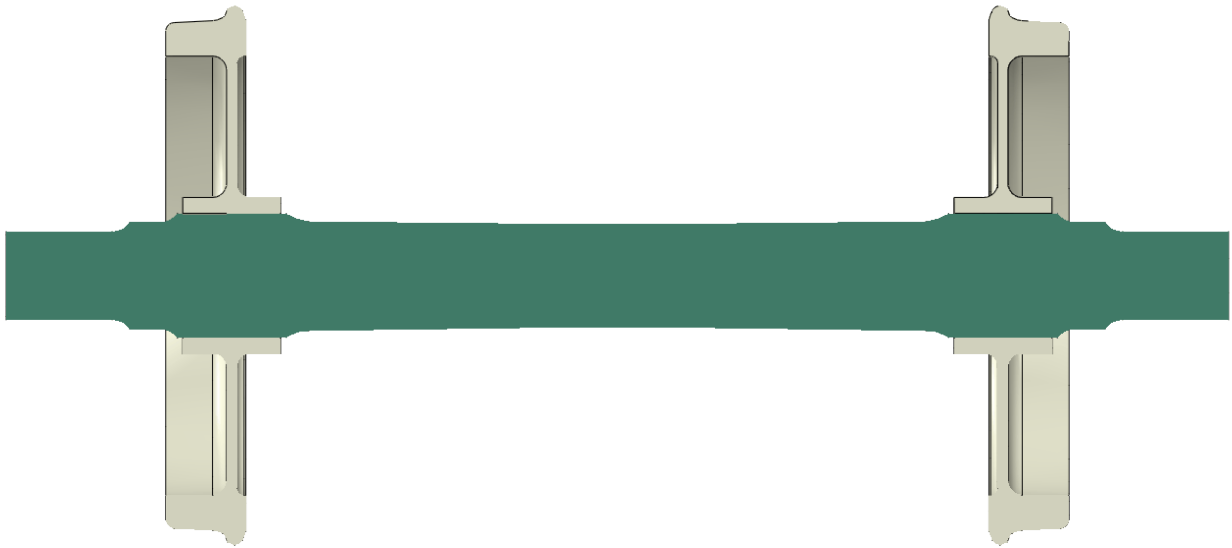
Figure 3. Created geometry of the wheelset, plan view.

The finite element model of the wheelset contained the axle and the two mounted wheels. The wheelset in the accident train was identified to have an AAR Class K (6 ½ x 9) axle and 36-inch, AAR 1-B, wide flange wheels [Reference 1]. The axle finite element model was created based on the AAR standard [Reference 2], as well as the drawing shown in figure 1. The wheel model was created based on the AAR standard [Reference 2] with simplified straight flanges. Figures 2 and 3 show the isometric and plan view of the created axle assembly model in Abaqus/CAE.

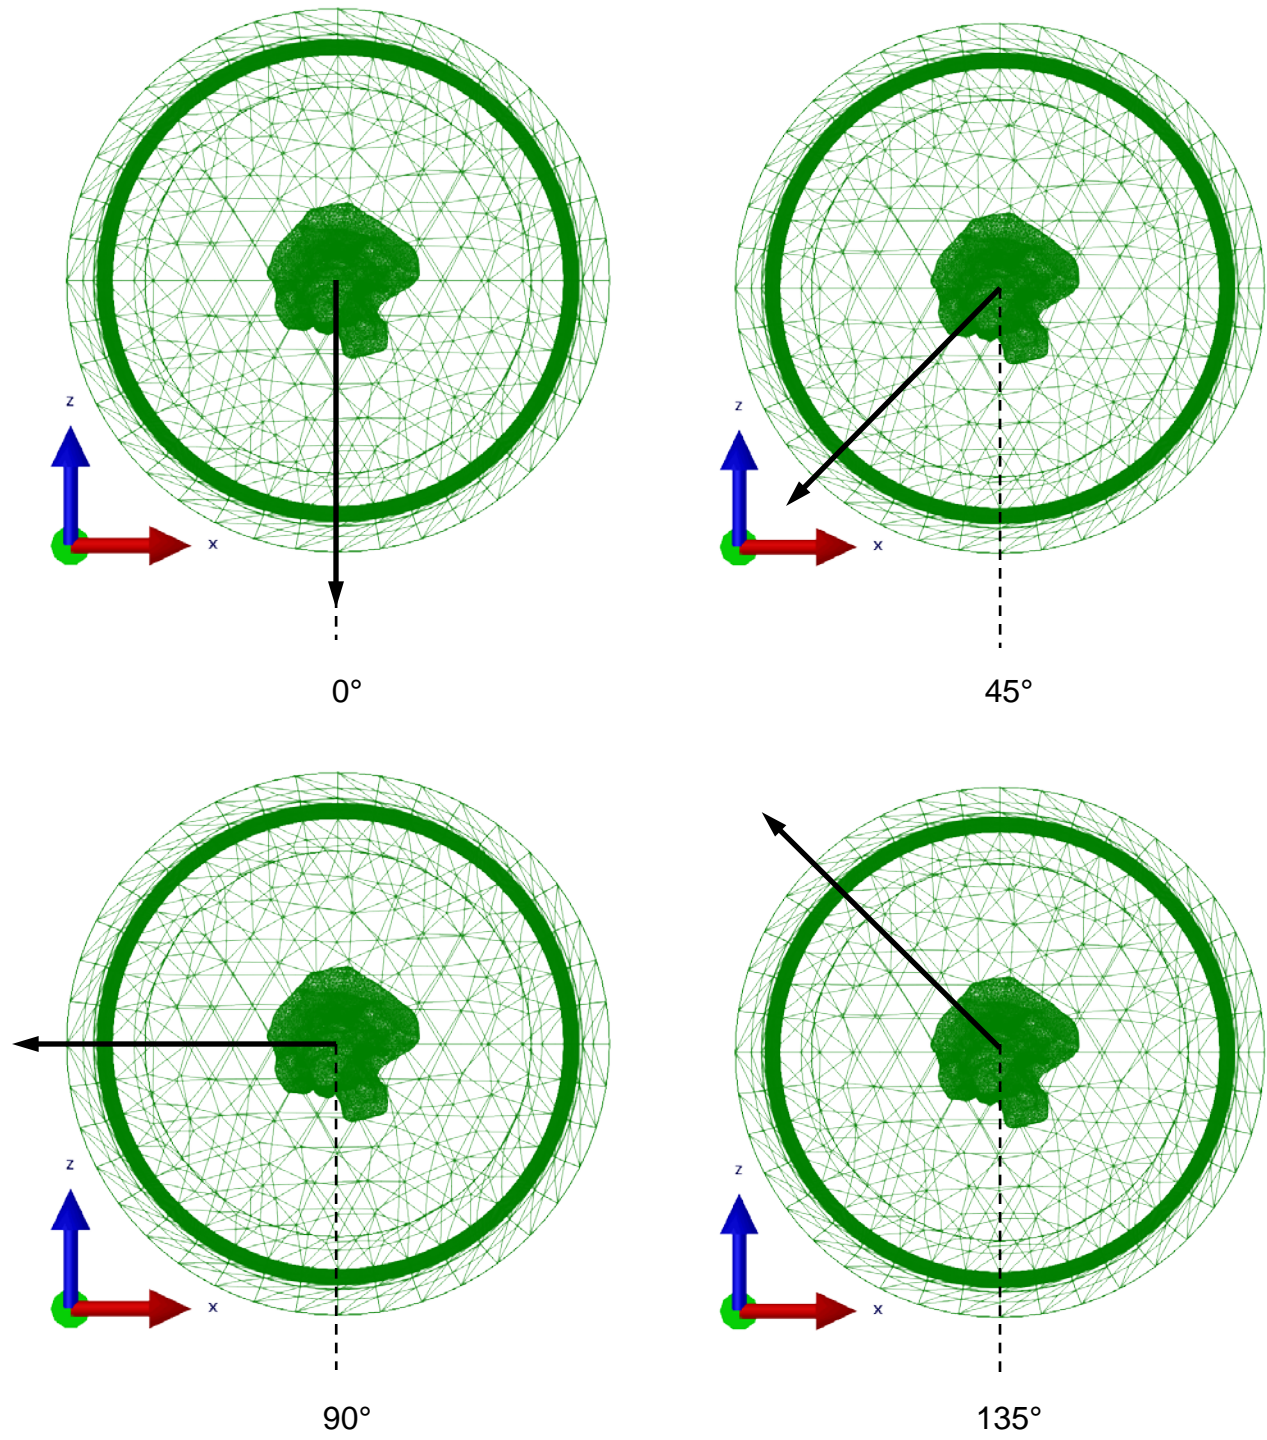
Figure 12. The 8 analyzed bending scenarios.

For the case without the internal defect, the structure was rotationally symmetric with respect to the longitudinal axis, and hence it was sufficient for this analysis to consider only one bending direction. For the case with the internal defect, the symmetry was lost and different bending directions needed to be analyzed. Eight bending scenarios were analyzed in this study, and the associated bending directions are shown in figure 12. The angle that was used to identify the directions was measured counterclockwise from the negative global z-direction of the model. For each bending scenario the load and support location were rotated about the axle axis accordingly.

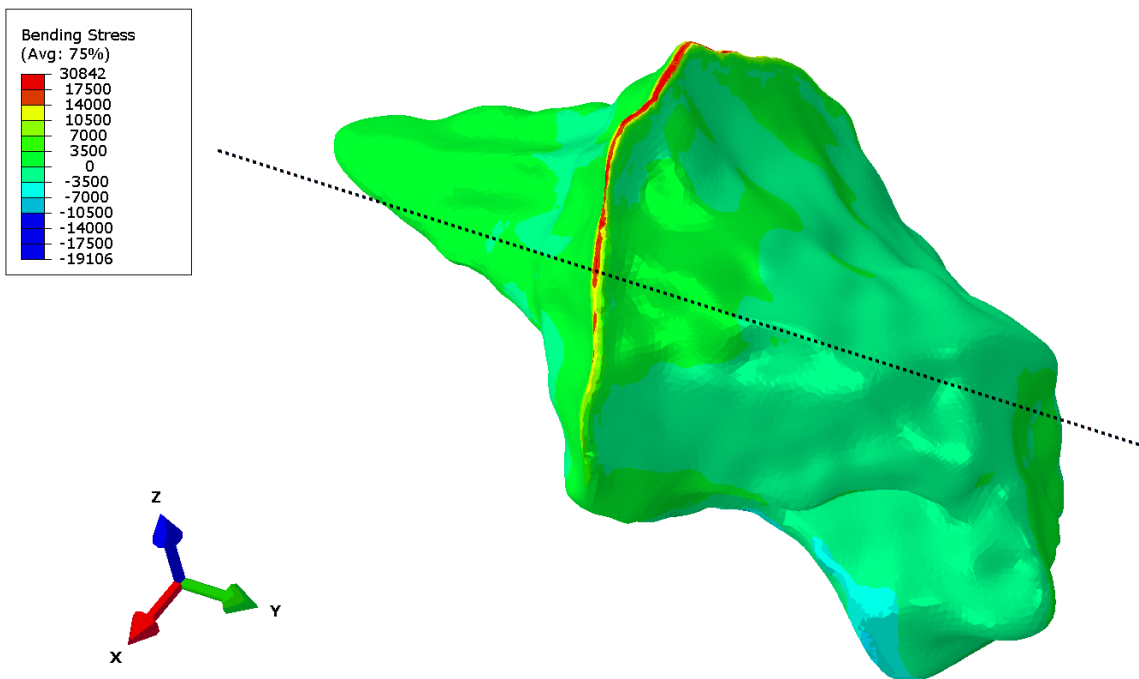
Figure 23. Bending stress (unit: psi) contour on the void surface, 0-degree bending case, isometric view, with axle centerline shown.

The case with the internal defect was analyzed next. The previously mentioned 8 bending scenarios were analyzed sequentially. Figure 16 and 17 show the cut view of the Mises stress contour plot of the 0-degree bending case. Figures 18 and 19 plot the same stress of the same case on the void surface. Figures 20 through 23 show the corresponding bending stress contours. Local stress exceeding 17.5 ksi, shown in red, can be found on the "ridge" of the surface furthest away from the bending neutral axis, and the peak value for Mises stress was approximately 26.3 ksi, which is nearly twice as large as the peak Mises stress found in the case without the internal defect. The 17.5 ksi value was taken from Reference 5, which cited a previous AAR experimental study that determined a stress level exceeding 17.5 ksi could cause fatigue failure in axles.

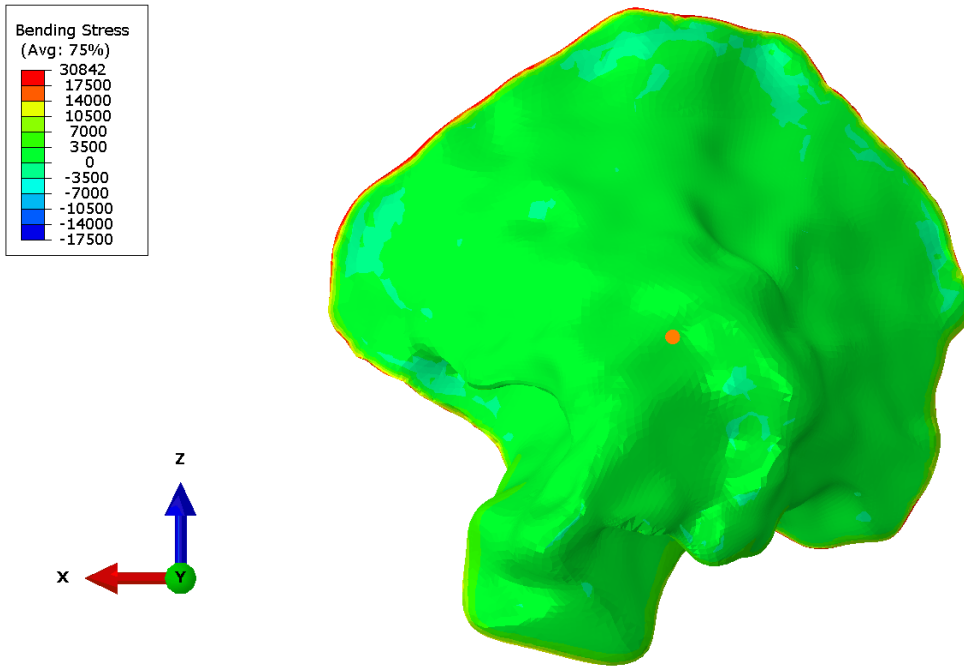
Figure 26. Maximum principal stress (unit: psi) contour on the void surface, overlaid plot from all 8 bending scenarios, end view, with axle centerline location marked.

Figures 26 and 27 show the same overlaid plot for the maximum principal stress contour. It can be seen that the region with high stress extends when all 8 bending directions are considered but is still limited to the “ridge” of the void surface. The high stress region is highlighted in figure 28 for better visualization. For comparison, figure 29 [Figure 8 of Reference 3] shows the actual fracture surface of the broken axle with progressive and overstress areas labeled. The area of progressive fatigue cracking was consistent with the high stress region shown in figure 28.

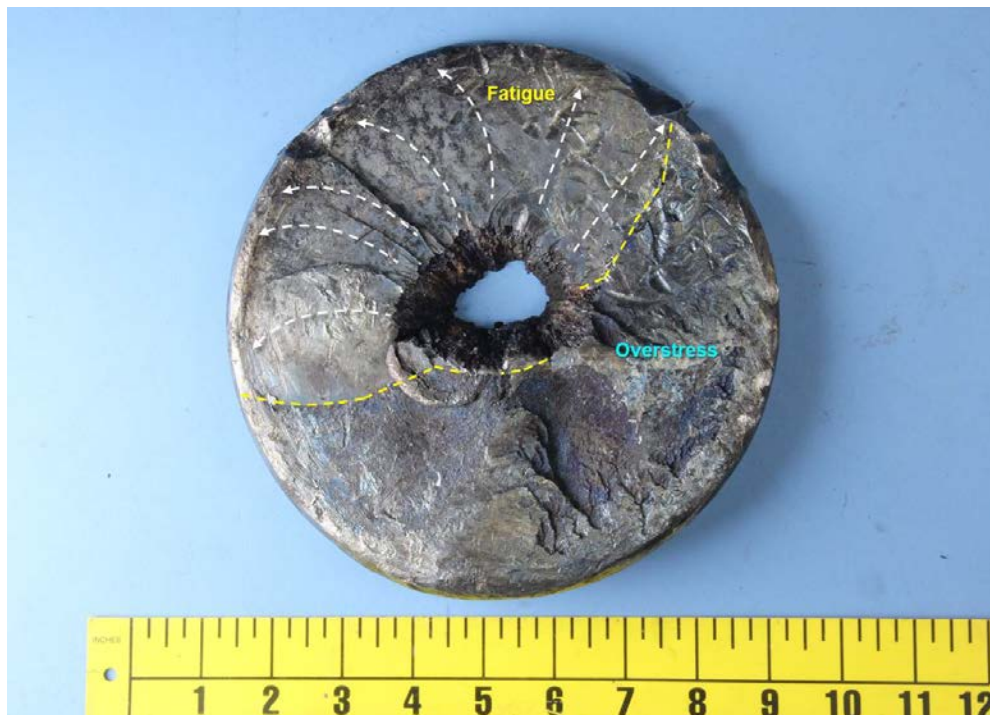
Figure 29. Fracture surface of the broken axle with fatigue and overstress areas labeled [Figure 8 of Reference 3].
