**NATIONAL TRANSPORTATION SAFETY BOARD
WASHINGTON, D.C.**

**FIRE AND EXPLOSION GROUP FACTUAL REPORT
Appendix II
(Sooting/Fracture Diagrams)
(34 pages)**

TWA FLIGHT 800 ACCIDENT INVESTIGATION

APPENDIX II SOOTING/FRACTURE DIAGRAMS

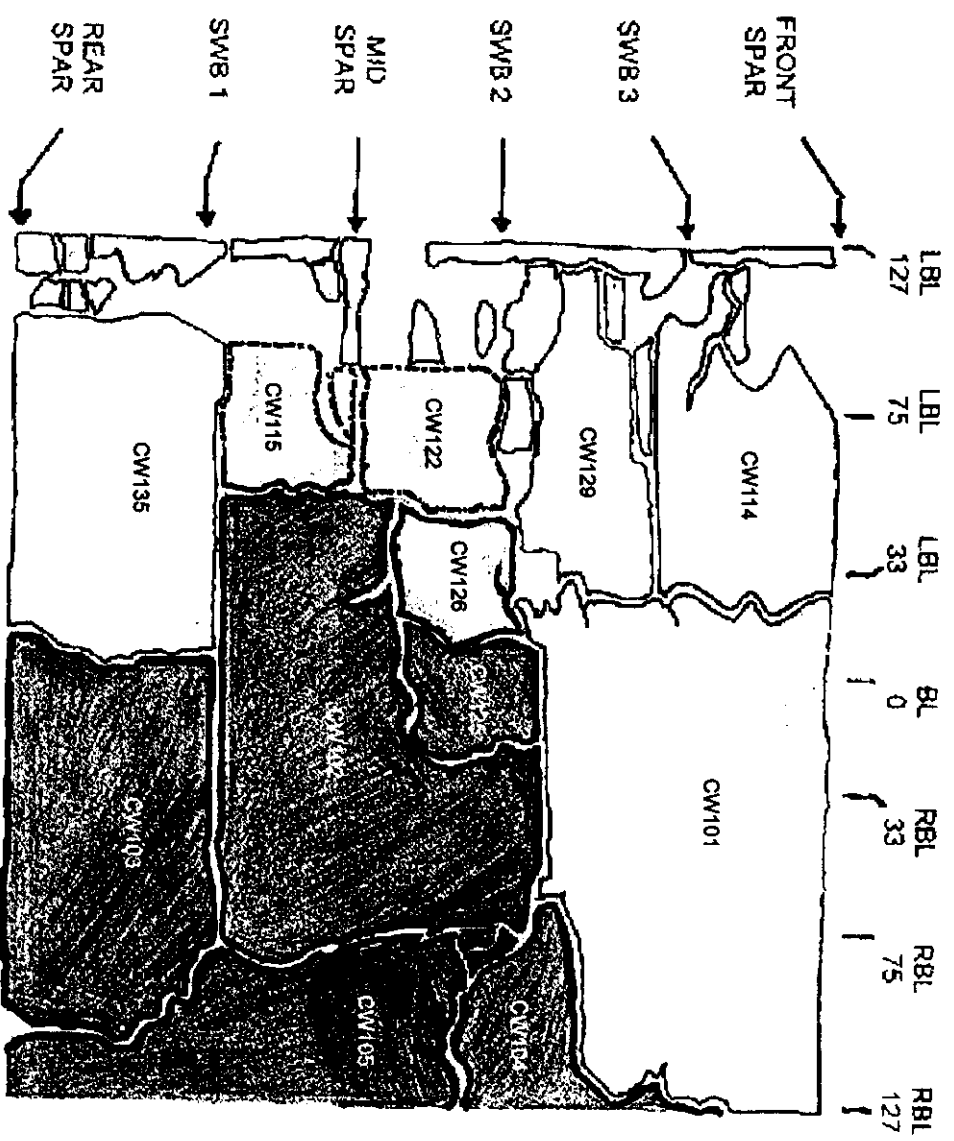
Diagram 1.

UPPER SKIN - UPPER SURFACE

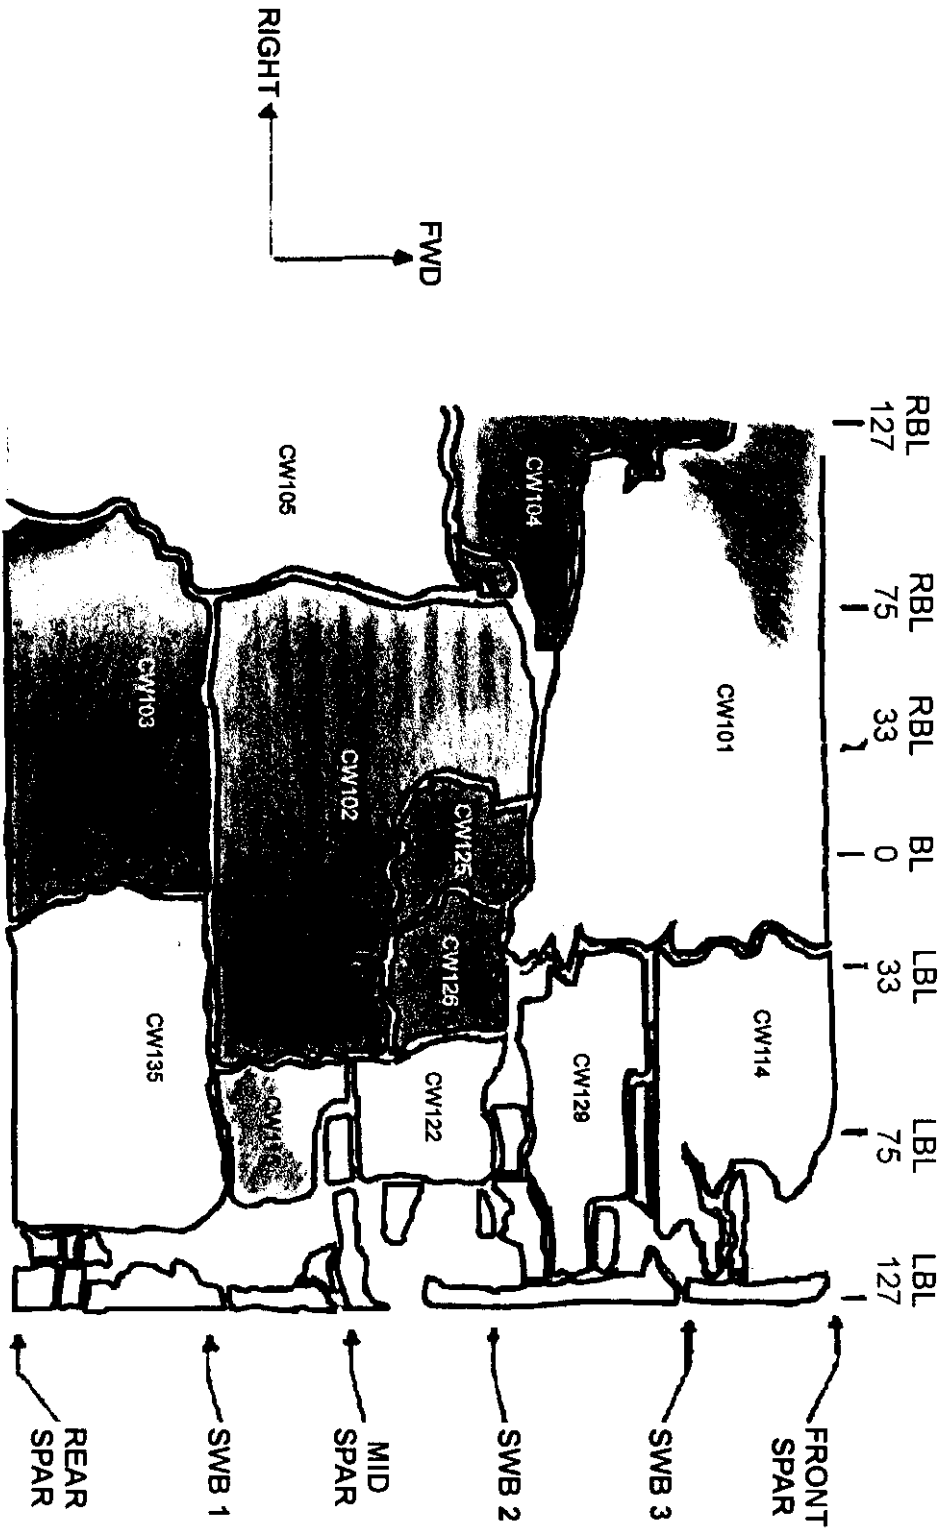
Diagram 2.

UPPER SKIN - LOWER SURFACE

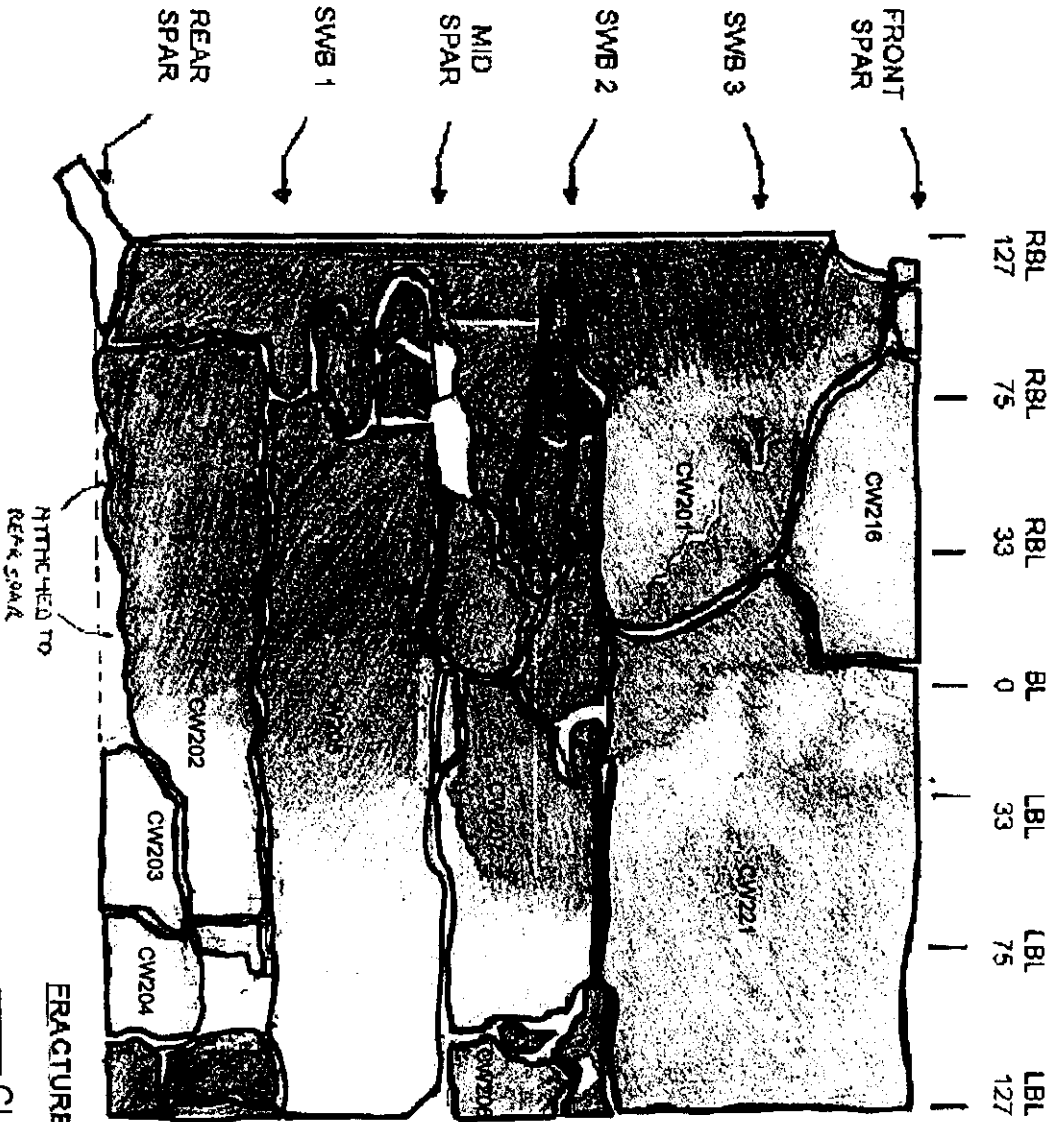
Diagram 4.

LOWER SKIN - LOWER SURFACE

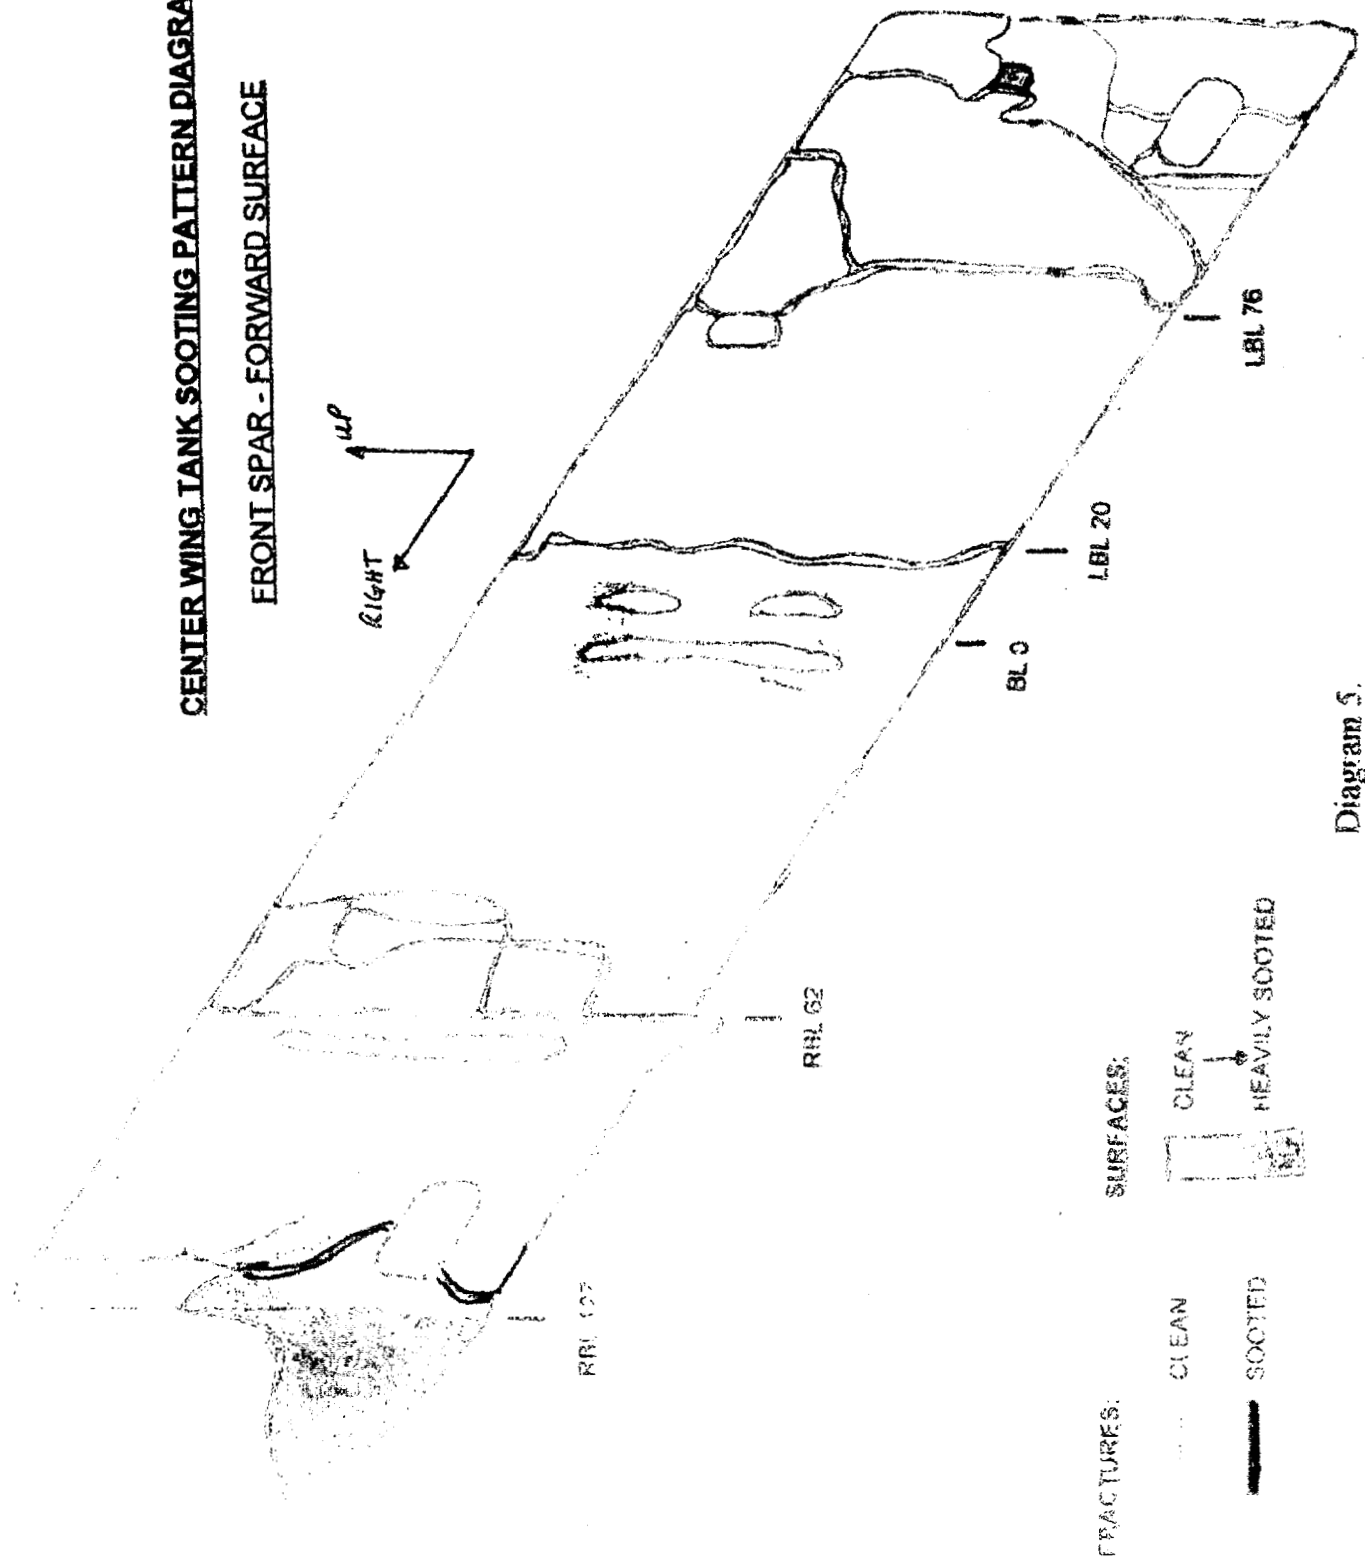
Diagram 5.

FRONT SPAR - FORWARD SURFACE

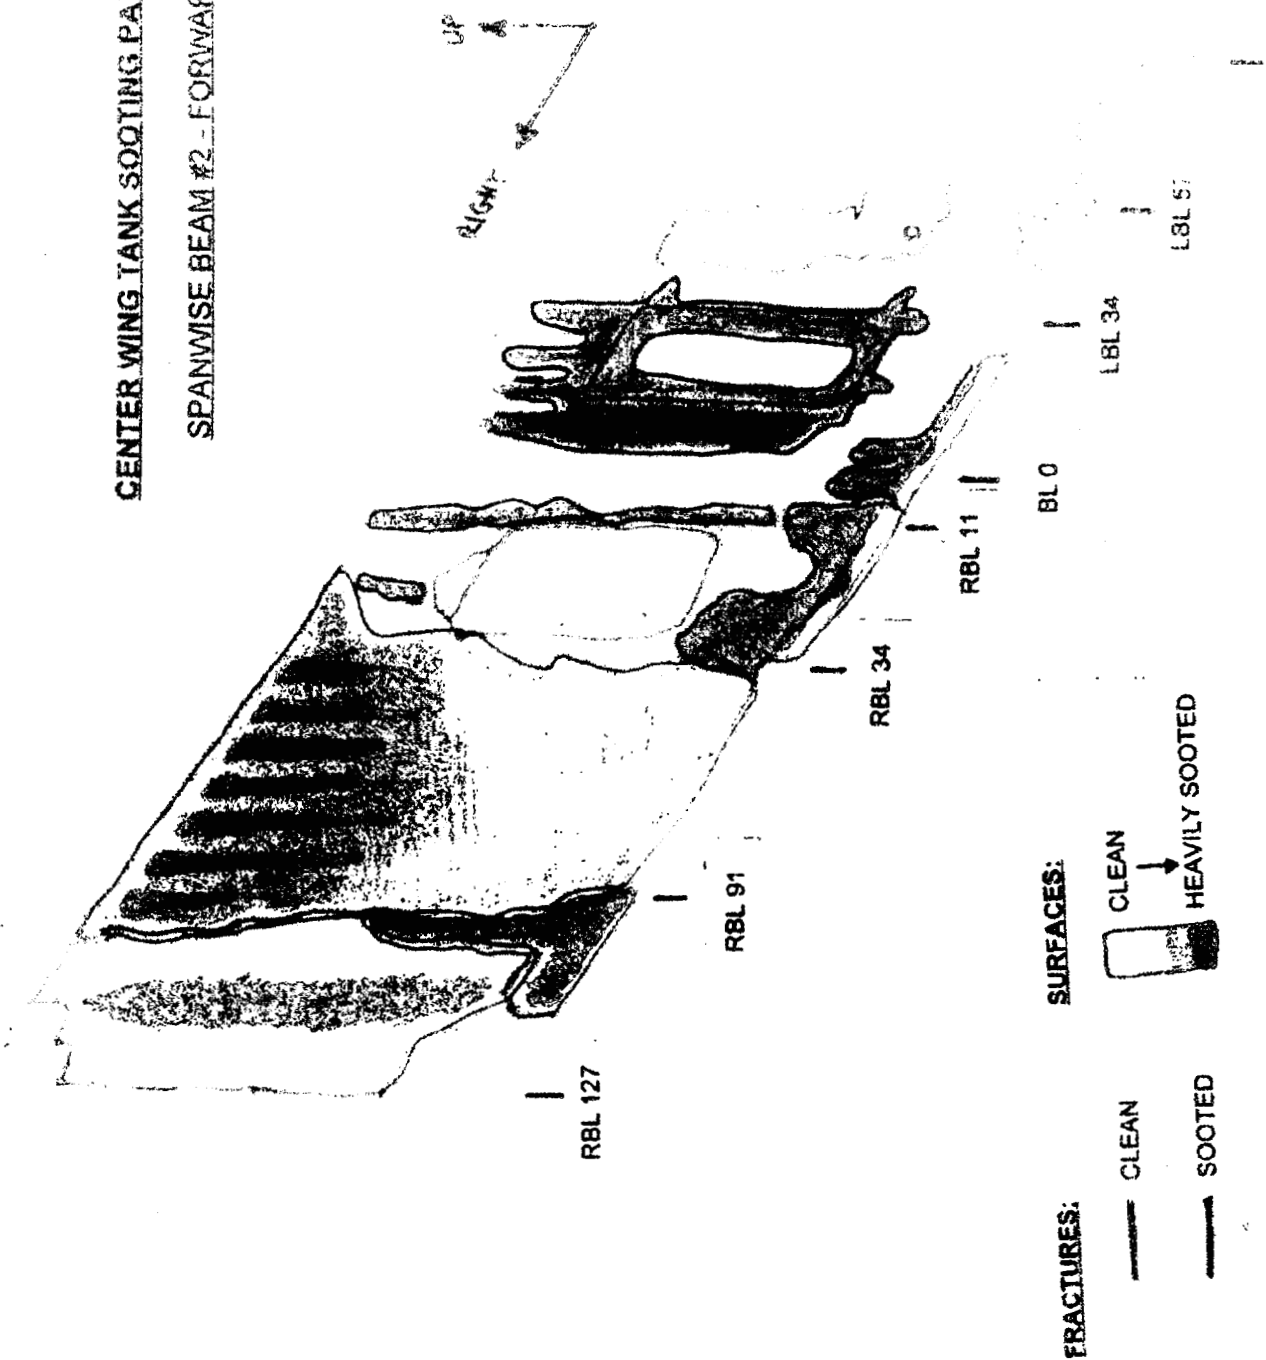
Diagram 9.

SPANWISE BEAM #2 - FORWARD SURFACE

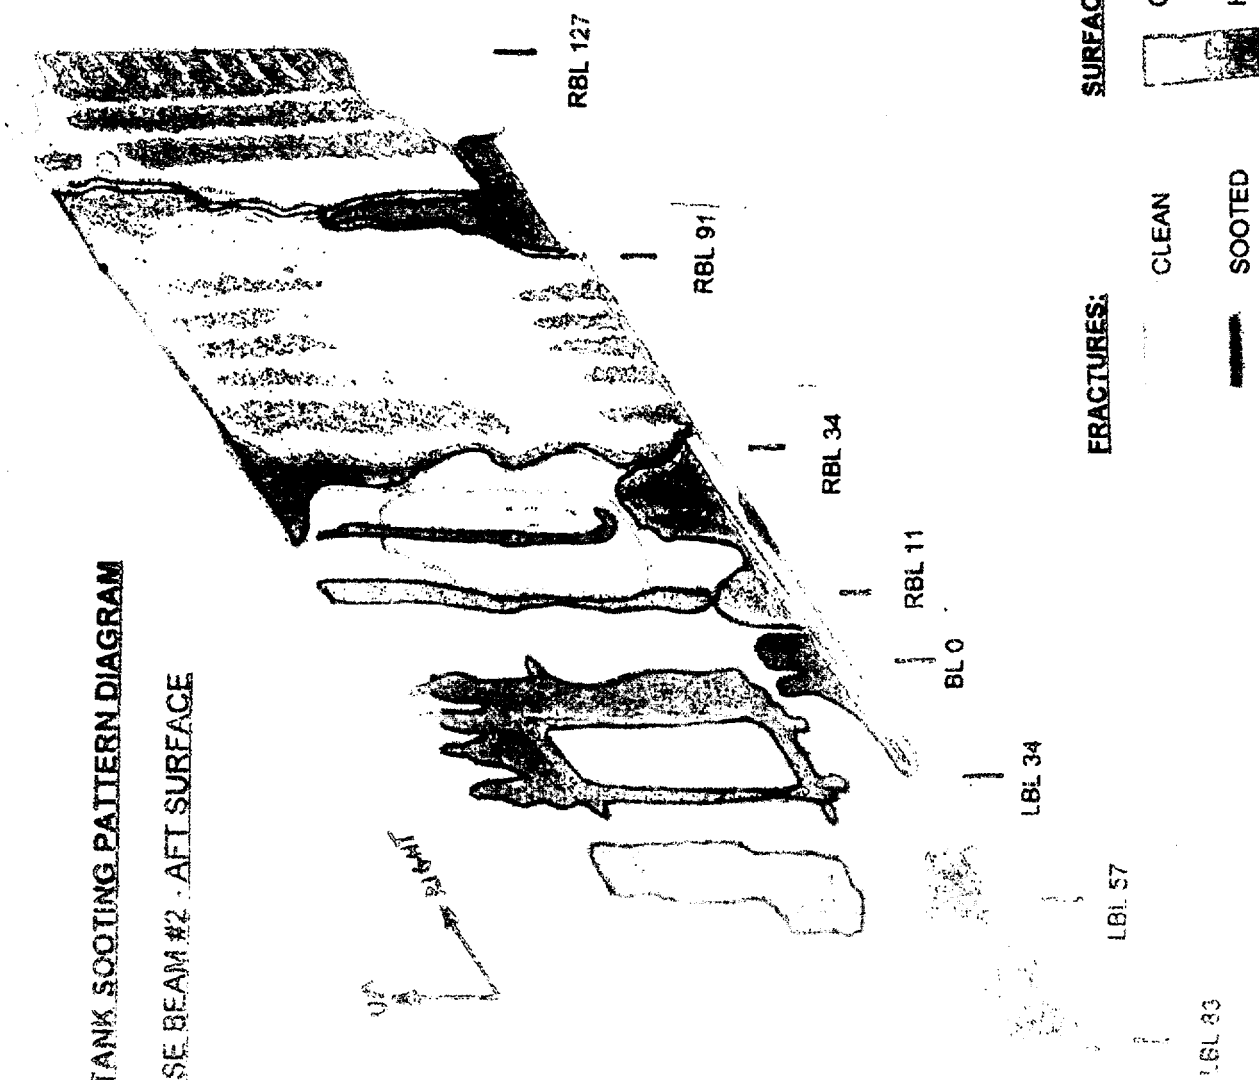
Diagram 10.

SPANWISE BEAM #2 - AFT SURFACE

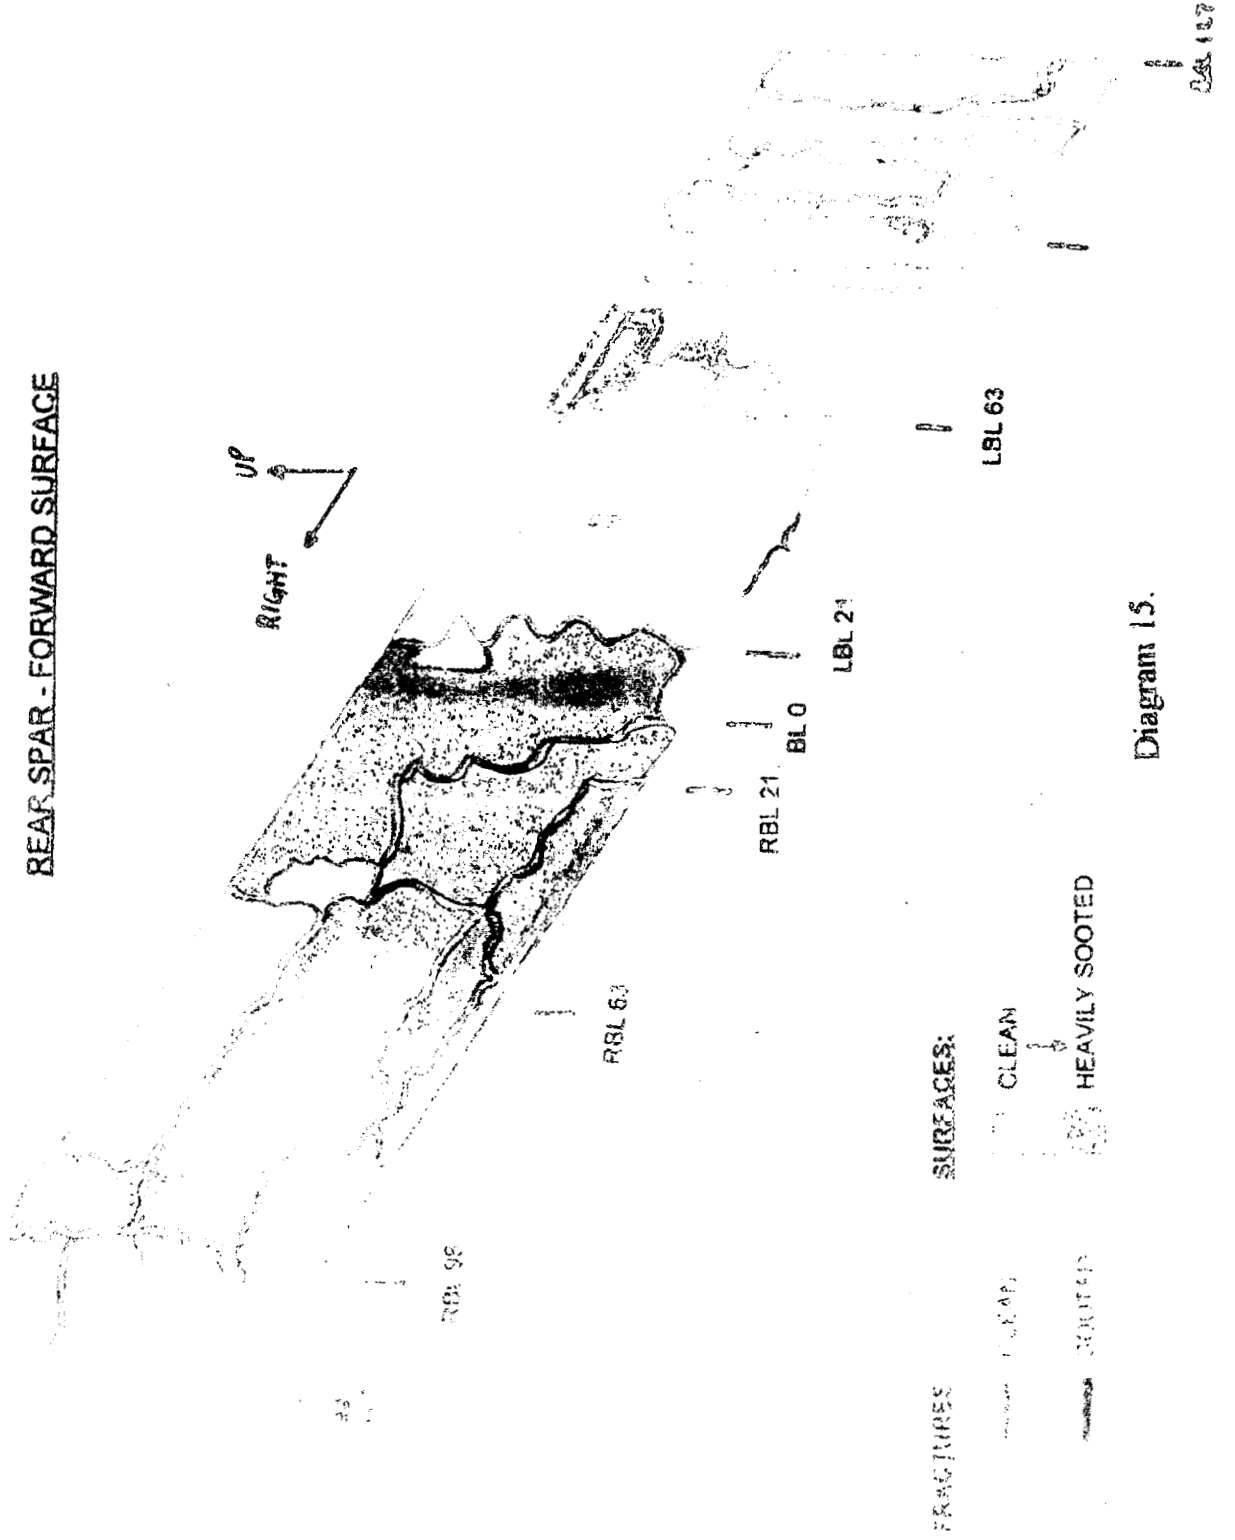
Diagram 15.

REAR SPAR - FORWARD SURFACE

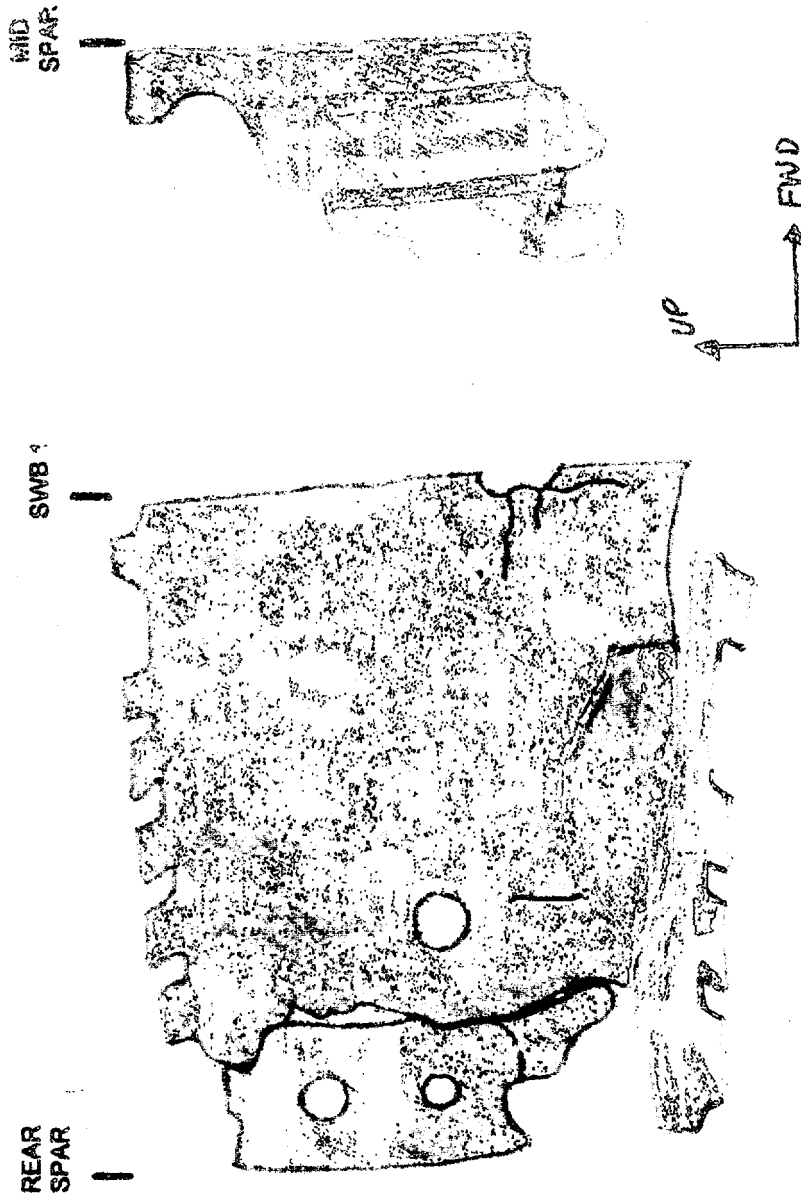
Diagram 18.

BL 0 RIB - RIGHT SURFACE

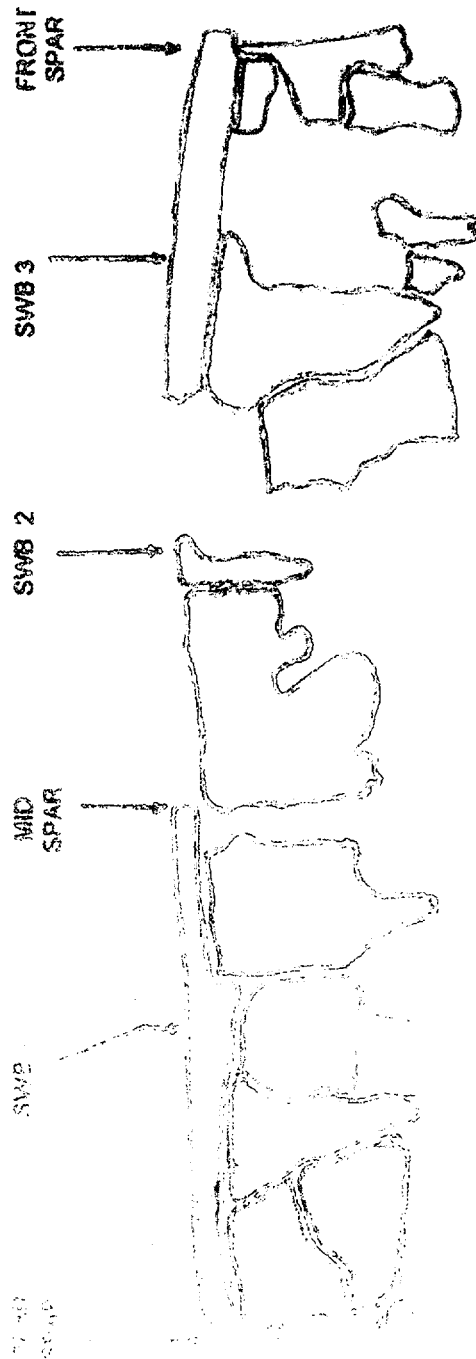
Diagram 19.

RIGHTHAND SIDE OF BODY RIB - OUTBOARD SURFACE

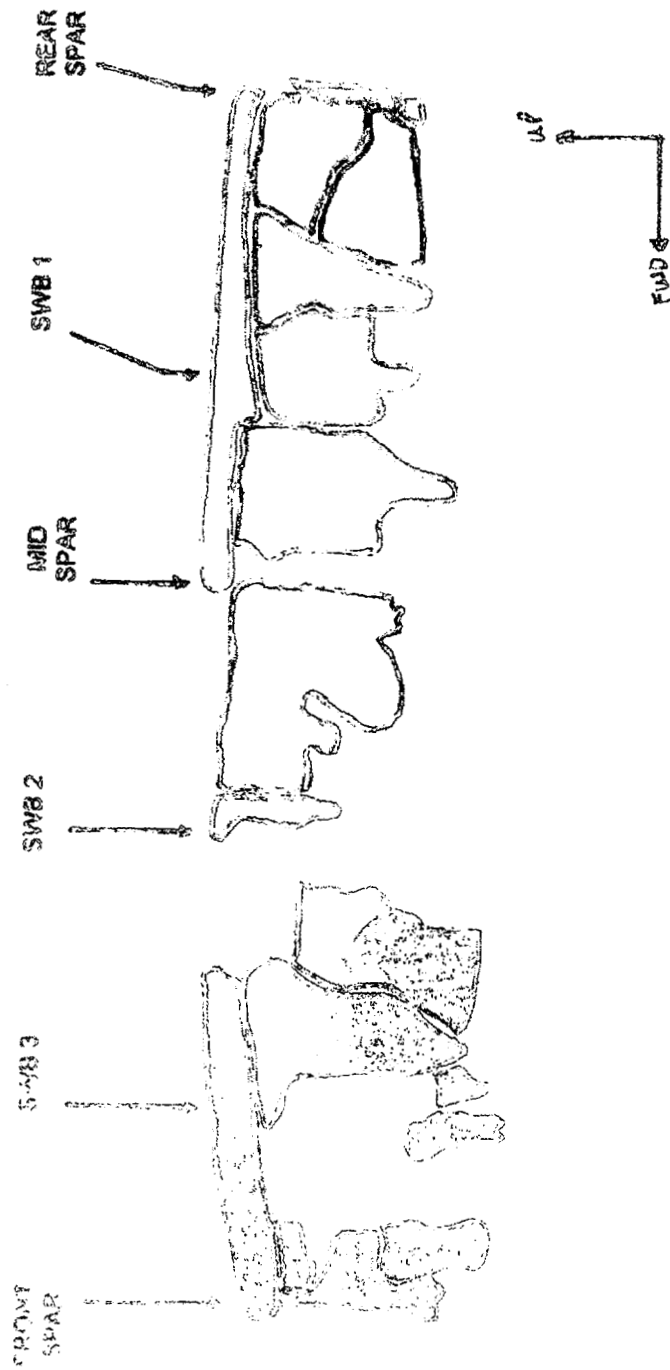
Diagram 20.

RIGHTHAND SIDE OF BODY RIB - INBOARD SURFACE

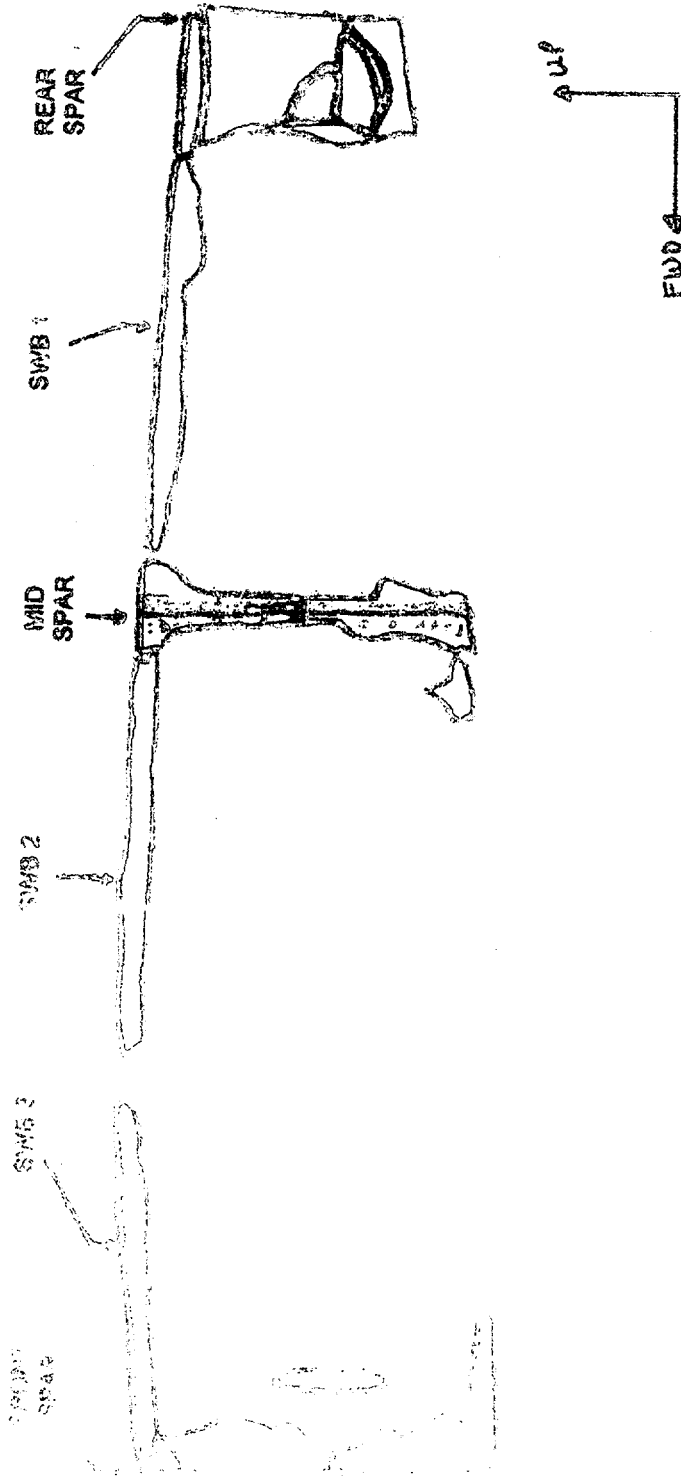
Diagram 21.

LEE/HAND SIDE OF BODY RIB - OUTBOARD SURFACE

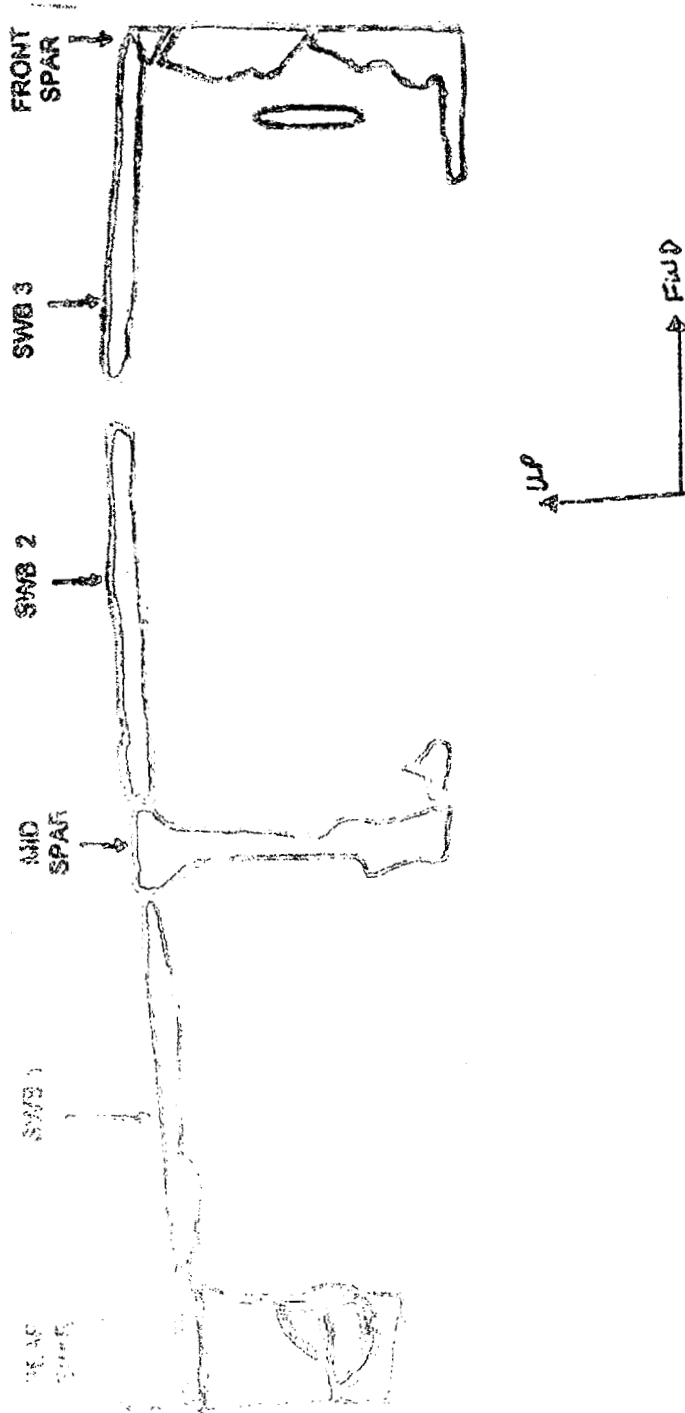
Diagram 22.

LEFT HAND SIDE OF BODY RIB - INBOARD SURFACE

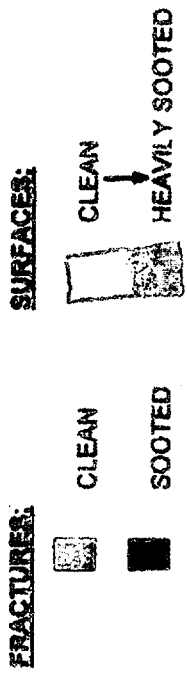
Diagram 24.

UPPER SKIN INTERNAL SURFACE

Note: See Vent Stringer for details of vent stringer sooting.

LOWER SKIN INTERNAL SURFACE

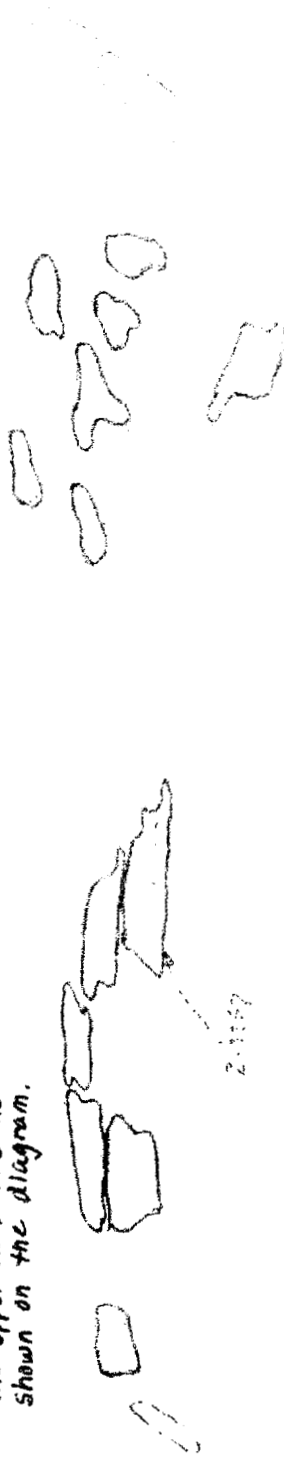
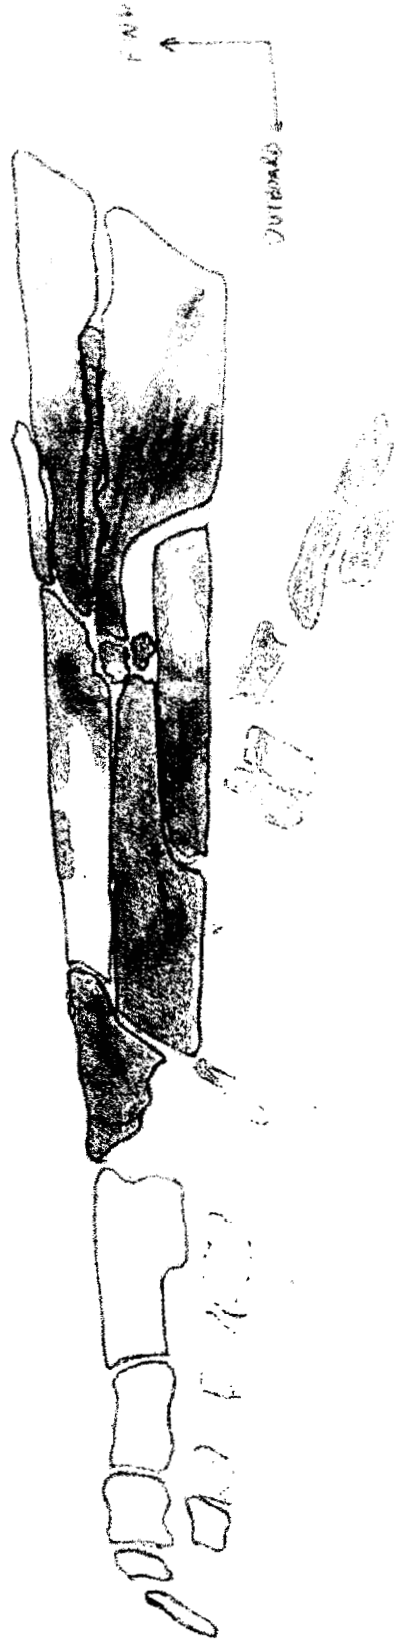
Diagram 25.

UPPER SKIN - EXTERNAL SURFACE

NOTE: Many small pieces of the upper skin are not shown on the diagram.

NOTE: With the exception of the piece noted, the external surface of the upper skin is clean. The control surfaces do show sooting and fire damage to the composite parts.

LOWER SKIN - EXTERNAL SURFACE

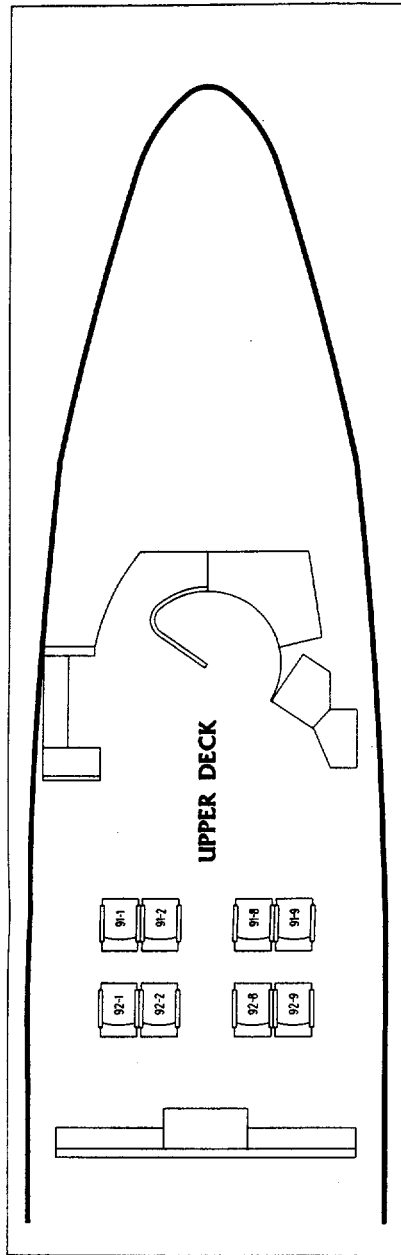
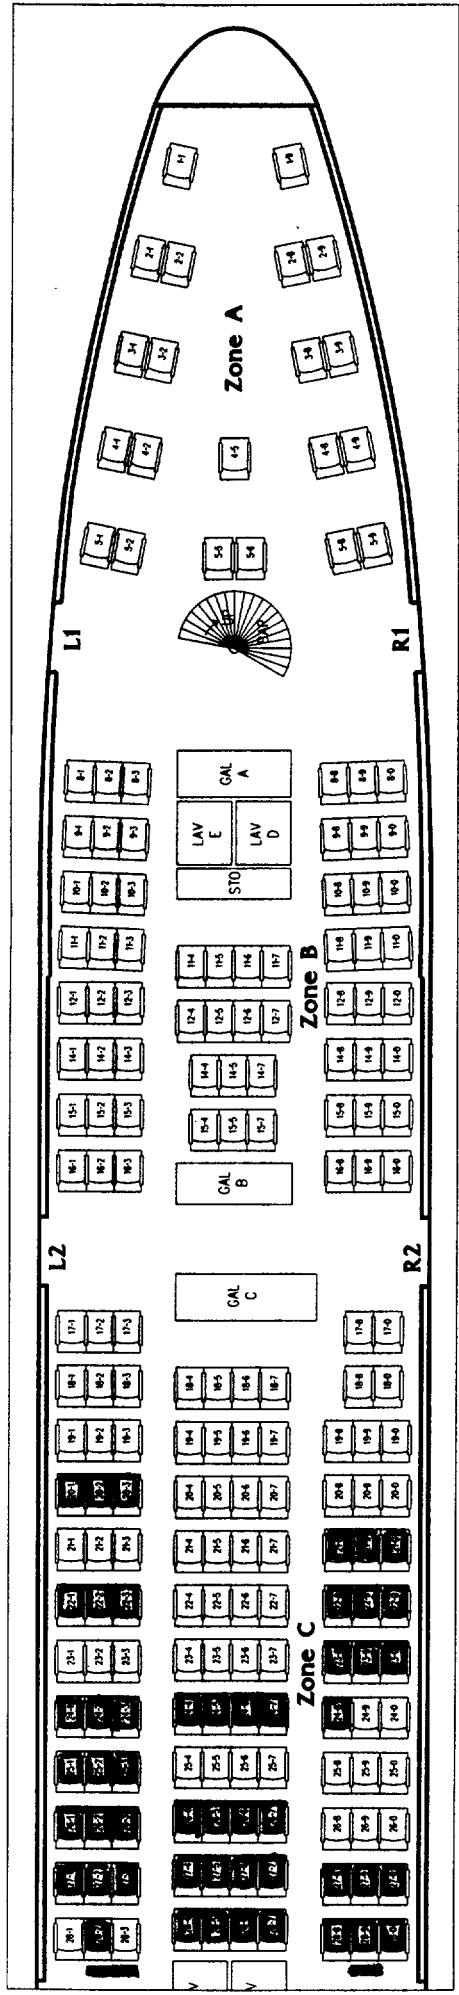
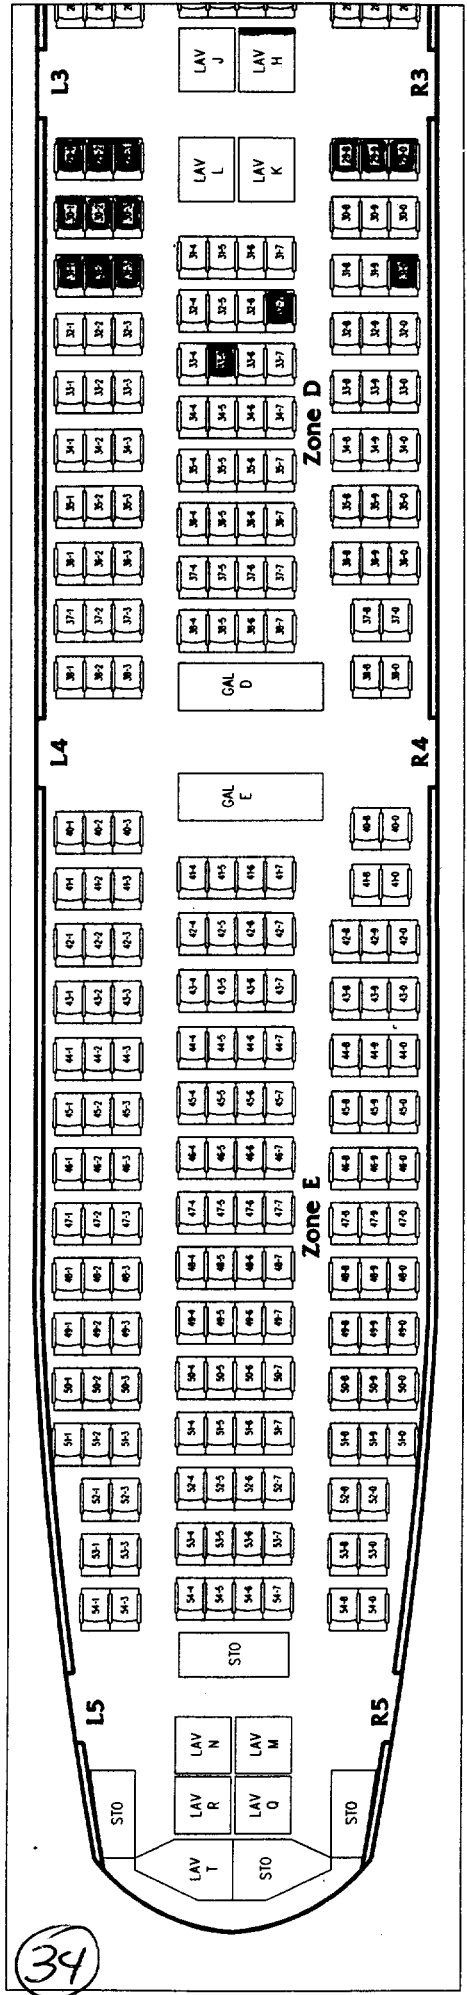
Diagram 29

Seat Damage
Center Wing Tank Area
Data gathered by Fire and Explosion Group

Fire Damage and/or Soot [] Not Recovered/Identified []

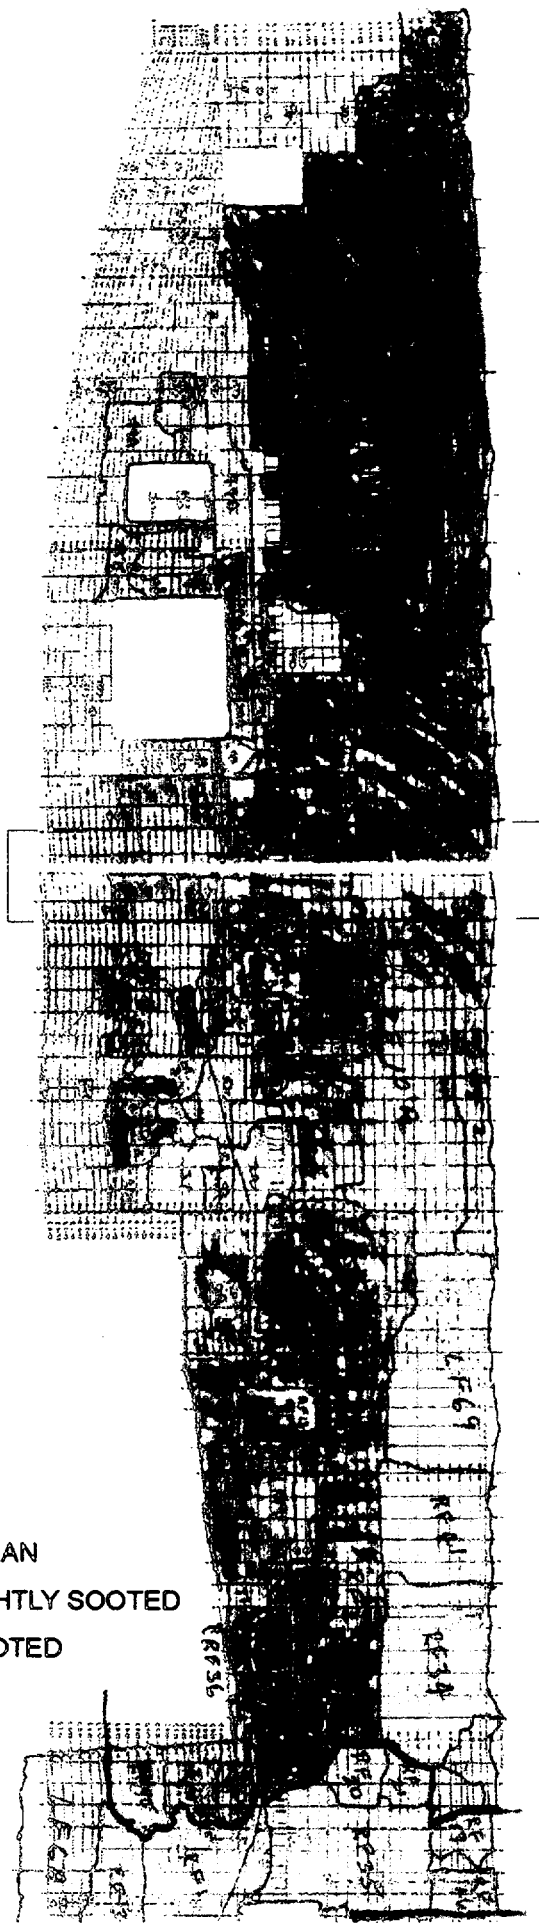
DIAGRAM 31

- CLEAN
- LIGHTLY SOOTED
- SOOTED

FUSELAGE
SOOTING
PATTERNS
