**NATIONAL TRANSPORTATION SAFETY BOARD
WASHINGTON, D.C**

Boeing 747-100 Center Wing Tank Ground Testing

Summary Data Report:
B-747-100 Center Wing Tank Ground Testing
at Marana, AZ

Joseph Kolly
Office of Research and Engineering
National Transportation Safety Board

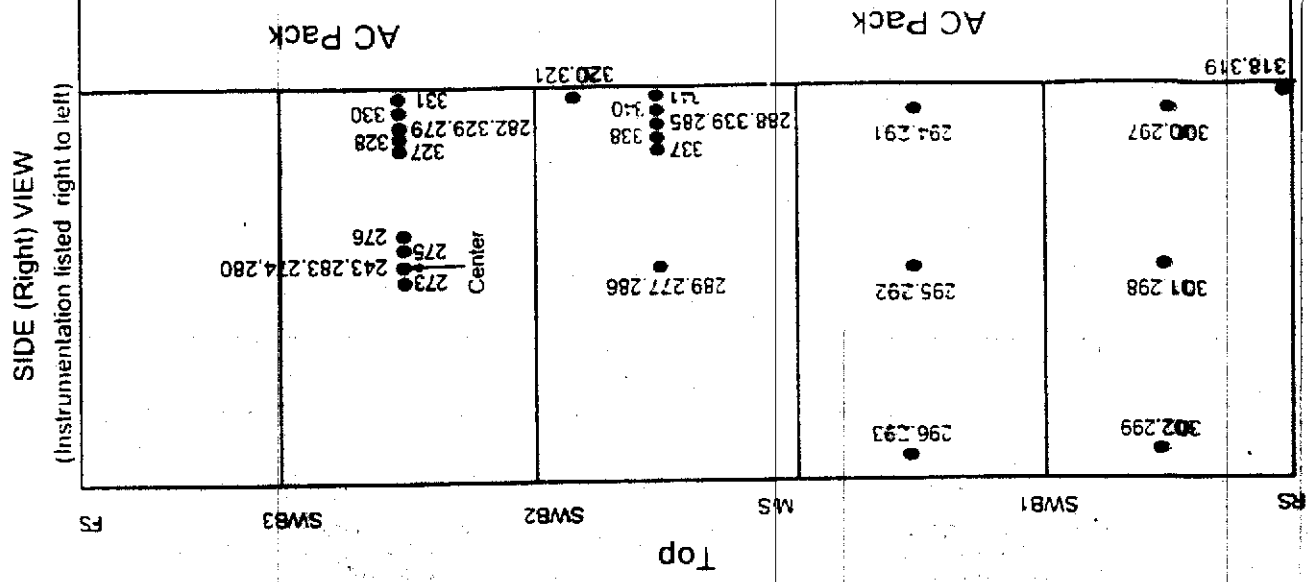
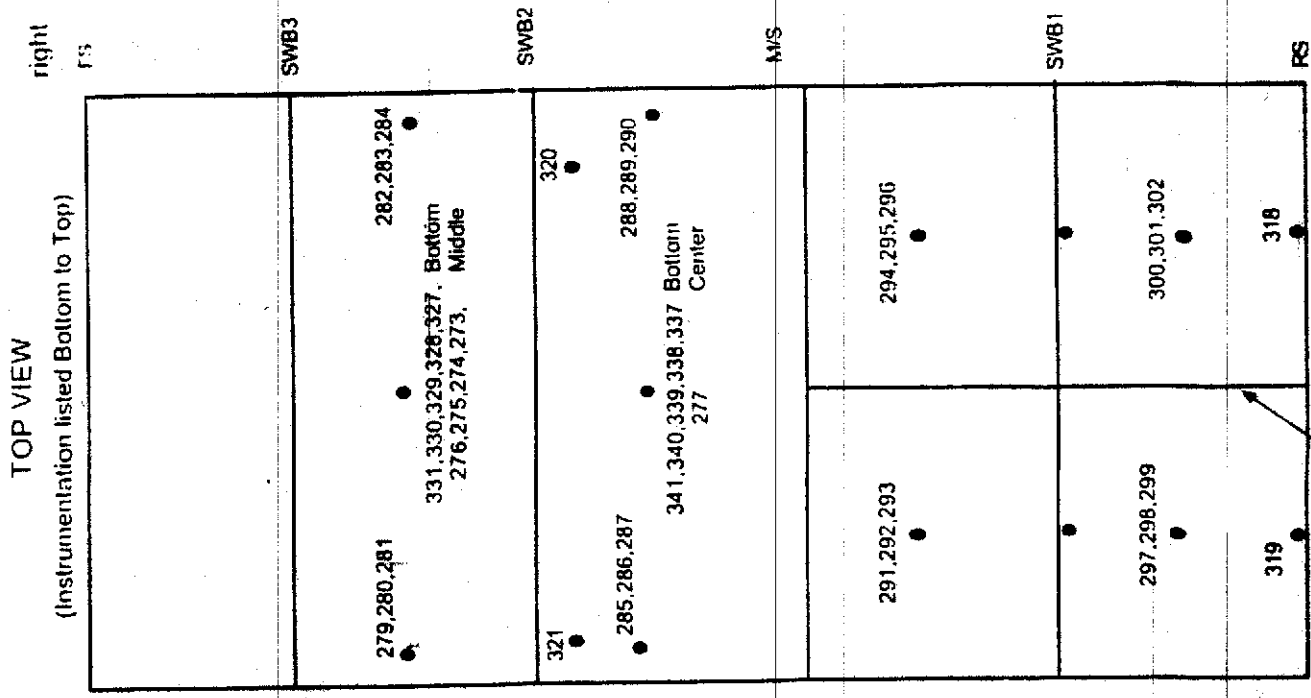
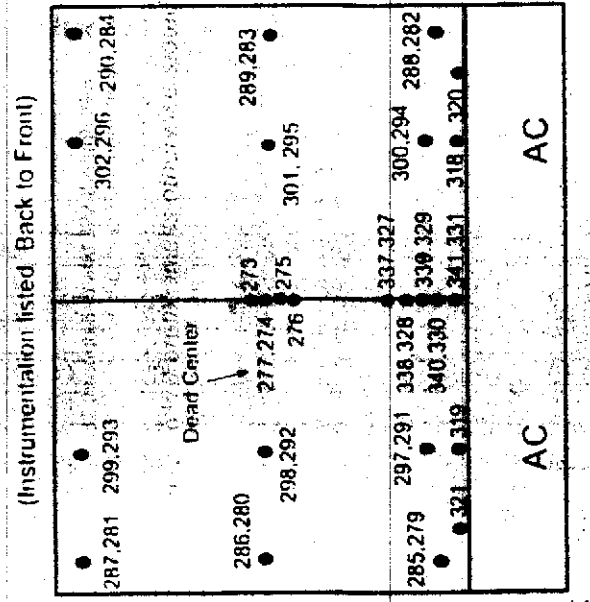
Figure 2.1 CWT internal instrumentation locations.

**NTSB CWT INSTRUMENTATION
FROM PREVIOUS NTSB
747-100 TESTING***

*6170332 through 336 and 322 through 326 have been deleted. Other boundary conditions were also deleted due to duplications with Figure 3. All T/C have 6170 prefix unless otherwise stated

Time histories of the ullage and fuel temperatures of each CWT bay are shown for Test 1 in Figures 3.1a-f. Three measurement locations are shown for each bay to illustrate the bulk stratification of temperatures within each bay. These selected thermocouple locations are centered laterally (port-starboard) and longitudinally (fore-aft) in each bay, at three elevations. The exception is the top thermocouple locations for Bays 1 and 2, where an off-center gage was selected (due to malfunction of the center gage). The identification of gages used for these plots is given in Table 3.4. These identifiers can be located on the instrumentation layout drawings, Figures 2.1-2.3.

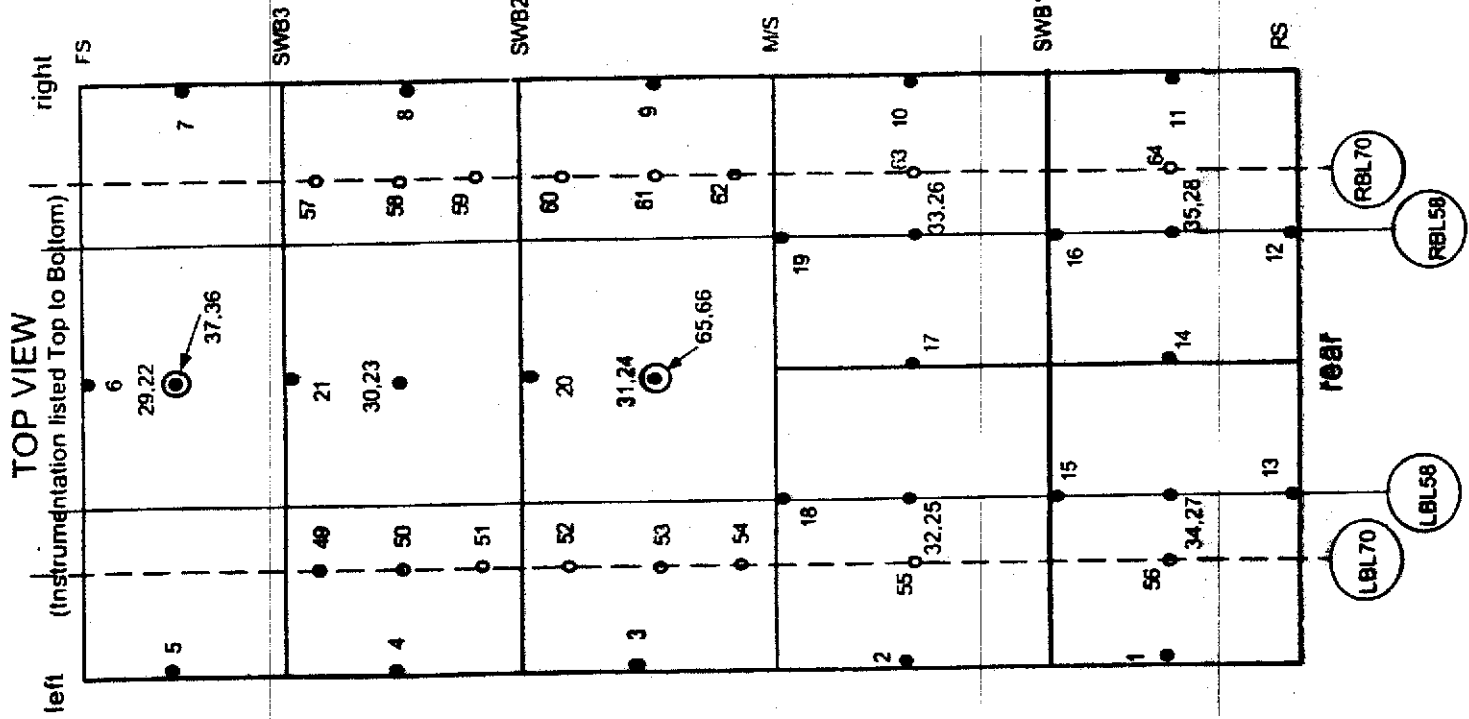
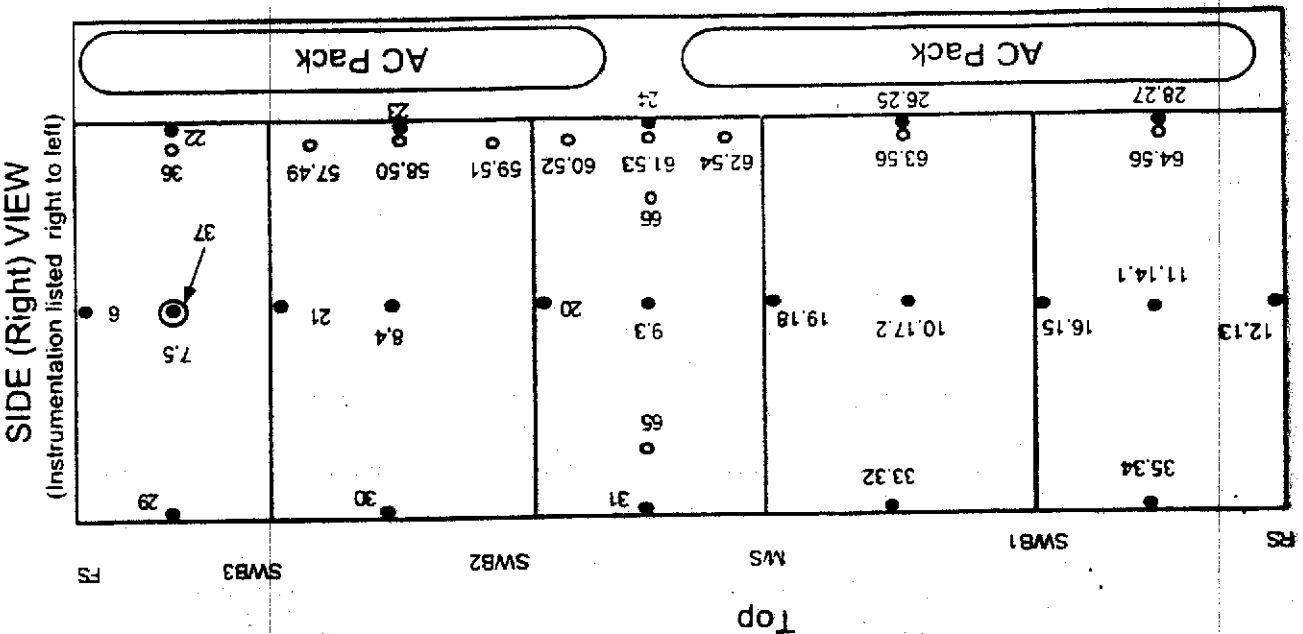
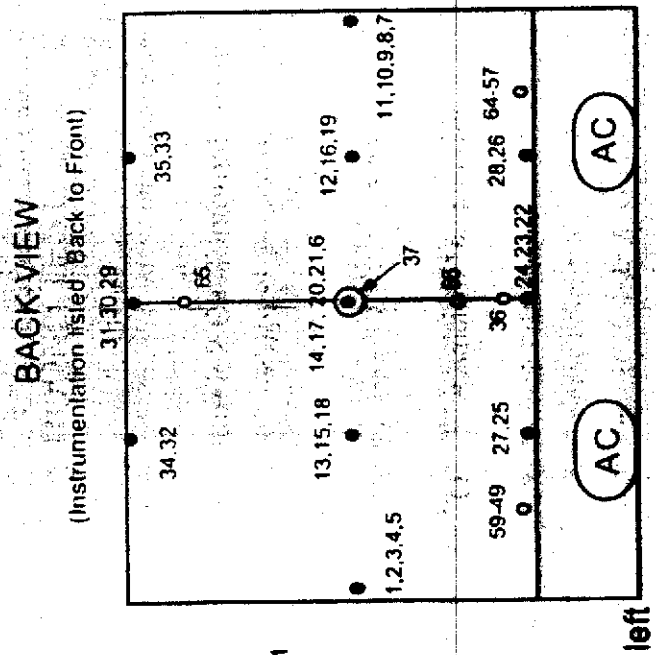
Figure 2.2 CWT internal instrumentation locations.

**CWT INSTRUMENTATION
FOR ECS DUCT INSULATION
GROUND TEST**

- = Ambient Temperature
- = Surface Temperature

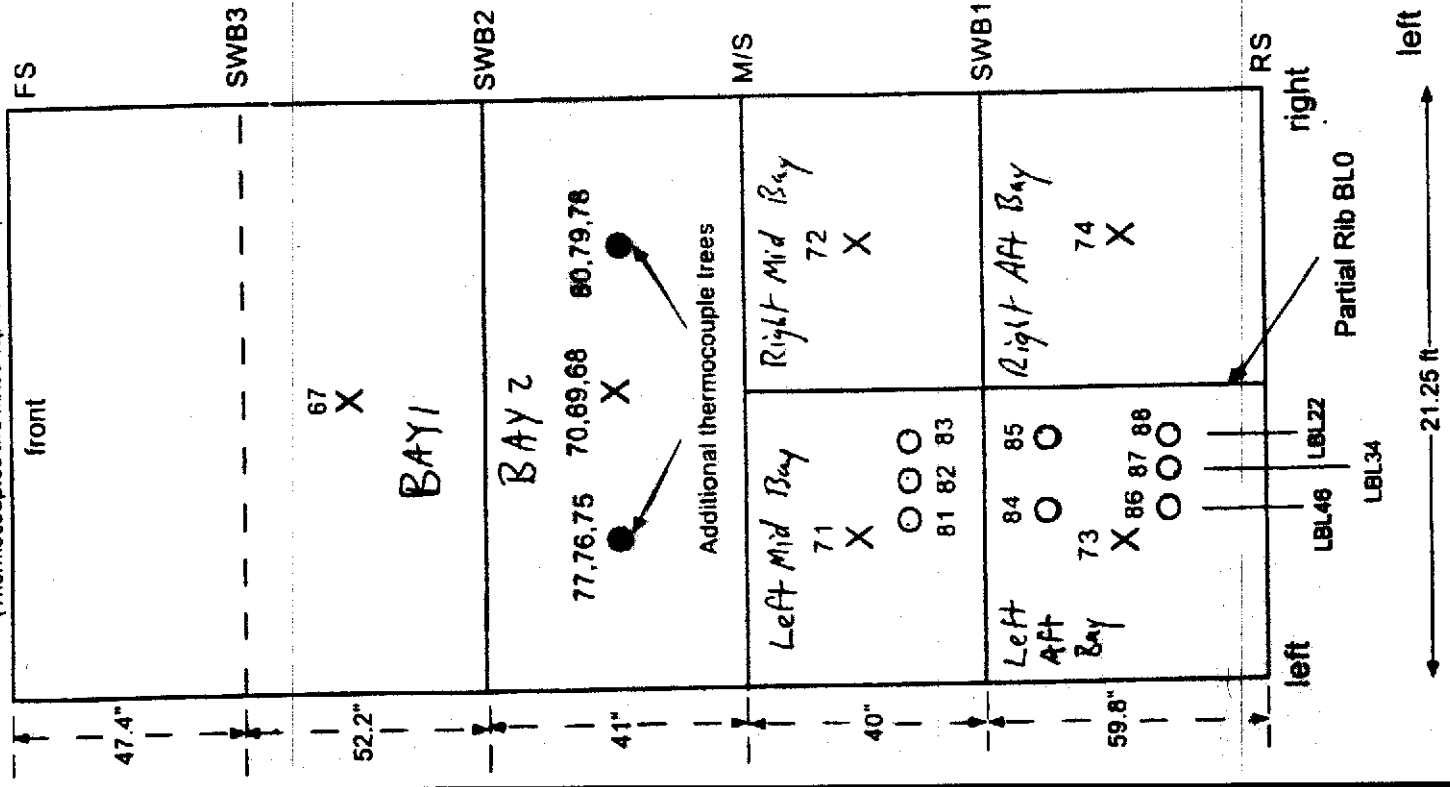
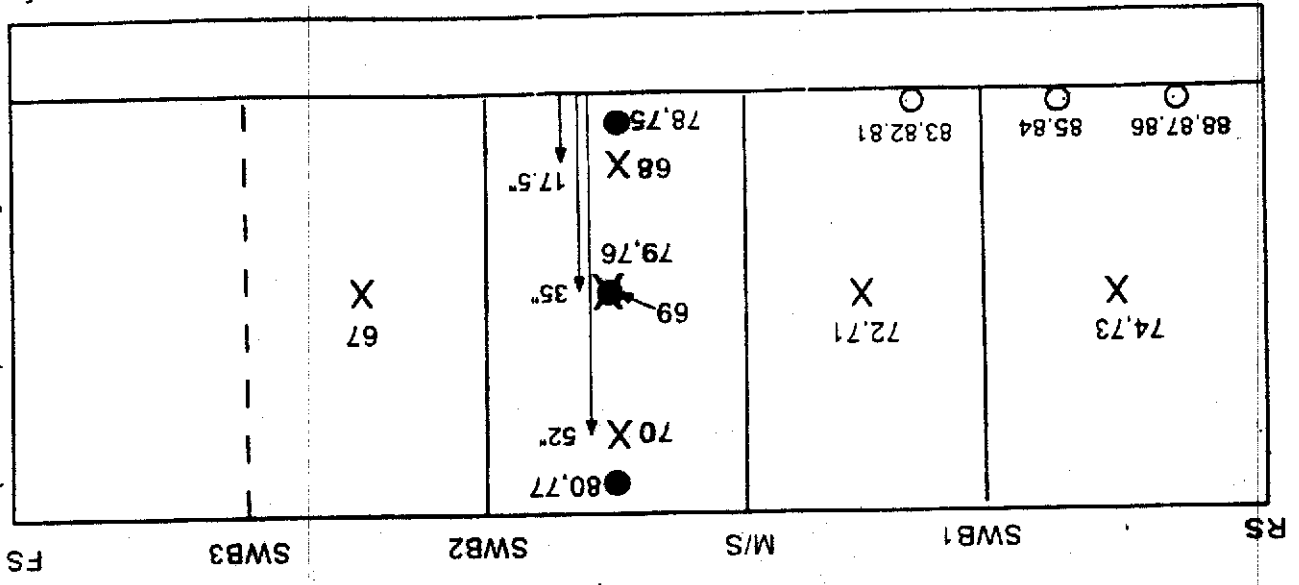
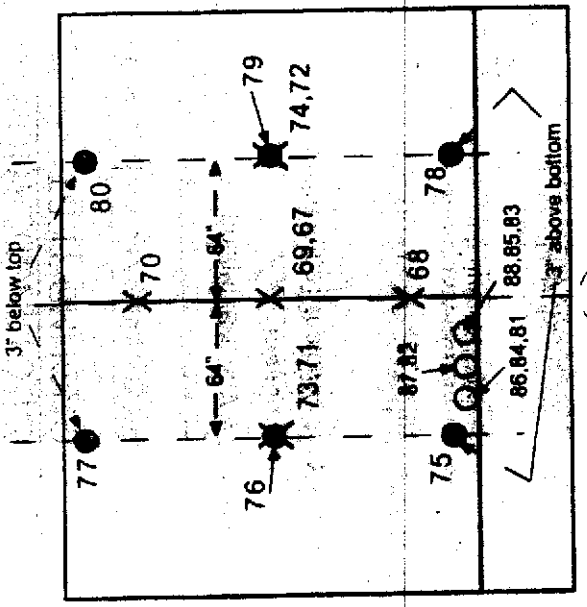
Figure 2.3 CWT internal instrumentation locations.

747 INTERNAL CWT INSTRUMENTATION ECS DUCT INSULATION GROUND TEST

- X = Vapor Sampling Probe Locations
- = Ambient Temperature Thermocouple Trees
- = Surface Temperature Thermocouples

Vapor samples of the ullage in each bay of the CWT were obtained during the first and third test. These samples were drawn near the middle of the volume of each bay, and at three different heights in Bay 2. The eight sample port locations are shown in Figure 2.3.

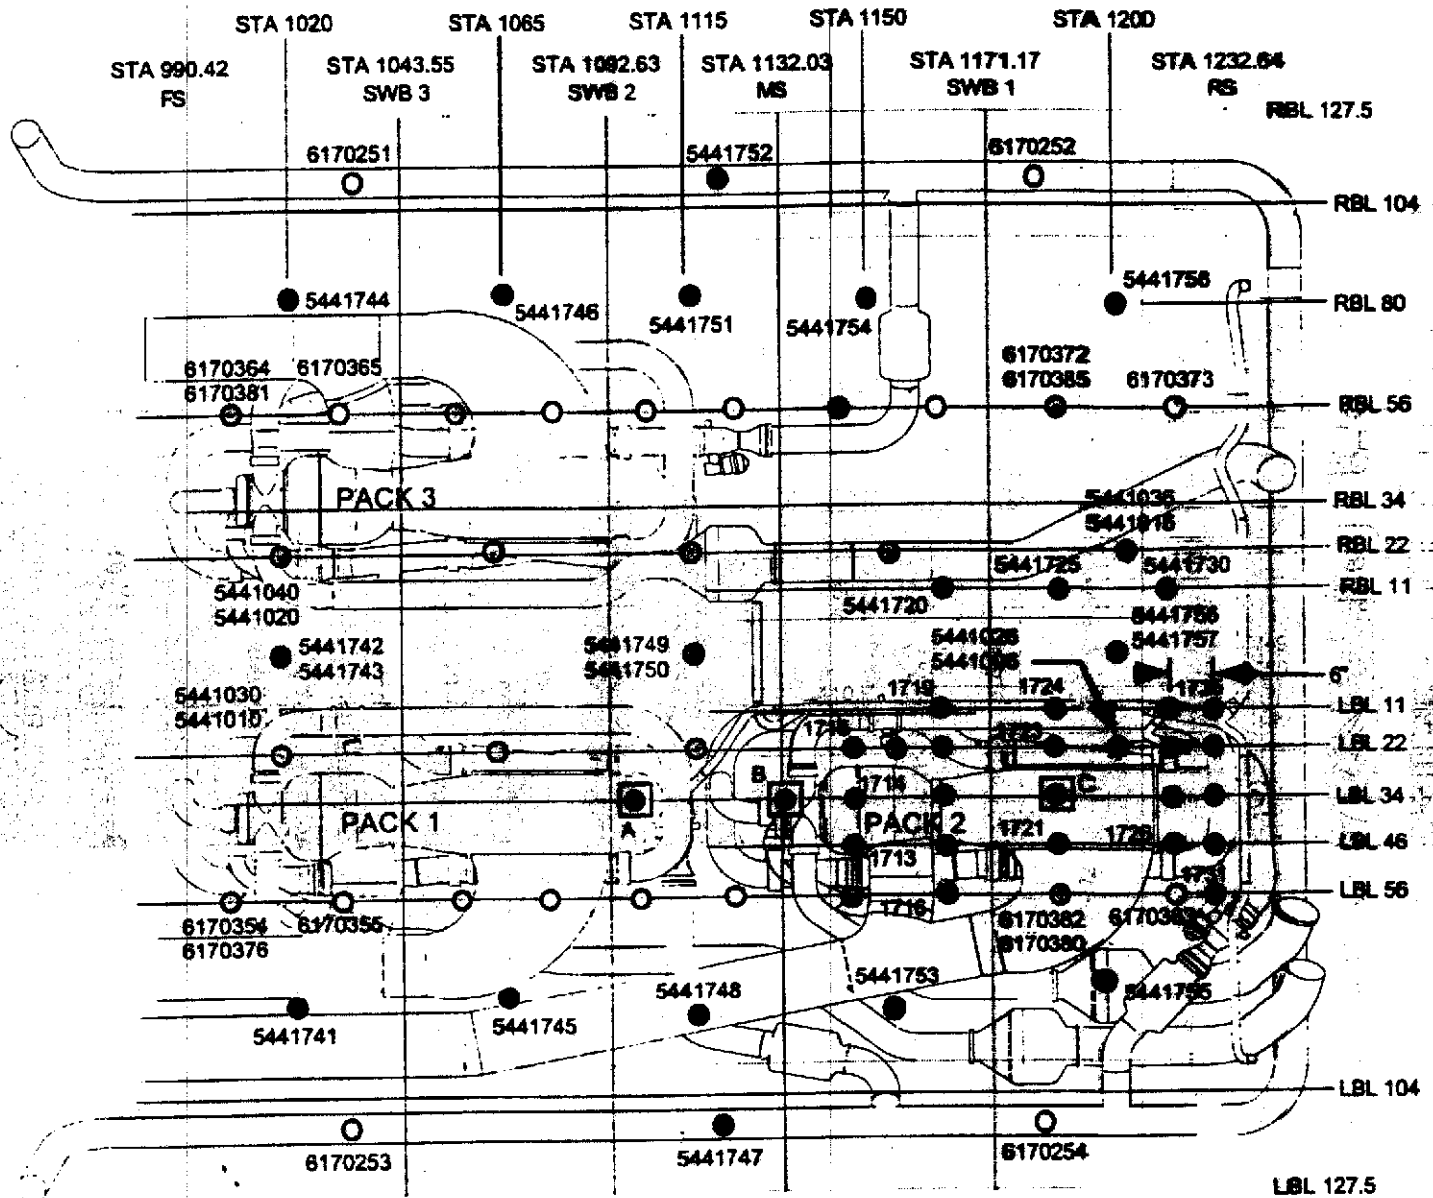
Figure 2.4 CWT internal instrumentation locations.

747-100 PACK BAY INSTRUMENTATION (CWT LOWER PANEL ONLY)

- NEW SURFACE TEMP (12 TOTAL)
 - NEW SURFACE & AMBIENT TEMP (6 TOTAL)
 - EXISTING SURFACE & AMBIENT TEMP W/ SENSOR NUMBER (40 TOTAL)
 - EXISTING SURFACE TEMP W/ SENSOR NUMBER (14 TOTAL)
 - NEW SURFACE TEMP (22 TOTAL, SUPPLIED BY NTSB)
 - NEW HEAT TRANSFER GAGE (3 TOTAL, SUPPLIED BY NTSB)
- A 5441781 (SENSOR), 5441781 (HEAT TRANSFER GAGE), 5441791 (RADIATION GAGE)
 B 5441783 (SENSOR), 5441783 (HEAT TRANSFER GAGE), 5441793 (RADIATION GAGE)
 C 5441782 (SENSOR), 5441782 (HEAT TRANSFER GAGE), 5441792 (RADIATION GAGE)

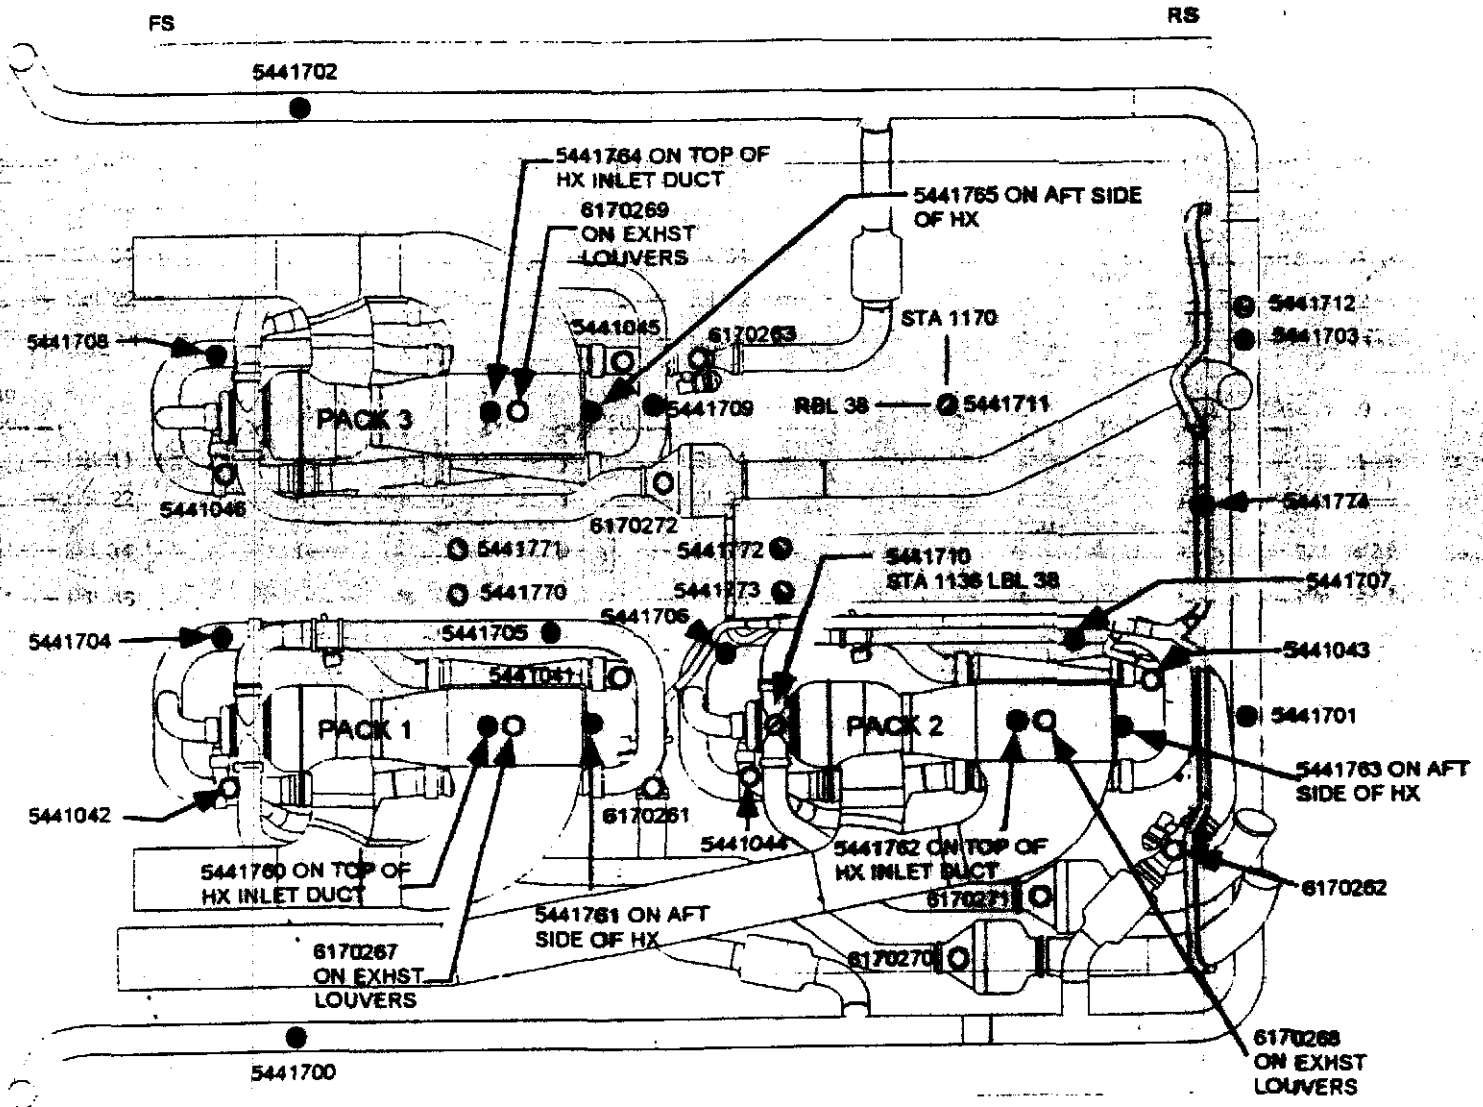
Figure 2.5 ECS pack instrumentation.

747-100 PACK BAY INSTRUMENTATION (ECS ONLY)

- NEW DUCT/HARDWARE SURFACE TEMP (14 TOTAL)
- ⊕ NEW INSULATION SURFACE TEMP (1 TOTAL)
- ⊙ NEW DOOR PANEL INSIDE SURFACE TEMP (2 TOTAL)
- ⊙ NEW KEEL BEAM INSIDE SURFACE TEMP (4 TOTAL)
- EXISTING SURFACE TEMP W/ SENSOR NUMBER (12 TOTAL)

All temperature measurements were made with Type E thermocouples. Thermocouples were used to acquire surface temperature measurements of the interior surfaces of the CWT. Thermocouples were also positioned free from the interior surface, to acquire ullage, or fuel ambient, temperatures. The locations and identification of these thermocouples are shown in Figures 2.1–2.3. Exterior to the CWT, 97 thermocouples were used to measure its bottom surface temperatures and the ambient temperatures within the pack bay. The locations and identification of these thermocouples are shown in Figure 2.4. The surface temperatures of various ECS components were also measured. 38 thermocouples were located at the component locations shown in Figure 2.5.

Total heat transfer and radiation heat transfer gages were installed on the bottom exterior CWT surface within the pack bay. These gages locations are shown in Figure 2.5. However, due to technical difficulties, valid measurements were not obtained from these instruments, and are not included in this report.

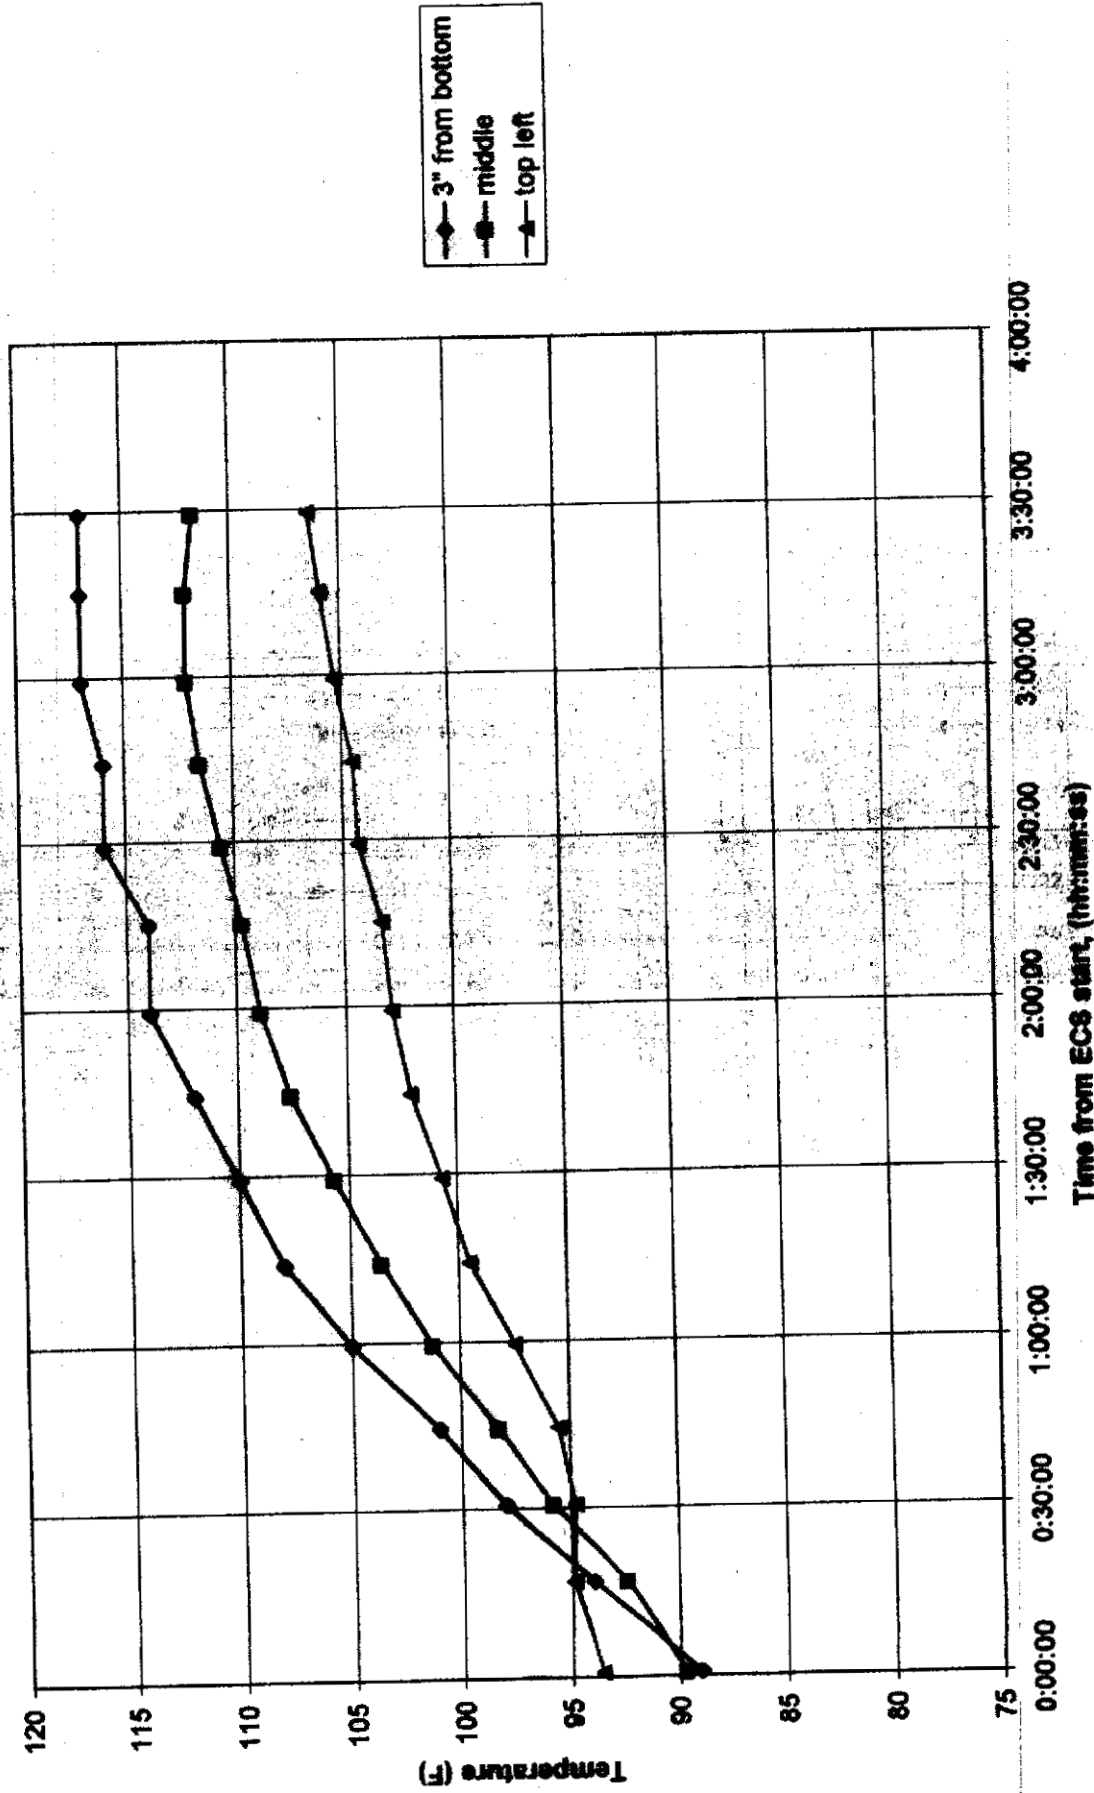
Figure 3.1a Bay 1 outage temperatures, Test 1.

Test 1
Bay 1

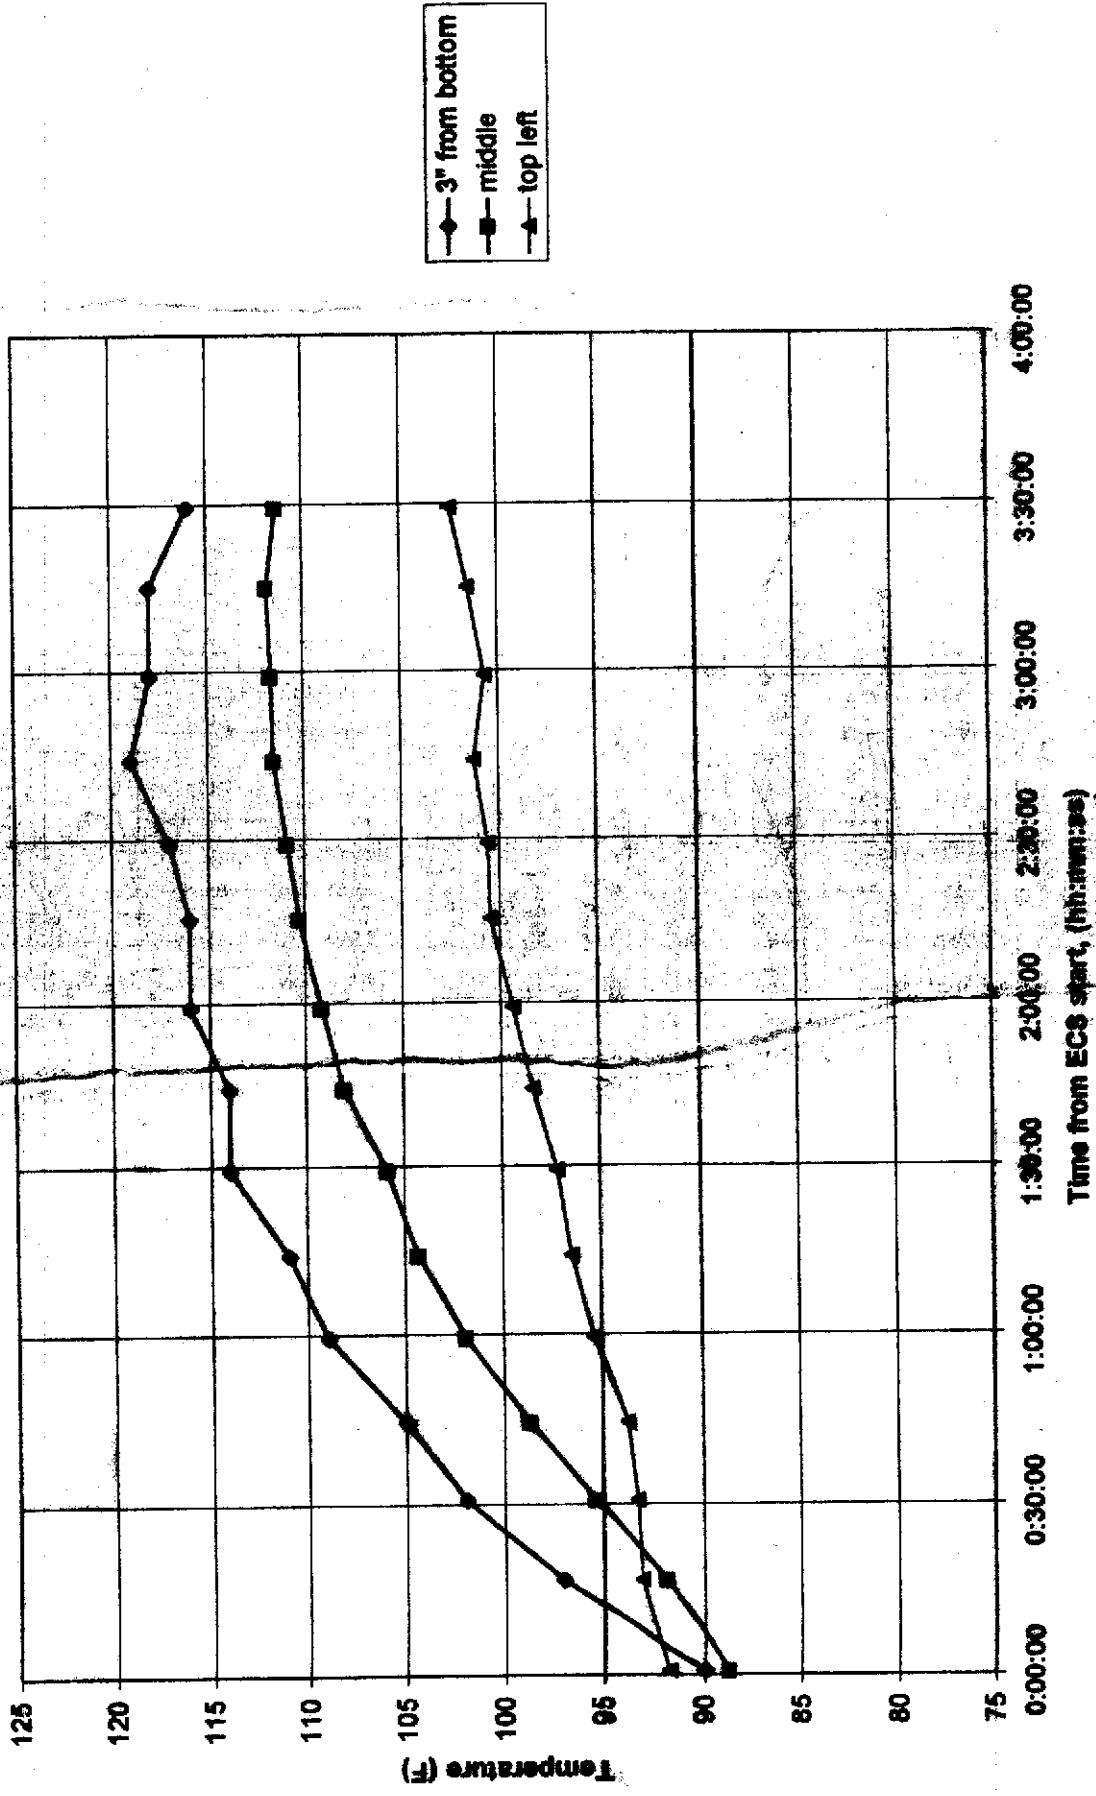
Figure 3.1b Bay 2 off-gas temperatures, Test 1

Test 1
Bay 2

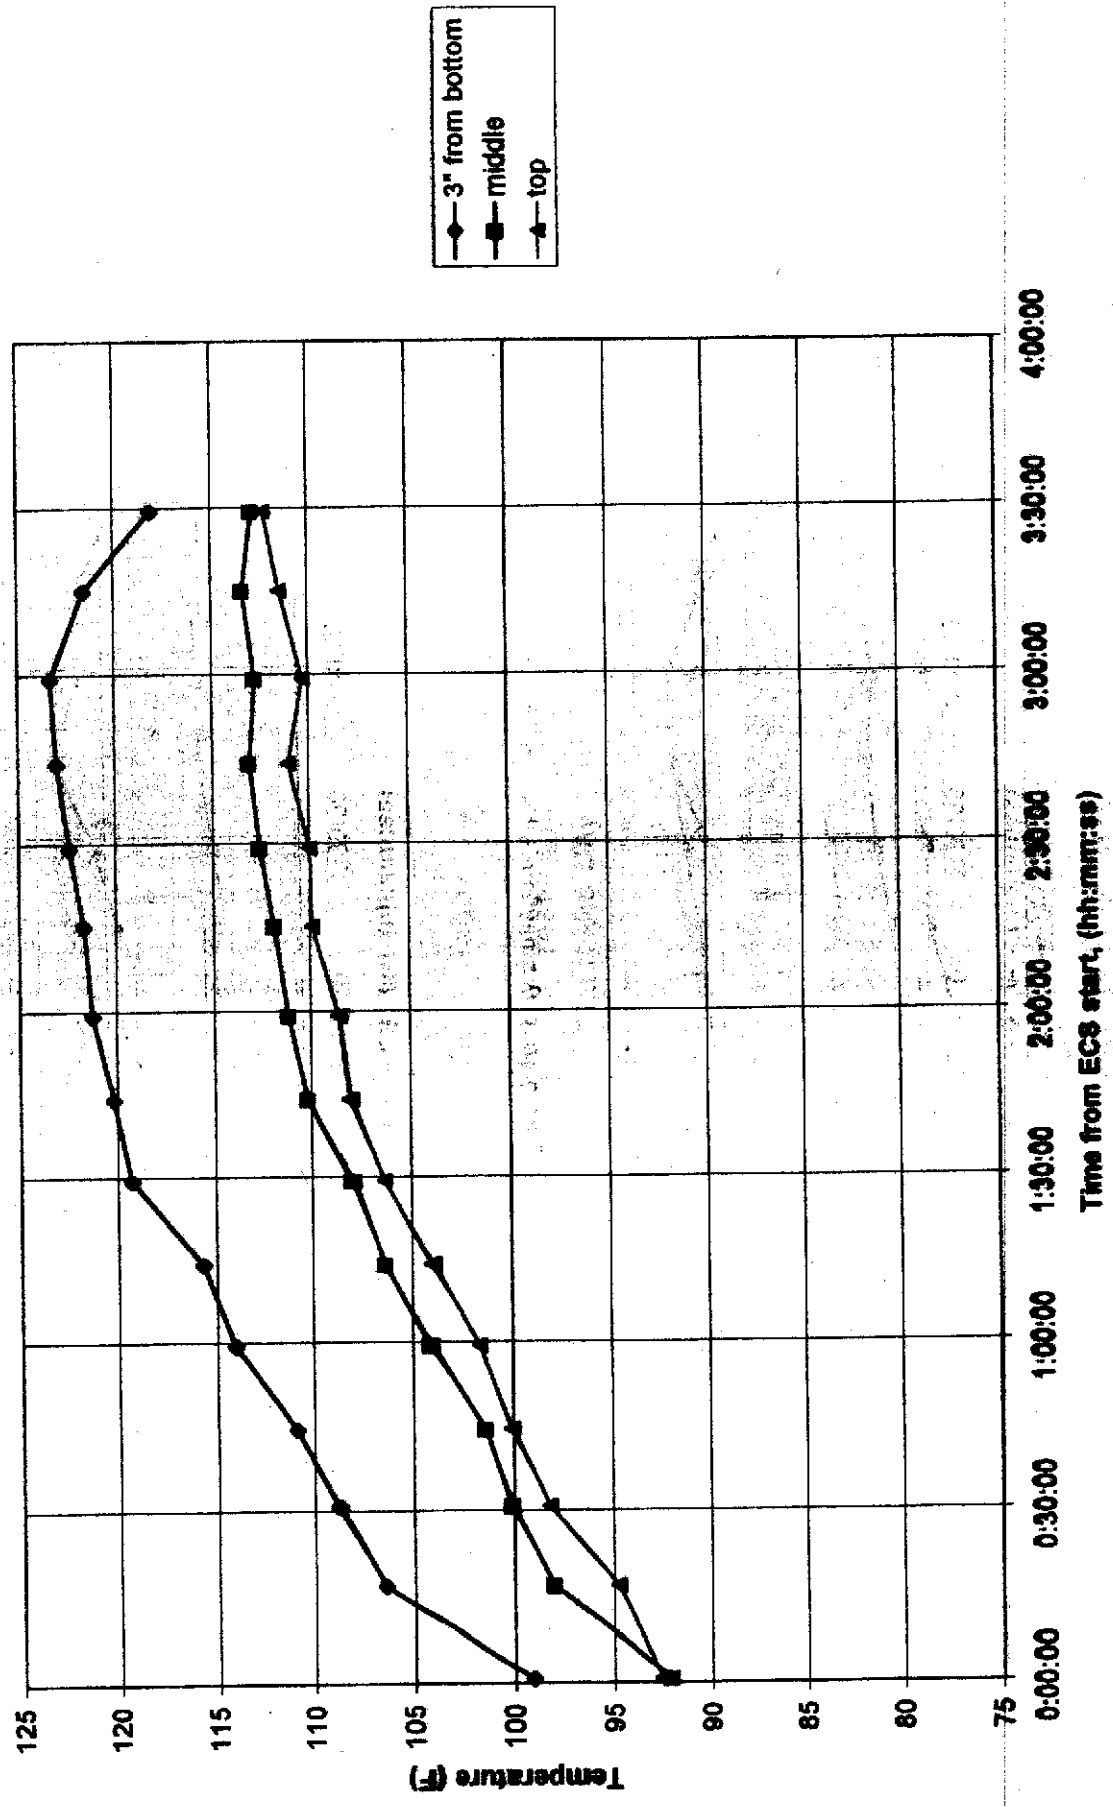
Figure 3.1c Left Mid Bay ullage temperatures, Test1.

Test 1
Left Mid Bay

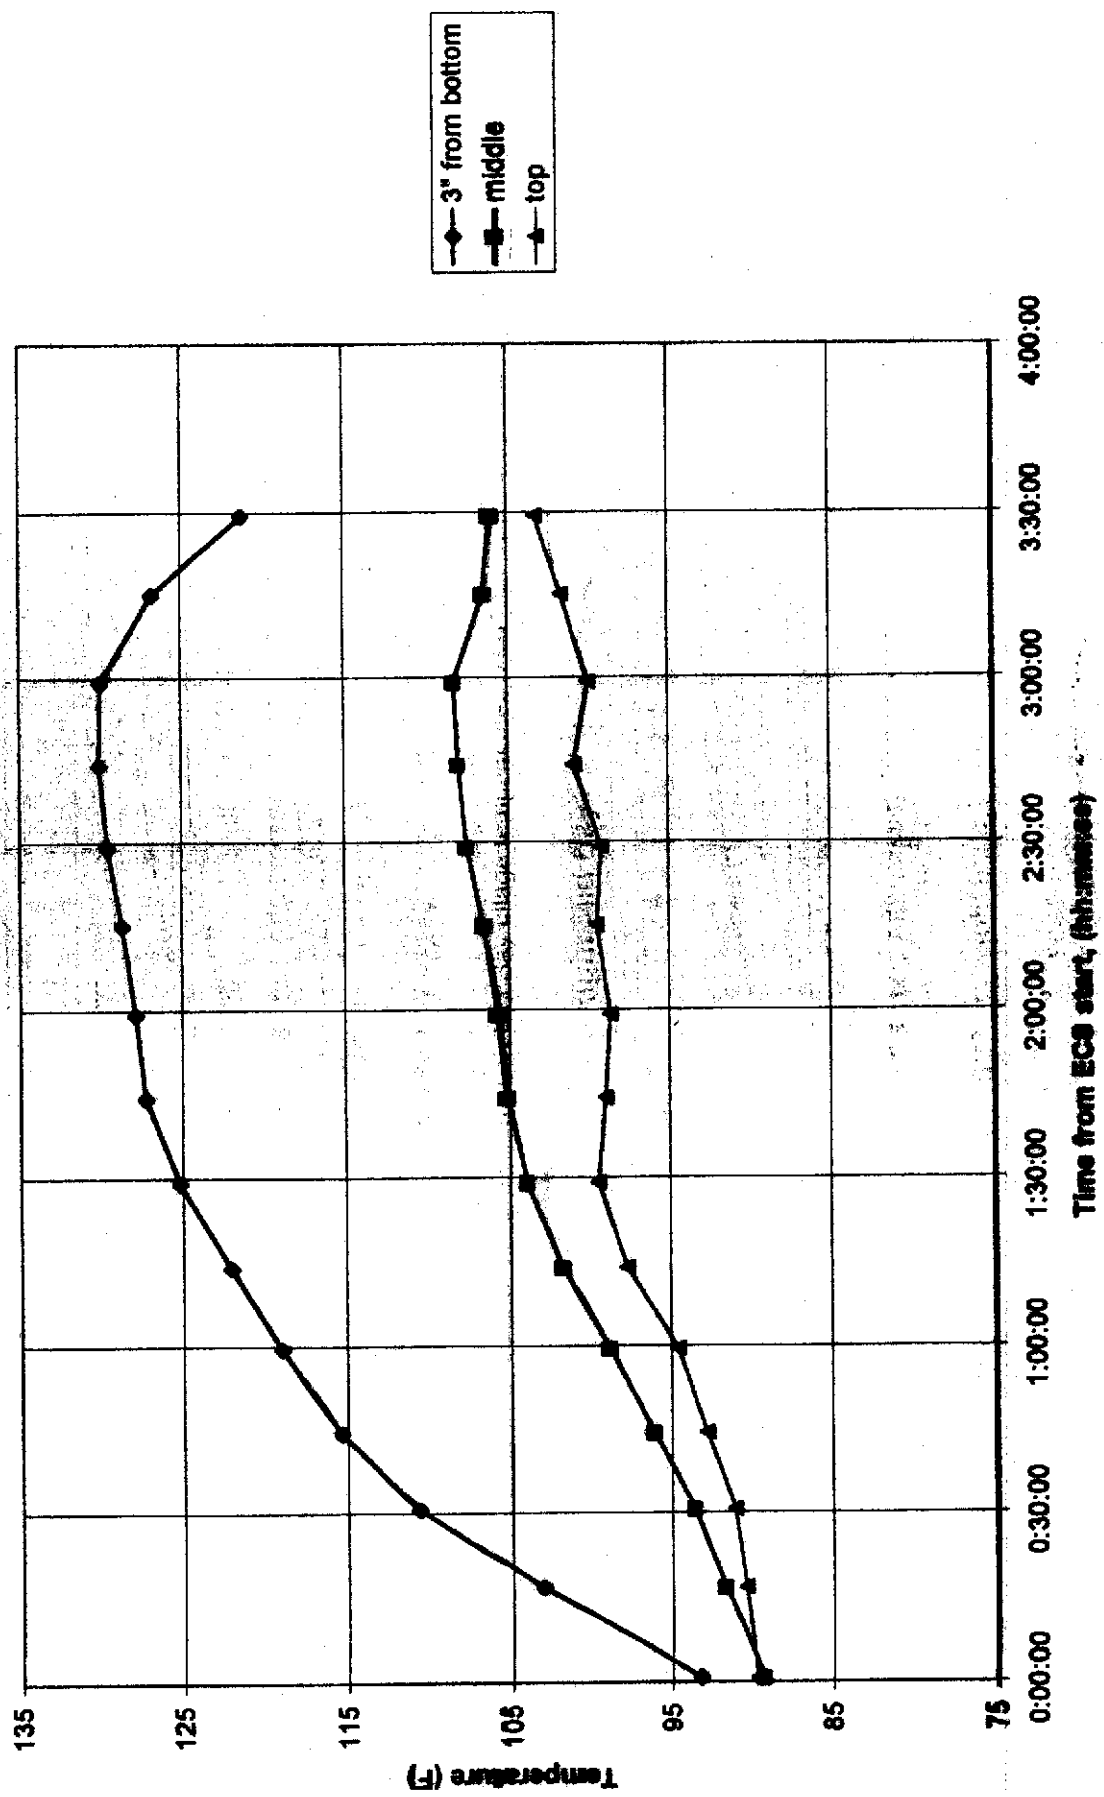
Figure 3.1d Right Mid-Bay village temperatures, Test 1.

Test 1 Right Mid Bay

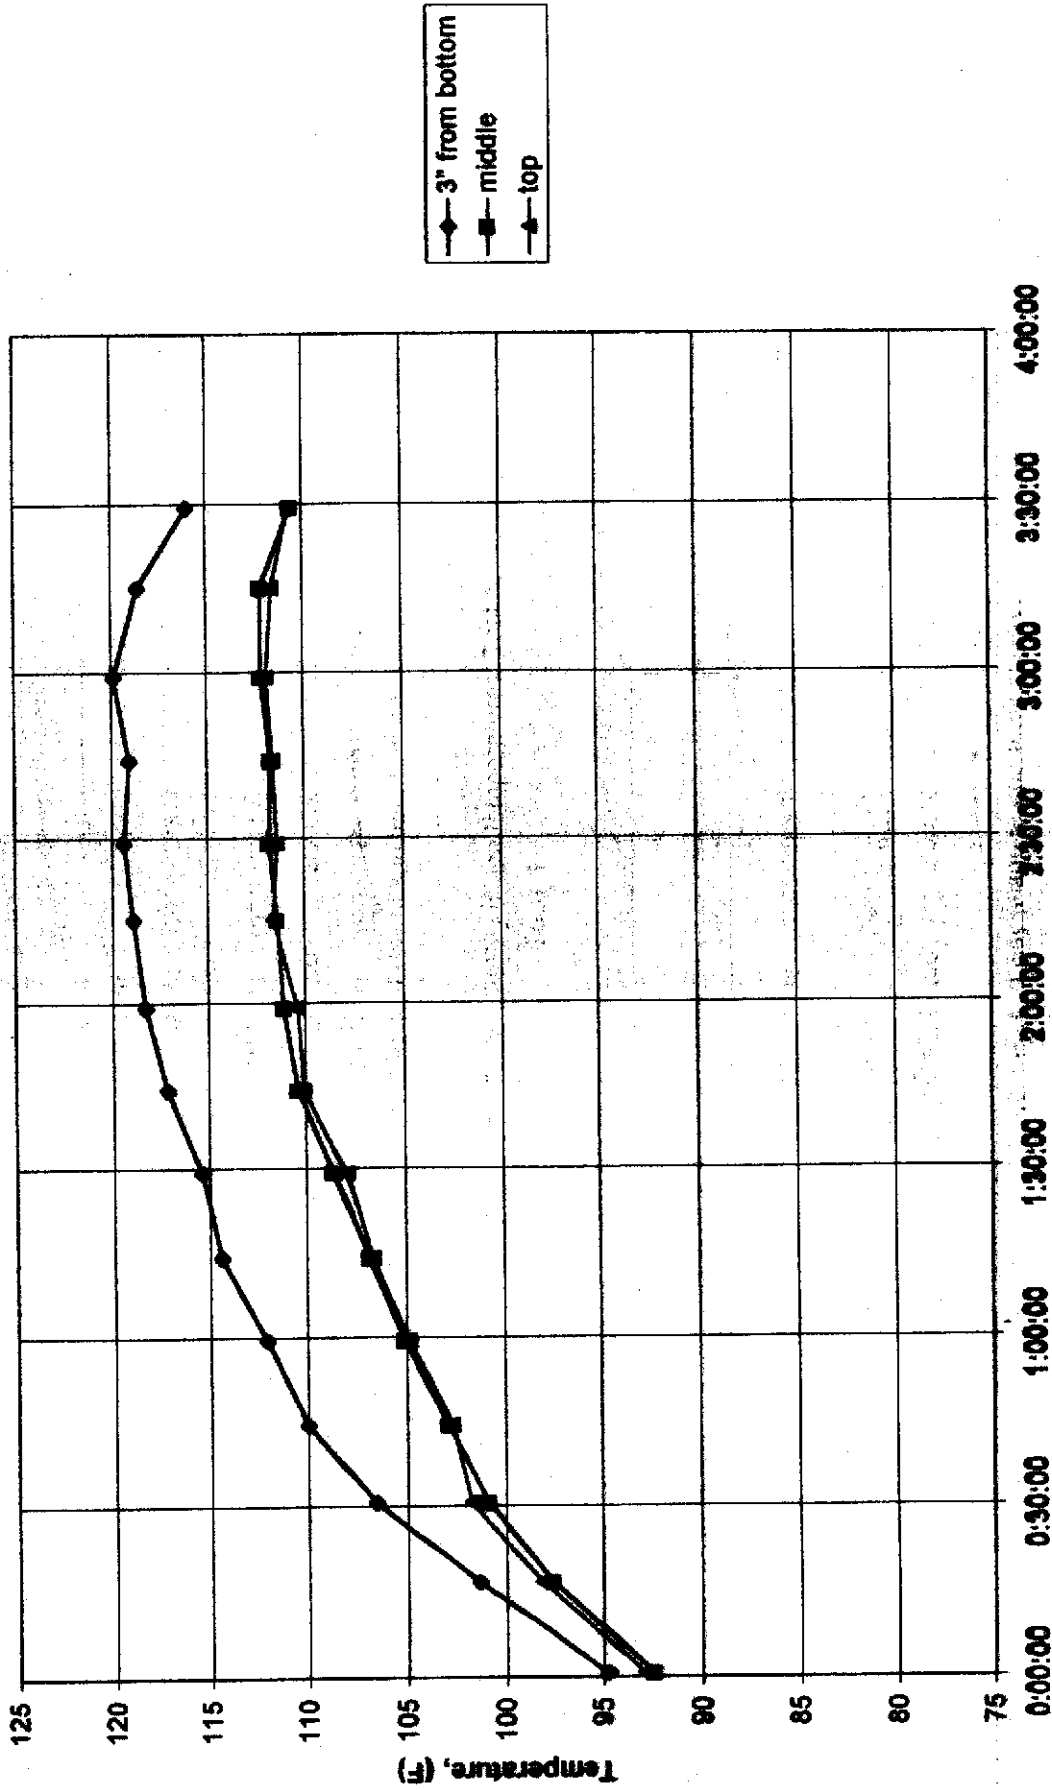
Figure 3.1e Left Aft Bay ullage temperatures, Test 1.

Test 1
Left Aft Bay

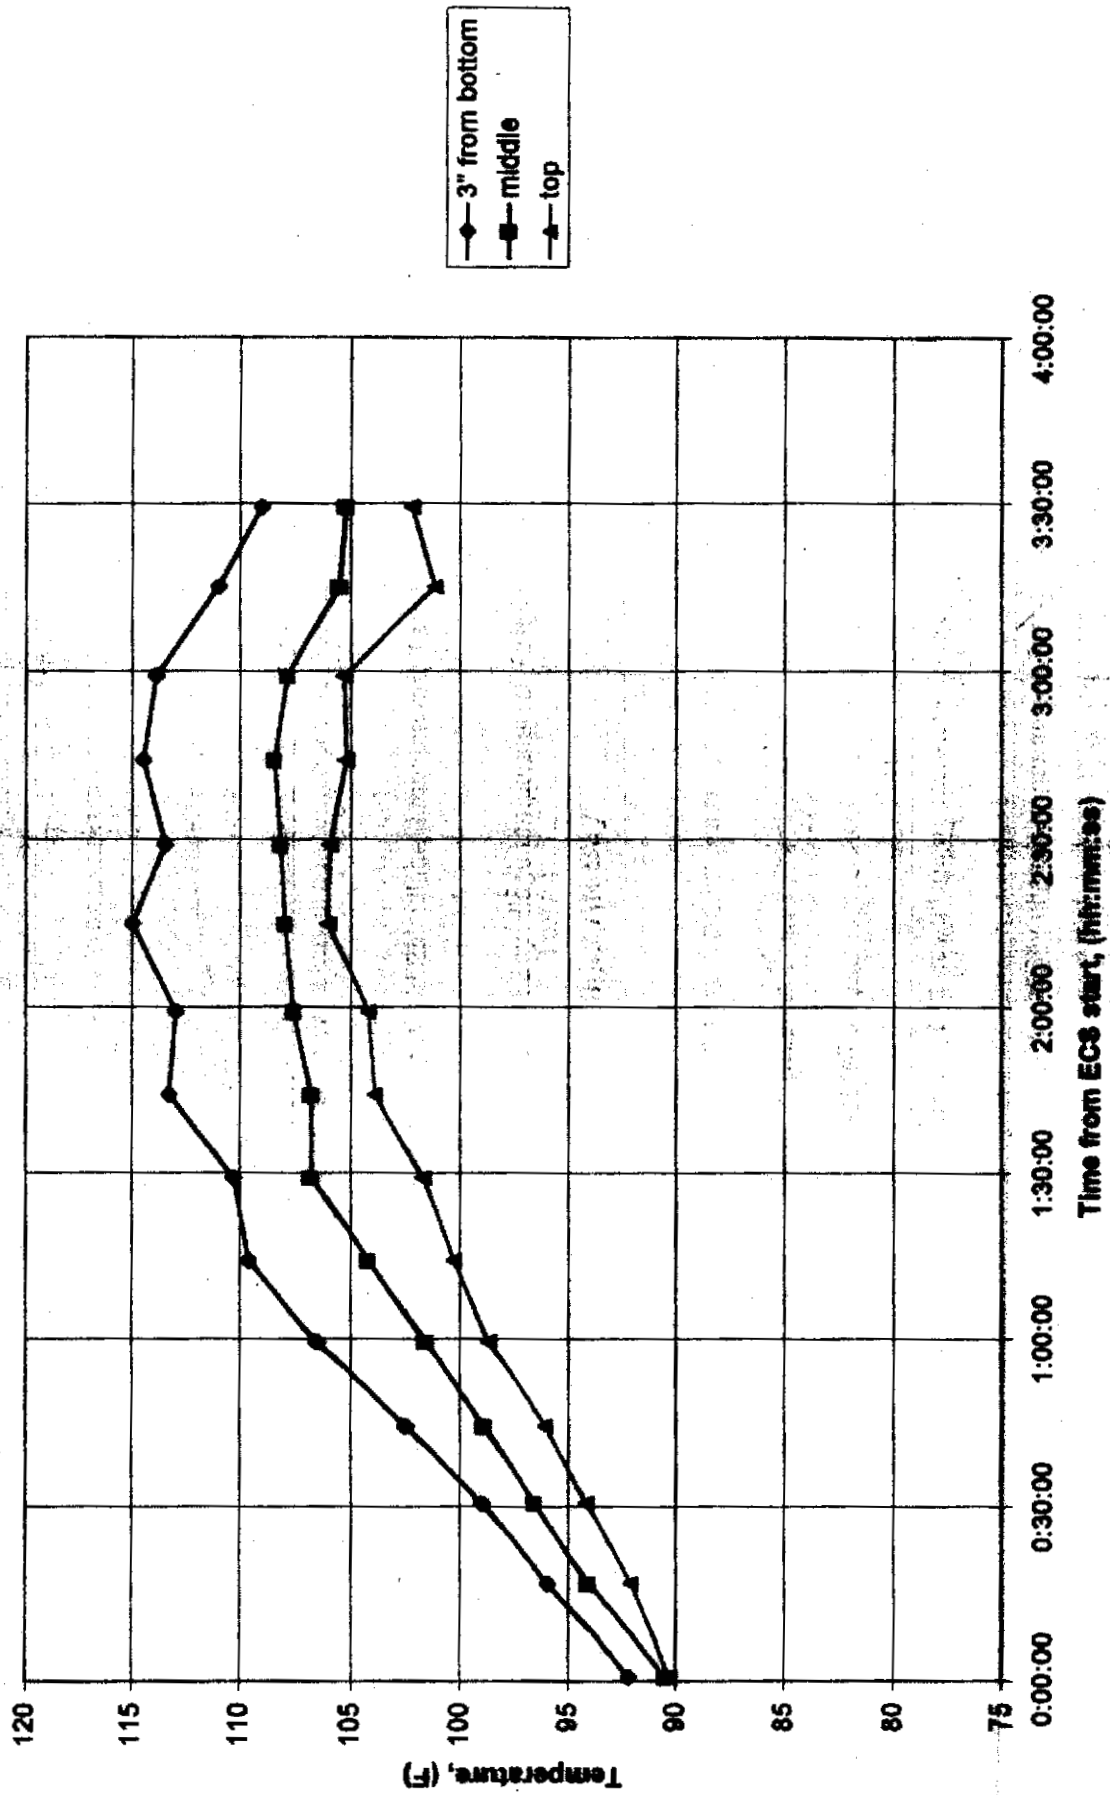
Figure 3.1f Right Aft Bay ullage temperatures, Test 1.

Test 1
Right Aft Bay
