**NATIONAL TRANSPORTATION SAFETY BOARD
WASHINGTON, D.C**

Boeing 747-100 Center Wing Tank Ground Testing

Summary Data Report:
B-747-100 Center Wing Tank Ground Testing
at Marana, AZ

Joseph Kolly
Office of Research and Engineering
National Transportation Safety Board

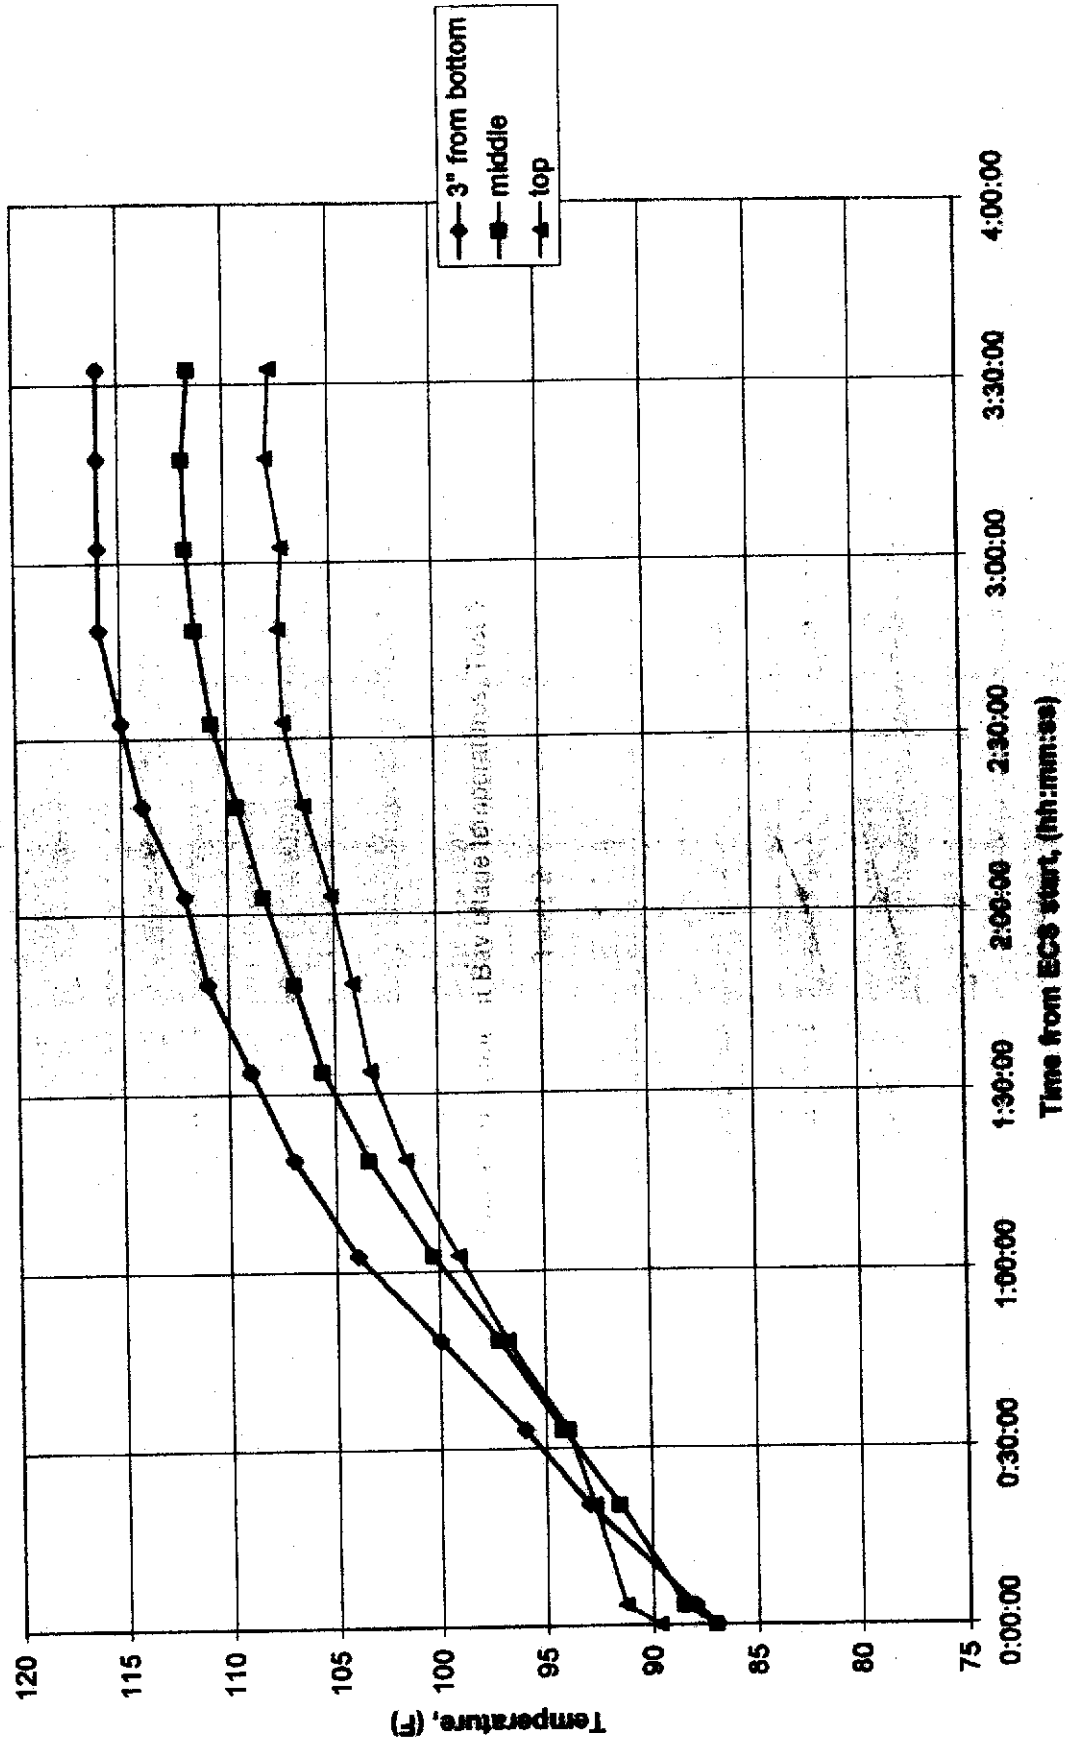
Figure 3.2a Bay 1 ullage temperatures, Test 2.

Temperature (F) vs. Time (hh:mm:ss) for Bay 1 ullage temperatures, Test 2

Test 2 Bay 1

Similar temperature - time histories for Test 2 and Test 3 are shown in Figures 3.2a-f and 3.3a-f, respectively.

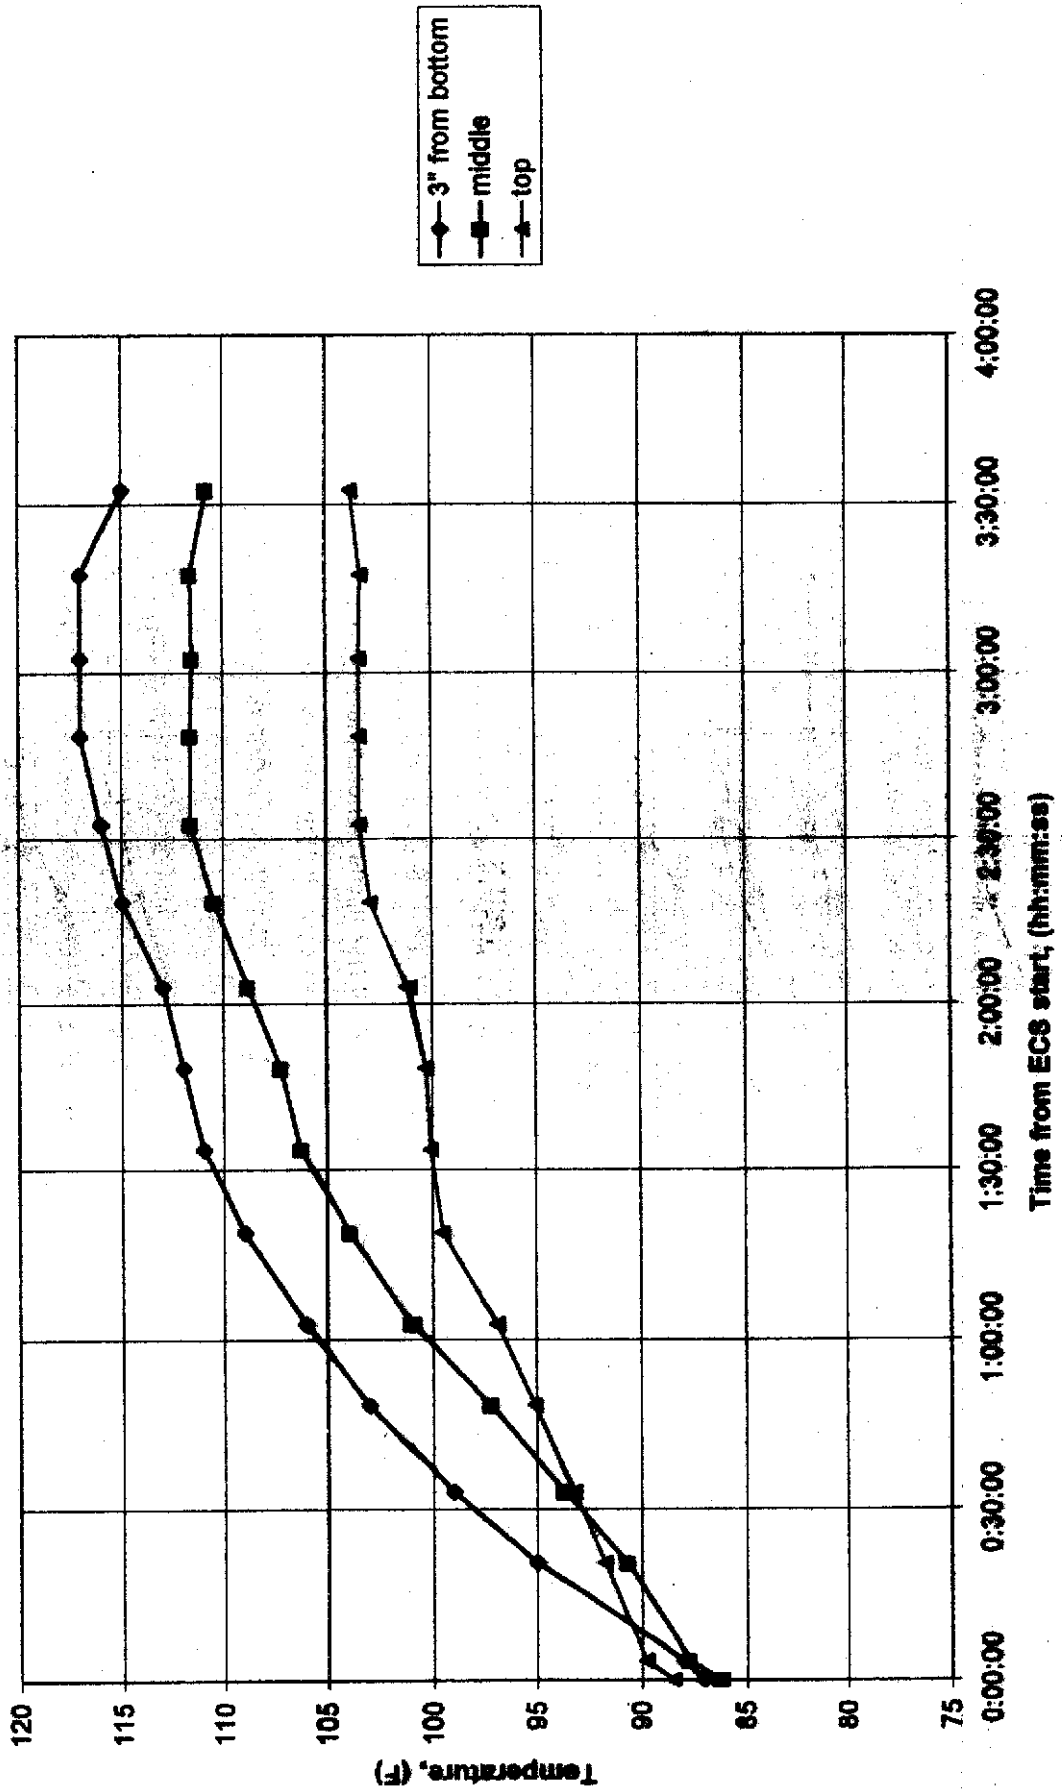
Figure 3.2b Bay 2 ullage temperatures, Test 2.

Test 2
Bay 2

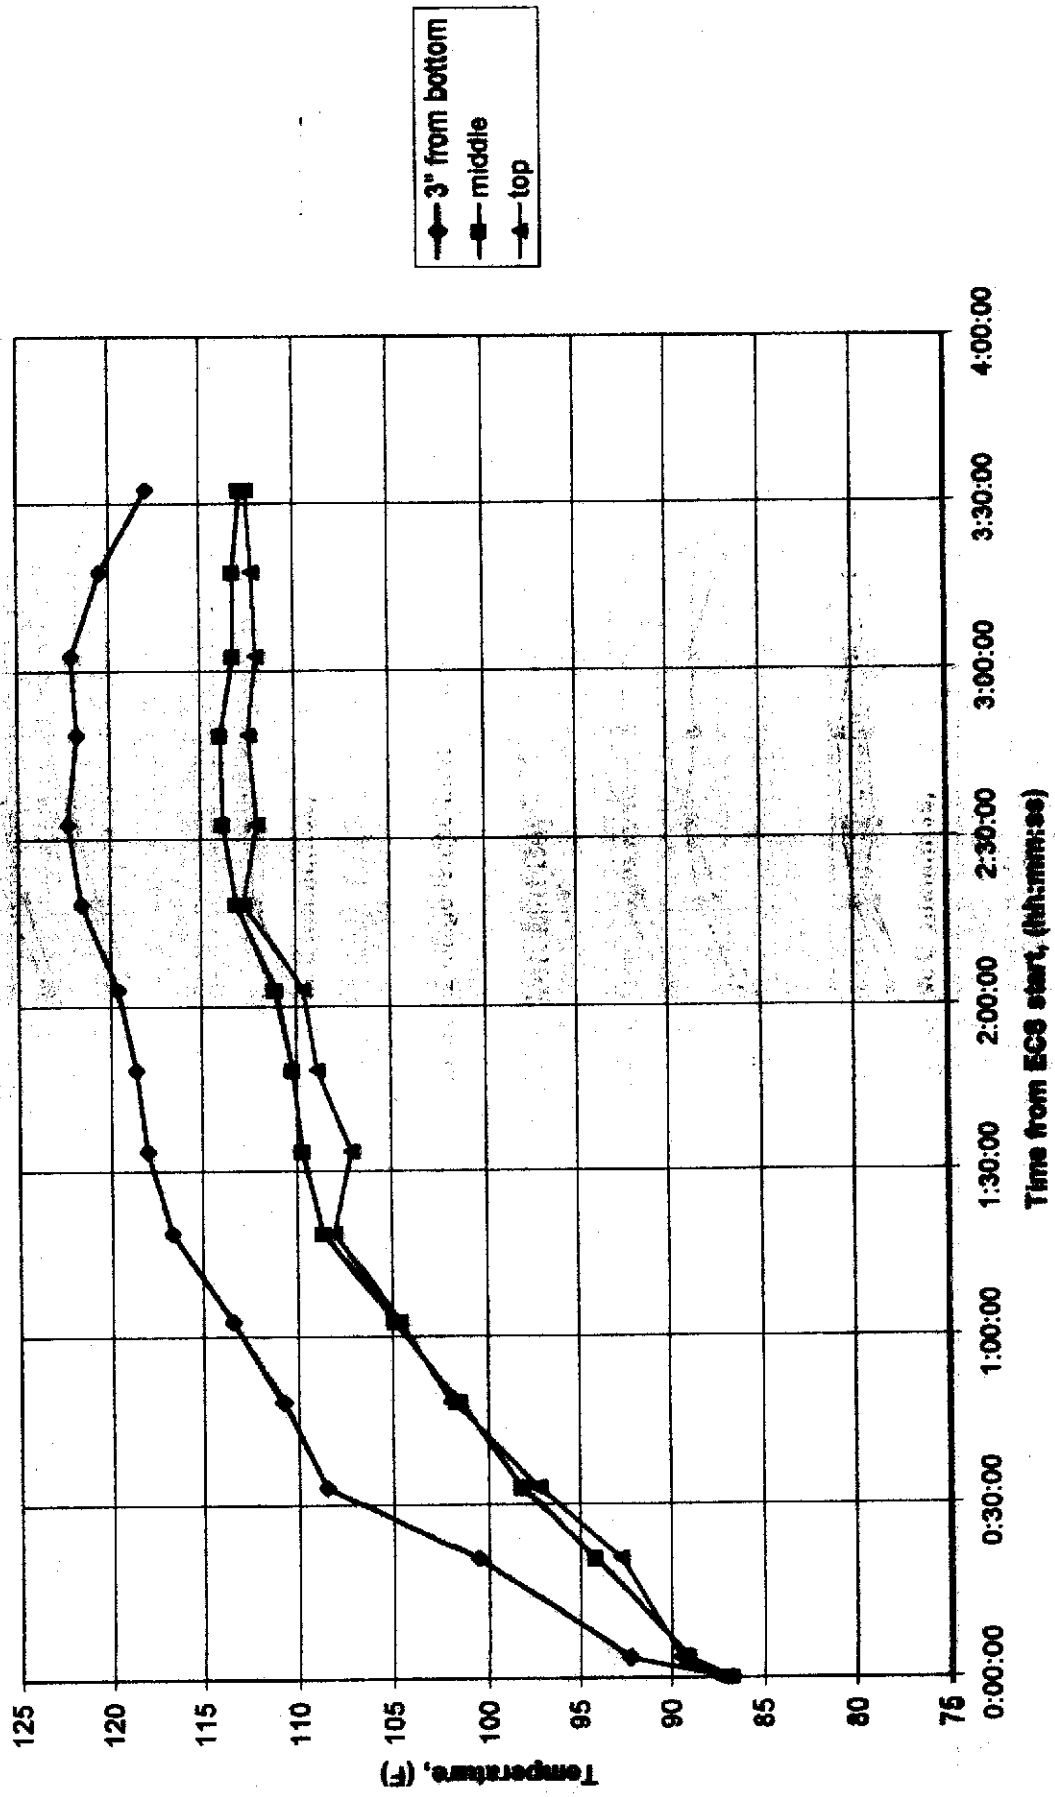
Figure 3.2c Left Mid Bay ullage temperatures, Test 2.

Test 2
Left Mid Bay

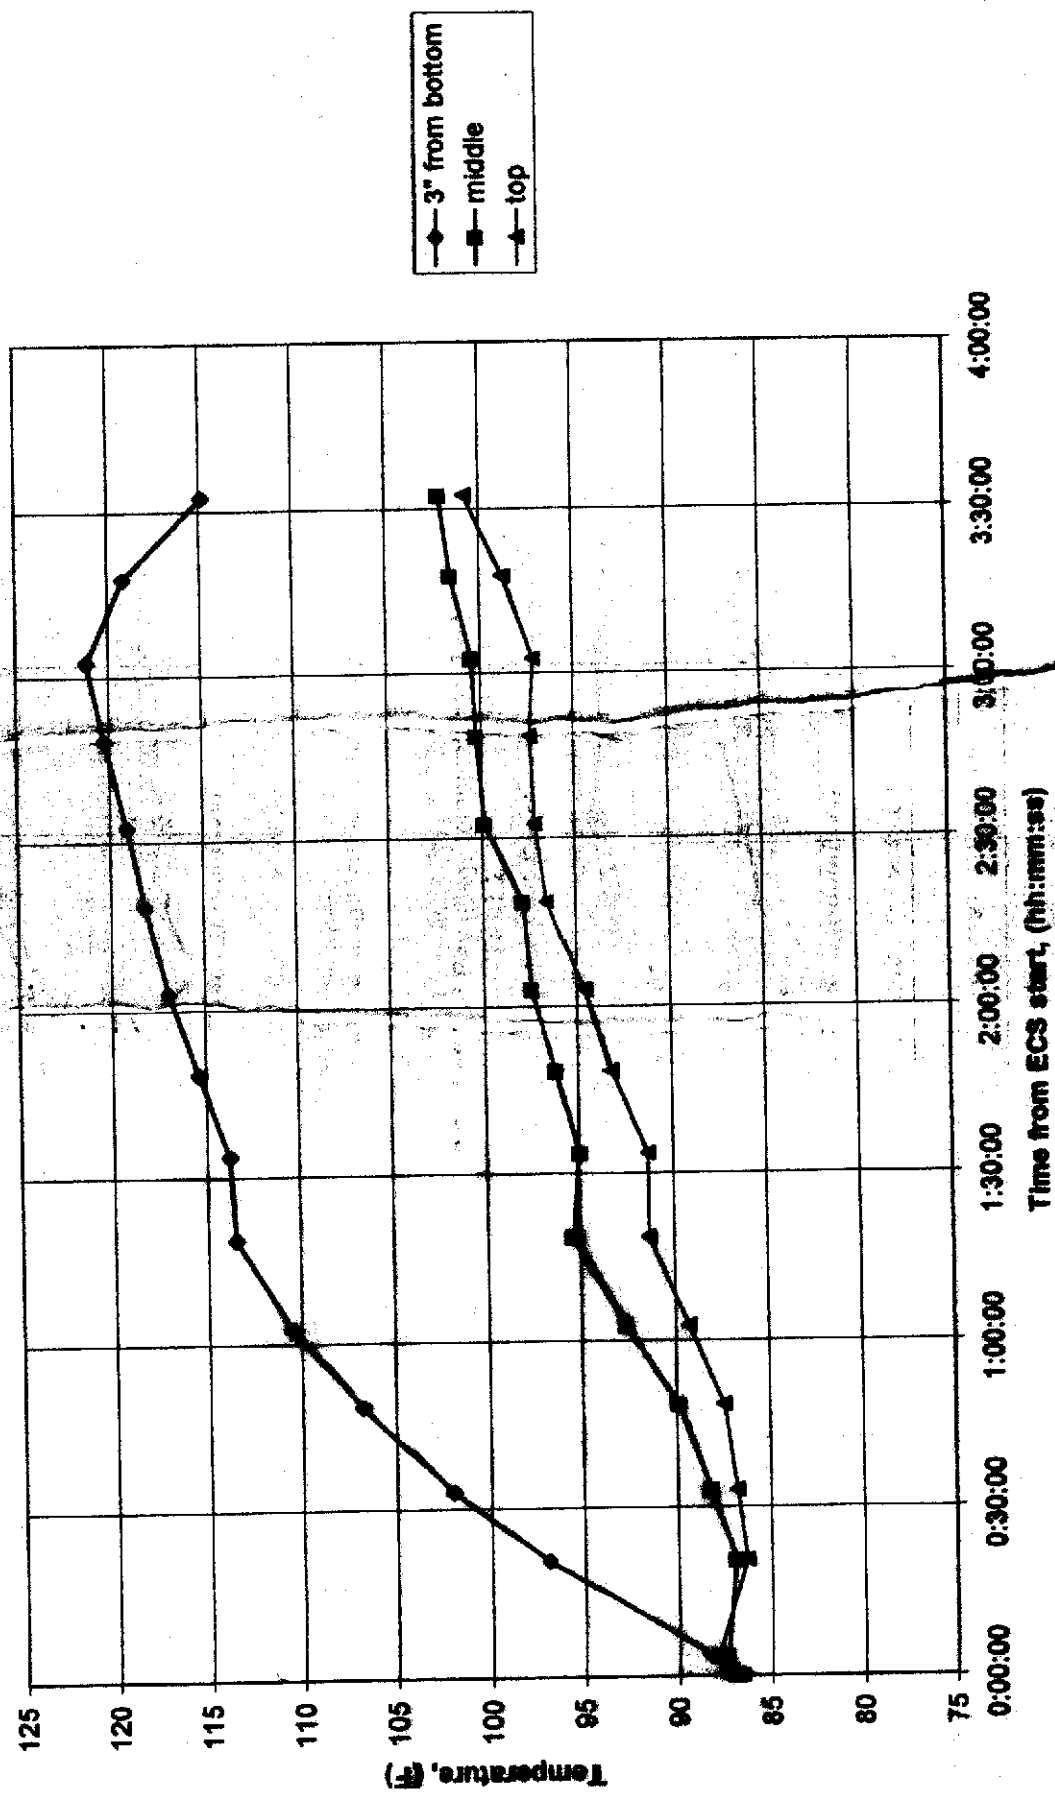
Figure 3.2d Right Mid Bay Inage Temperatures, Test 2.

Right Mid Bay
 Test 2

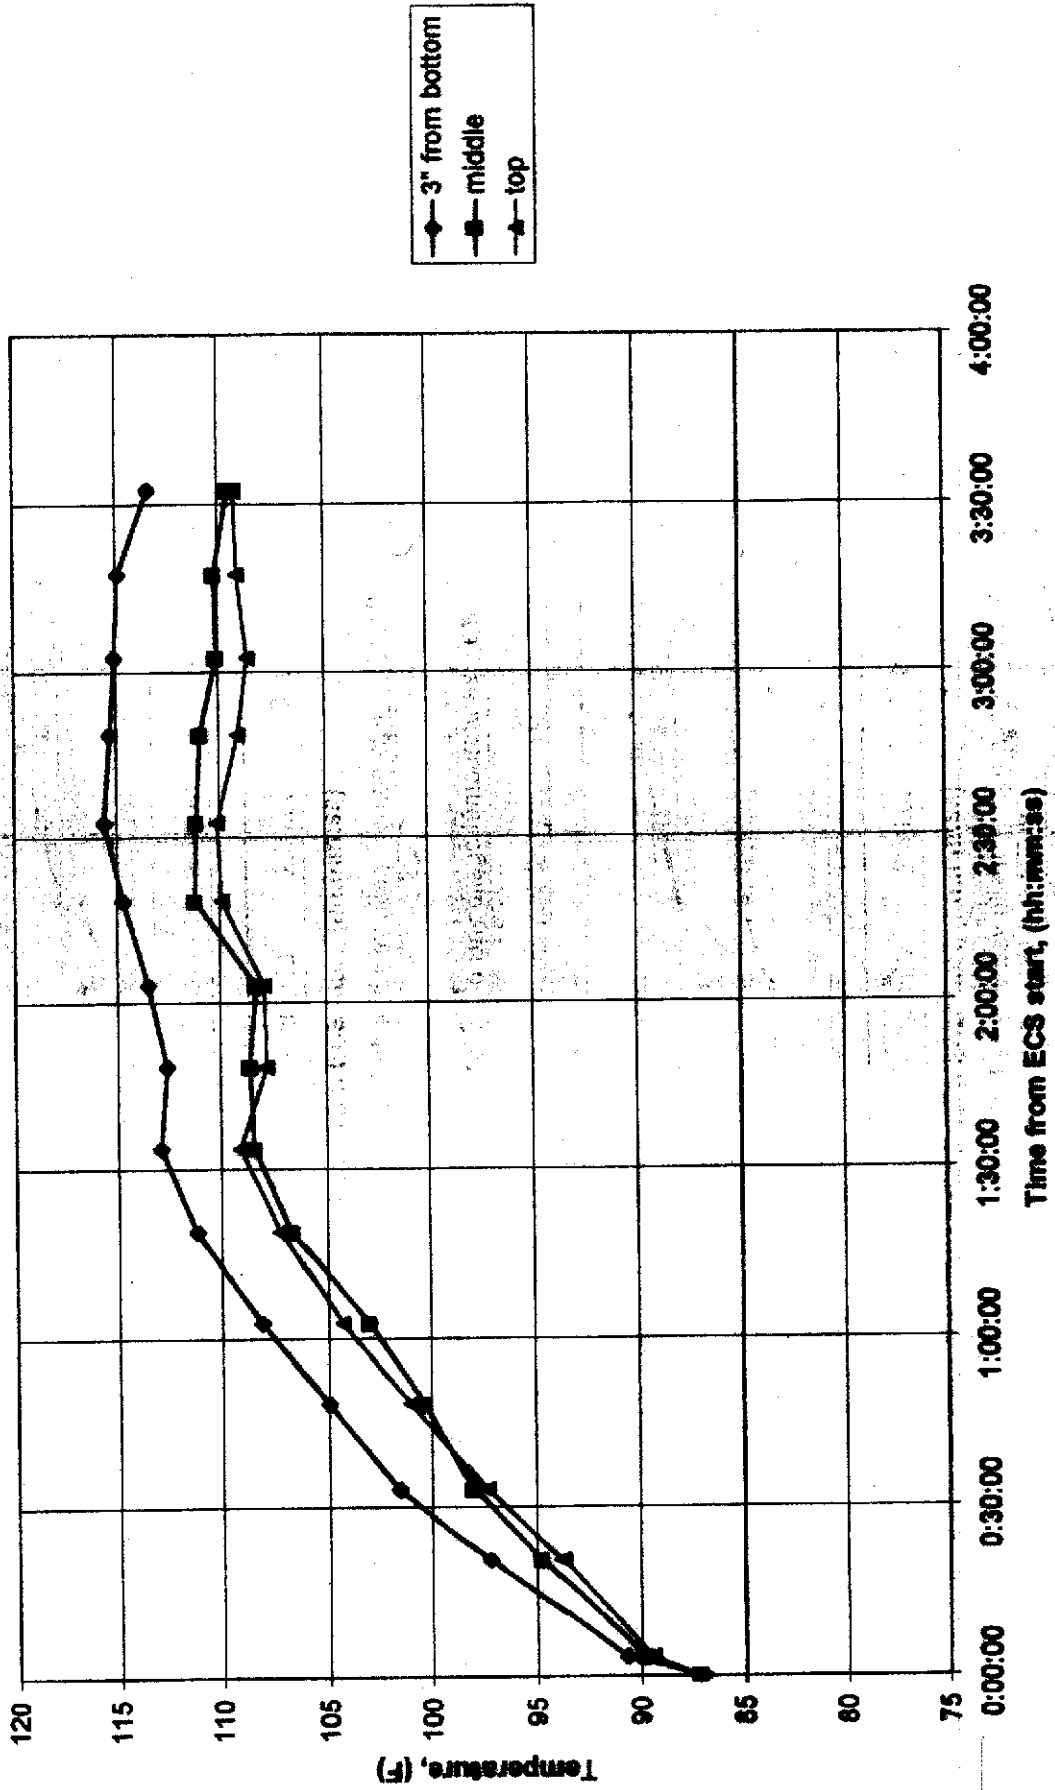
Figure 3.2e Left Aft Bay ullage temperatures, Test 2.

Test Z
Left Aft Bay

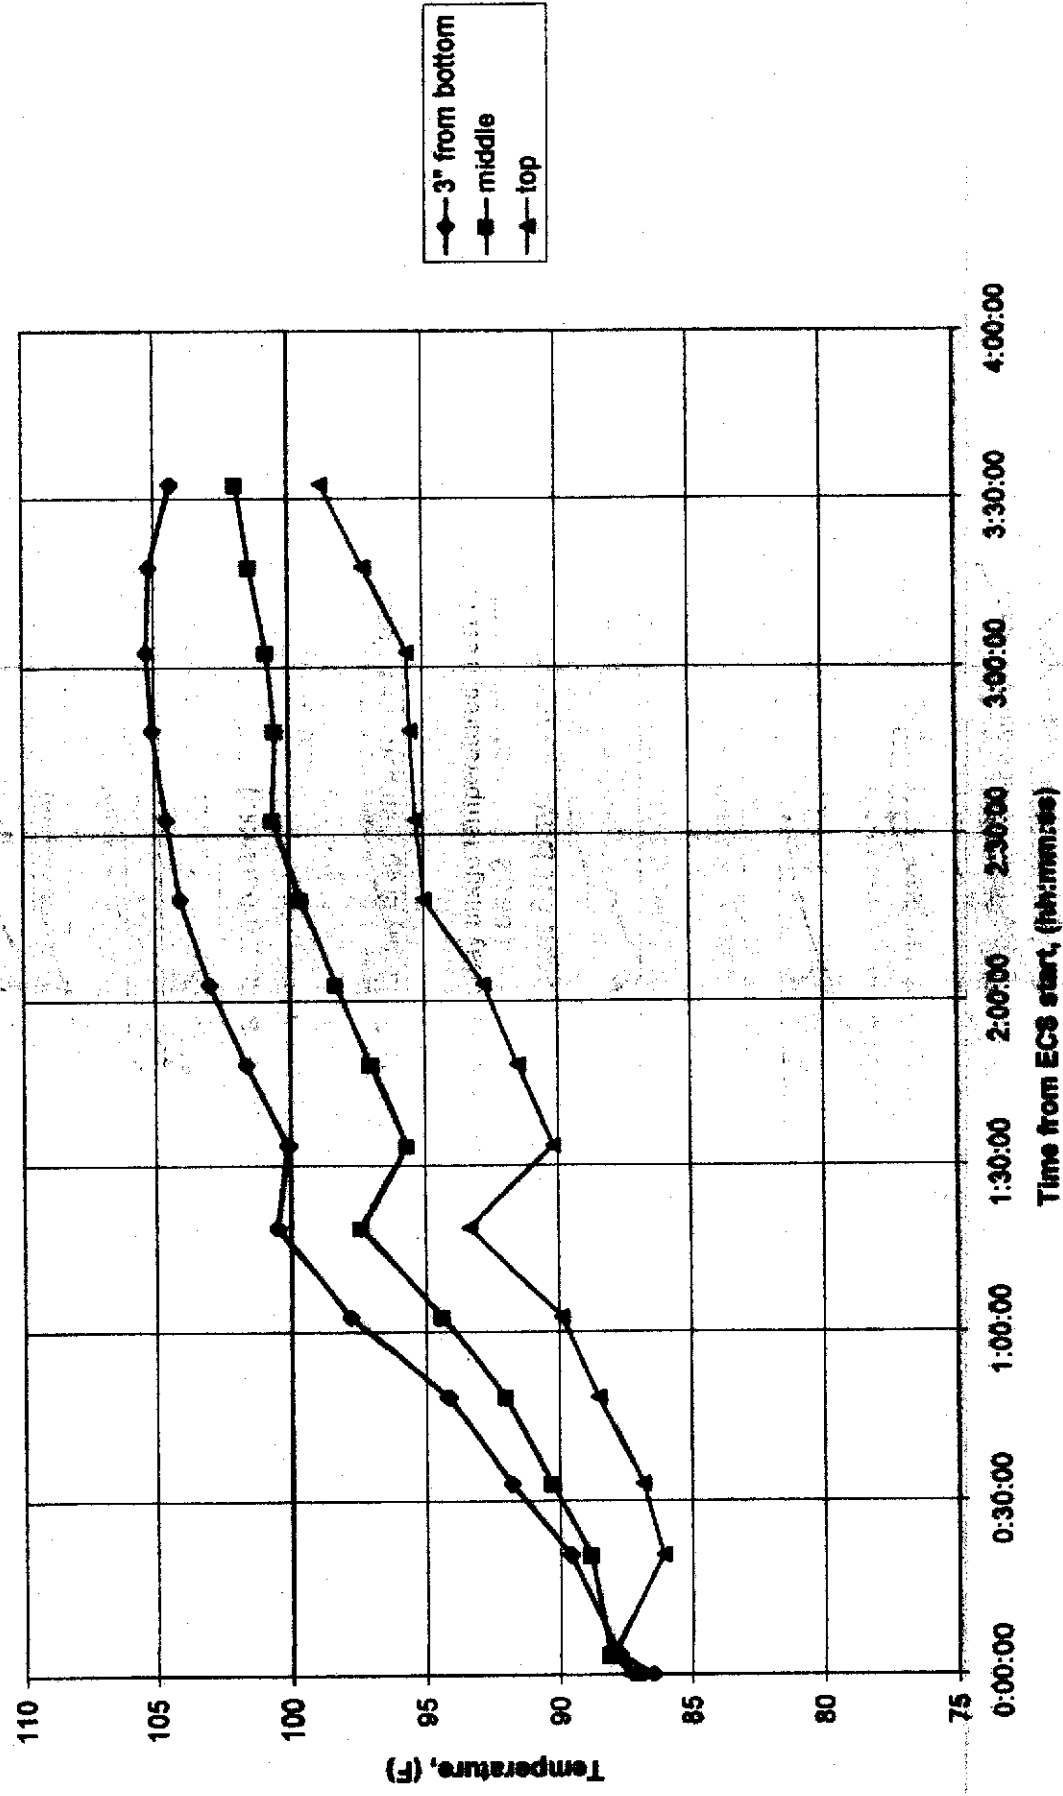
Figure 3.2f Right Aft Bay ullage temperatures, Test 2.

Right Aft Bay
 Test 2

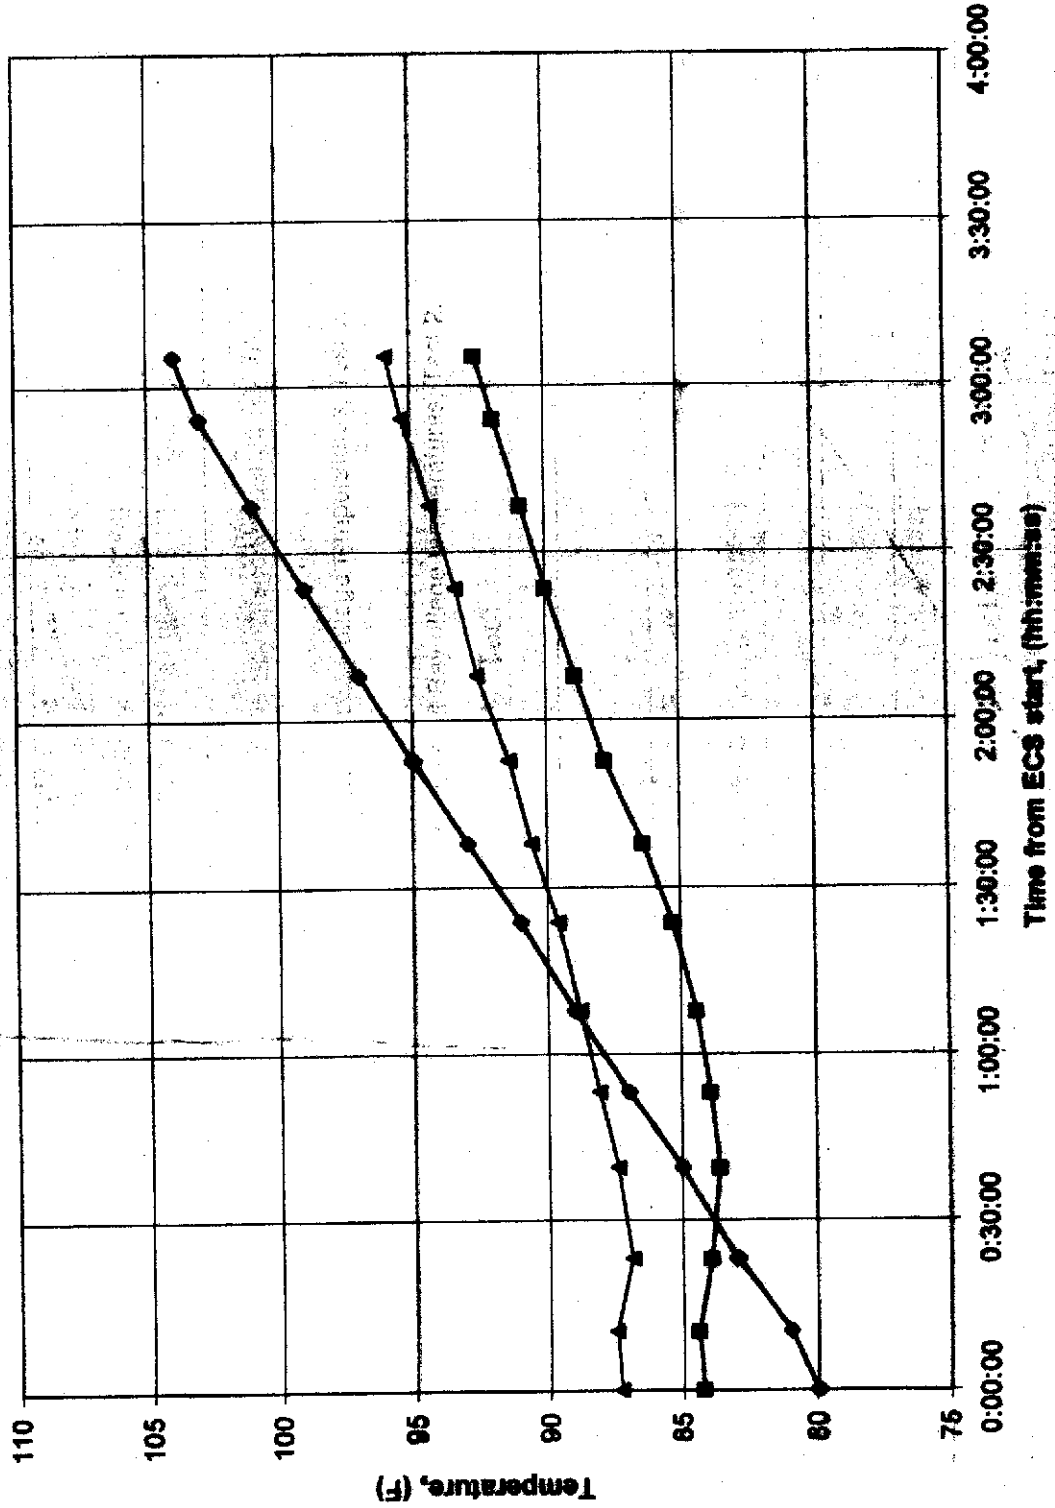
Figure 3.3a Bay 1 ullage temperatures, Test 3.

Test 3
Bay 1

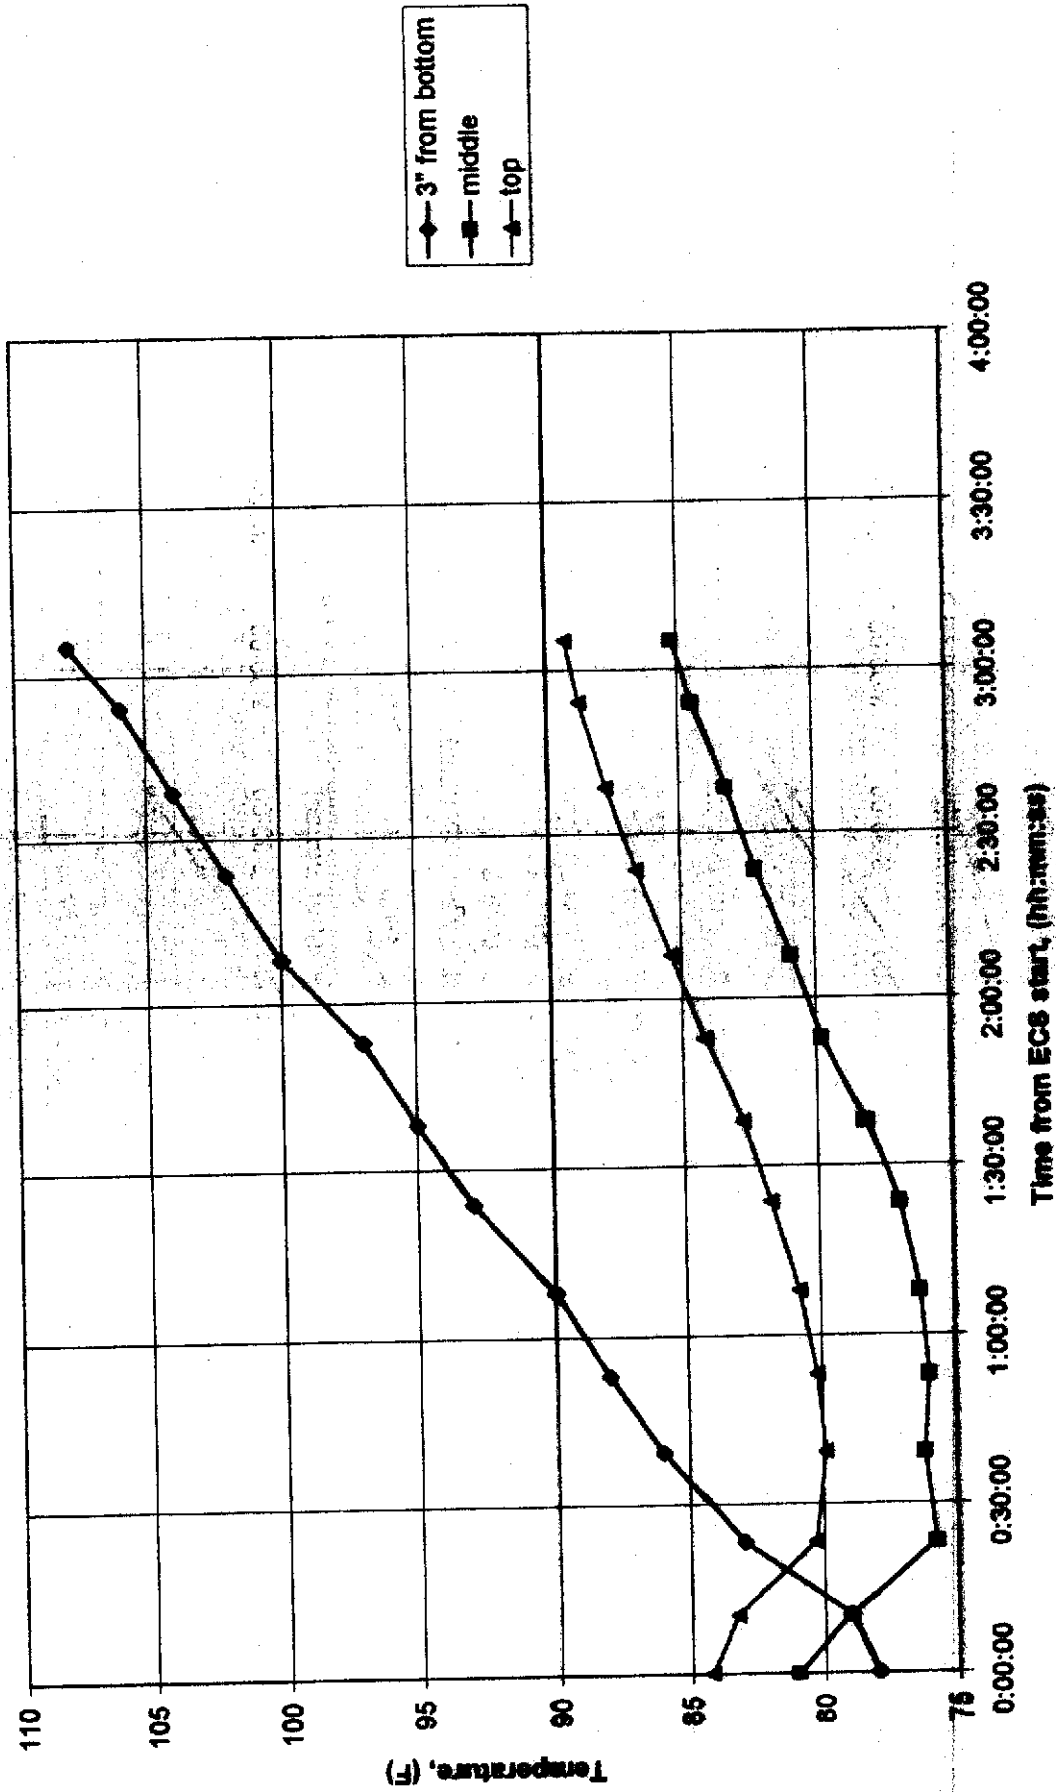
Figure 3.3b Bay 2 ullage temperatures, Test 3.

Test 3
Bay 2

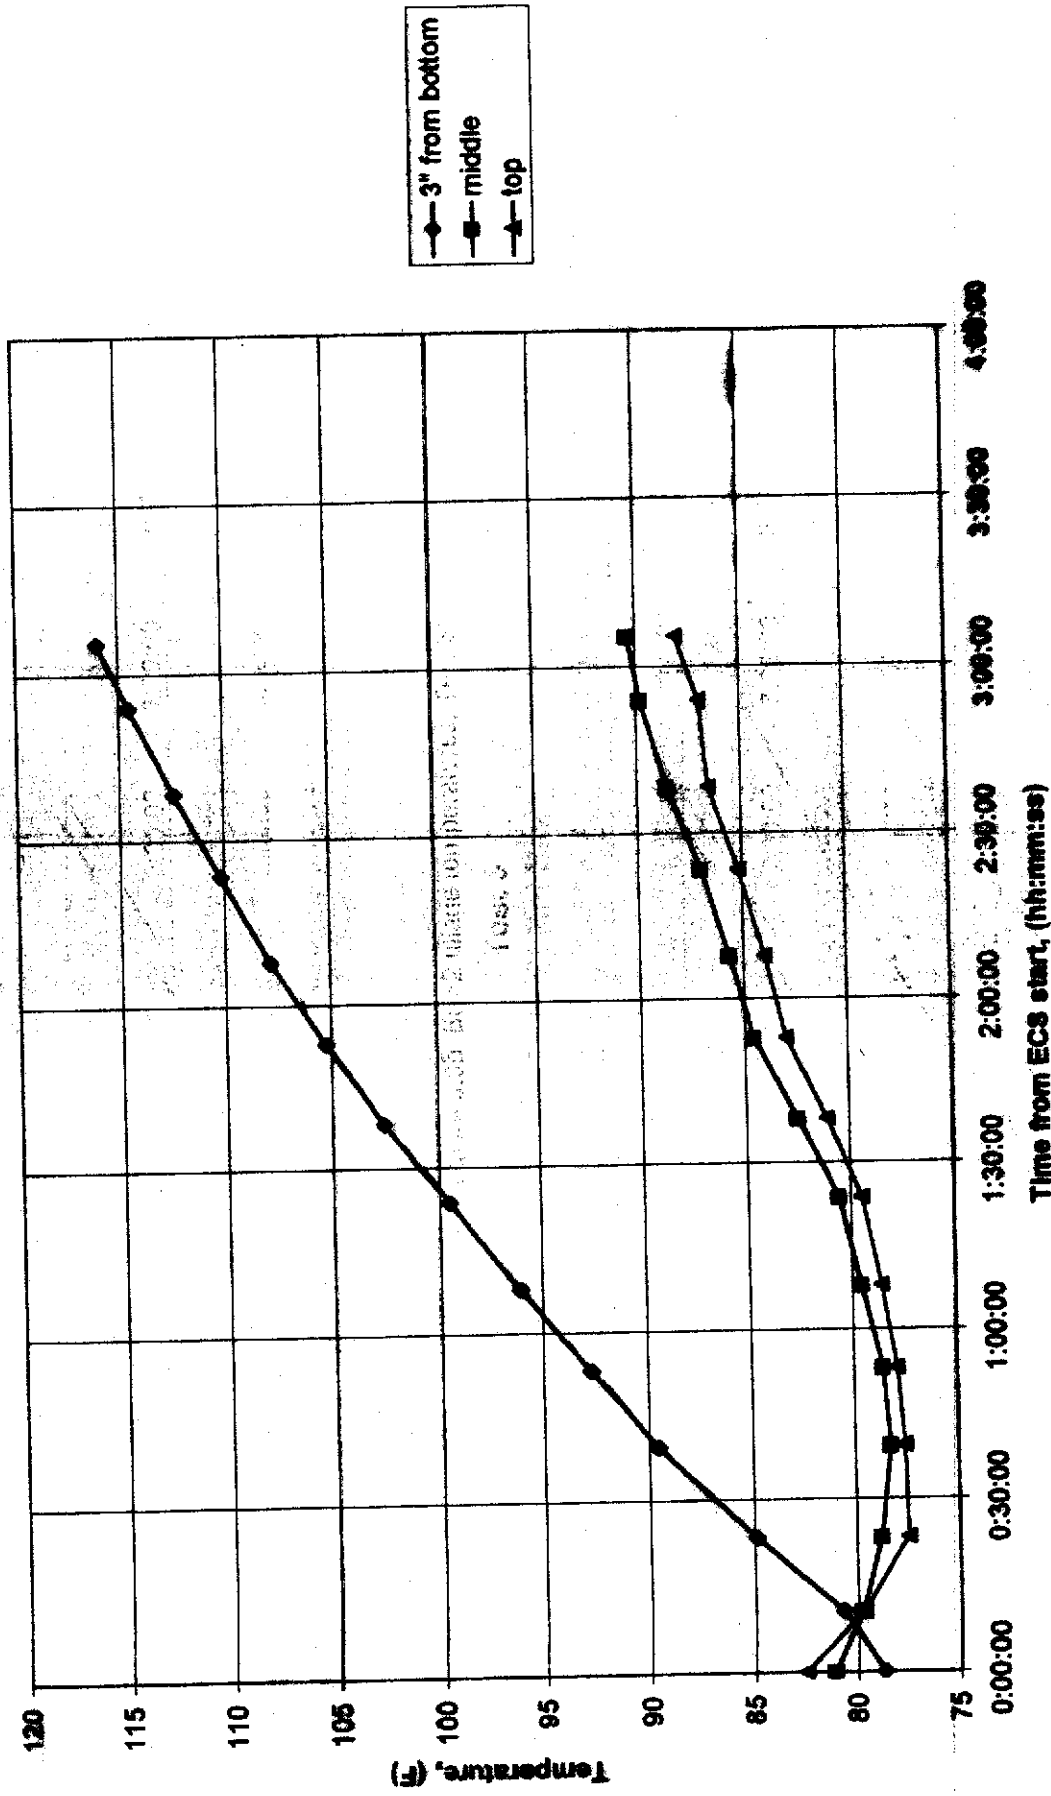
Figure 3.3c Left Mid Bay ullage temperatures, Test 3.

Test 3 Left Mid Bay

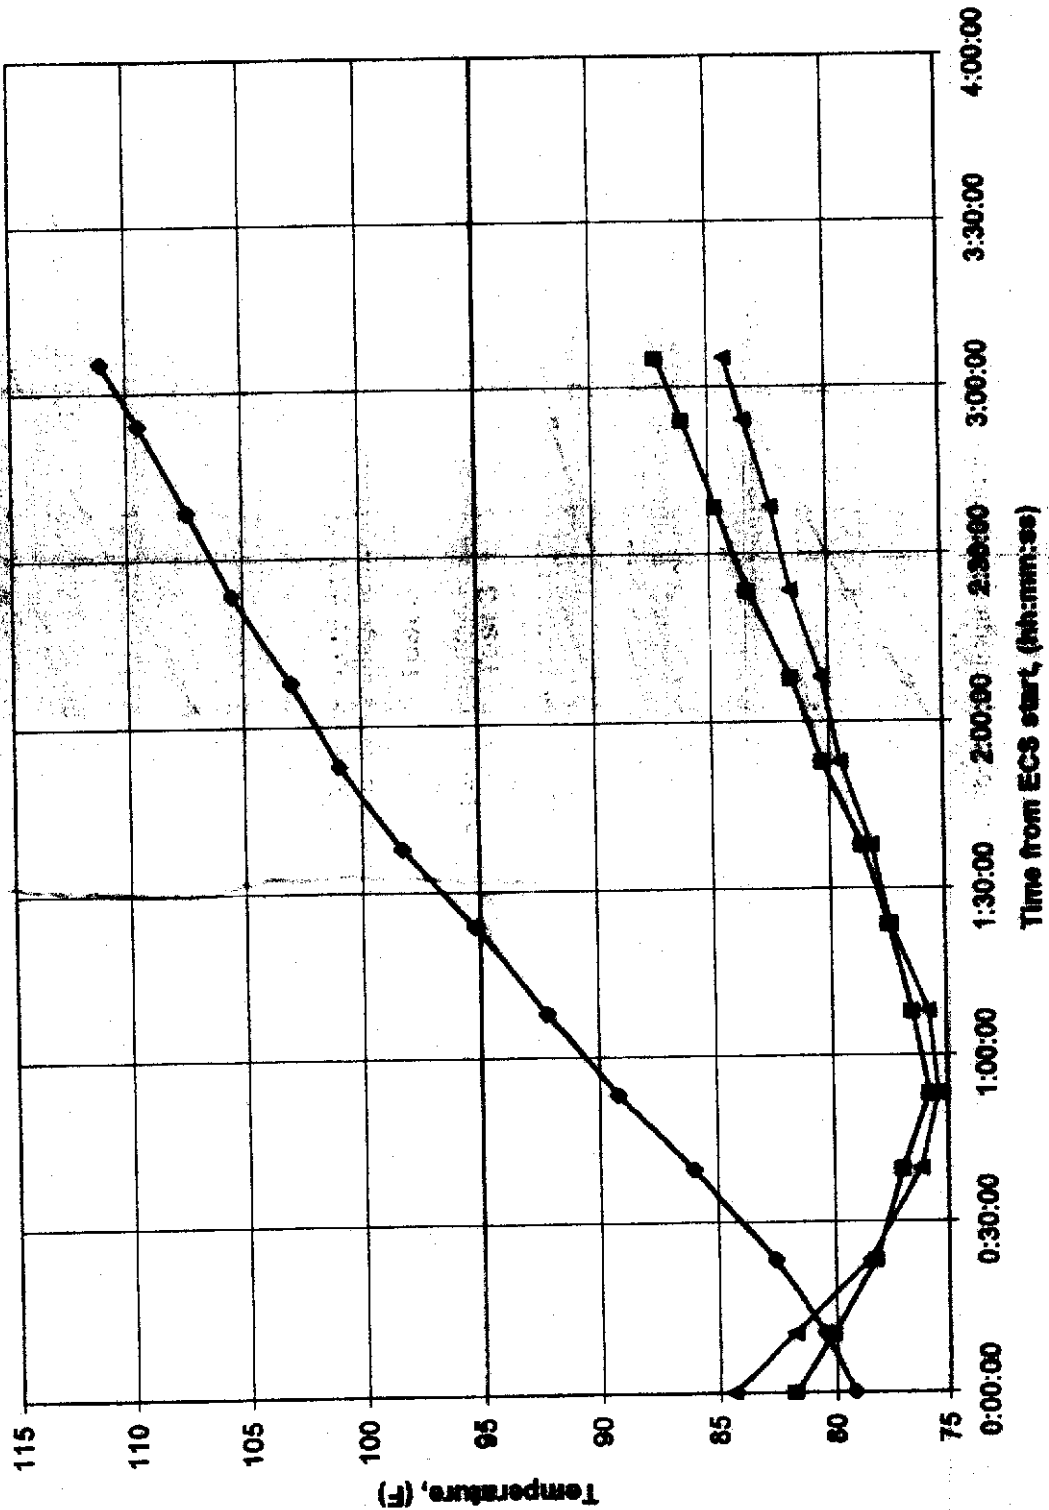
Figure 3.3d Right Mid Bay ullage temperatures, Test 3.

Test 3
Right Mid Bay

● 3" from bottom
 ■ middle
 ▲ top

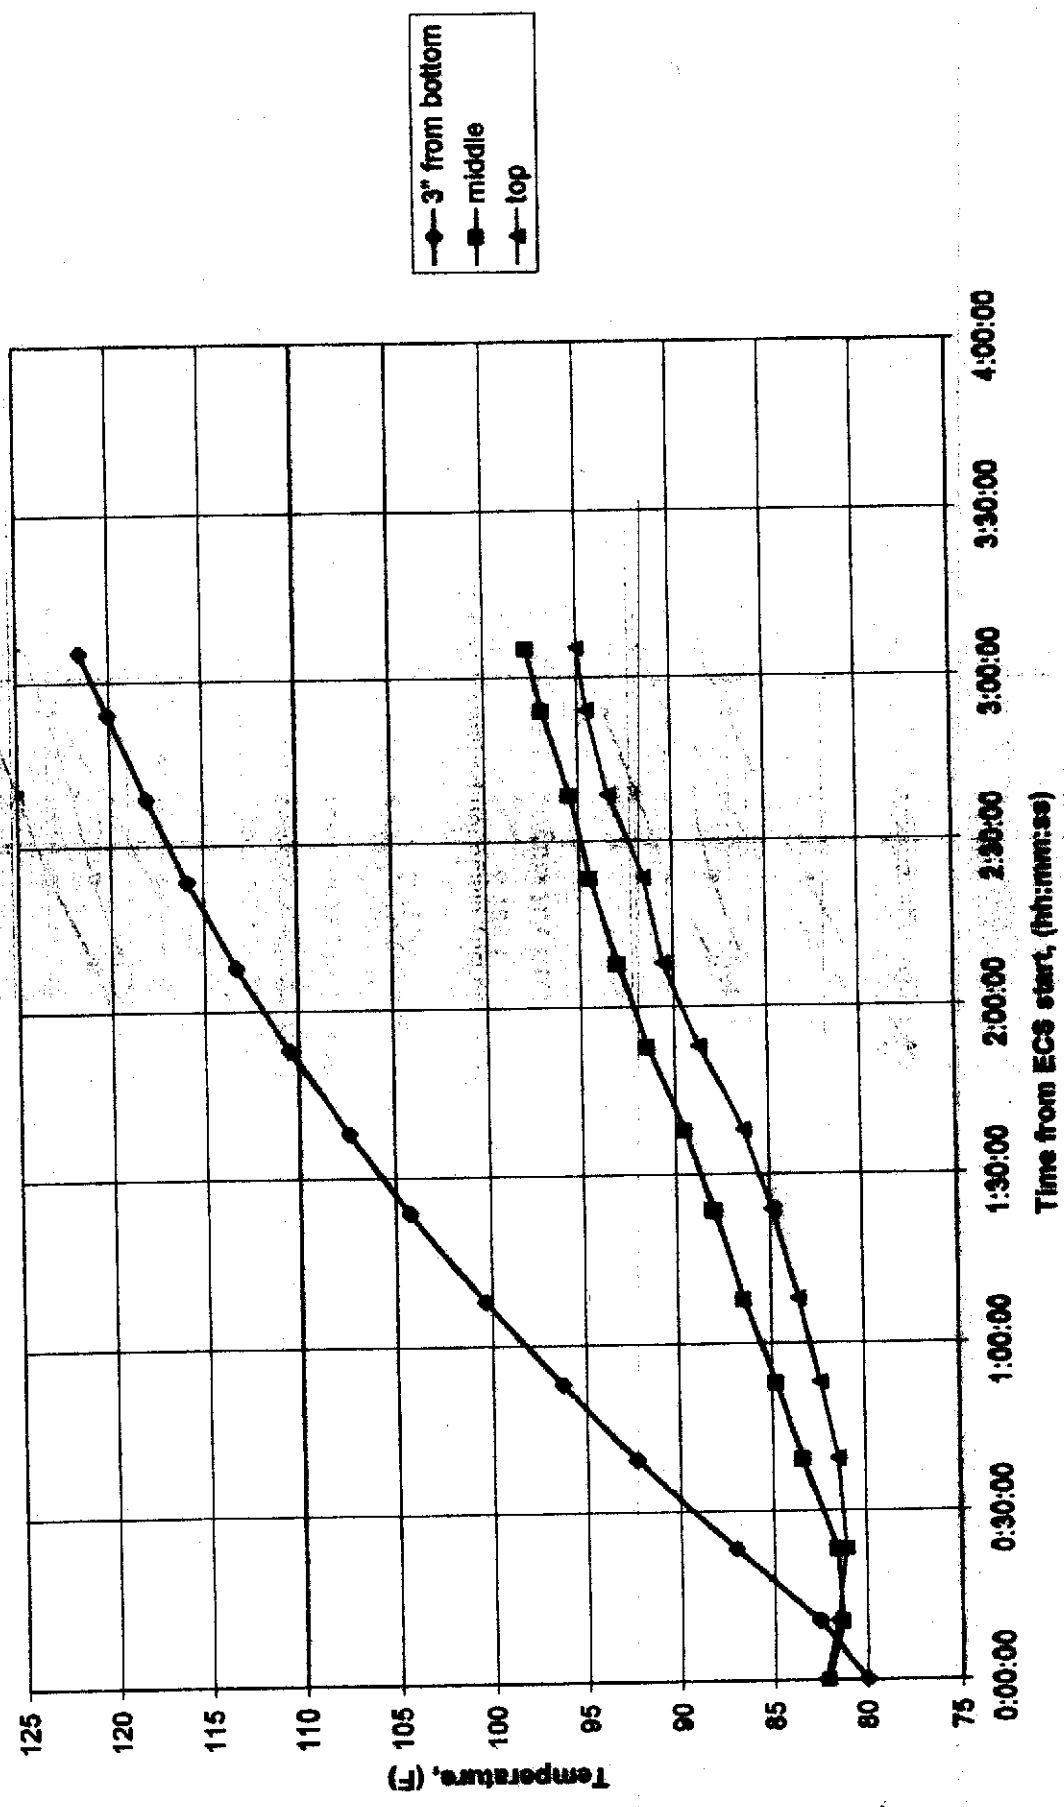
Figure 3.3e Left Aft Bay ullage temperatures, Test 3.

Test 3
Left Aft Bay

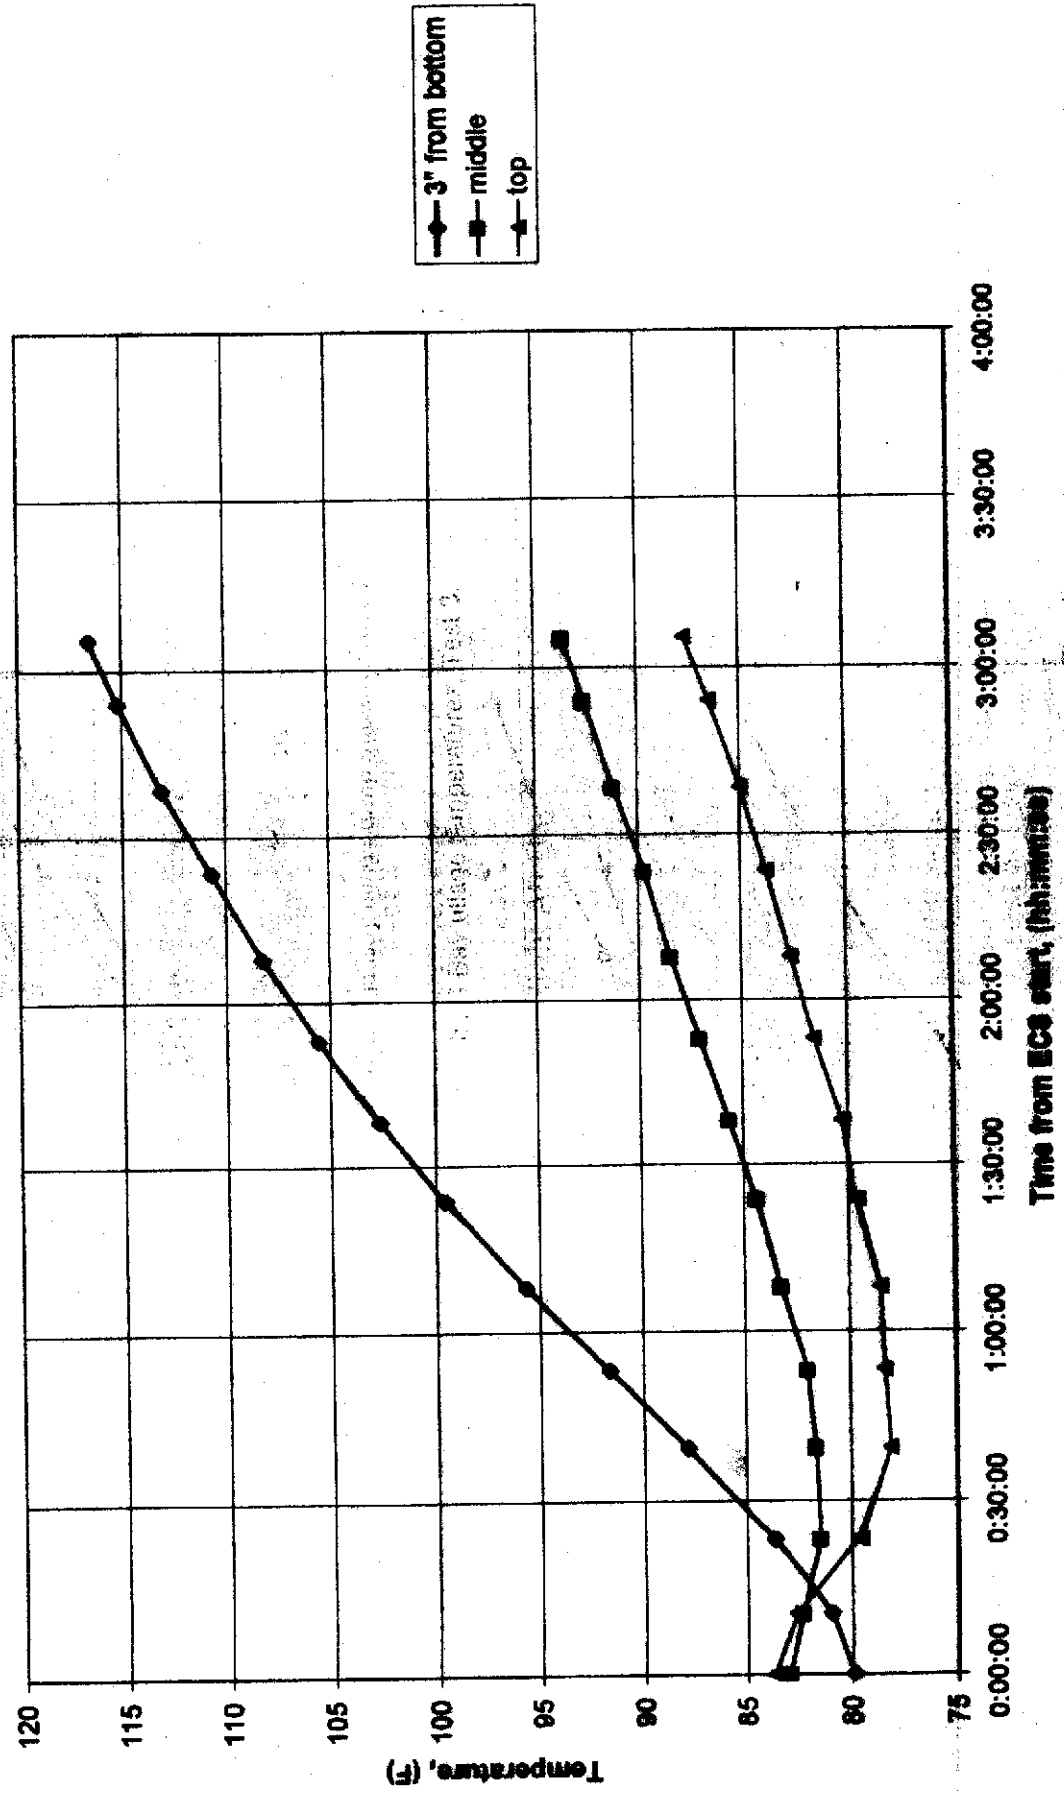
Figure 3.3f Right Aft Bay ullage temperatures Test 3.

Right Aft Bay
 Test 3
