**NATIONAL TRANSPORTATION SAFETY BOARD
WASHINGTON, D.C**

Boeing 747-100 Center Wing Tank Ground Testing

Summary Data Report:
B-747-100 Center Wing Tank Ground Testing
at Marana, AZ

Joseph Kolly
Office of Research and Engineering
National Transportation Safety Board

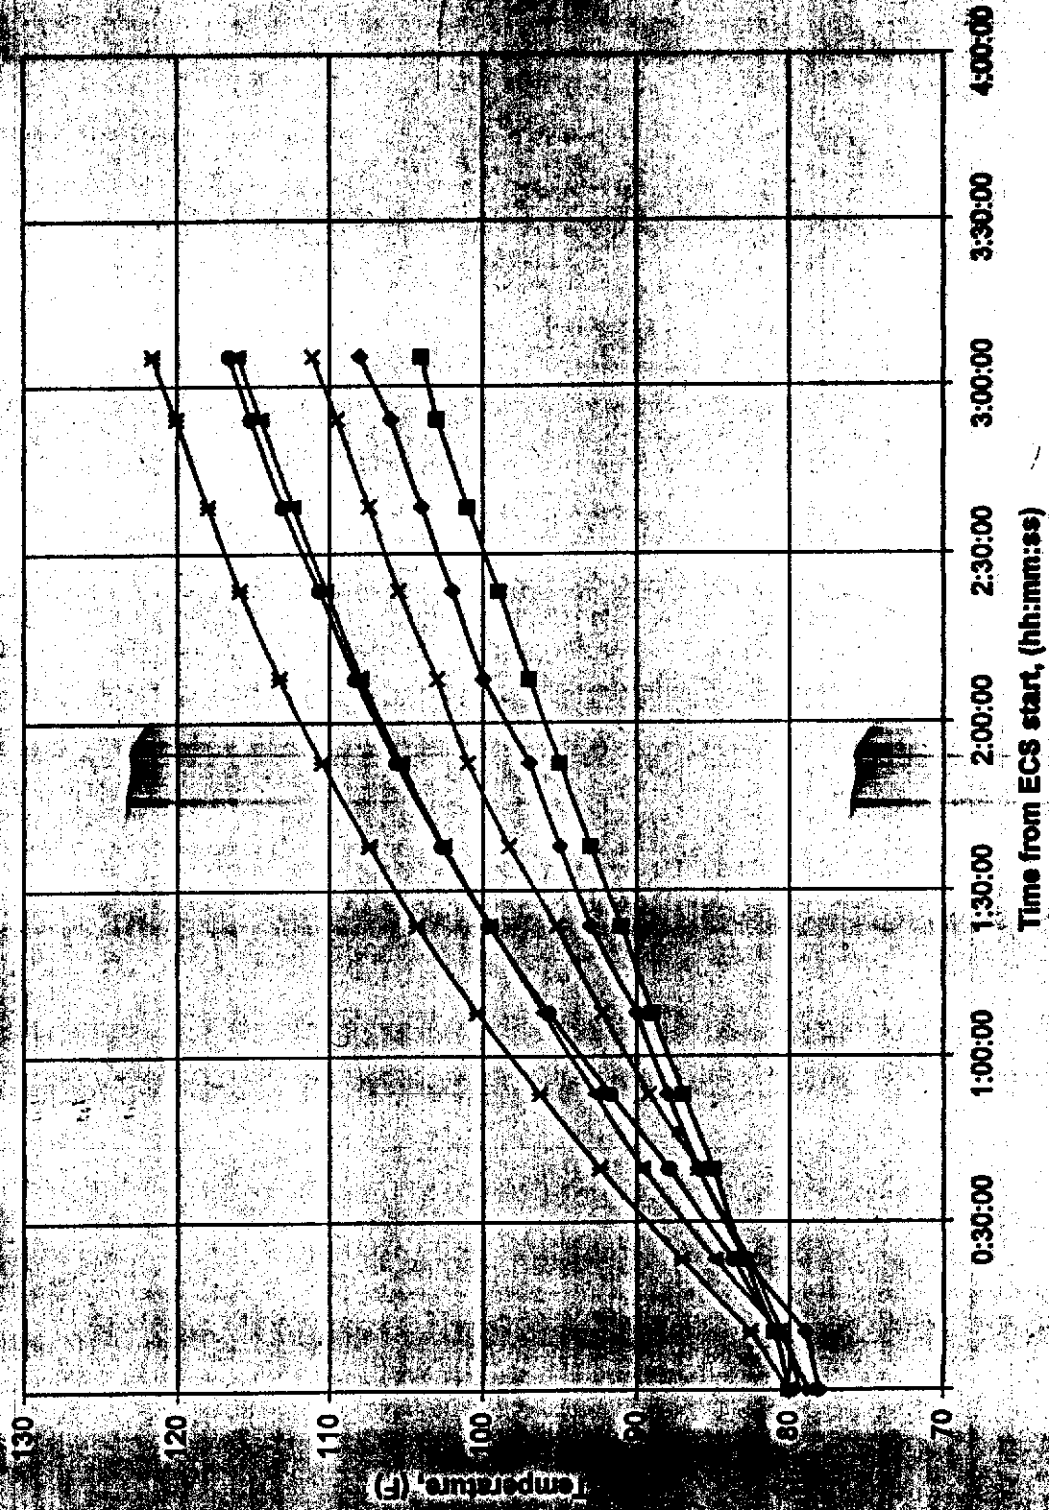
Figure 3.4 Fuel temperatures at 3-inch height, Test 3.

Test 3
Fuel Temperatures 3-Inches From Bottom

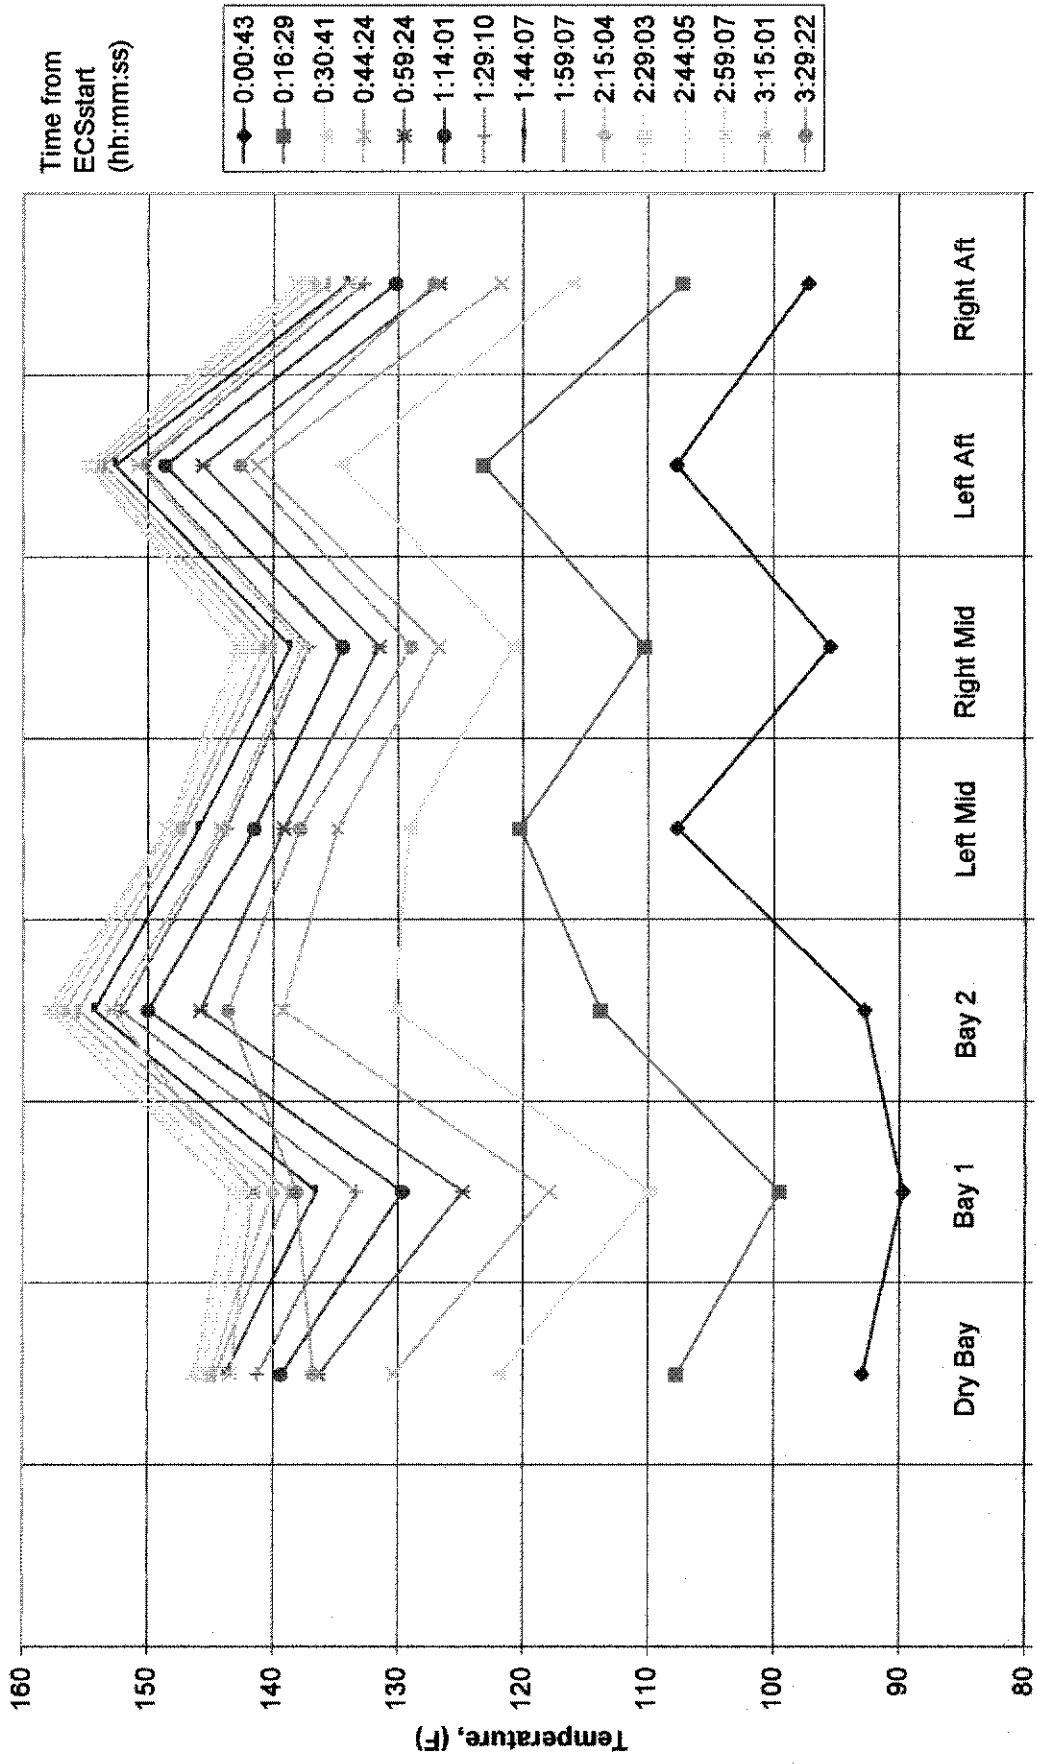
Figure 3.5 CWT bottom internal surface temperatures, Test 1.

Test 1
CWT Internal Bottom Surface Temperatures

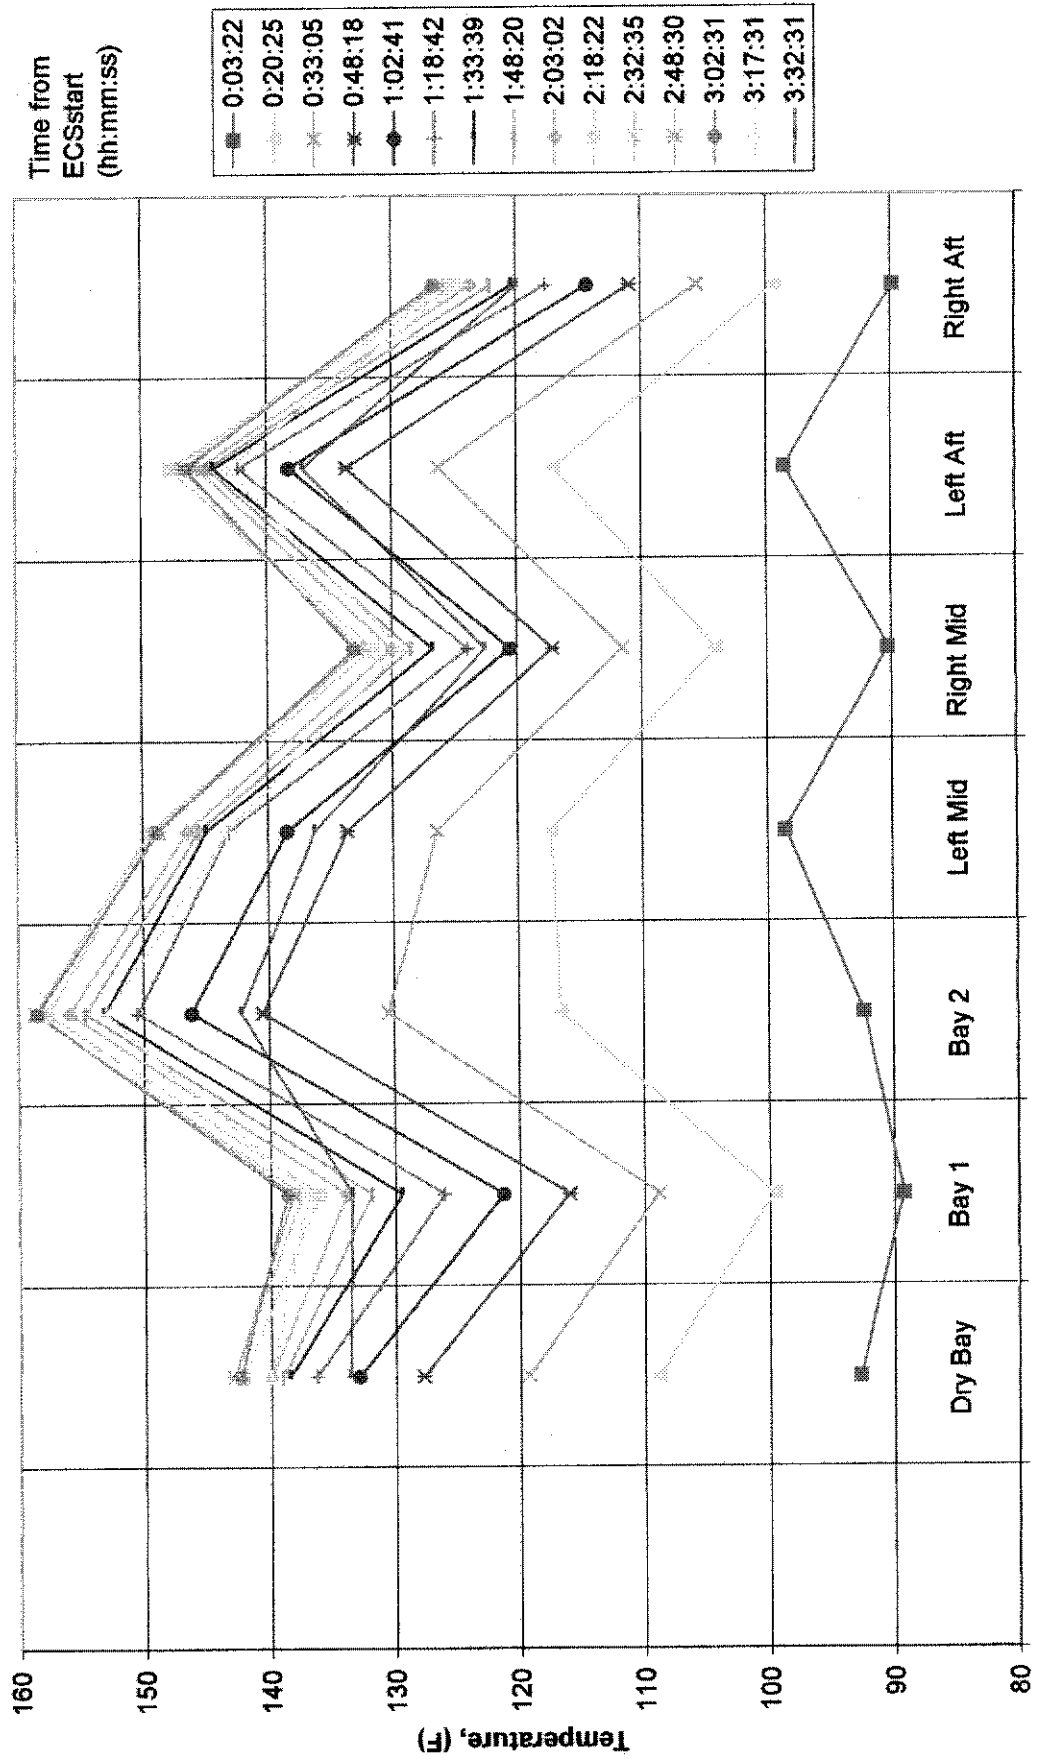
Figure 3.6 CWT bottom internal surface temperatures, Test 2.

CWT Internal Bottom Surface Temperatures

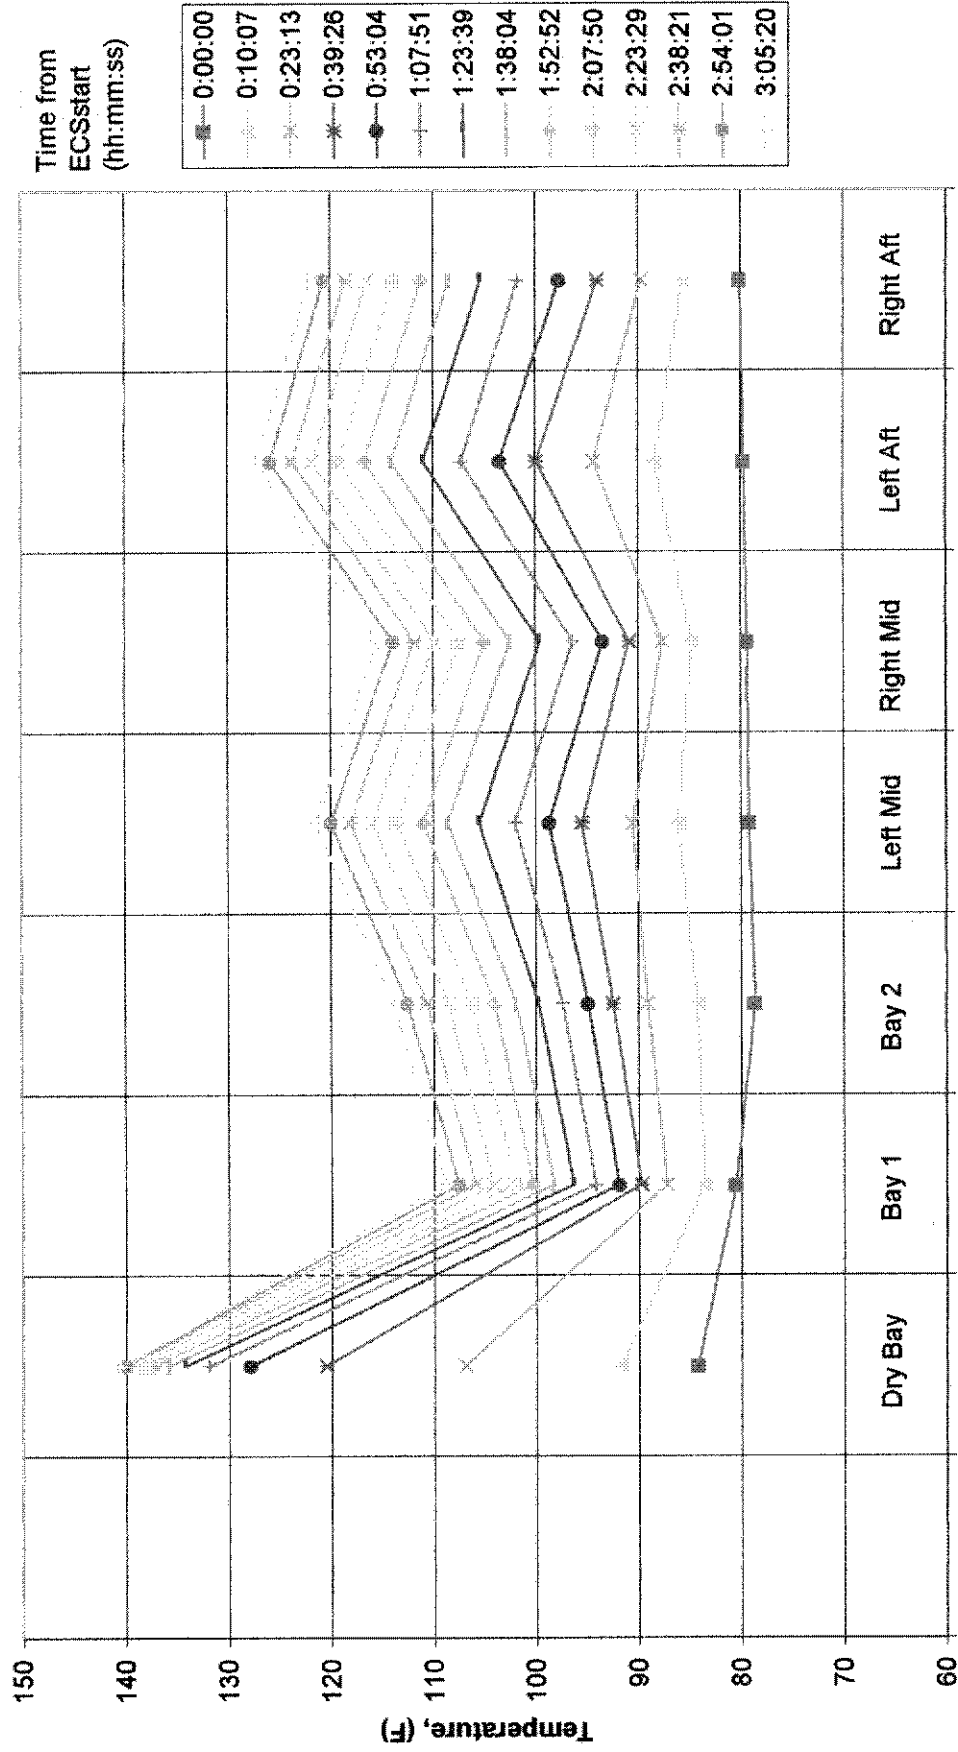
Figure 3.7 CWT bottom internal surface temperatures, Test 3.

Test 3
CWT Internal Bottom Surface Temperatures

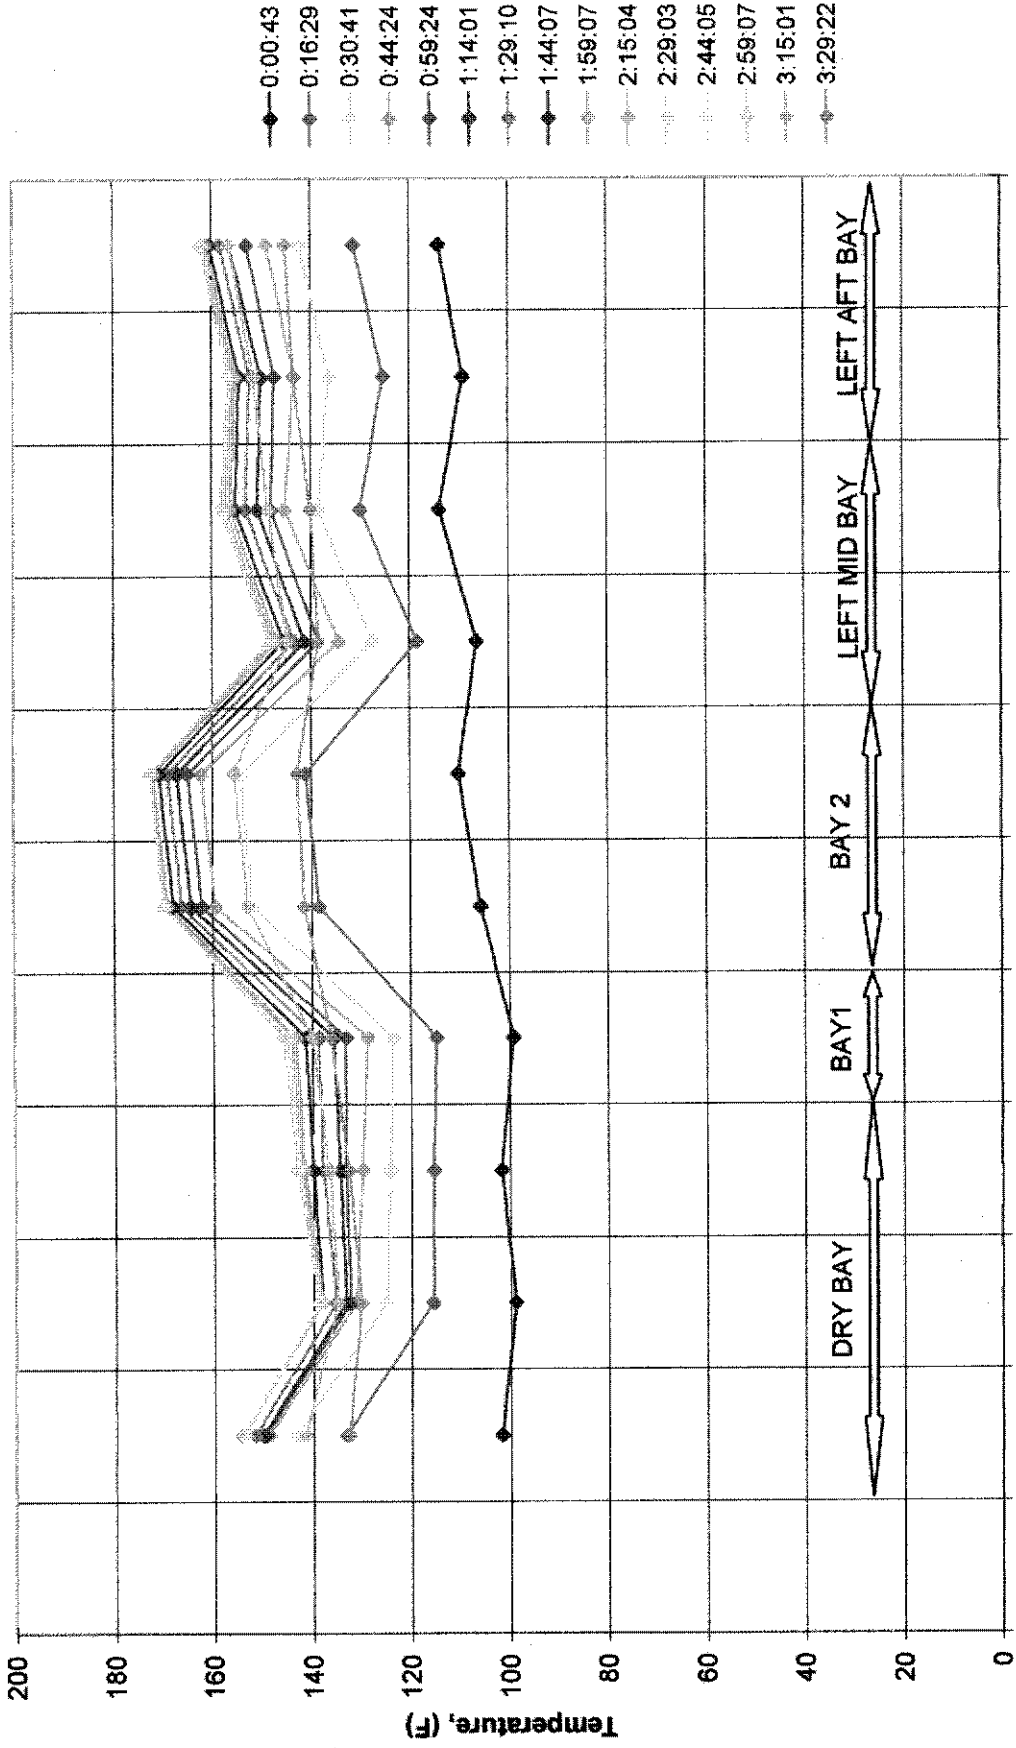
Figure 3.8 CWT bottom external surface temperatures, LBL58, Test 1.

Test 1, left built line surface temps

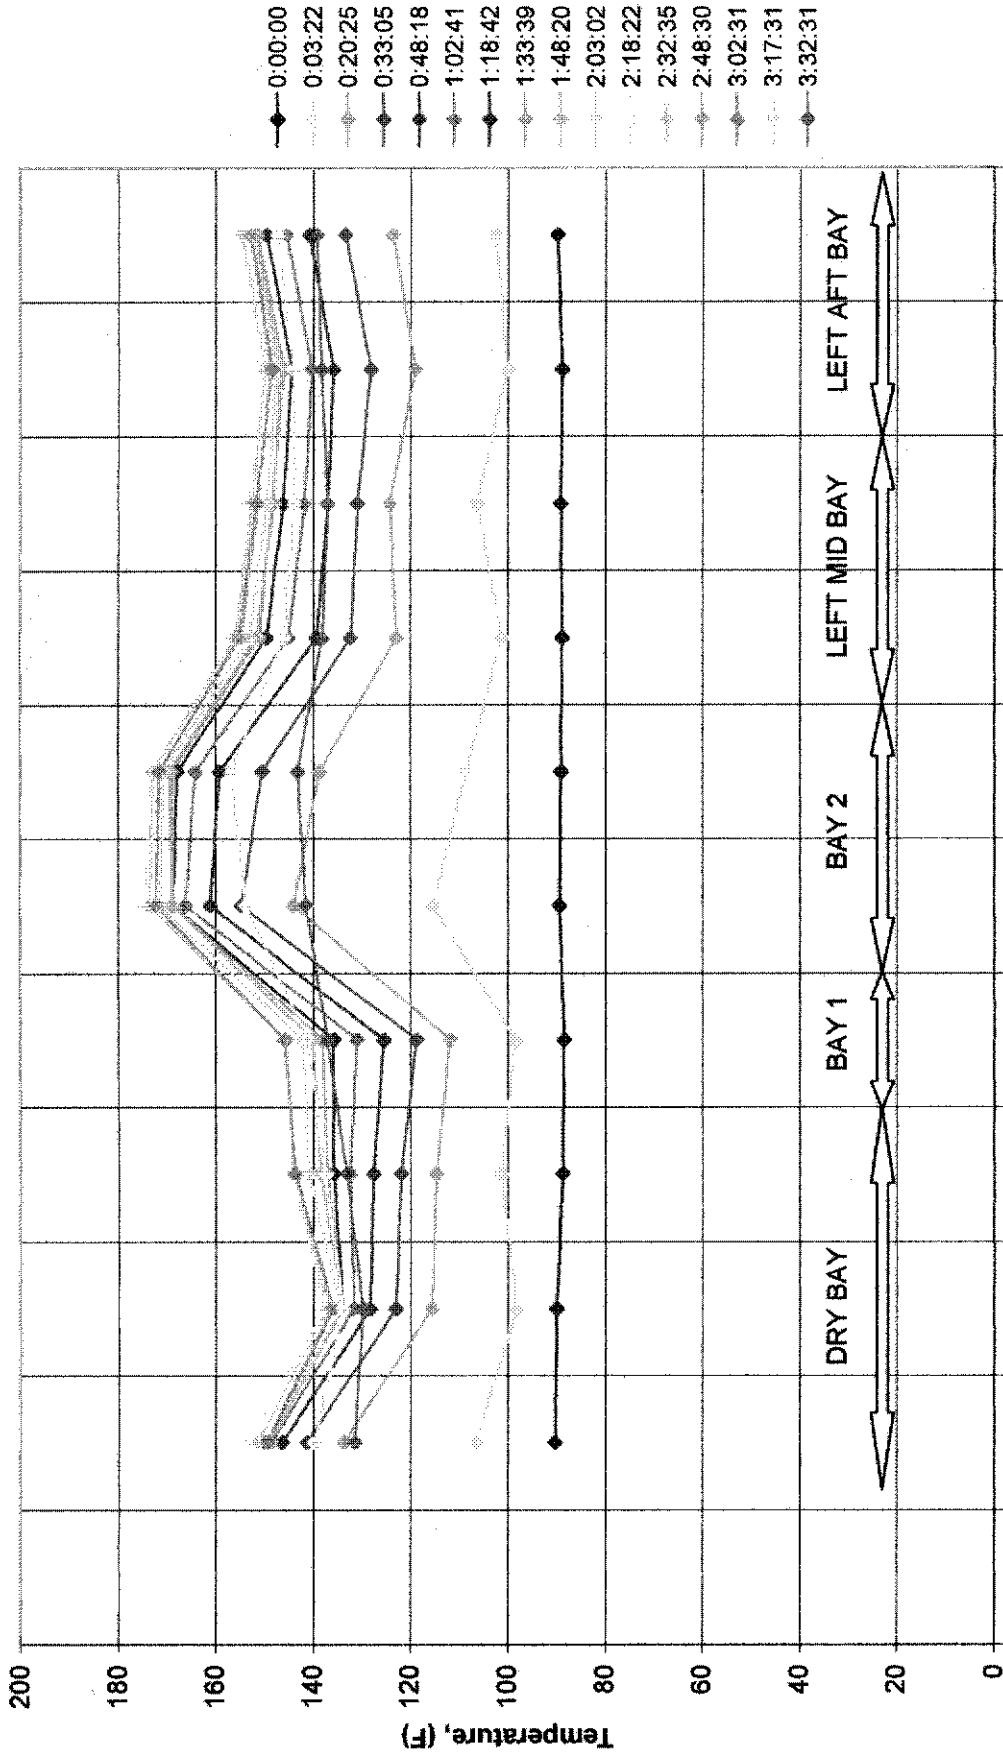
Figure 3.9 CWT bottom external surface temperatures, LBL58, Test 2.

Test 2, left butt line surface cwt

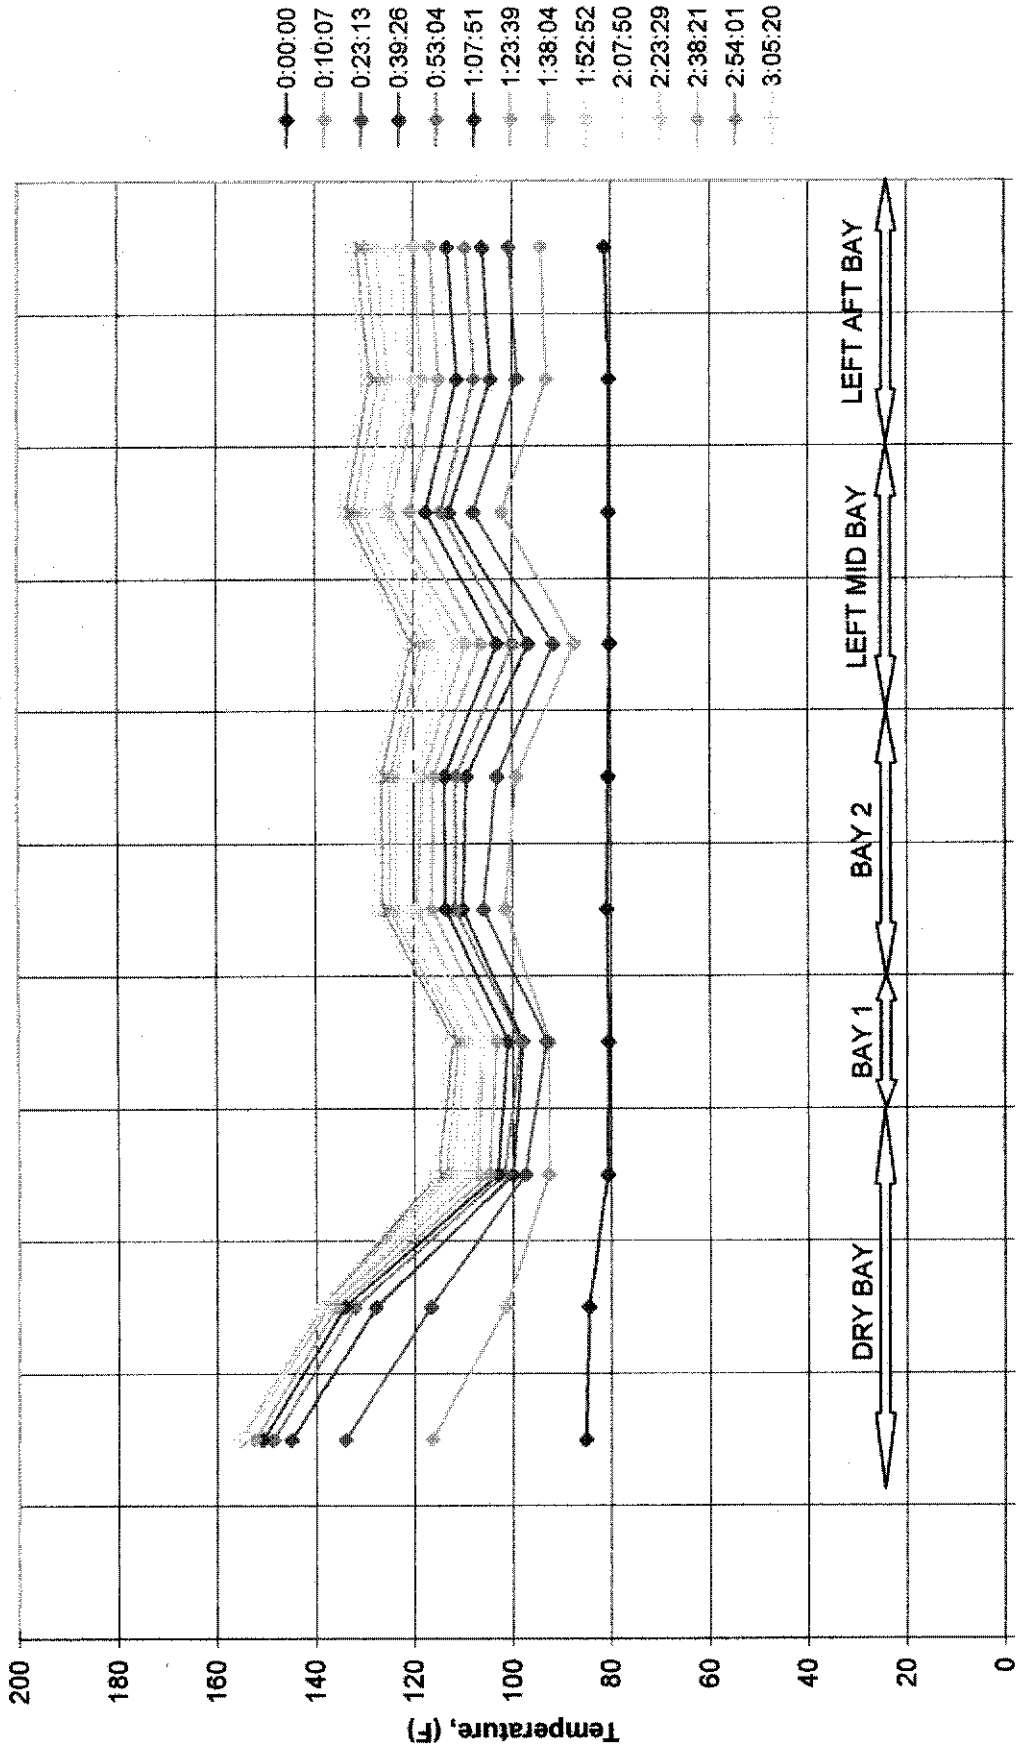
Figure 3.10 CWT bottom external surface temperatures, LBL58, Test 3.

Test 3, left butt line 58 surface cwt

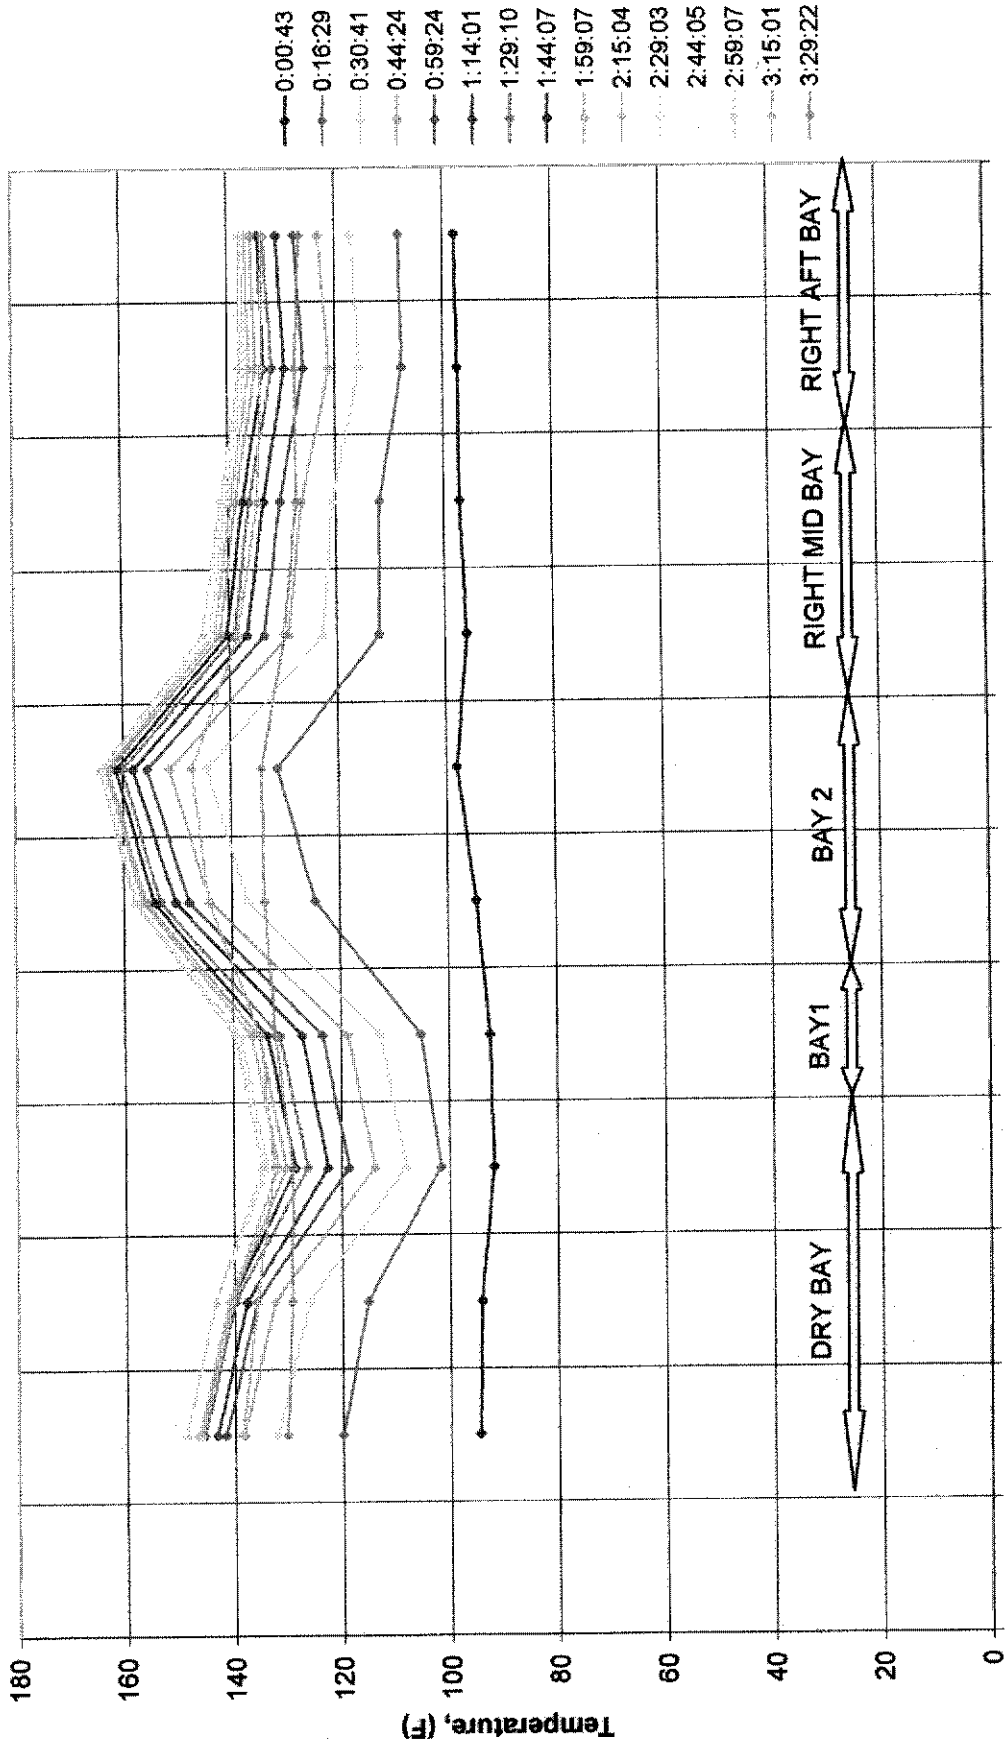
Figure 3.11 CWT bottom external surface temperatures, RBL58, Test 1.

Test 1 Right butt line 58 surface cwt

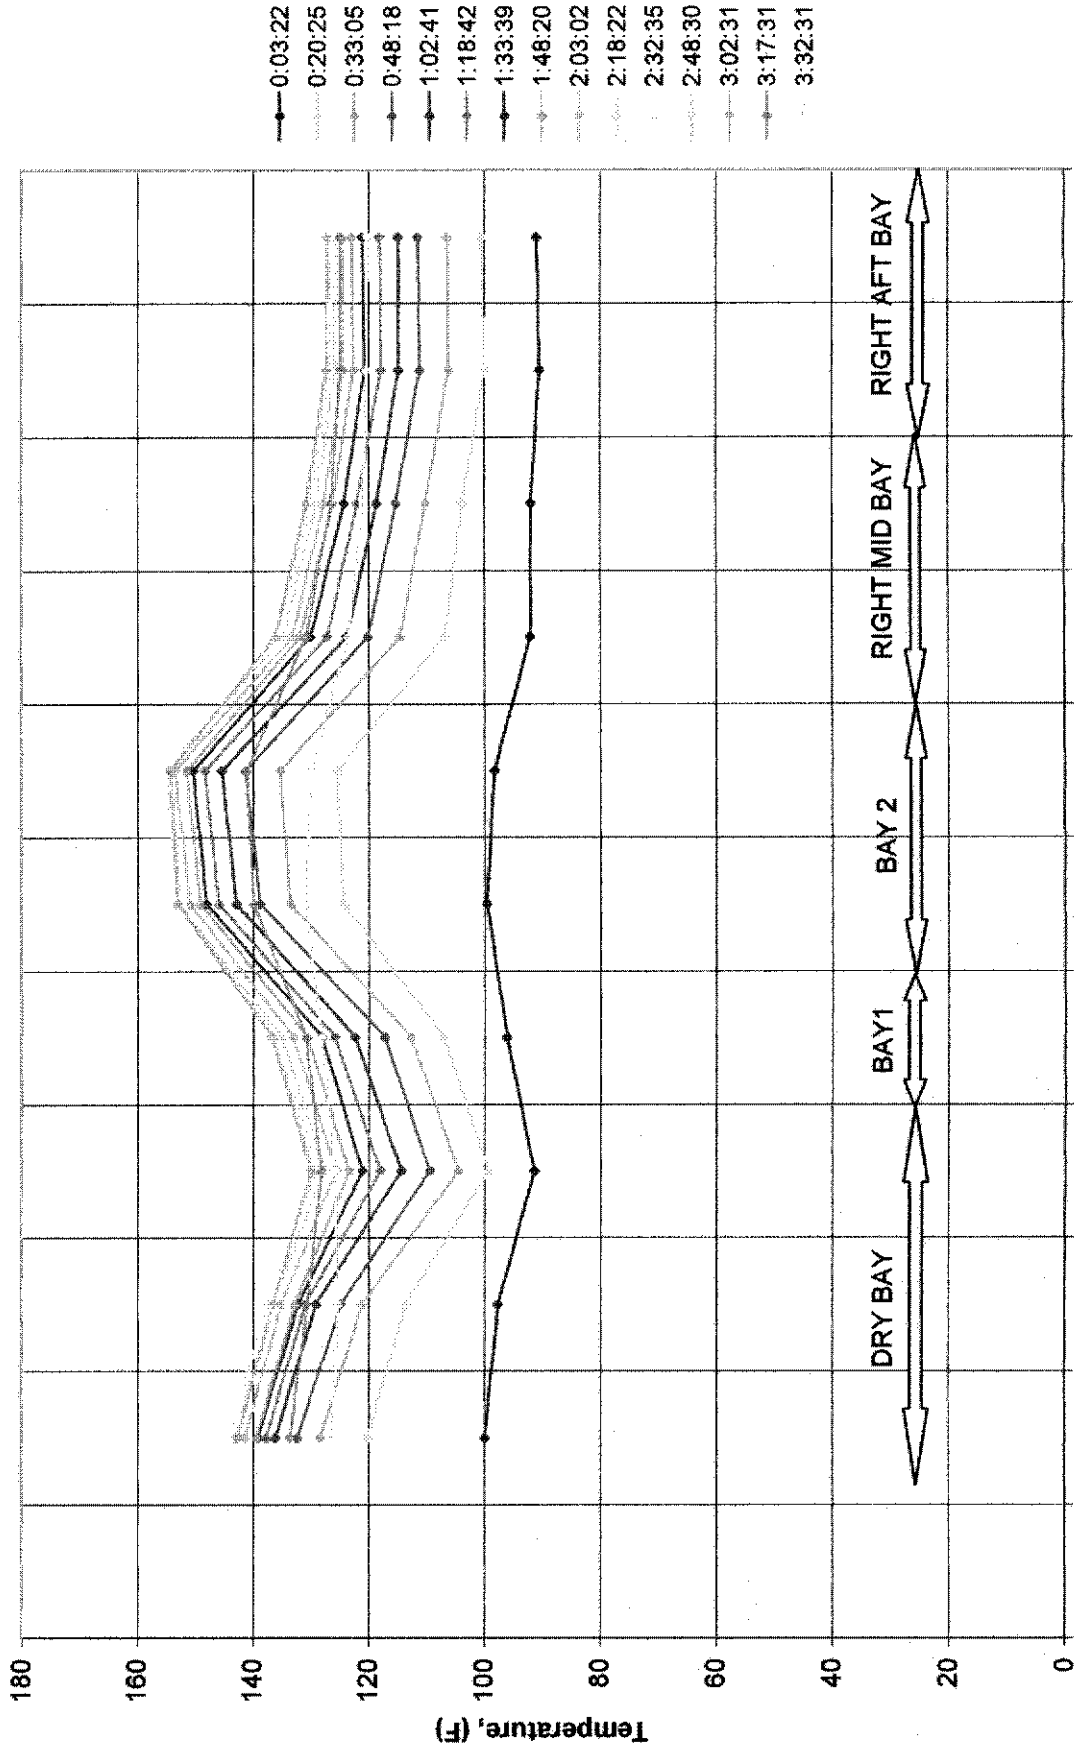
Figure 3.12 CWT bottom external surface temperatures, RBL58, Test 2.

Test 2 Right butt line 58 surface cwt

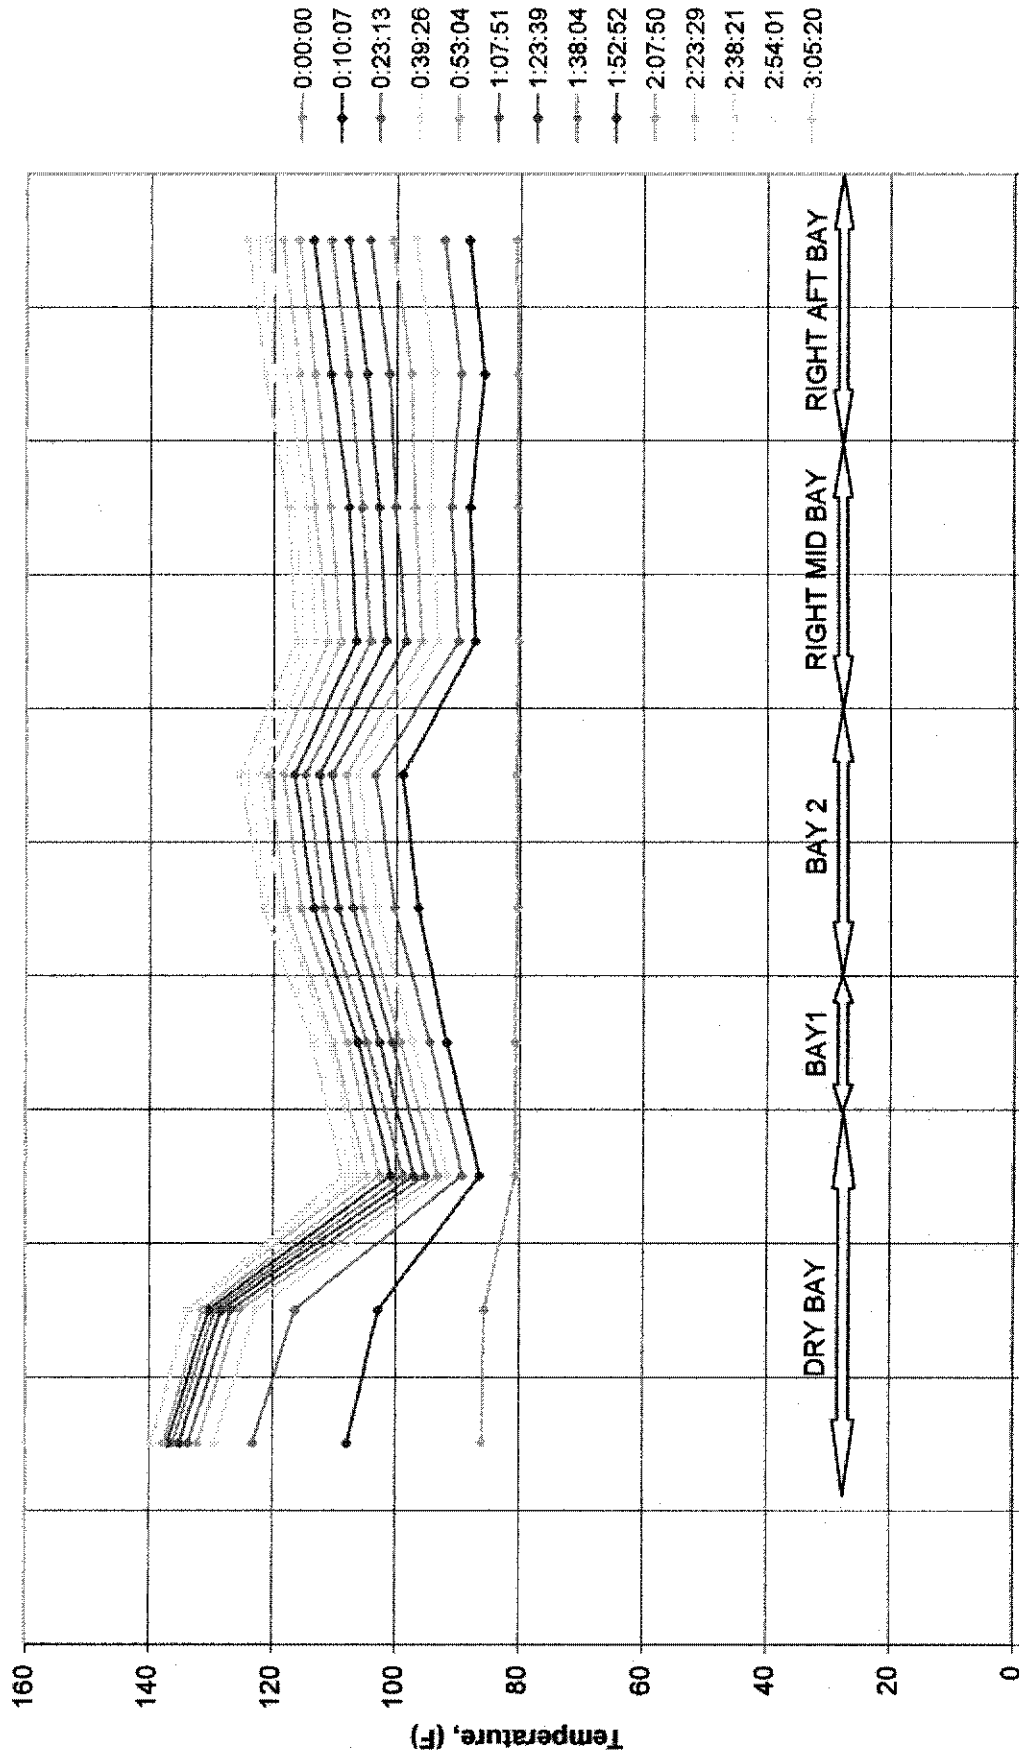
Figure 3.13 CWT bottom external surface temperatures, RBL58, Test 3.

Test 3 Right butt line 58 surface cwt

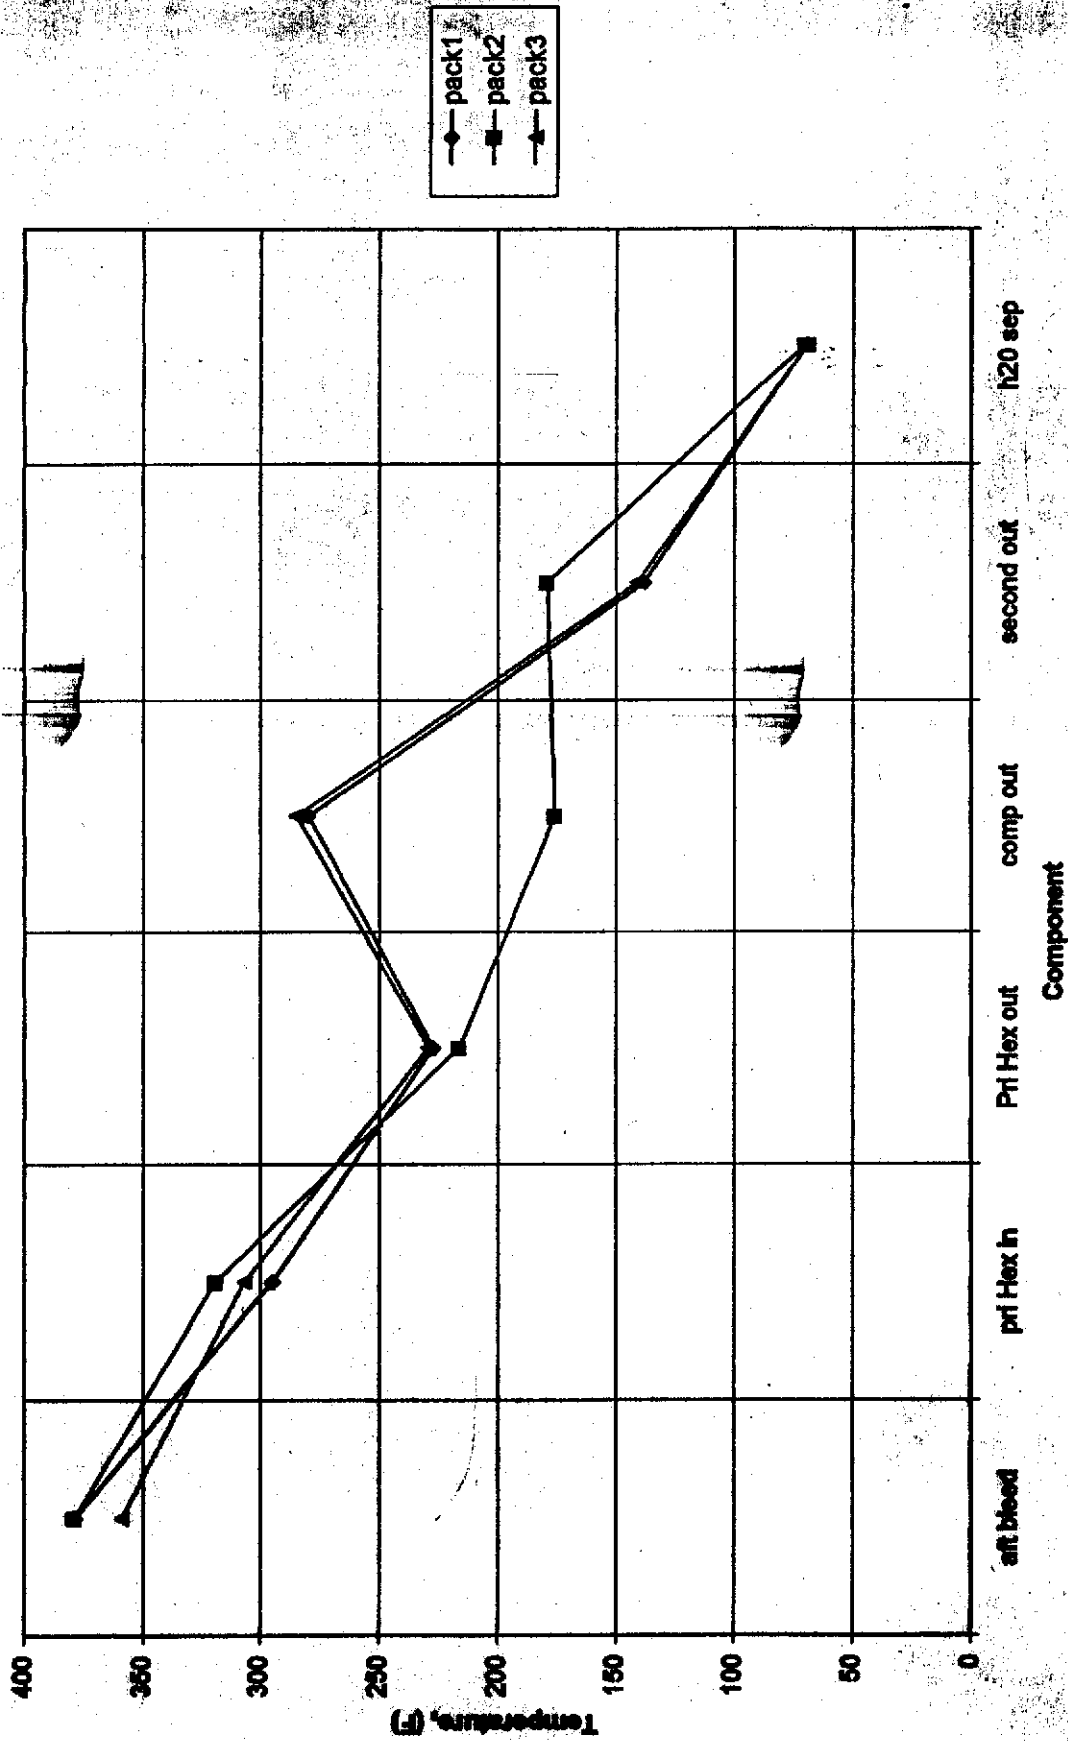
Figure 3.14 ECS component temperatures, Test 1.

Test 1
ECS Component Surface Temperatures

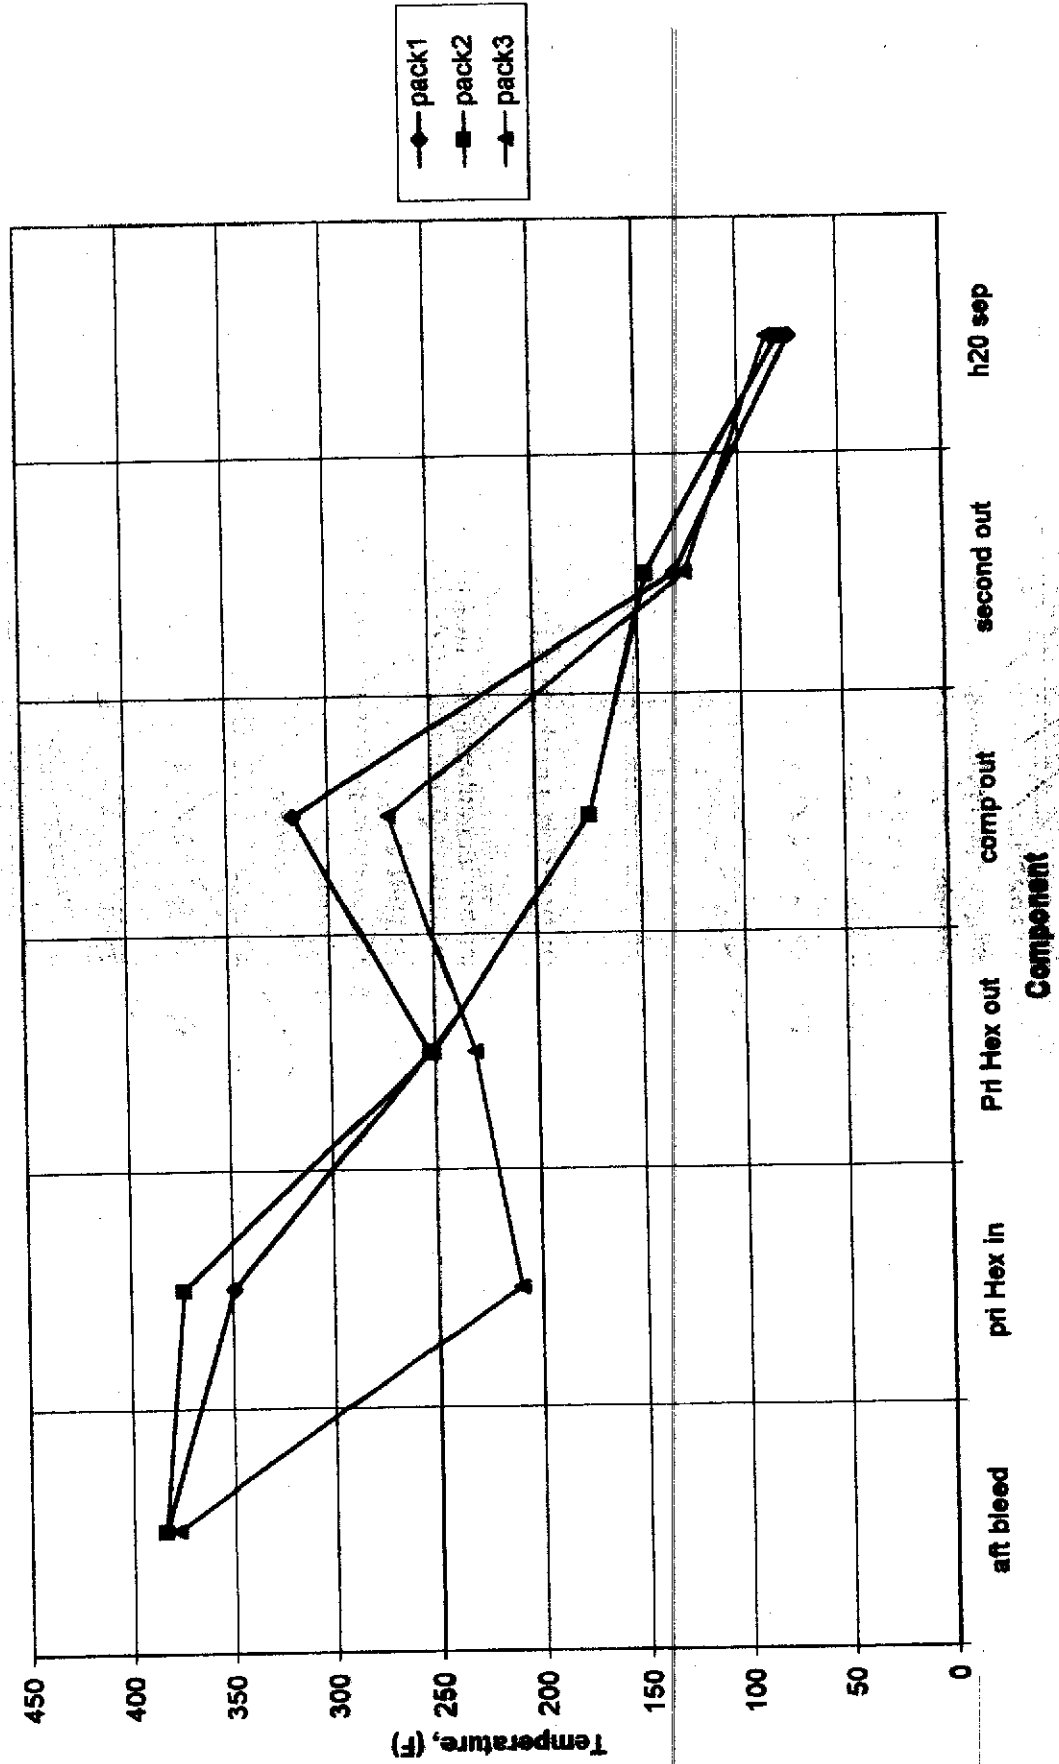
Figure 3.15 ECS component temperatures, Test 2.

Test 2
ECS Component Surface Temperatures
