**NATIONAL TRANSPORTATION SAFETY BOARD
WASHINGTON, D.C**

Boeing 747-100 Center Wing Tank Ground Testing

Summary Data Report:
B-747-100 Center Wing Tank Ground Testing
at Marana, AZ

Joseph Kolly
Office of Research and Engineering
National Transportation Safety Board

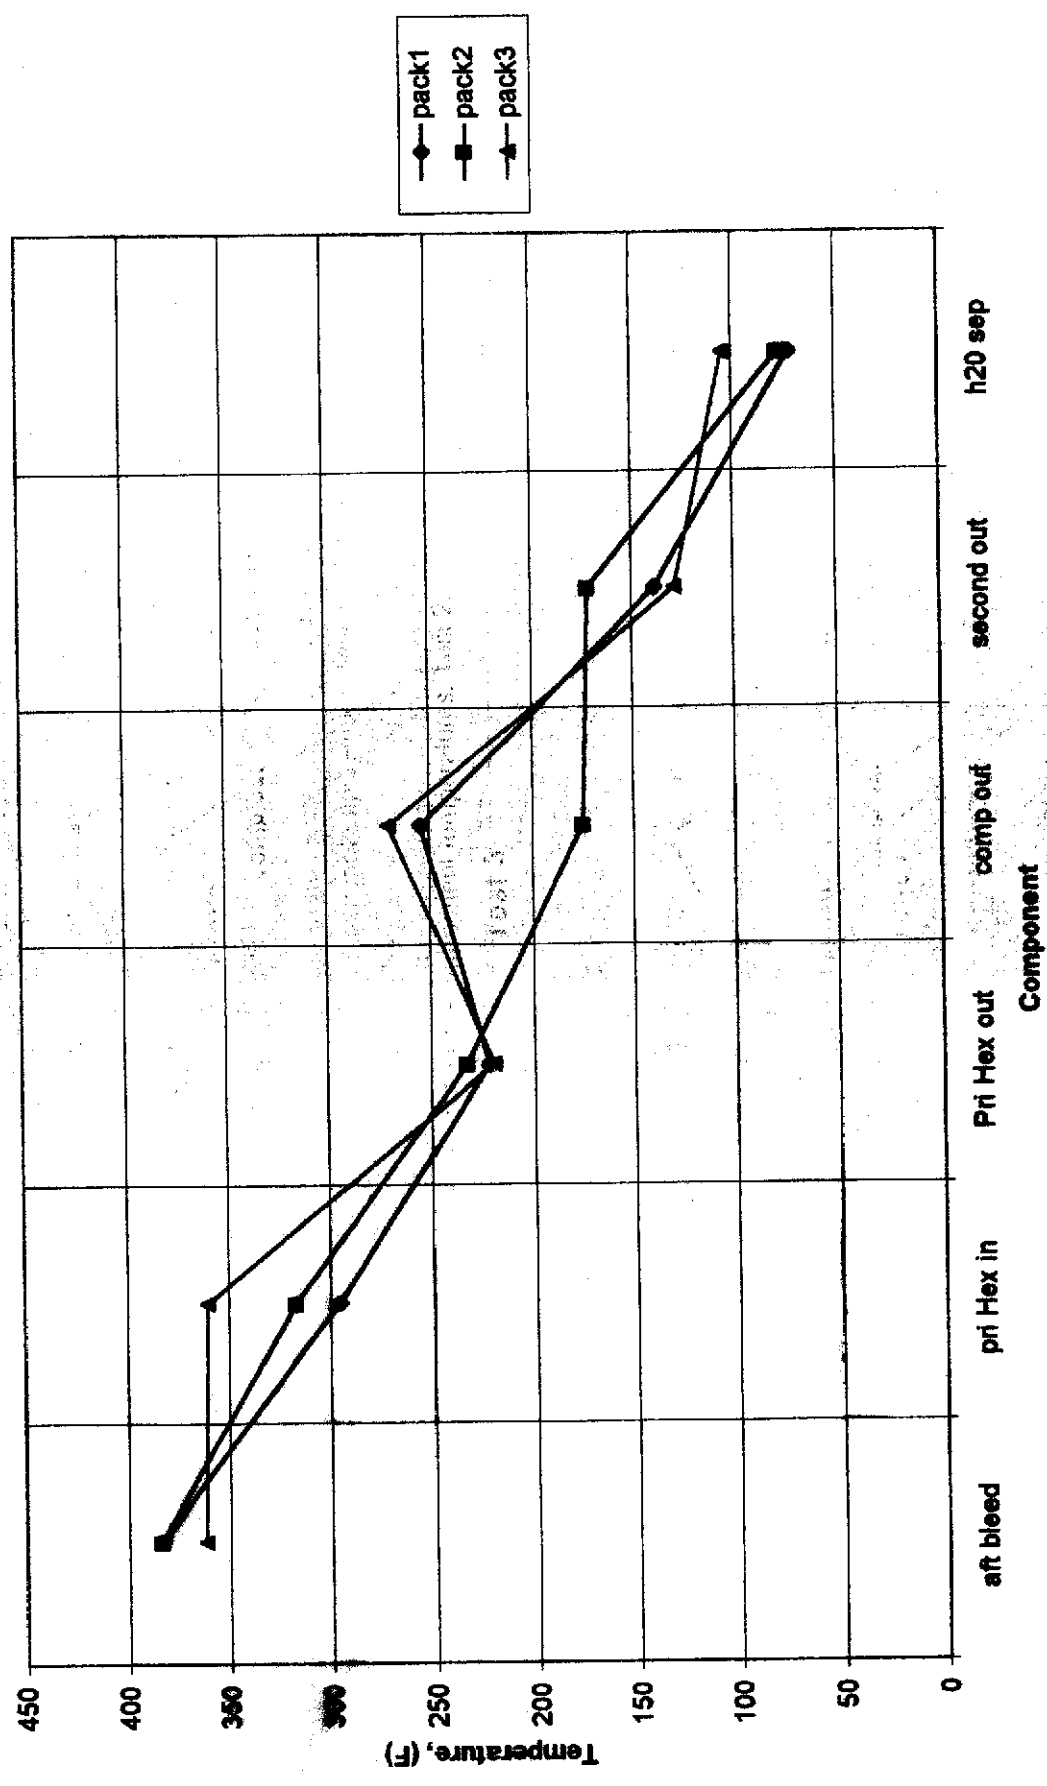
Figure 3.16 ECS component temperatures, Test 3.

Test 3
ECS Component Surface Temperatures

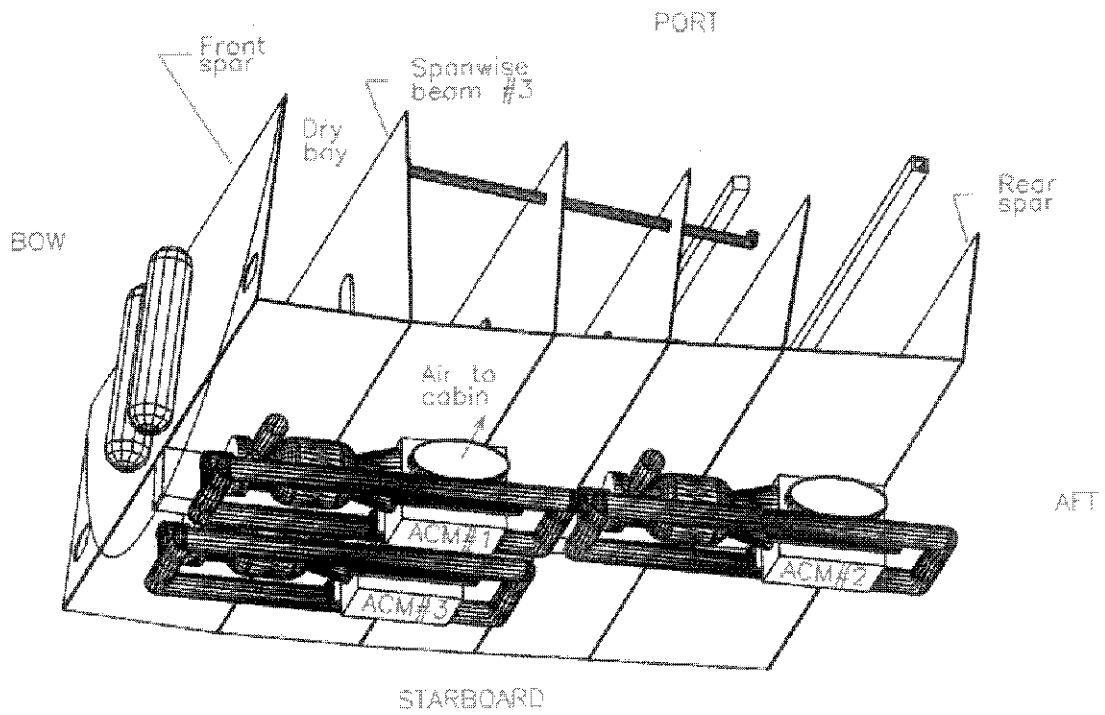
Figure 1: A 3-D schematic view of the tank along with the three ACM underneath it.

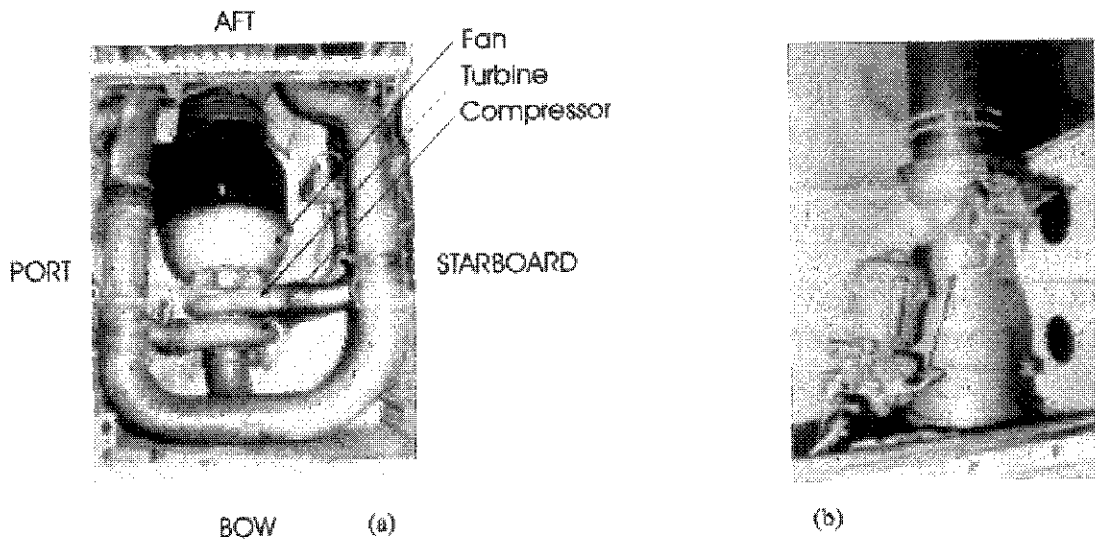
Figure 2: (a) Pack number 1 with parts identified; (b) Flow control valve number 3.

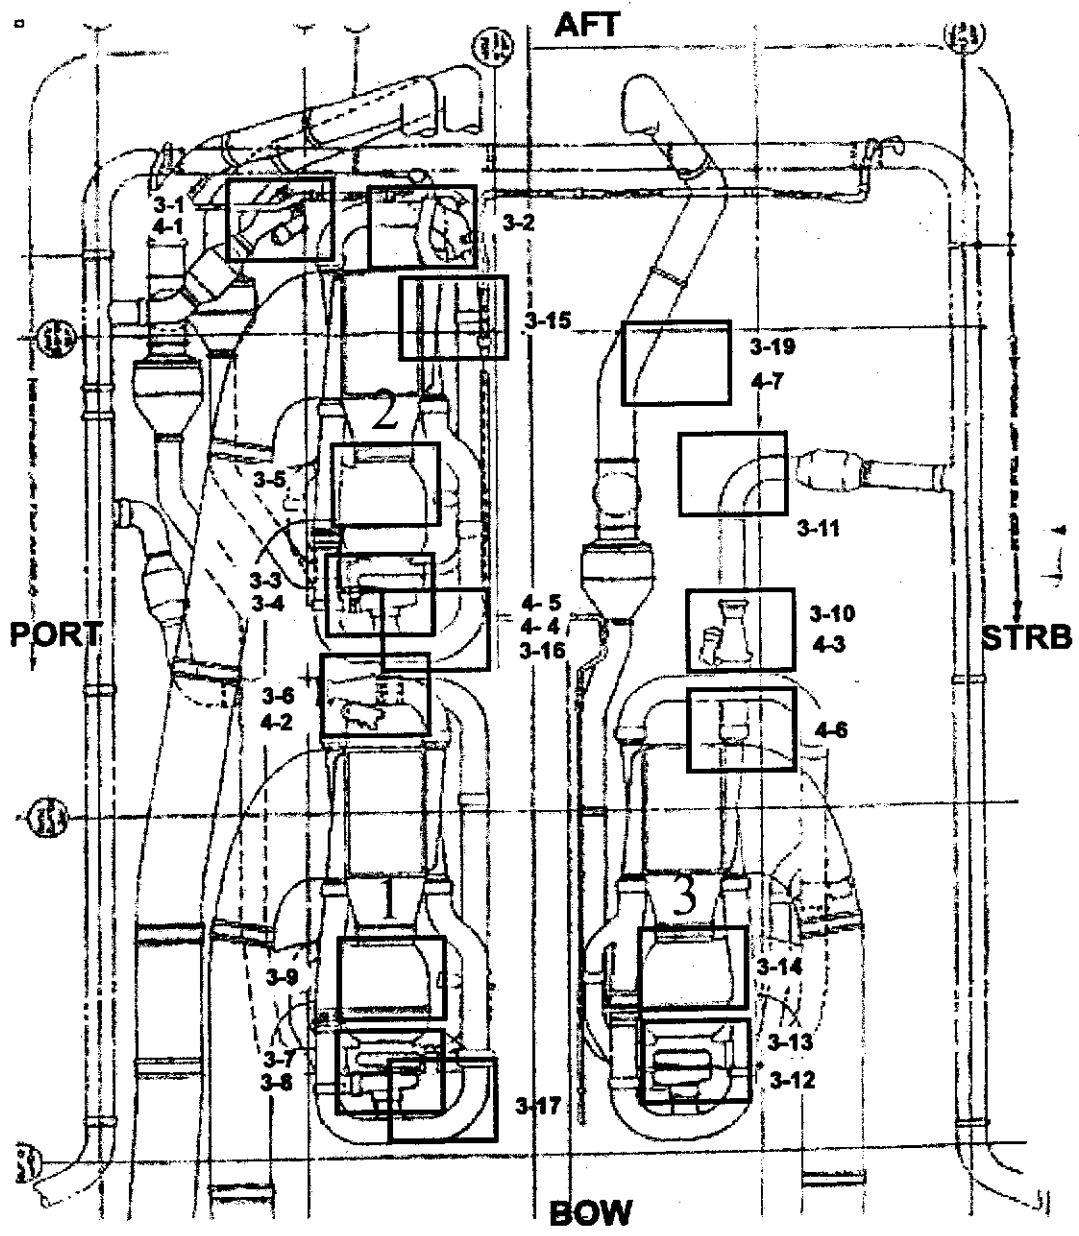
Figure 3: IR-images locations superimposed on schematic of ACM bay equipment (adapted from a Boeing technical drawing). The configuration of ACM bay is as seen from beneath the plane.

During the imaging, the video recorder ran continuously, with the line being attached alternately to the IR camera and the visible video camera. As a particular section was imaged, handheld thermocouple probes were used to get temperature readings for comparison with those obtained from the IR camera. Mark Ahler of Boeing also took temperature readings of the target objects. It was found that the response of the hand held probe was slow, and even the quicker one (Boeing's) was not stationary in output (indicated temperature was typically rising). The temperature data from IR camera and the handheld probes is given in Table 3 along with the description of the IR-images that were taken during this third test. Photos of typical assets of the ACM bay are shown on Figure ref-stillphotos and the layout mapping the locations of the IR-images is at Figure 3. The IR-images themselves are in Figures 4, 5 and 6.

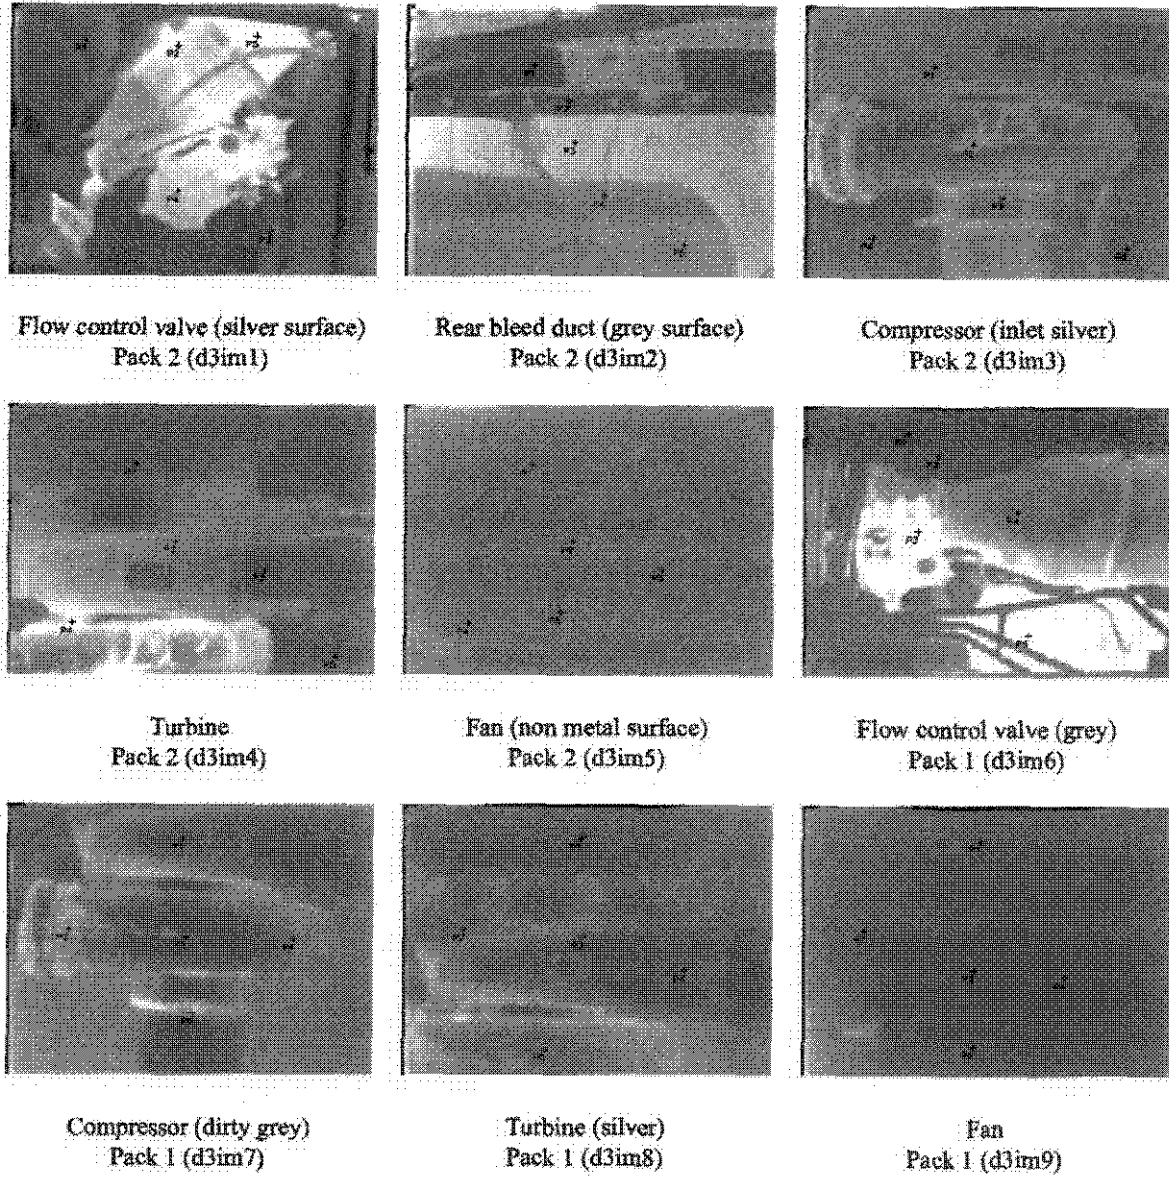
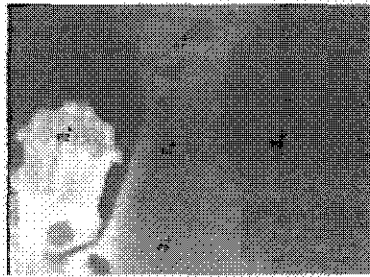
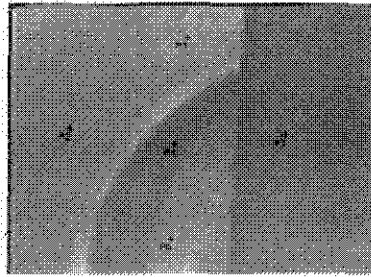
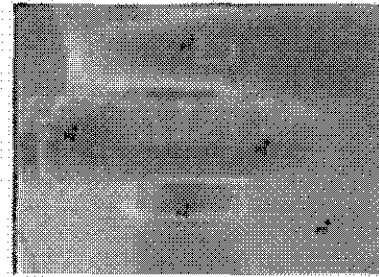
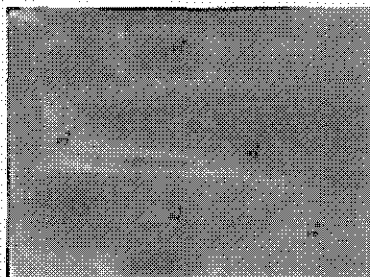
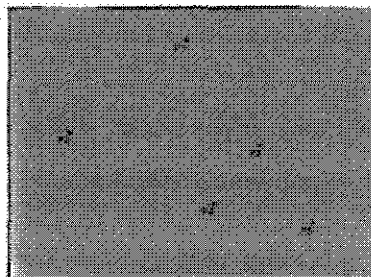
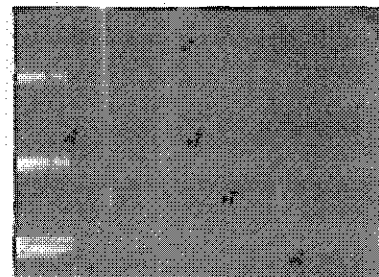
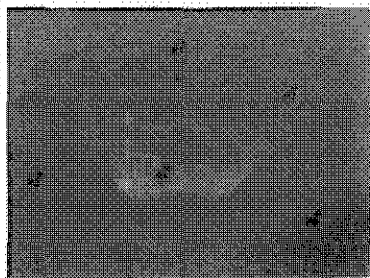
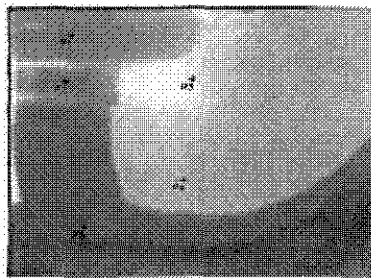
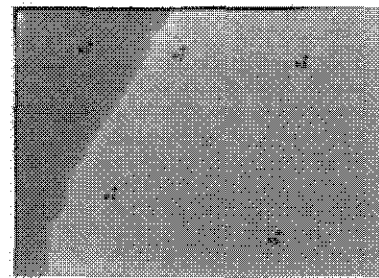
Figure 4: IR-images during cool-off phase (ACM packs off) of test no.3.

Flow control valve (silver)
Pack 3 (d3im10)

Bleed duct
Pack3 (d3im11)

Compressor
Pack 3 (d3im12)

Turbine
Pack 3 (d3im13)

Fan
Pack 3 (d3im14)

Green tank bottom beside louvres
Pack 3 (d3im15)

Tank bottom near Pack 1 heat exch.
radiometer (d3im16)

Tank bottom beside compressor
Pack 1 (d3im17)

Tank bottom surface; aft
Pack 3 (d3im19)

Figure 5: IR-images during cool-off phase (ACM packs off) of test no.3...continued.

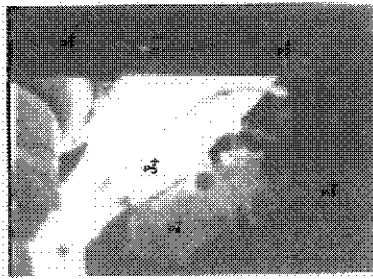
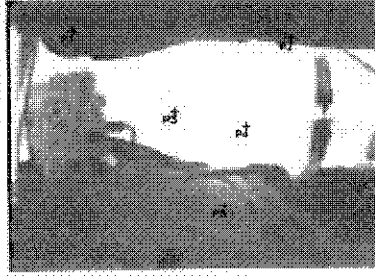
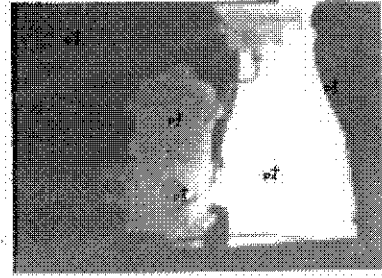
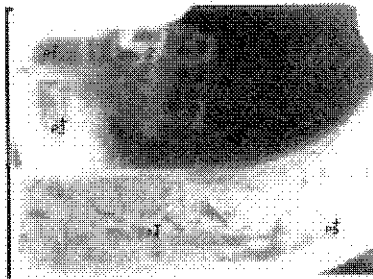
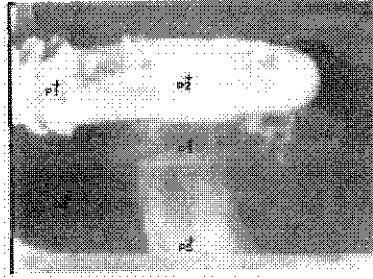
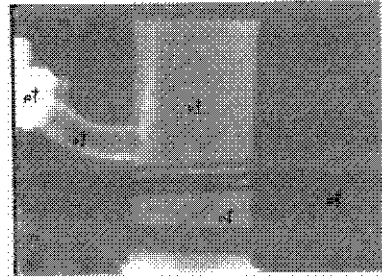
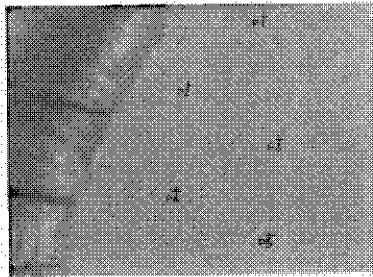
Flow control valve
Pack 2 (d4im1)

Flow control valve
Pack 1 (d4im2)

Flow control valve
Pack 3 (d4im3)

Tank bottom between
Packs 1 and 2 (d4im4)

Tank bottom between
Packs 1 and 2 (d4im5)

Junction before flow control valve
Pack 3 (d4im6)

Tank Bottom; aft
Pack 3 (d4im7)

Figure 6: IR images with ACM packs on during test no.3.

17:22	d4im3	Pack 3 Flow control valve	0.95	over-ranged	-	261
	d4im4	Tank bottom between Packs 1 and 2	0.95	-	-	-
	d4im5	Tank bottom between Packs 1 and 2	0.95	217	-	-

17:28	----- Packs turned off -----					
17:28	d4im6	Pack 3 Junction before flow control valve	0.95	201-190	-	196
	d4im7	Pack 3 Tank bottom (aft)	0.95	122	-	114
