**NATIONAL TRANSPORTATION SAFETY BOARD**  
Vehicle Recorder Division  
Washington, DC 20594

## **Flight Data Recorder - Addendum**

### **Specialist's Factual Report Addendum By Christopher Babcock**

Location:	Bedford, Massachusetts
Date:	May 31, 2014, 2140 Eastern Daylight Time (EDT)
Aircraft:	Gulfstream GIV, N121JM
Operator:	Arizin Ventures, LLC
NTSB Number:	ERA14MA271

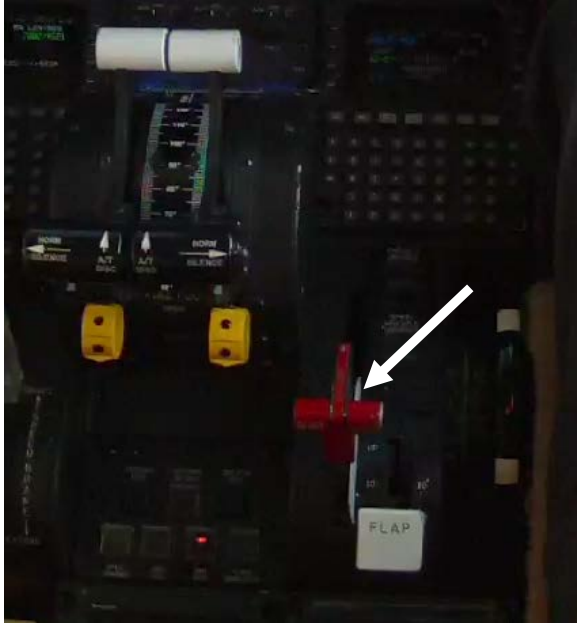
**Figure 1.** Gust lock handle in up/aft and latched (on) position.

For the purposes of this testing, a description of "gust lock on" or "gust lock engaged" indicates that the gust lock handle is positioned in its fully up/aft position (gust lock system locked) (Figure 1). A description of "gust lock off" indicates that the gust lock handle is in its fully down/forward (gust lock system unlocked) (Figure 2). A description of "gust lock handle unlatched" indicates that the gust lock handle is in an intermediate position; between fully forward and fully aft (Figure 3).

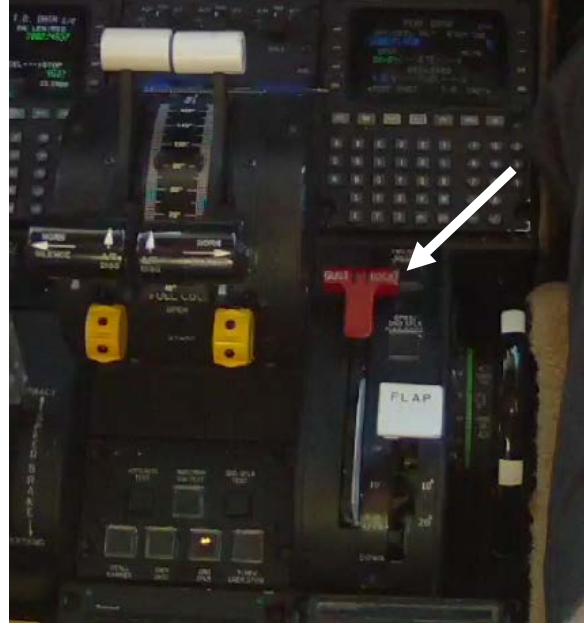
**Figure 2.** Gust lock handle in down/forward and latched (off) position

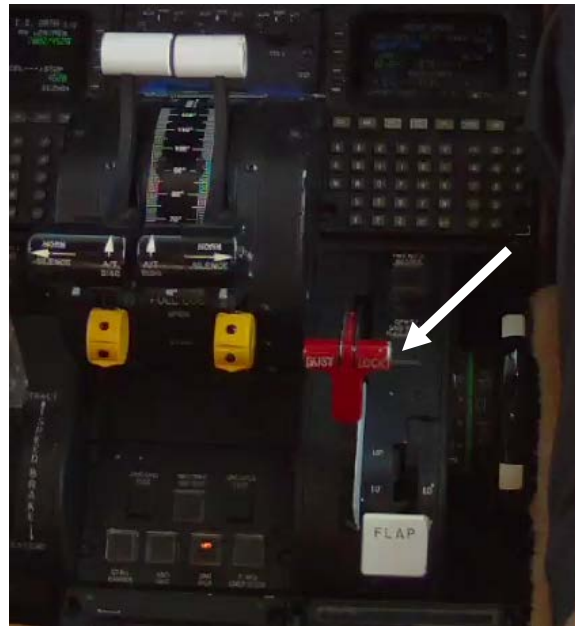
**Figure 3.** Gust lock handle in unlatched (intermediate) position.

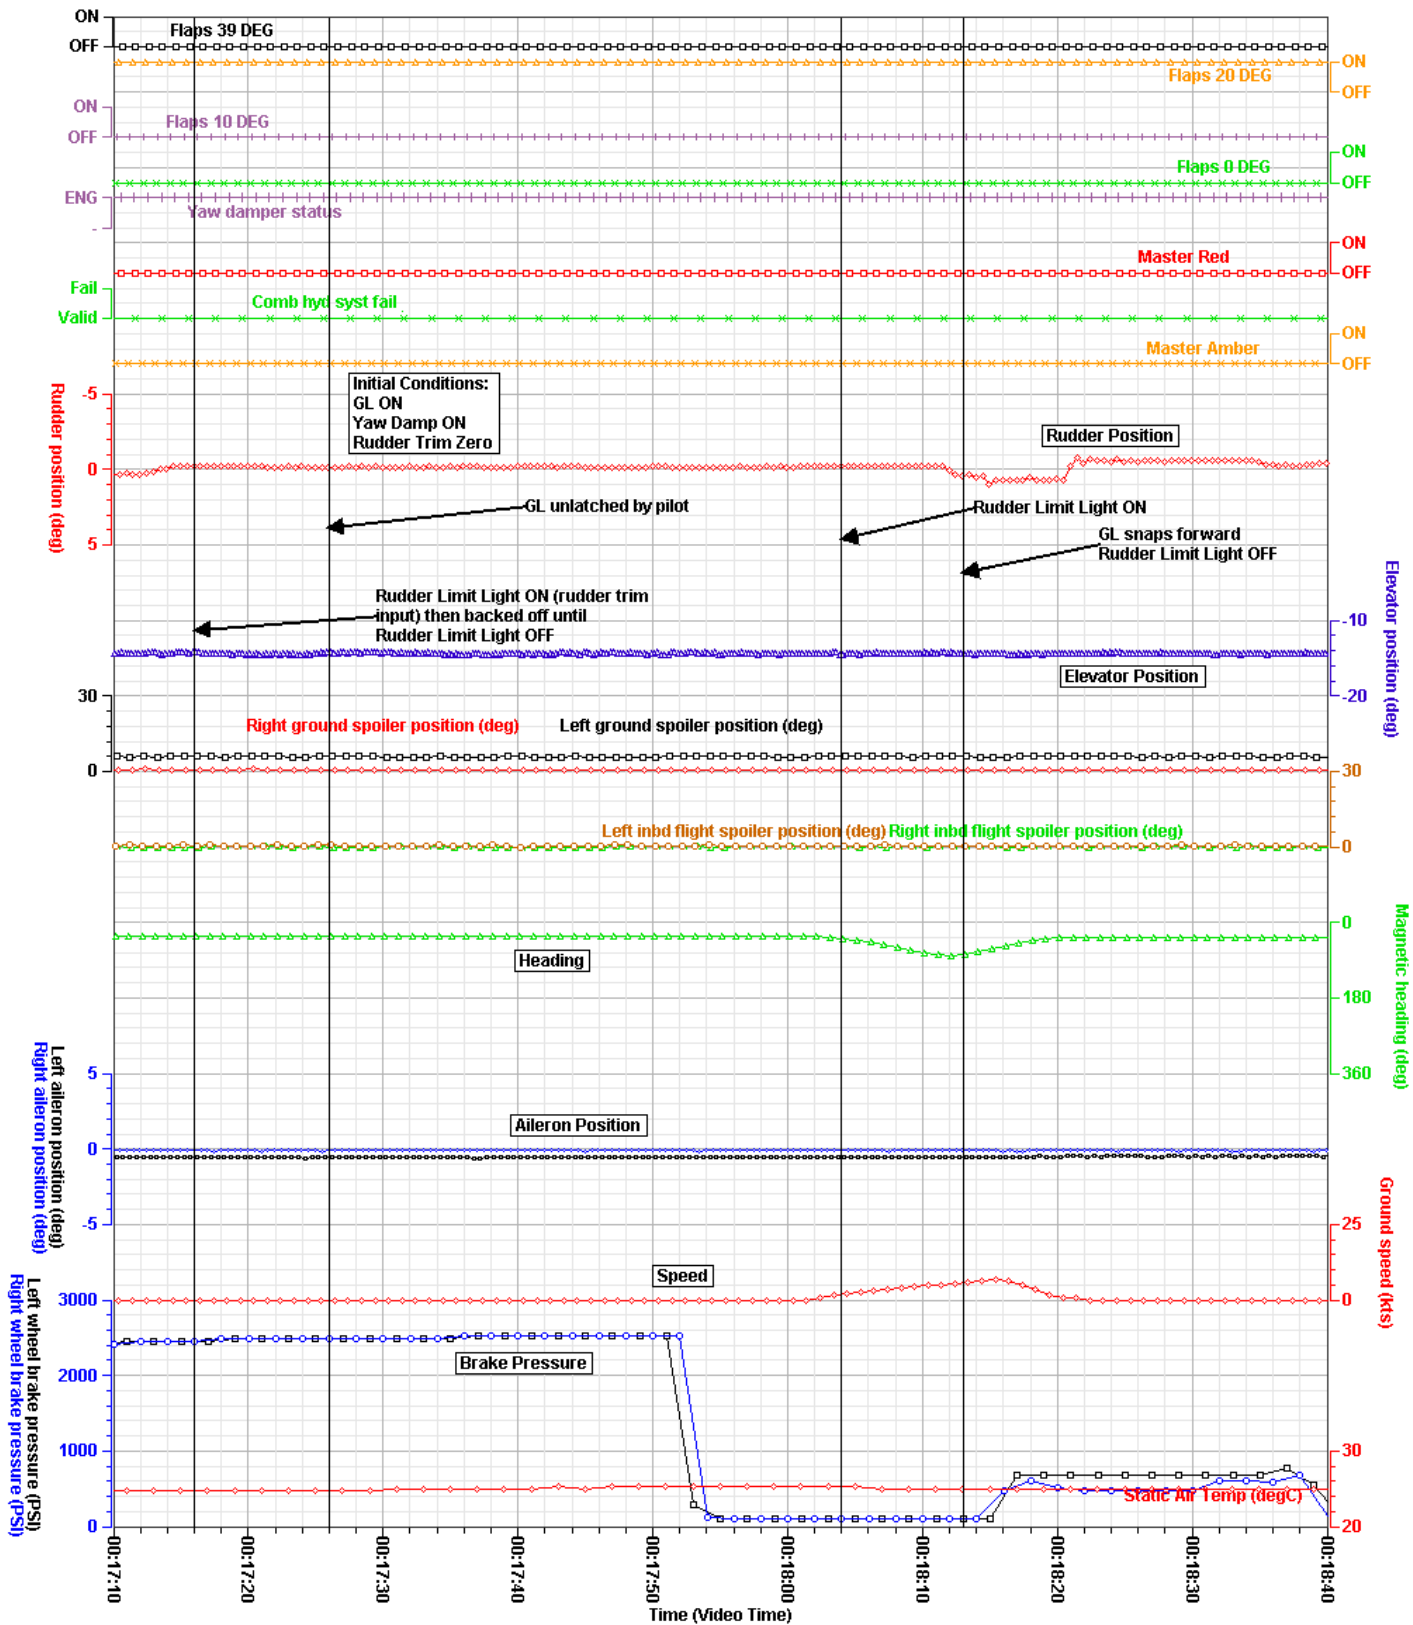
Dynamic Taxi Test - GL Unatched Yaw Damper Characte...

**Figure 11.** Dynamic taxi test - gust lock unatched yaw damper characterization (GIV-GER-9980 Test T4).

Figures 9 through 15 contain data for tests conducted on July 29, 2014. Figure 9 contains an exemplar preflight stall barrier and flight control check. Figure 10 contains data showing the authority of the yaw damper to move the rudder surface with the gust lock on during turns in both directions while taxiing. Figure 11 contains data showing the function of the behavior of the blue “Rudder Limit” crew alerting system (CAS) message and the gust lock handle during turns in both directions with a rudder preload provided by trim input and the gust lock handle unlatched (gust lock hooks remained engaged). Turning to the right caused the “Rudder Limit” light to illuminate. The gust lock handle sprang forward during a turn to the left. Figure 12 contains data from a repeat of this test point. Figure 13 contains data showing the behavior of the autothrottle and engines when the gust lock handle was unlatched to the intermediate position. The PLA reached 30° when the autothrottles were engaged and the engine pressure ratios (EPR) reached their target of 1.59. Figures 14 and 15 show data from additional tests not described in the flight test plan. Figure 14 contains data for an autothrottle engagement at 1.17 EPR with a target of 1.59 EPR with the gust lock on. The thrust levers moved to the gust lock interlock and PLA angles increased to 21.4° and 22.8° before retreating to 18.7°. The autothrottles disconnected within three seconds. Figure 15 contains data for an autothrottle engagement with the thrust levers positioned against the gust lock interlock. The PLA angles momentarily increased and the autothrottles disconnected within three seconds.

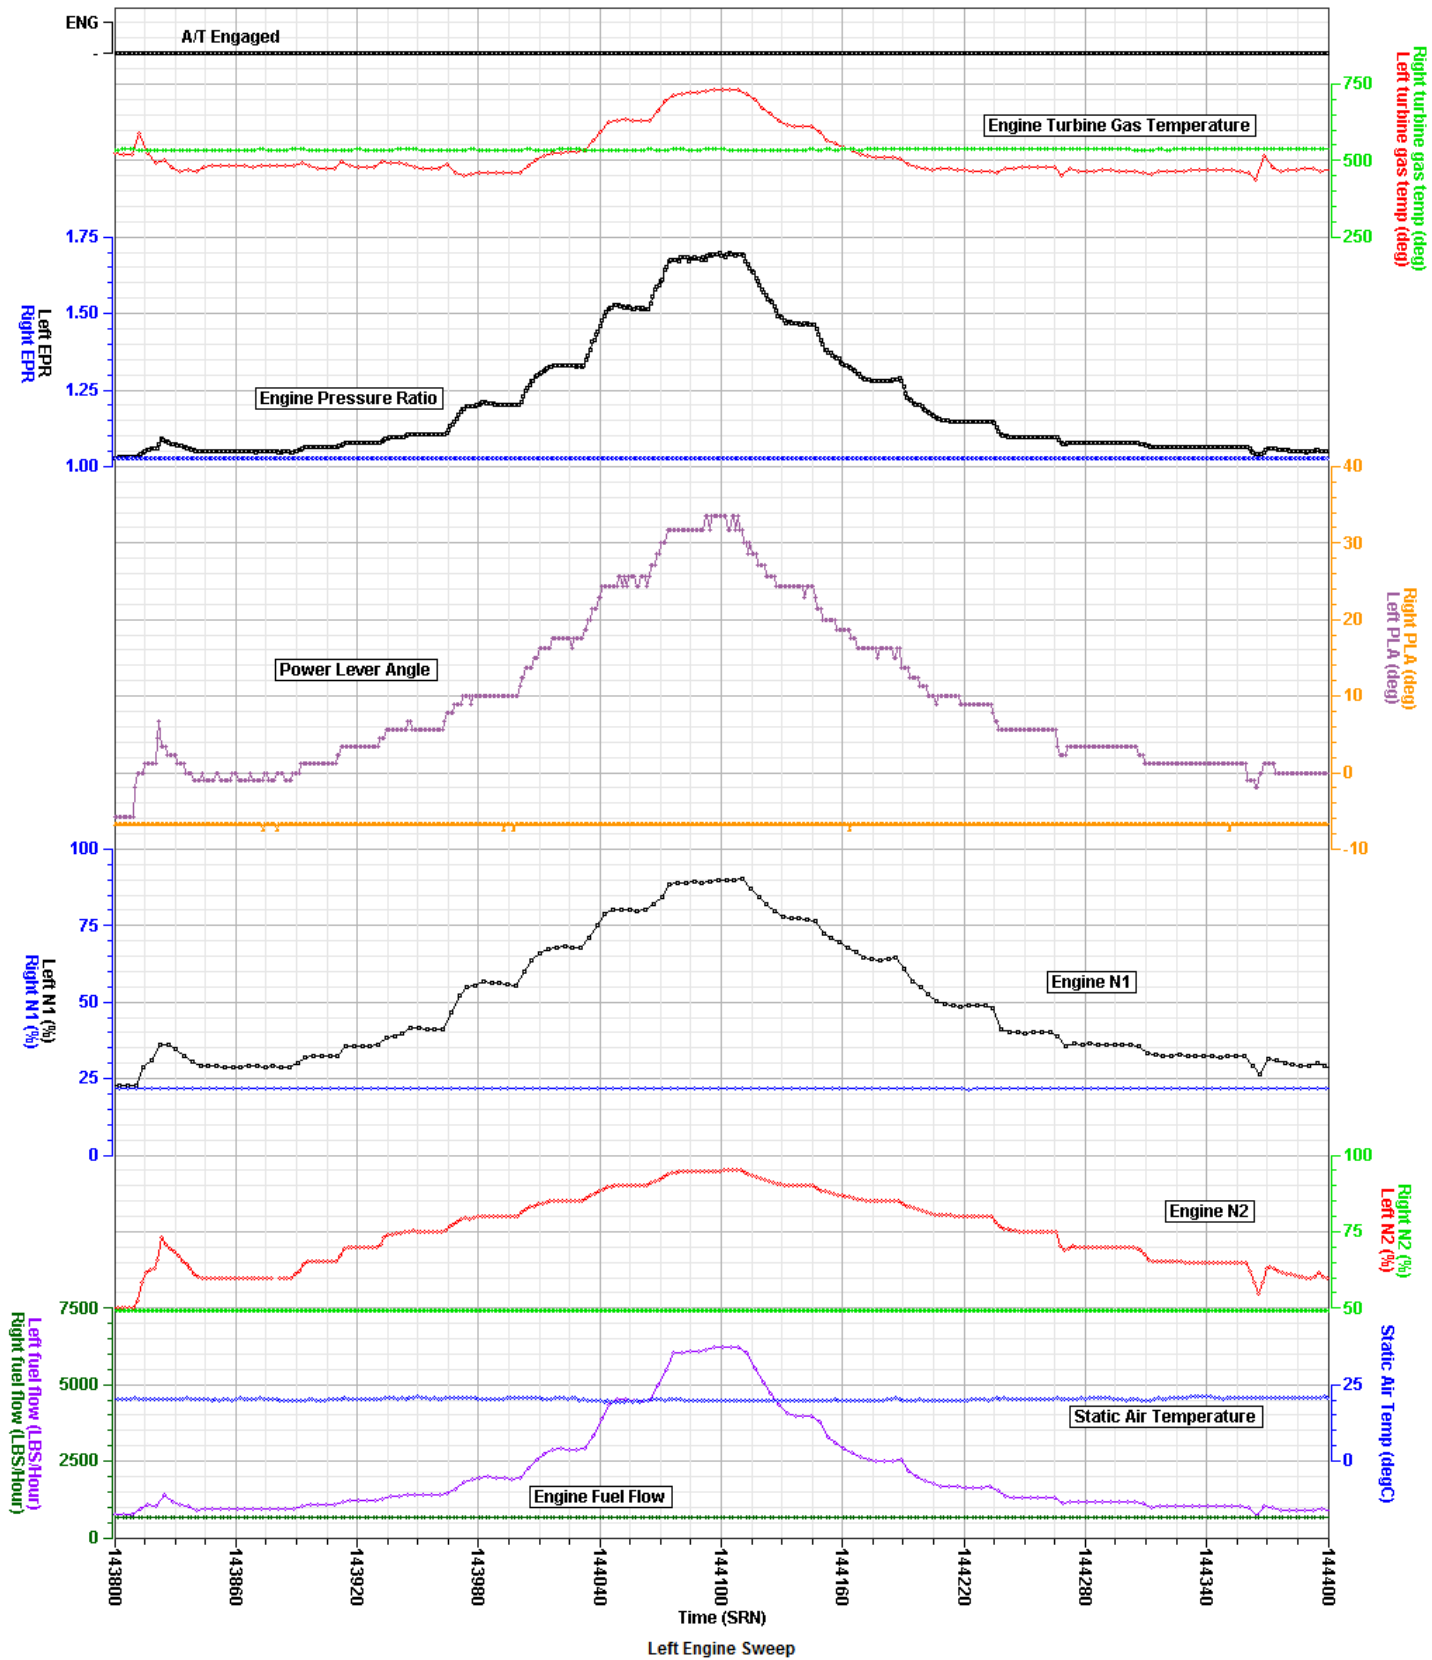
Figure 16. Left engine sweep.

Figures 16 through 25 contain data for tests conducted on November 13, 2014. Figures 16 and 17 document the EPR/PLA relationship on the test day. These test points were conducted prior to the start of the video recording so time is represented in raw subframe counts. Figures 18 and 19 document the EPR that can be attained on the test day when the power levers are moved to the gust lock interlock, both with no pilot pressure against the interlock and with firm pressure against the interlock. Figure 20 documents the speed at which the control column began to move aft due to air loads during a high speed taxi with the gust lock off, approximately 70 knots. Figures 21 through 23 contain data for high speed taxi tests with the gust lock on. The intent of these test runs was to investigate and replicate the reduction in PLA and EPR as recorded on the accident takeoff FDR (see Figure 10 of the FDR Factual Report for comparison). The aircraft accelerated to 70 knots with autothrottle on and the copilot attempted to unlatch the gust lock handle. On the first run (Figure 21), the copilot was

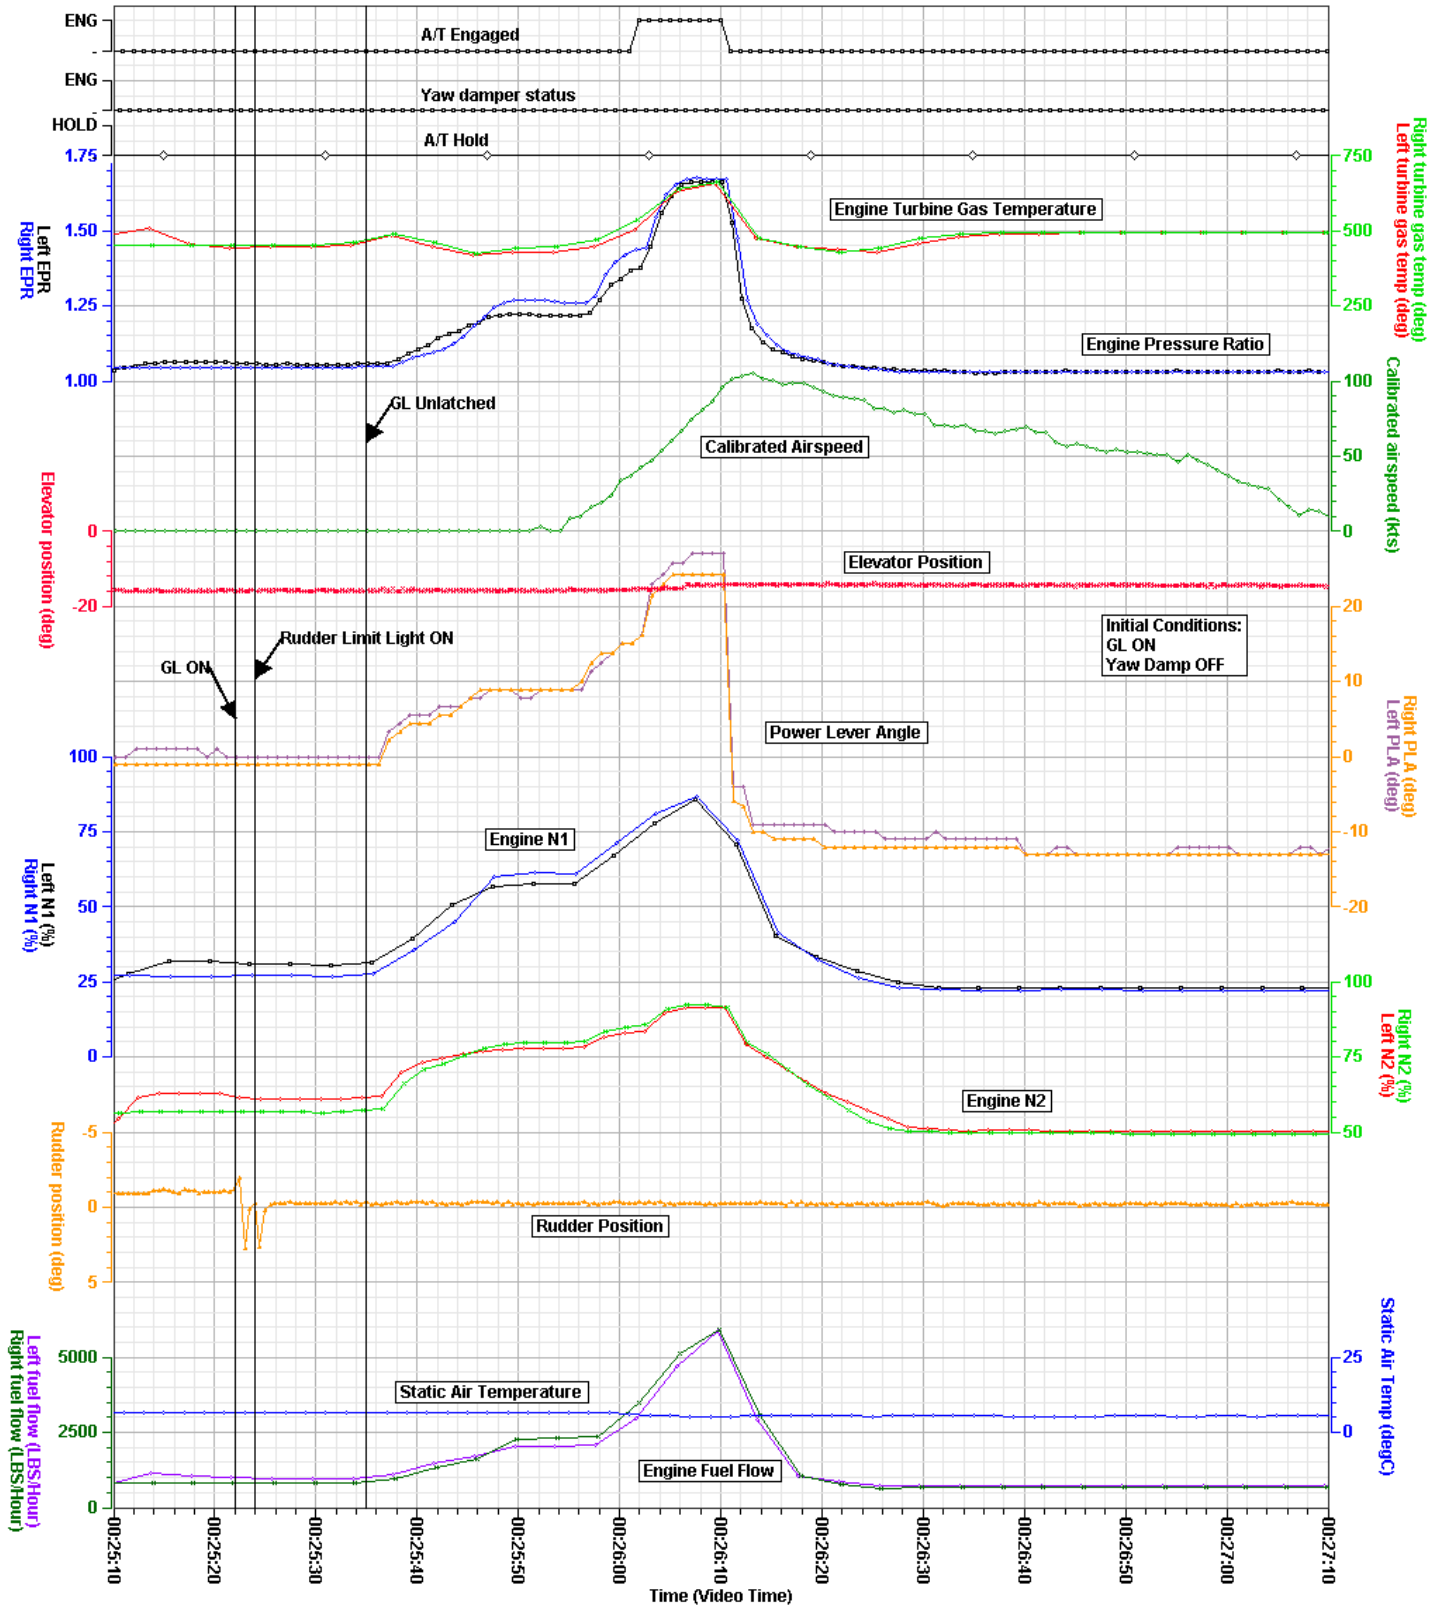
Taxi w GL Unlatched Repeat 2

Figure 28. Second repeat of taxi test with gust lock unlatched (Rated EPR).

Figures 26 through 28 contain data for tests conducted on November 14, 2014. They document high speed taxi tests with the gust lock handle unlatched using Rated EPR. The gust lock snapped forward without pilot input during the first two attempts (Figures 26 and 27). The gust lock handle remained in the unlatched position with no pilot input for the entirety of this test (Figure 28). The yaw damper was disengaged for this attempt due to wind gusts.
