# NATIONAL TRANSPORTATION SAFETY BOARD

## Flight Data Recorder - 10

### Specialist's Factual Report

Location: Point Mugu, California  
Date: May 18, 2011  
Aircraft: Boeing 707  
Registration: N707AR  
Operator: Omega  
NTSB Number: DCA11PA075

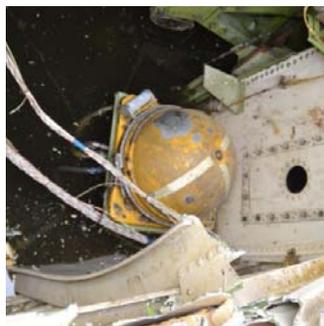
The flight data recorder (FDR) on board this aircraft was an LAS 109-C oscillographic foil-type recorder. Following the accident, the FDR was located in the wreckage as seen in Figure 1 below.

Figure 1. FDR as found in N707AR

The entire FDR unit was unable to be removed immediately following the event so the FDR cover was opened in situ and the cassette containing the recording medium was removed. Figure 2 is not the actual unit from the accident aircraft but rather an exemplar of the same type of recorder showing the recording medium cassette with its top cover removed.

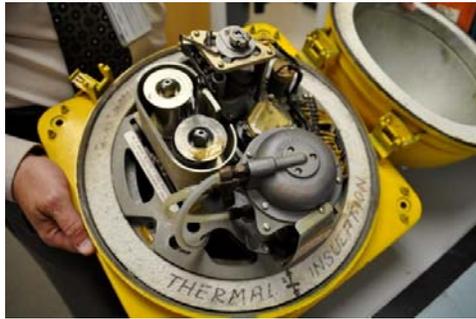
**Figure 2. Exemplar interior of similar FDR**

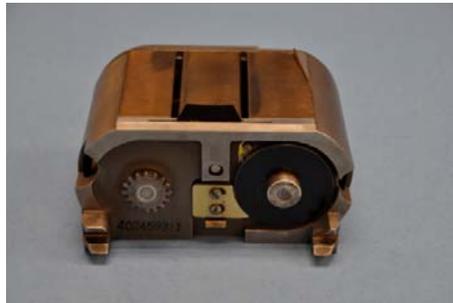
The recording medium was received by the Safety Board's Vehicle Recorder Division in Washington, DC on May 24, 2011. Normally for this type recorder, the foil medium is spooled on a supply reel, spanned over an open strip where styli imprint data traces and then wound by a take-up reel. When the cartridge was examined in the laboratory, figure 3, it was noted that there was no exposed foil medium observed.

**Figure 3. Recording medium cassette**

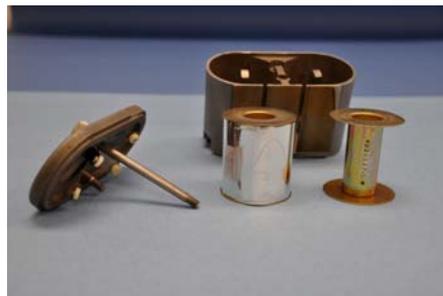
When the top cover was opened, it was observed that one of the reels was full of foil and the other reel was empty. When the reels were removed from the cassette, figure 4, it was evident that the full reel had been secured with clear tape. This indicated that the recorder was not operating at the time of the accident flight and for an undetermined time beforehand. Thus, no accident data was recorded on the unit.

**Figure 4. FDR foil media from N707AR**
