**NATIONAL TRANSPORTATION SAFETY BOARD**  
Office of Research and Engineering  
Washington, D.C.

**Group Chairman's Factual Report - Flight Data Recorder**

**DCA98RA013**

Location	:	Palembang, Indonesia
Date	:	December 19, 1997
Time	:	About 1614 Local Time
Aircraft	:	Silk Air Flight MI-185, a Boeing B-737-36N, 9V-TRF

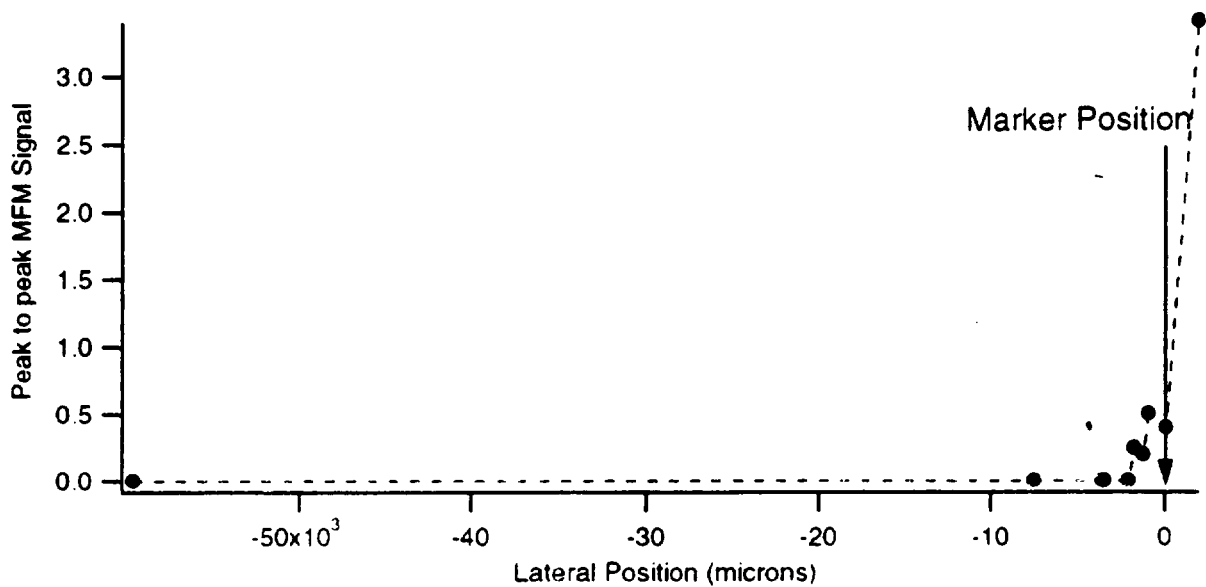
# MFM Signal vs. Lateral Position

The degradation in signal amplitude observed with the MFM technology was greater than that observed with the waveform analysis performed on the signal readout with the tape head. In order to determine if additional bits do exist beyond those already recovered, further MFM analysis is required. A special rig with a measurement device must be constructed to accommodate the reels of tape and regulate the movement of the sample. The data, beginning at a known reference point, would have to be mapped out along the weakening signal until they completely disappear. These waveforms must be

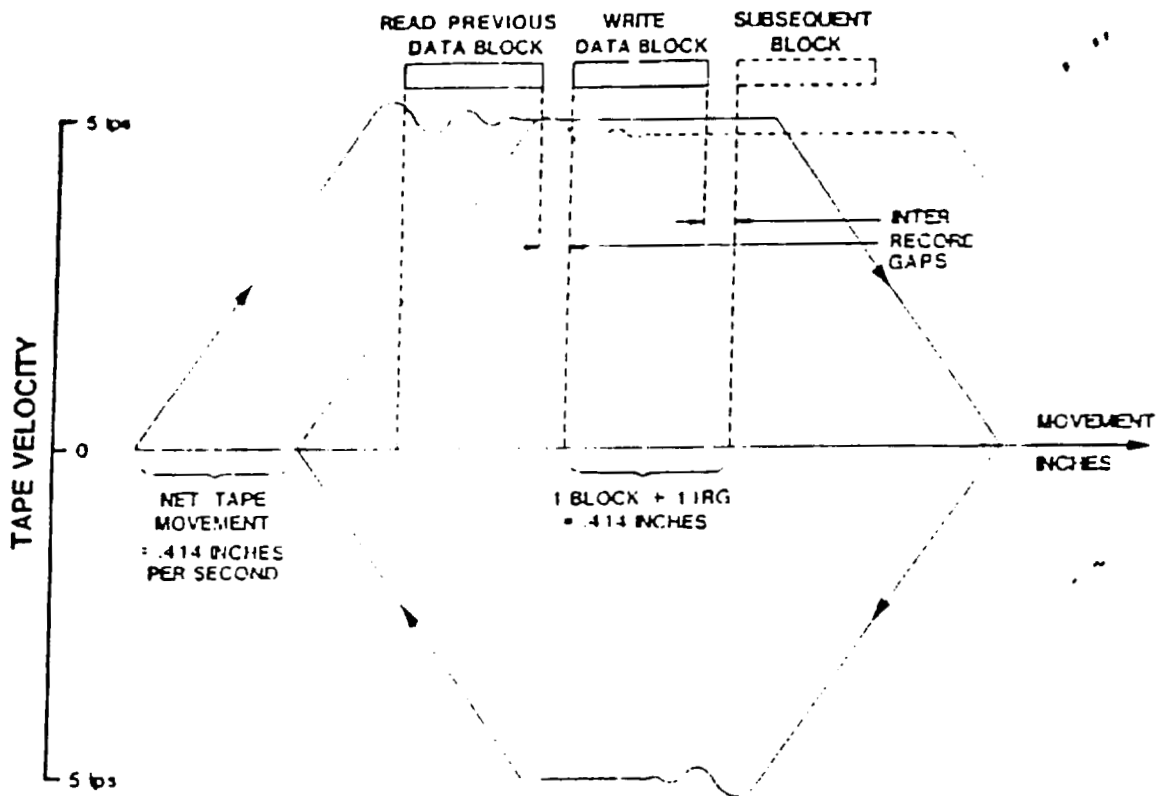
FIGURE 3-3

## UFDR CHECKSTROKE PRINCIPLE

TAPE VELOCITY VERSUS DISPLACEMENT GRAPH

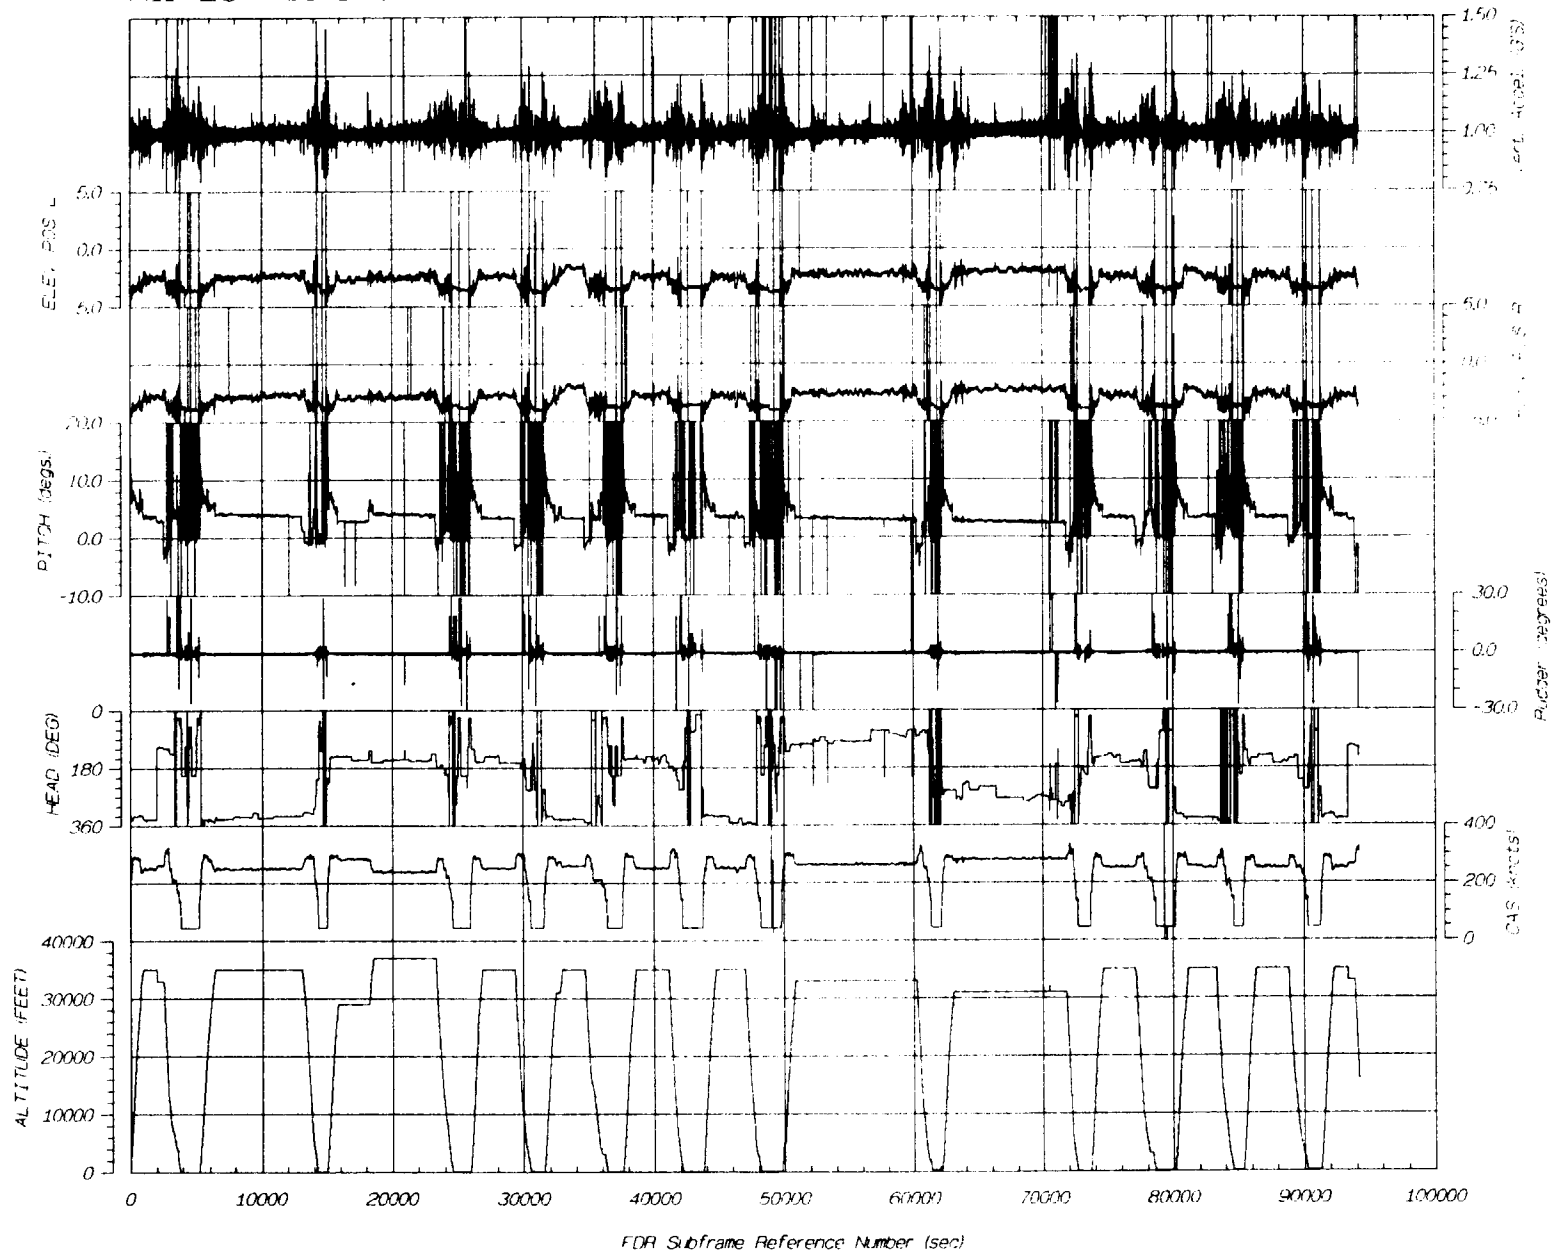
All 25 Hours of FDR

2) The 25 hours of recorded data was examined to determine if any excitation of vertical 'g' or abnormality in elevator position could be observed which might suggest control surface flutter. This data was compared with data recorded during an actual elevator flutter event. No excitation or abnormalities in either the elevator position or vertical acceleration data were noted.
