NATIONAL TRANSPORTATION SAFETY BOARD
Vehicle Recorder Division
Washington, D.C. 20594

Flight Test Data Recorder

Group Chairman's Factual Report
By Charles Cates

Location: Italy, Texas
Date: July 6, 2016
Aircraft: Bell 525
Registration: N525TA
Operator: Bell Helicopter
NTSB Number: DCA16FA199

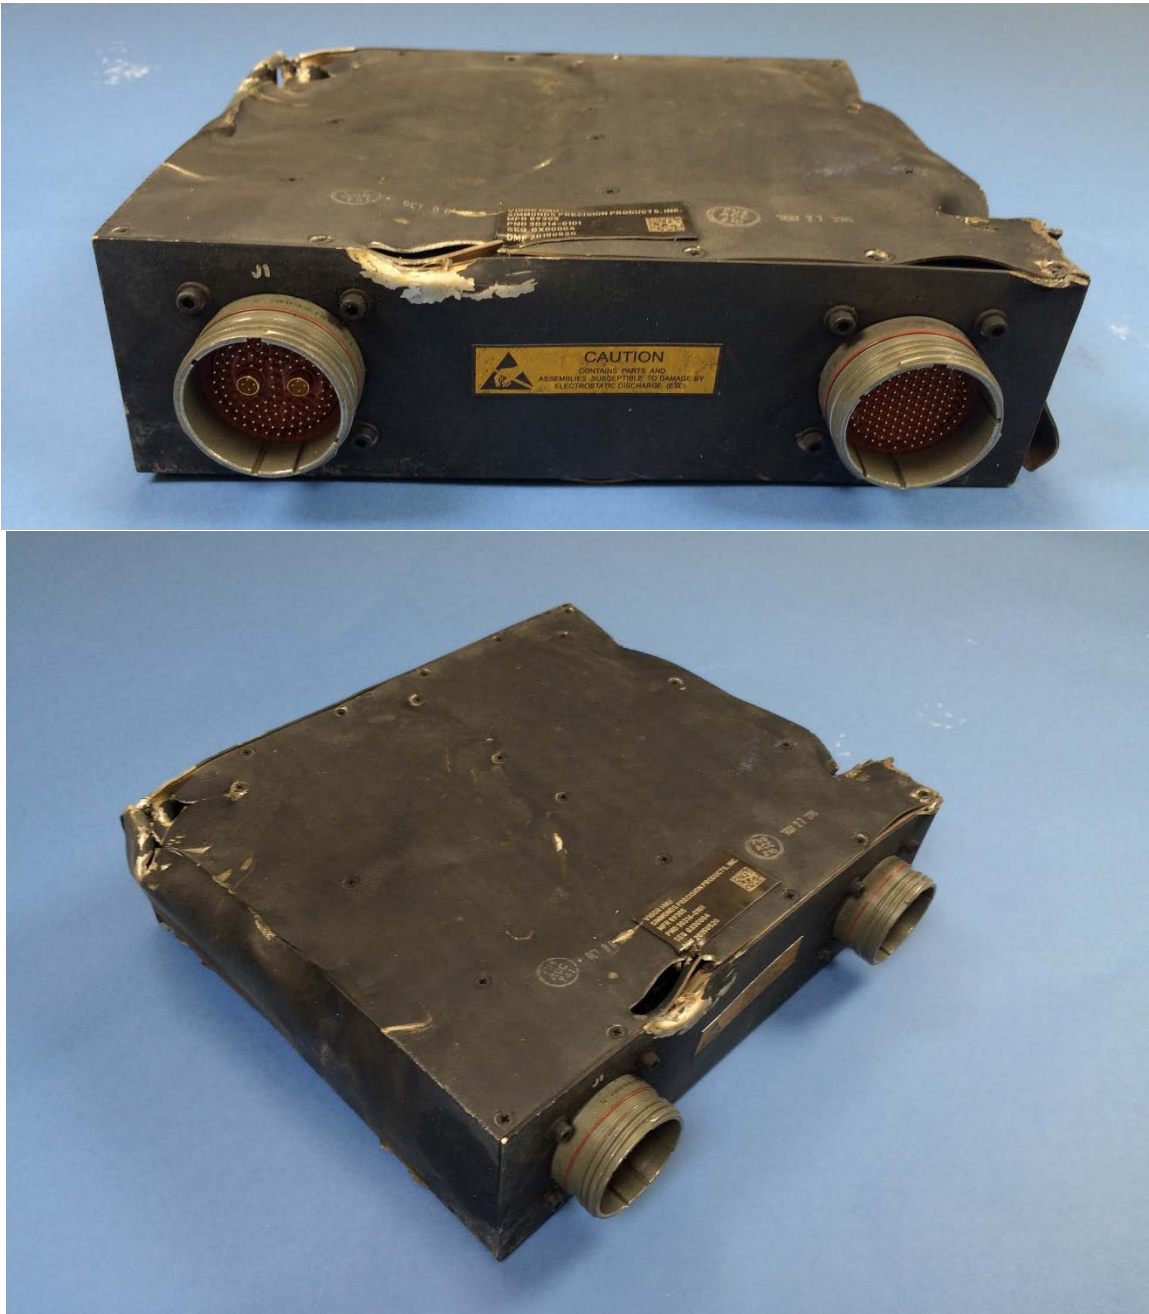
The Vigor HMU was damaged in the event by mechanical impact forces. No thermal or other fire-related damage was evident. The extent of the damage is shown in the as-received picture of the HMU, in figure 1.

Figure 1. Exterior of Vigor HMU as-received.

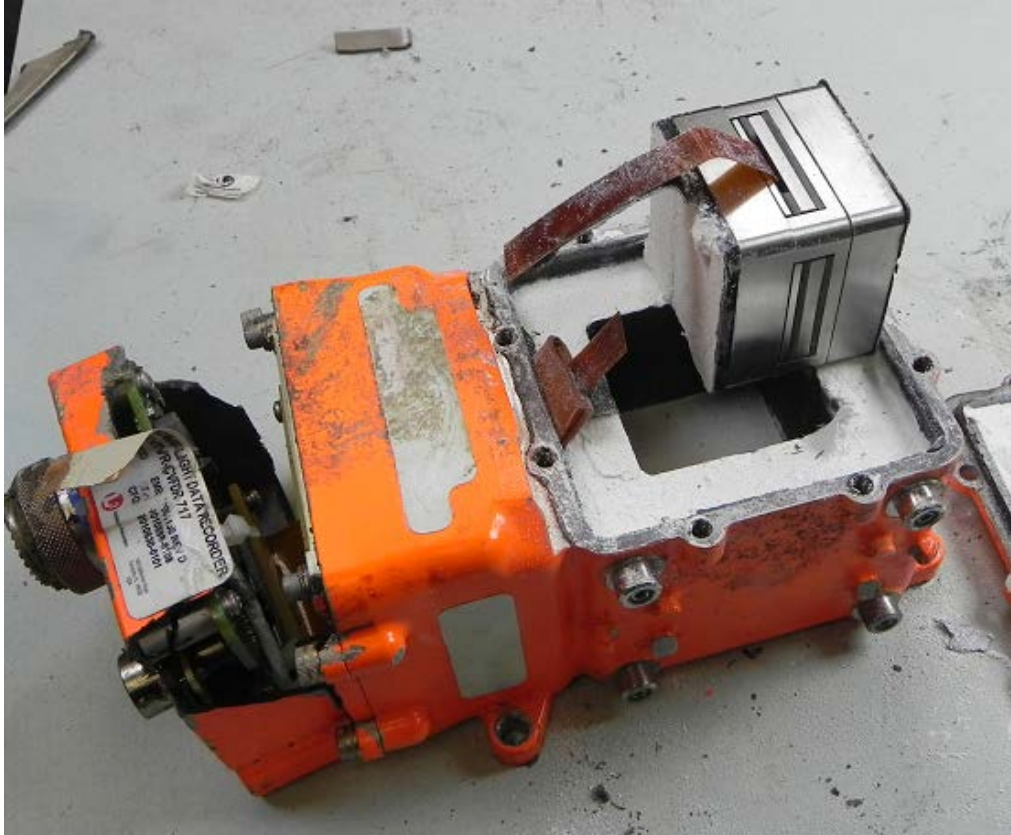
Figure 4. Crash survivable memory unit removed from unit.

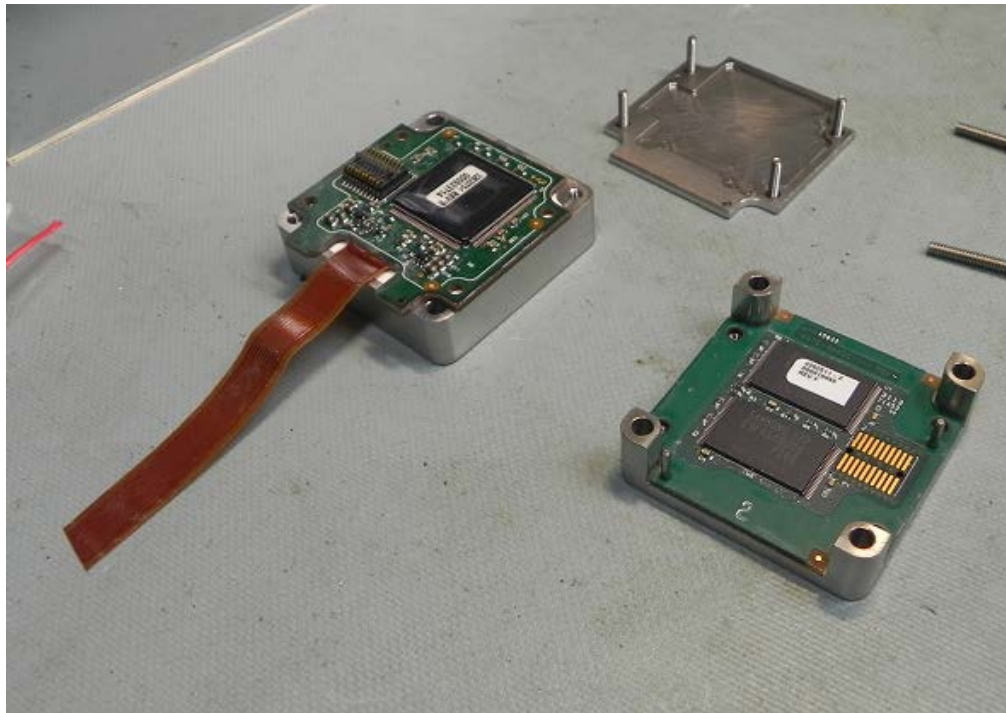
Figure 5. Component and memory board inside crash survivable memory unit.

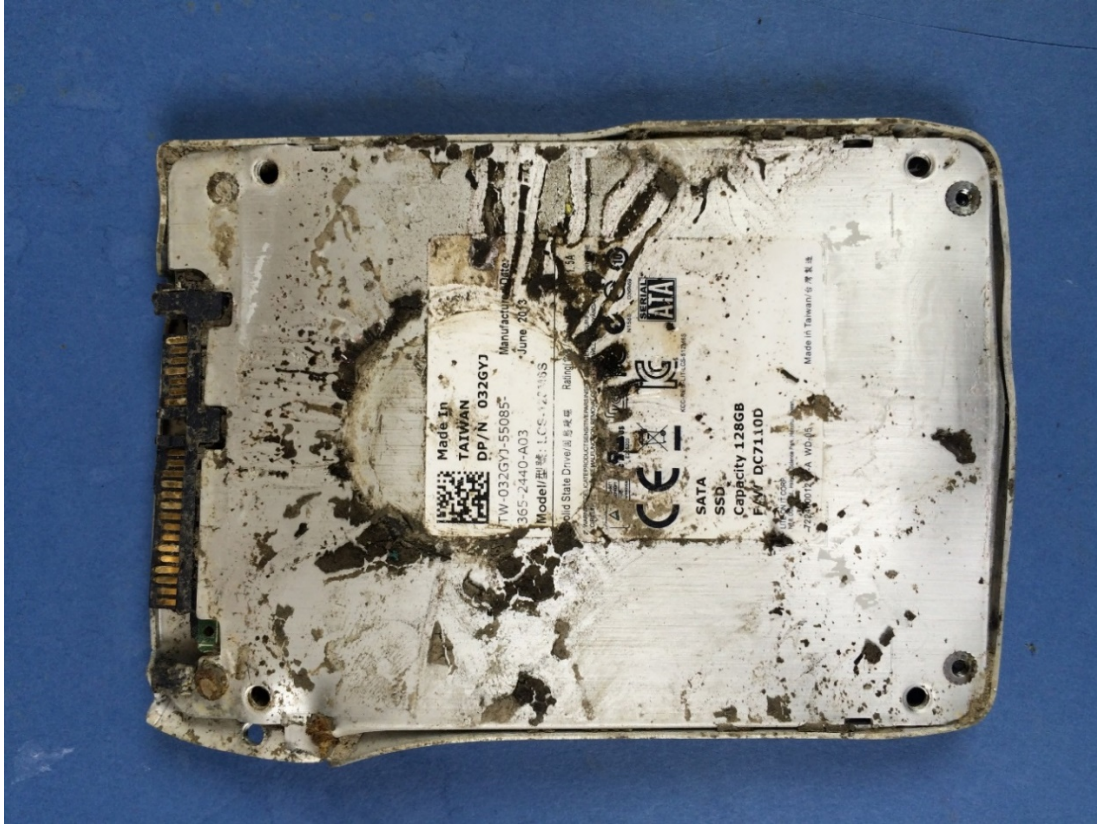
Upon arrival at the laboratory, it was evident that the drive had been subject to severe impact forces and sustained significant structural damage, as shown in figure 6. The structural damage included crushing and bending of the hard drive case. The unit also showed signs of fuel contamination and had dirt and mud packed in to the drive connectors and breaches in the drive casing, but no signs of thermal damage or sooting.

Figure 6. Solid state hard drive from avionics bus recorder, as-received.

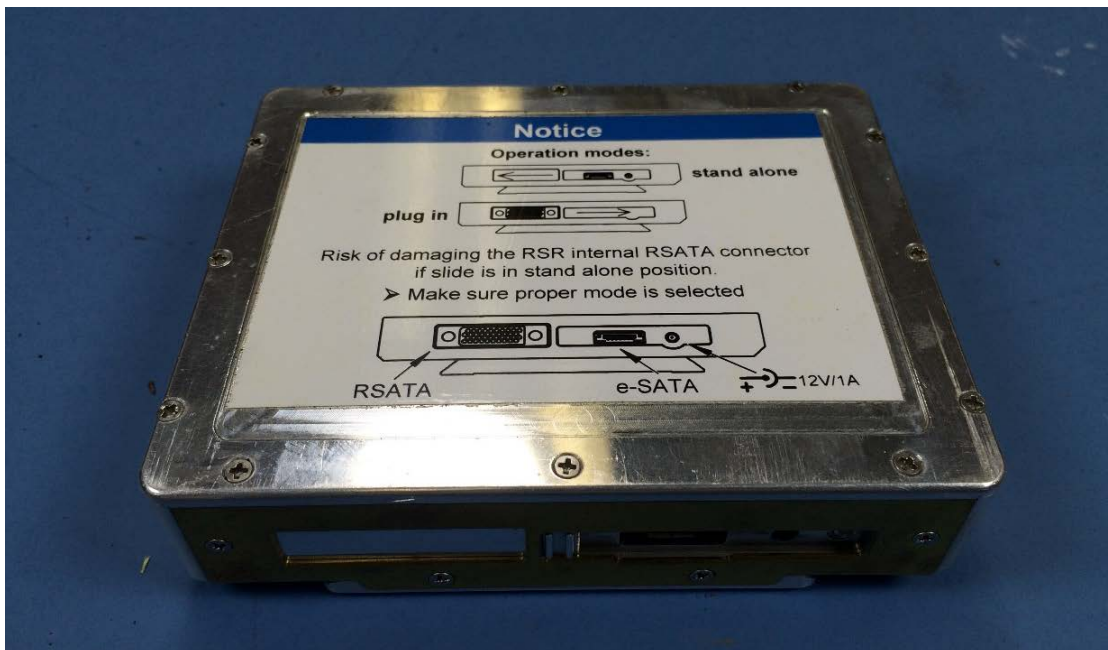
The RSM module was ejected from the helicopter during the crash sequence, and was found apart from the main aircraft wreckage. The module was found in good condition, with no apparent impact or thermal damage. The data module is shown in Figure 6.

Figure 8. RSM module, as-received.

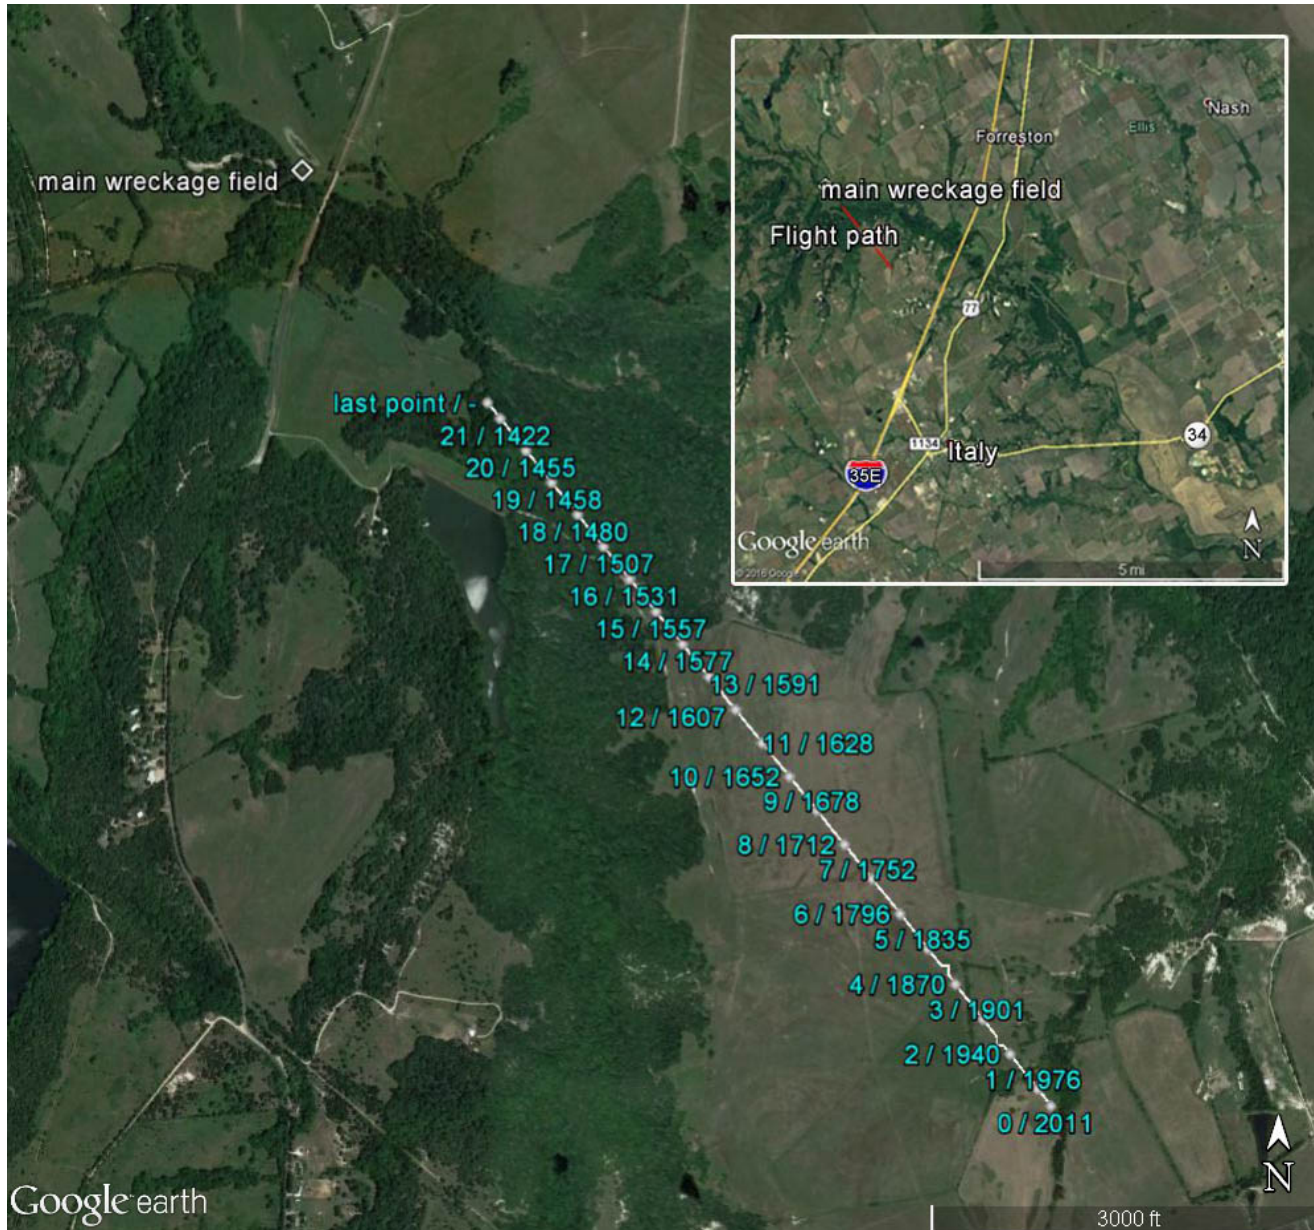
Figure 12. Map overlay of aircraft position with time and height above ground level (AGL) during test point 51.

Following the strike, rotor blade strain gauges became erratic until the end of the recording, about 0.2 sec later. There were no other reaction forces indicating other high energy events such as additional blade strikes. Data ended with the aircraft at about 1,100 ft above ground level and 160 knots indicated airspeed.

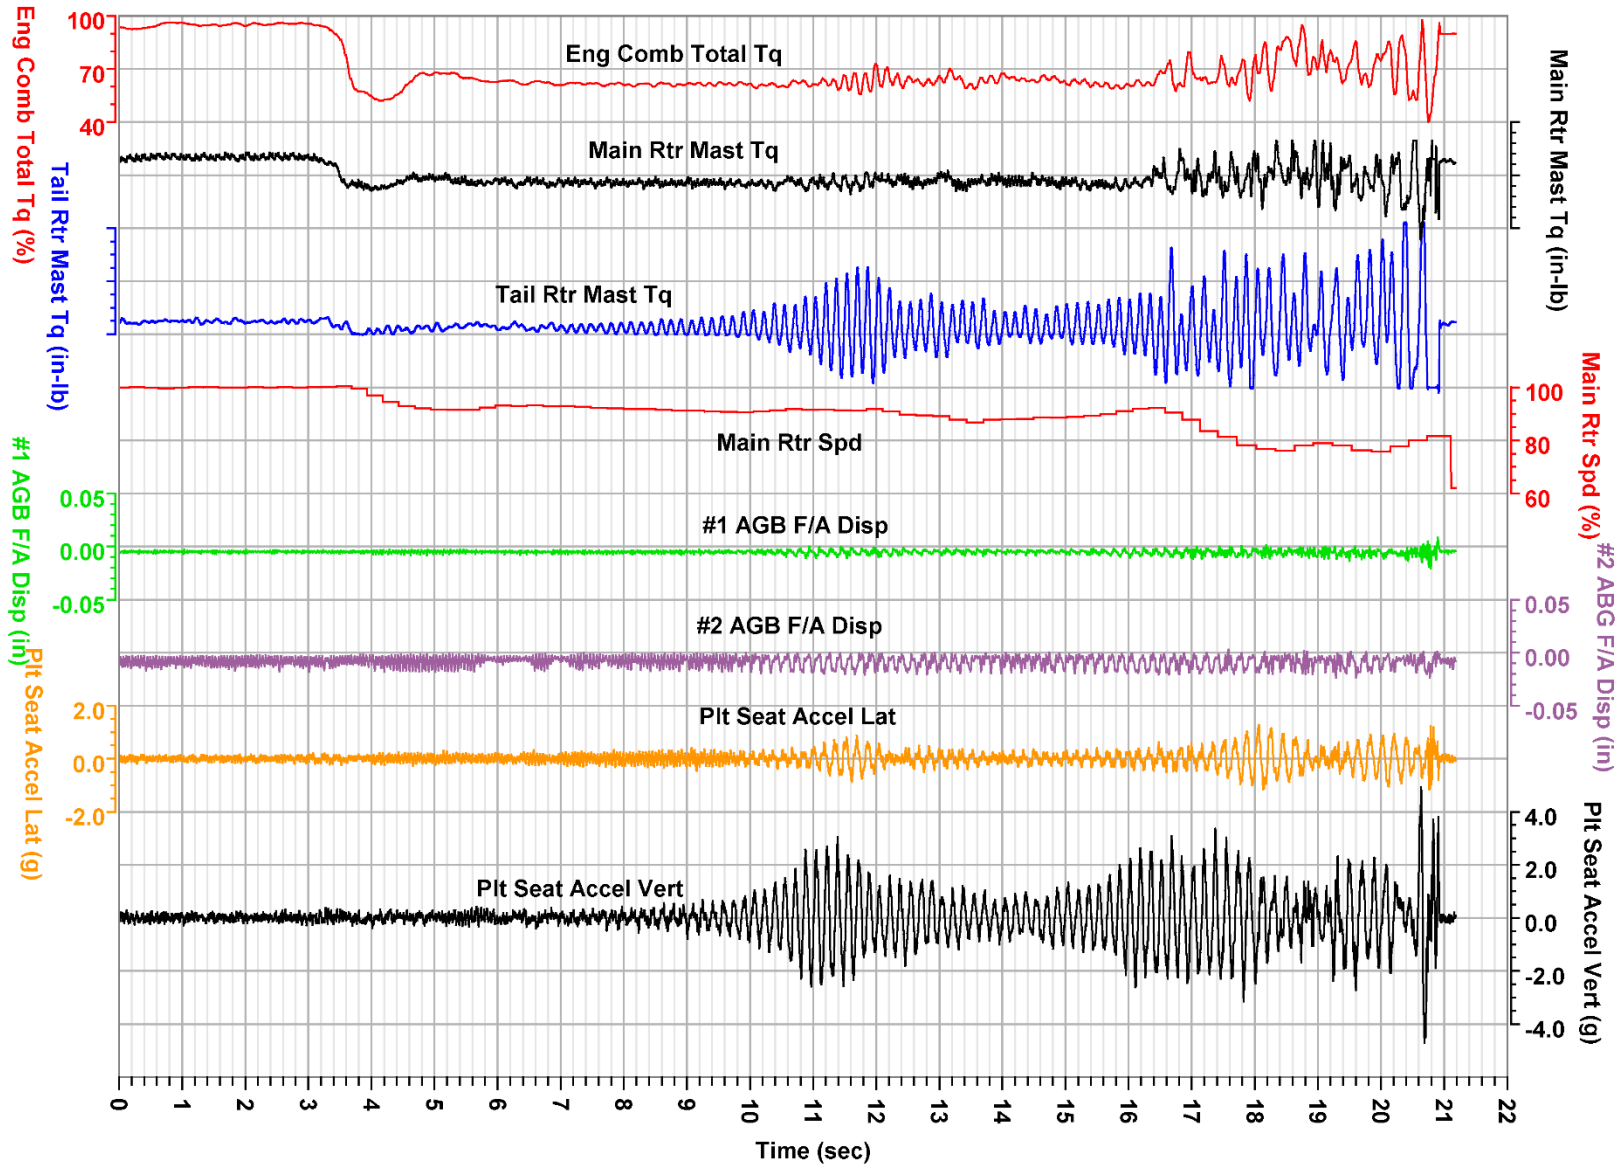
At about 12 seconds, and again at 17.5 seconds into the test point, the pilot seat experienced sustained vertical accelerations of greater than ± 3 g and the collective stick position increased, still with a 6 Hz oscillatory component present and $\pm 7\%$ displacement in the commanded position. Engine torque and rotor mast torques experienced large fluctuations at about 6 Hz, particularly in the tail rotor mast torque. Tail rotor blade lead-lag positions and forces also became erratic at this time. With the engines still operating in simulated OEI mode, main rotor speed decreased to about 75%.

Figure 14. Engine and rotor torque, accelerometers showing vibration bloom at pilot seat during TP 51.

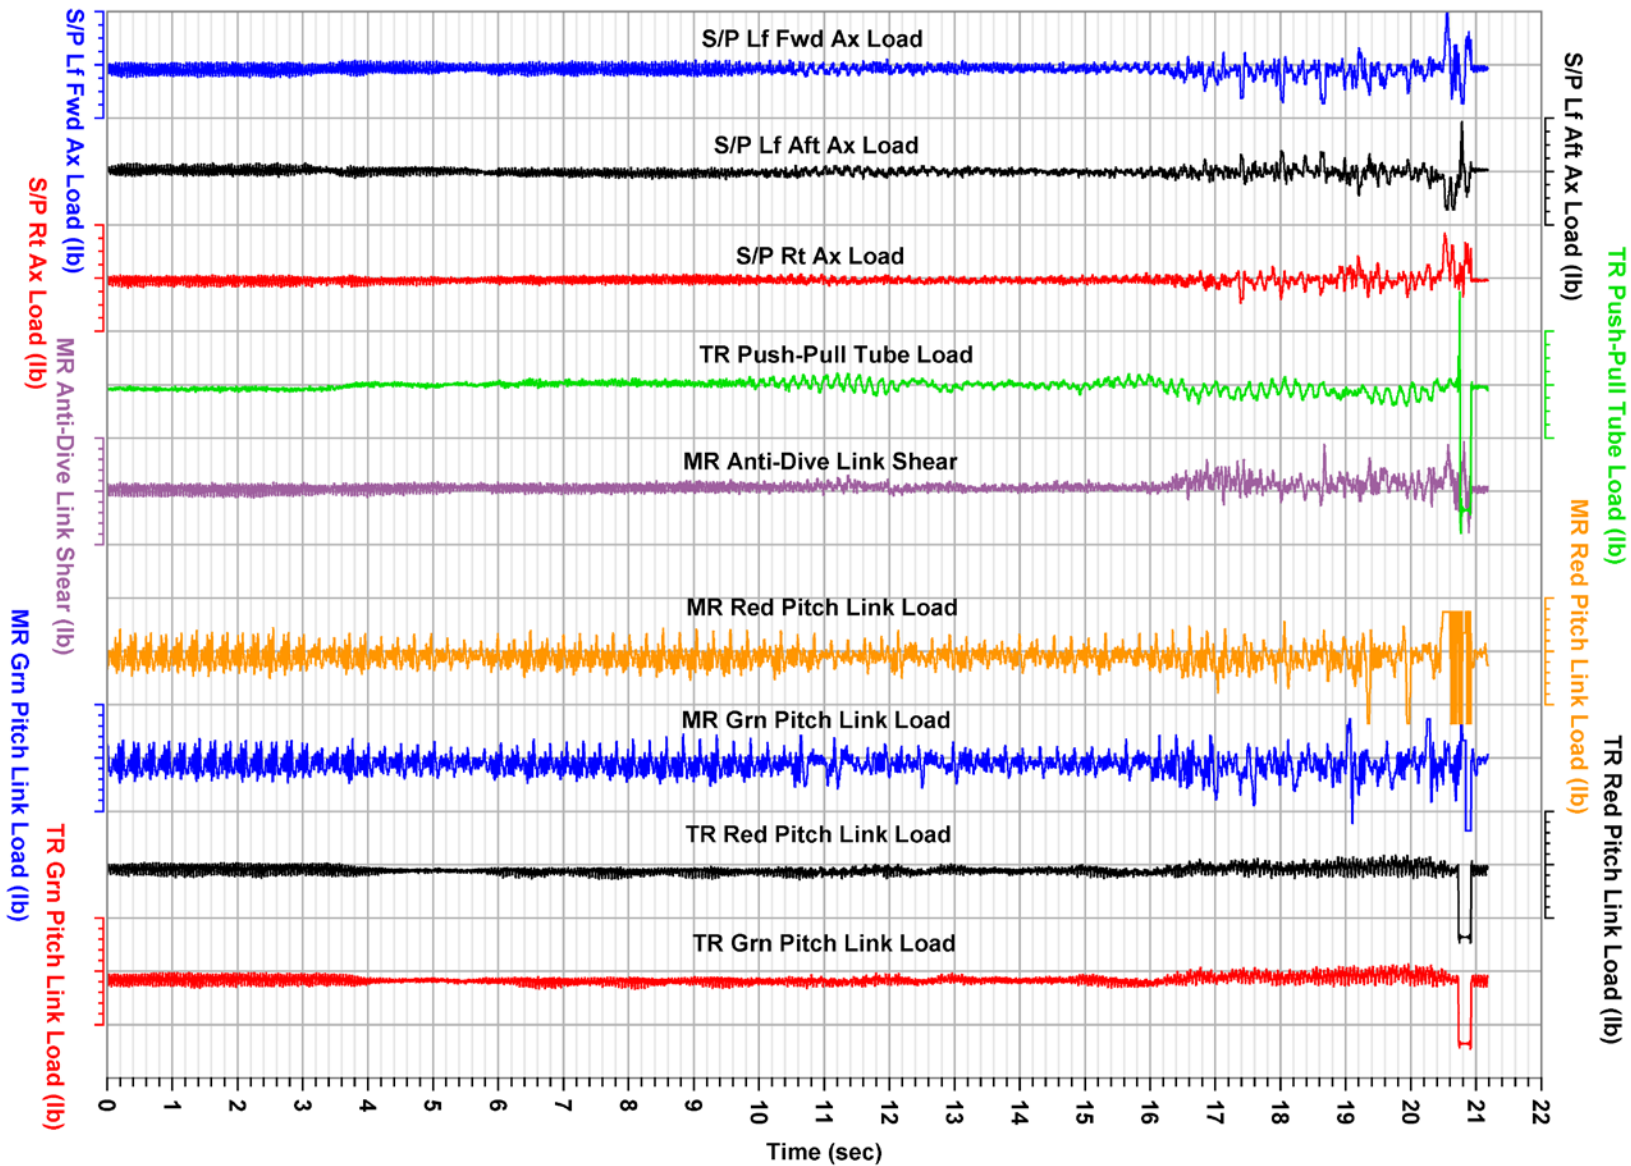
Figure 17. Swashplate, control tube, and pitch link load forces during TP51.

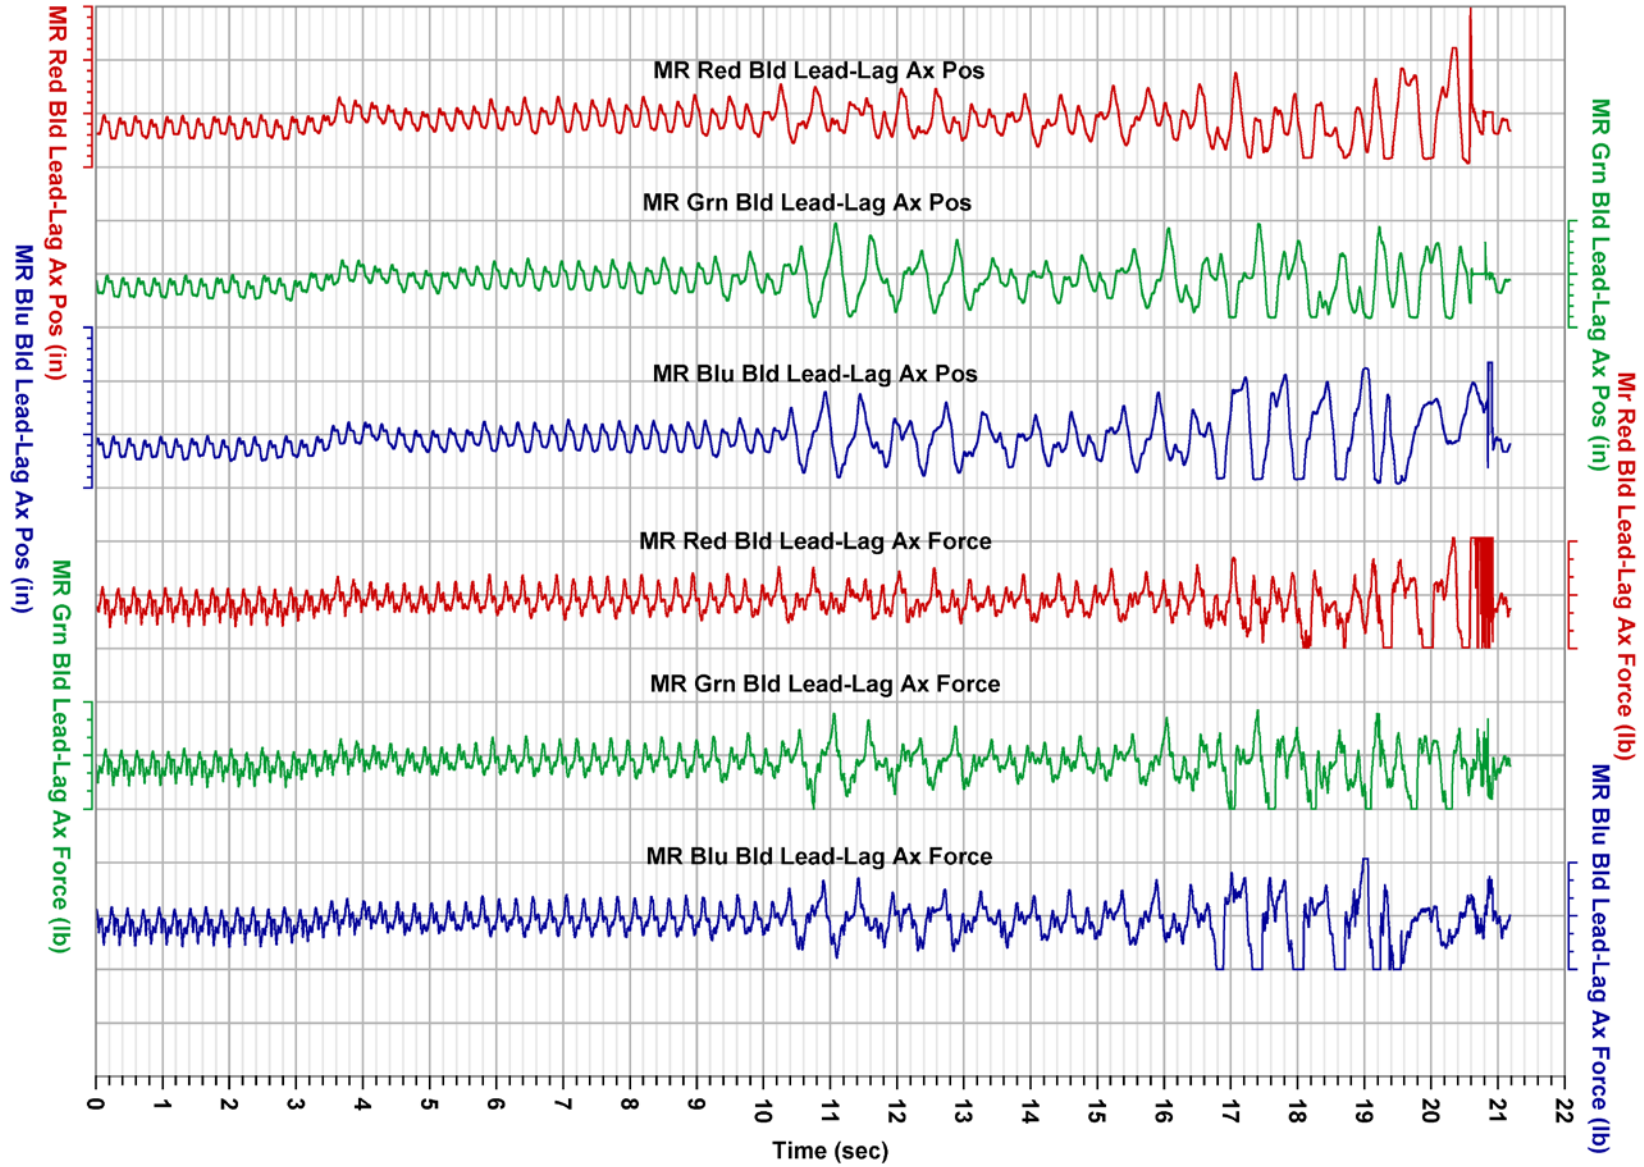
Figure 19. Main rotor damper lead-lag position and force during TP 51.

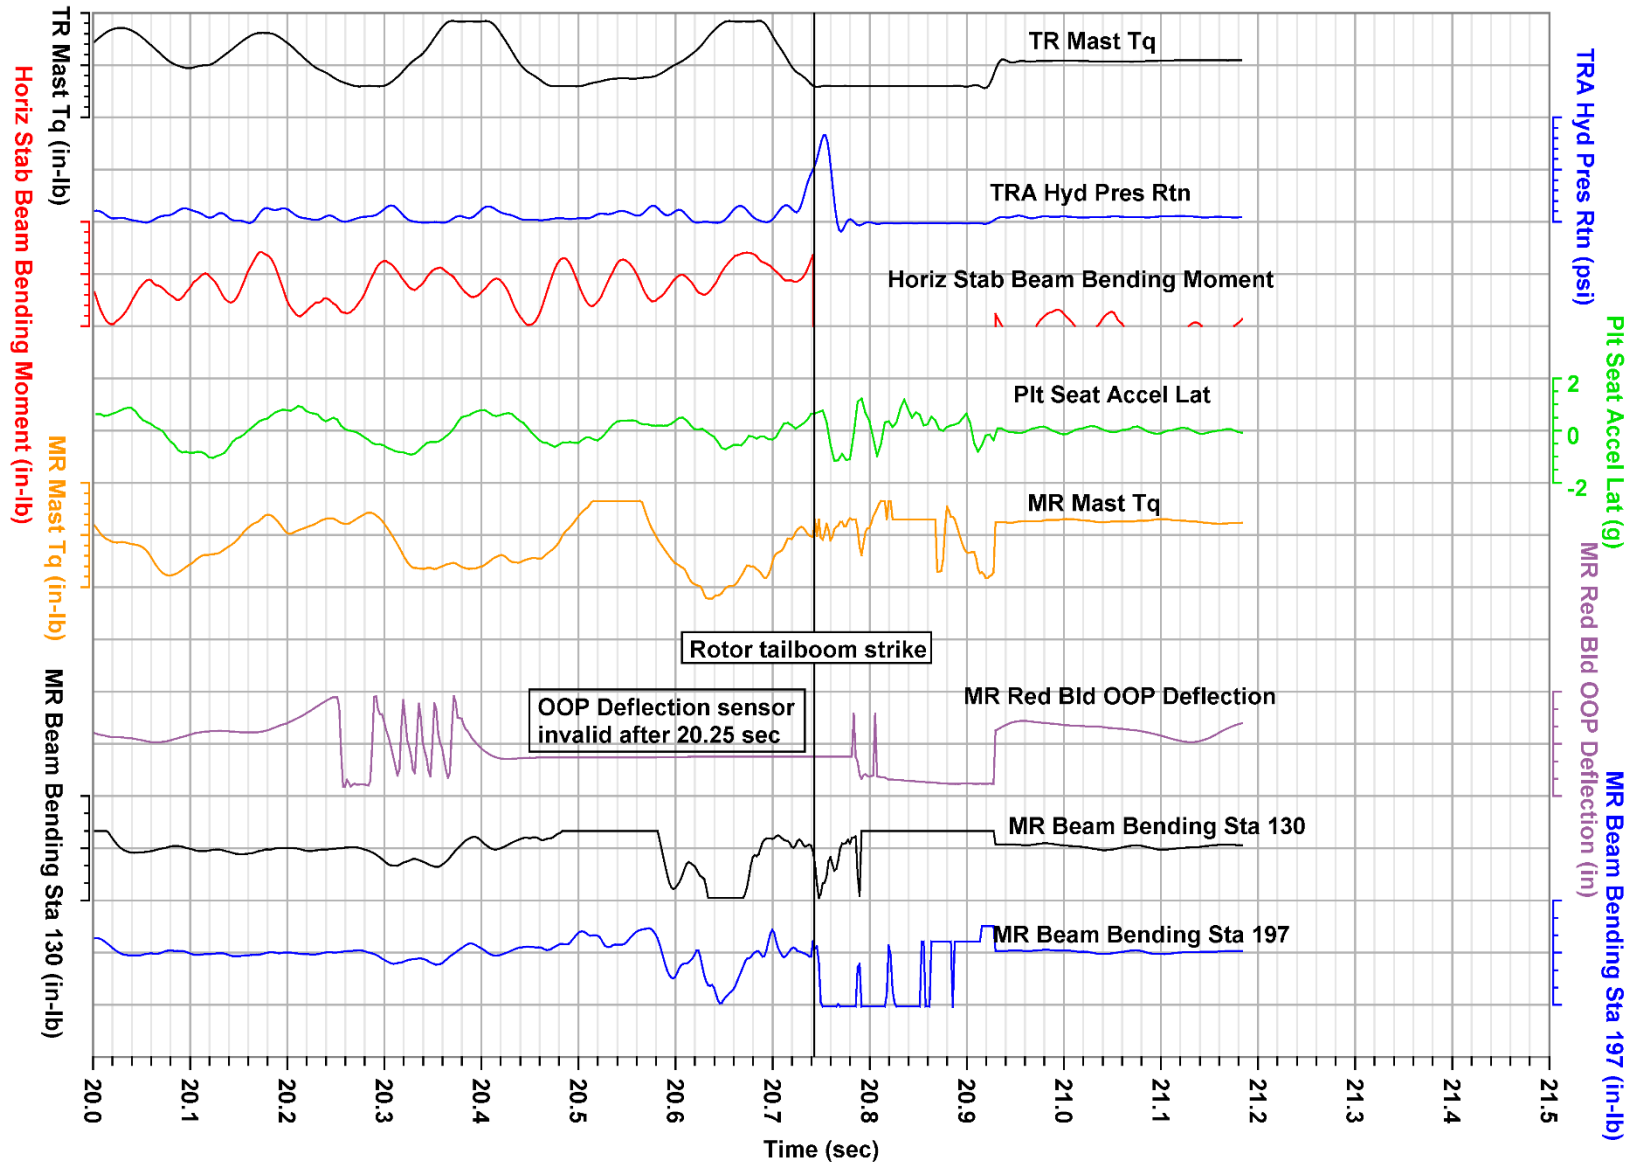
At about 20.25 seconds into the test point, the main rotor red blade string potentiometer measuring blade out-of-plane deflections reached and exceeded its upper instrumentation limit and became invalid, indicating that the blade was flapping high out of plane. Half a second and 2.5 rotor revolutions later, discontinuities and shock loads were recorded in parameters involving the horizontal stabilizer, main rotor, and tail rotor. The pilot seat lateral acceleration also spiked at this time. These readings were consistent with a high energy event such as a reaction to the main rotor red blade striking the tail boom.

Figure 21. Parameters showing red blade impact of tail boom in TP 51.

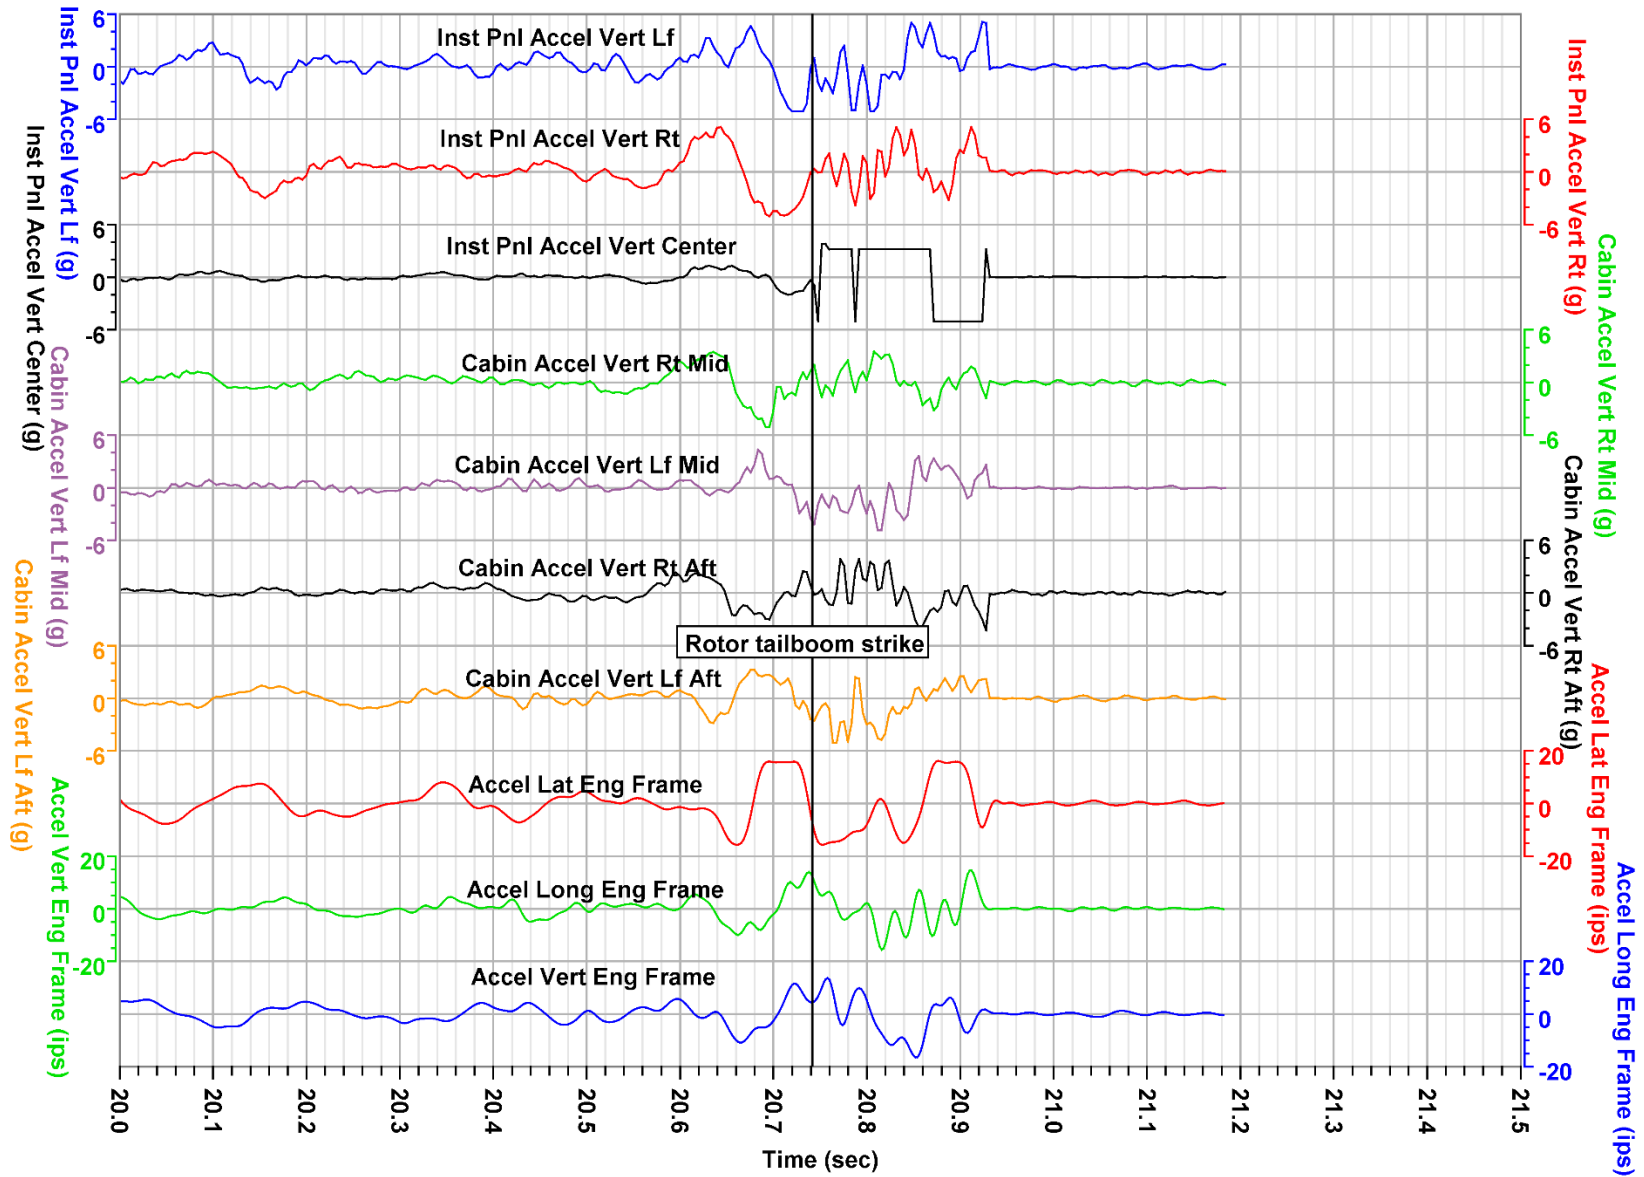
Figure 22. Additional accelerometers' response to rotor tailboom strike during TP51.
