NATIONAL TRANSPORTATION SAFETY BOARD
Vehicle Recorder Division
Washington, D.C. 20594

Flight Test Data Recorder

Group Chairman's Factual Report
By Charles Cates

Location: Italy, Texas
Date: July 6, 2016
Aircraft: Bell 525
Registration: N525TA
Operator: Bell Helicopter
NTSB Number: DCA16FA199

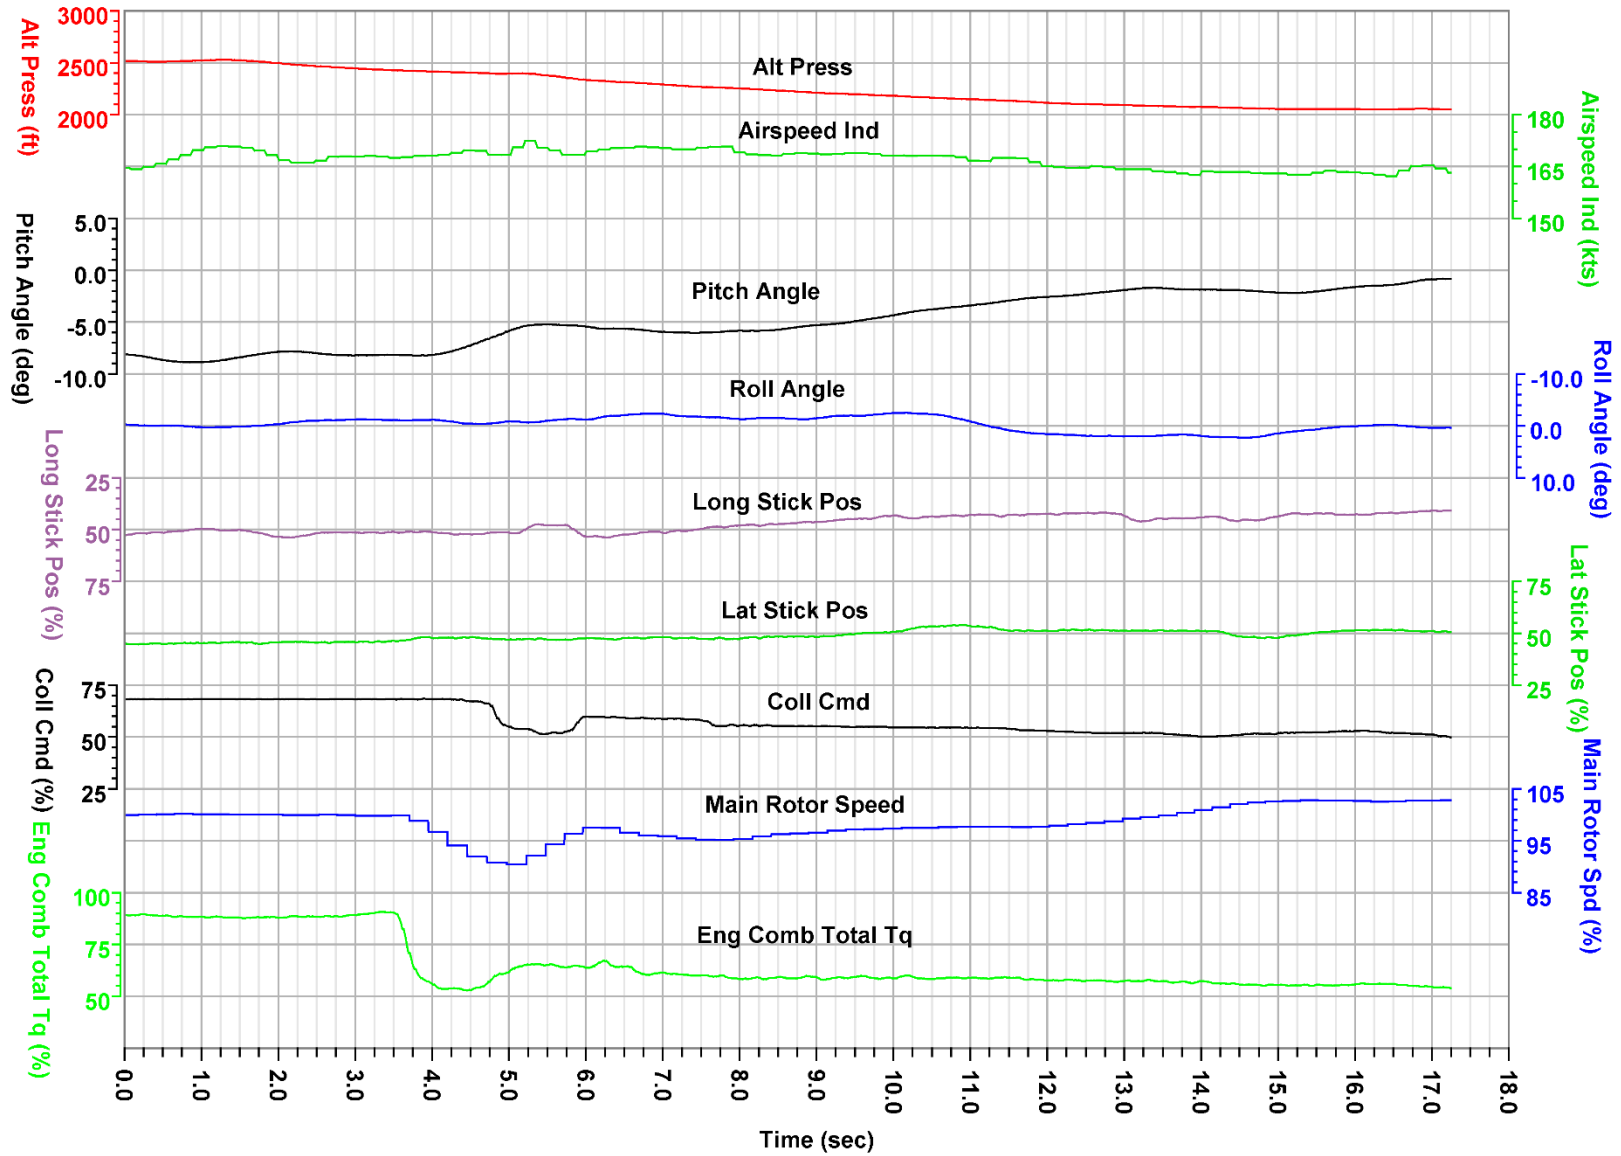
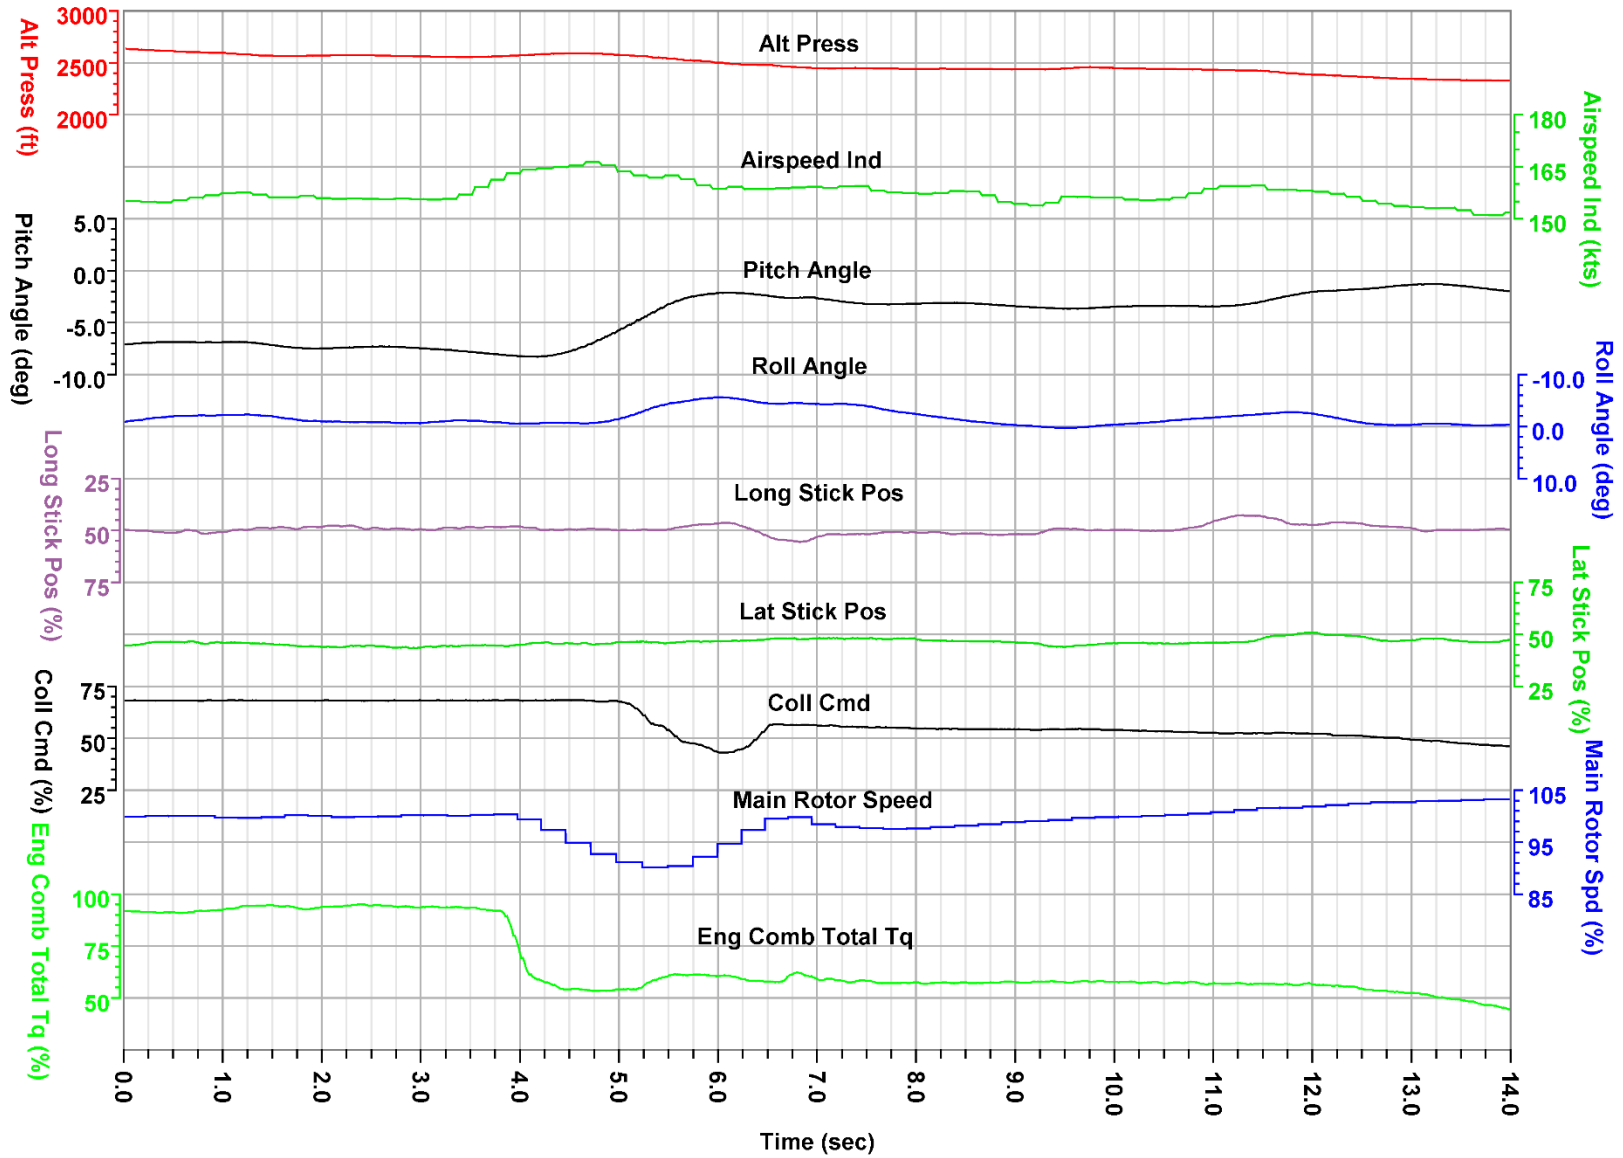
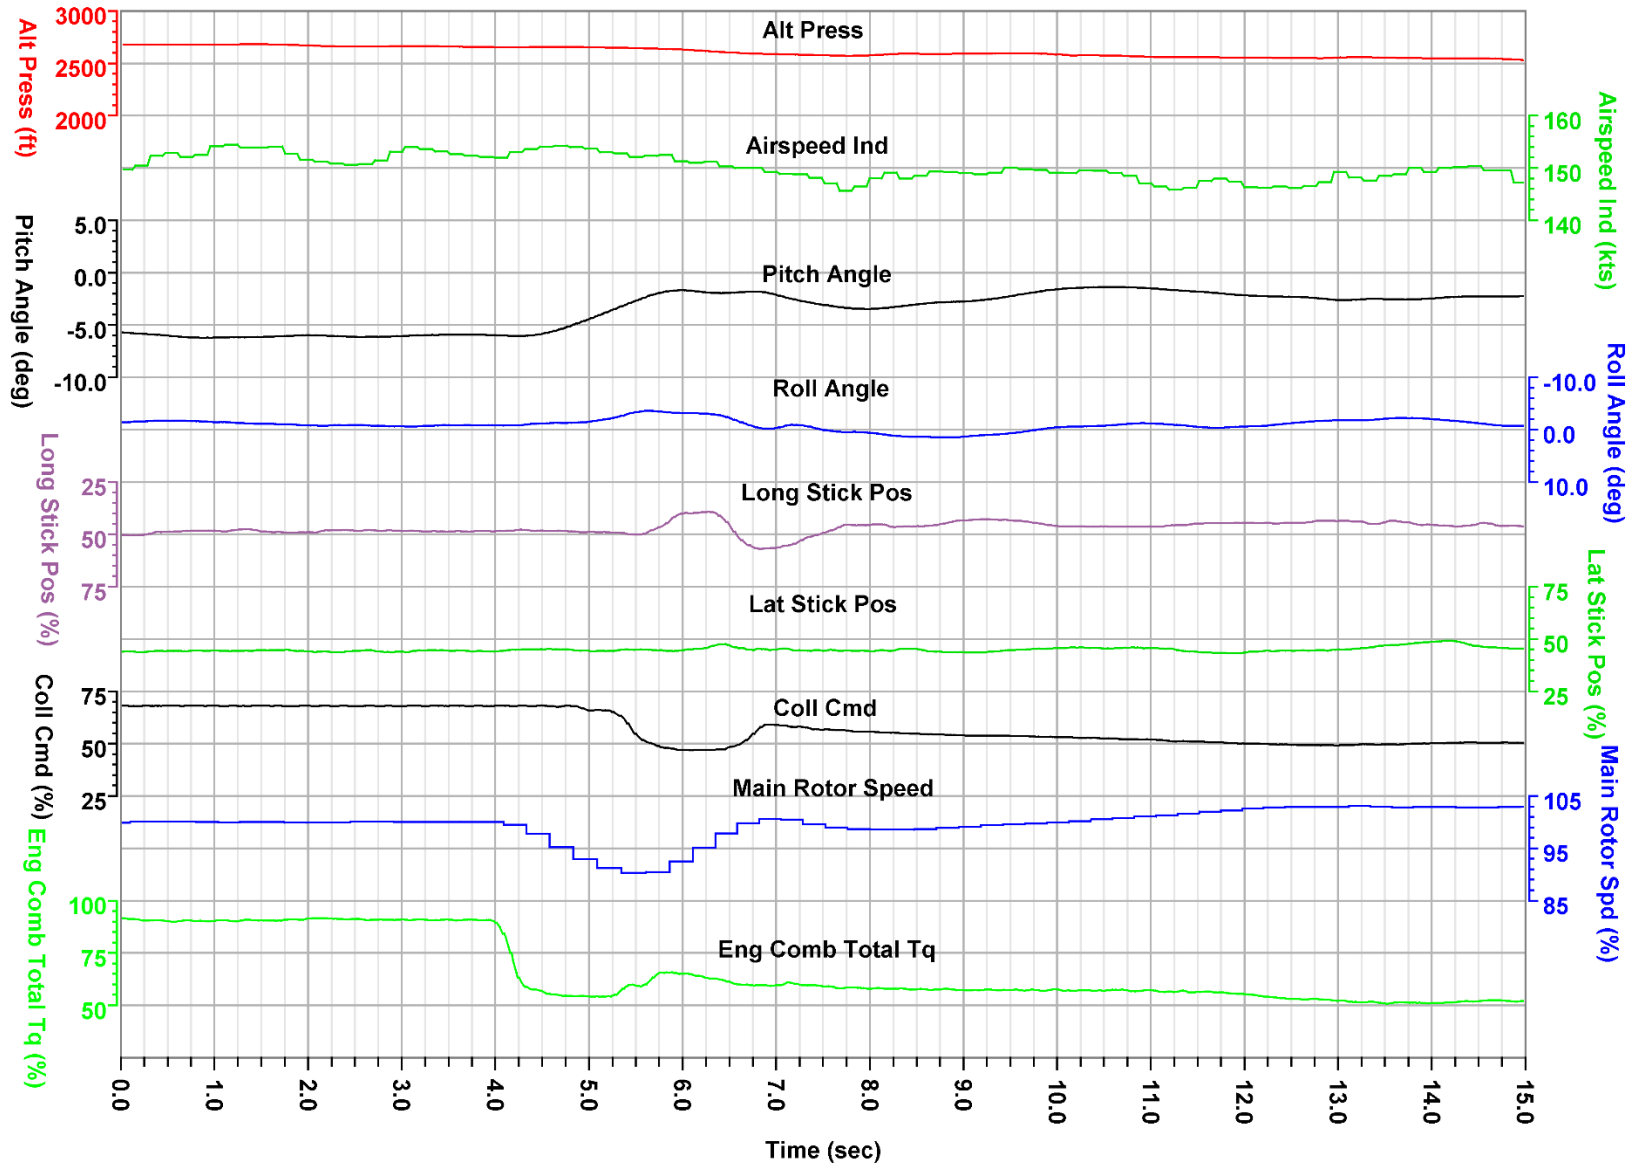
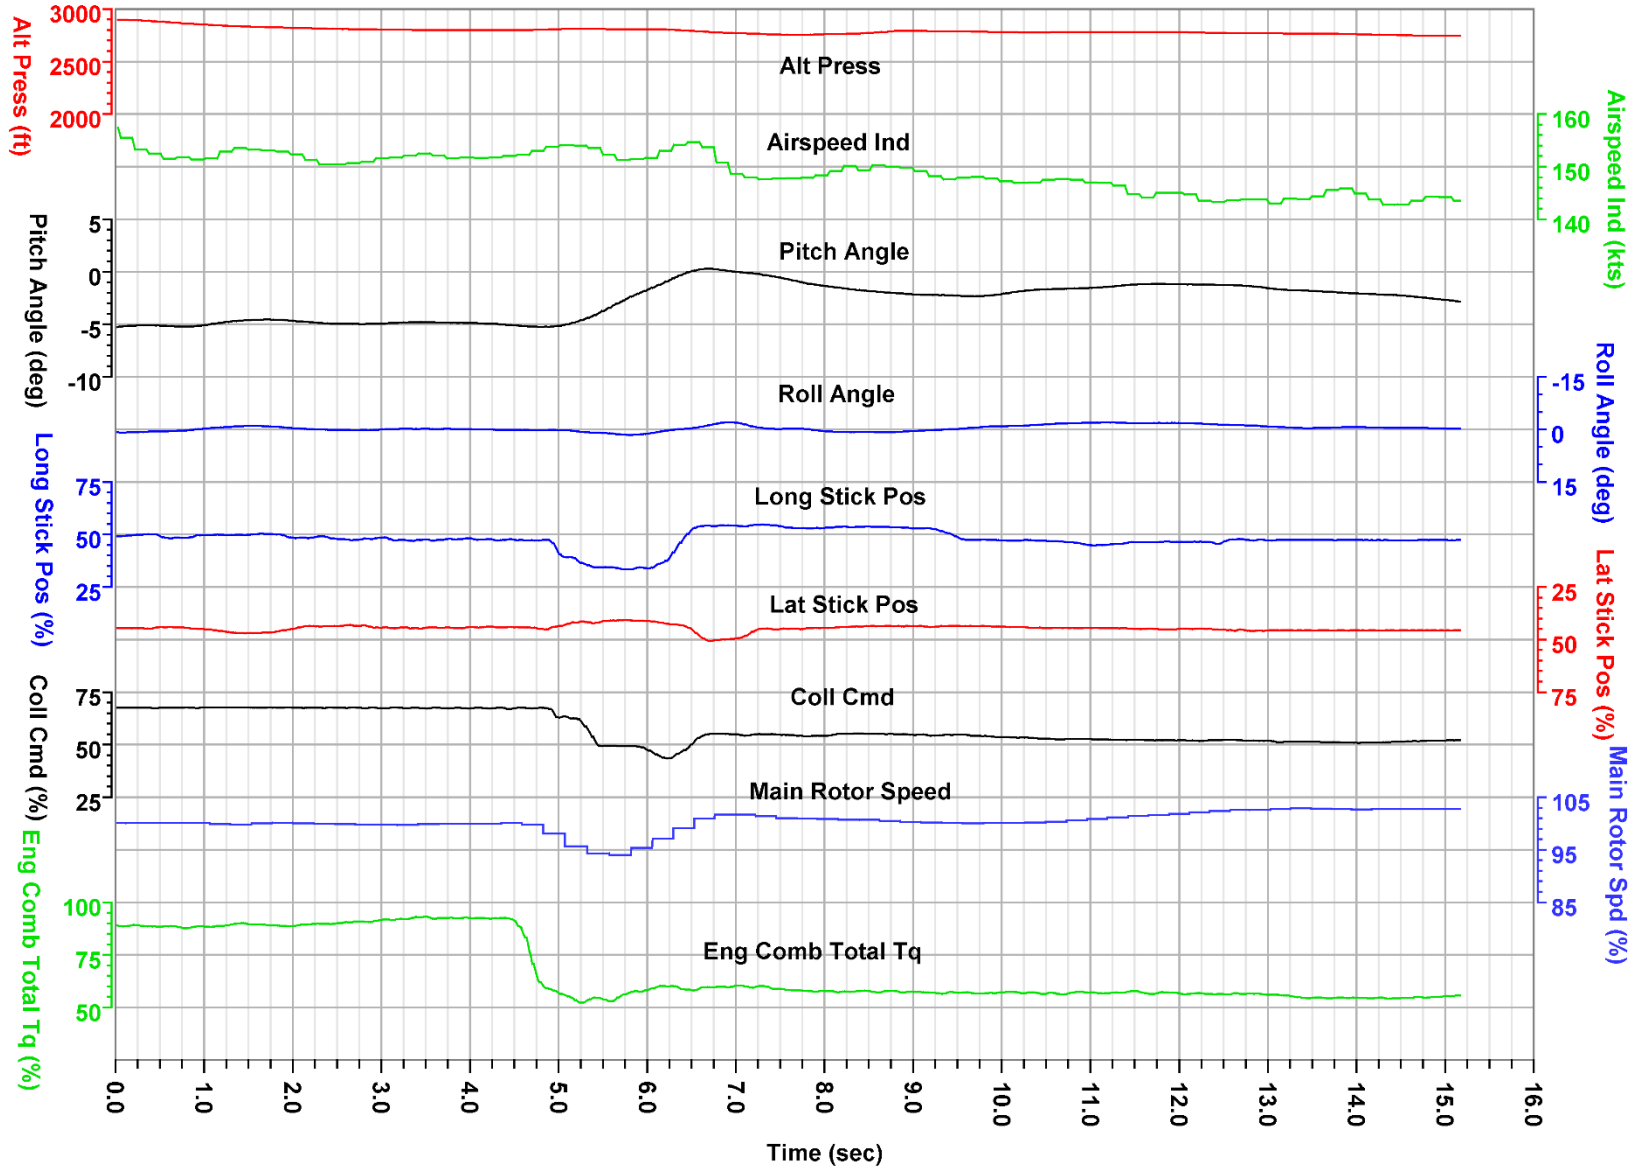
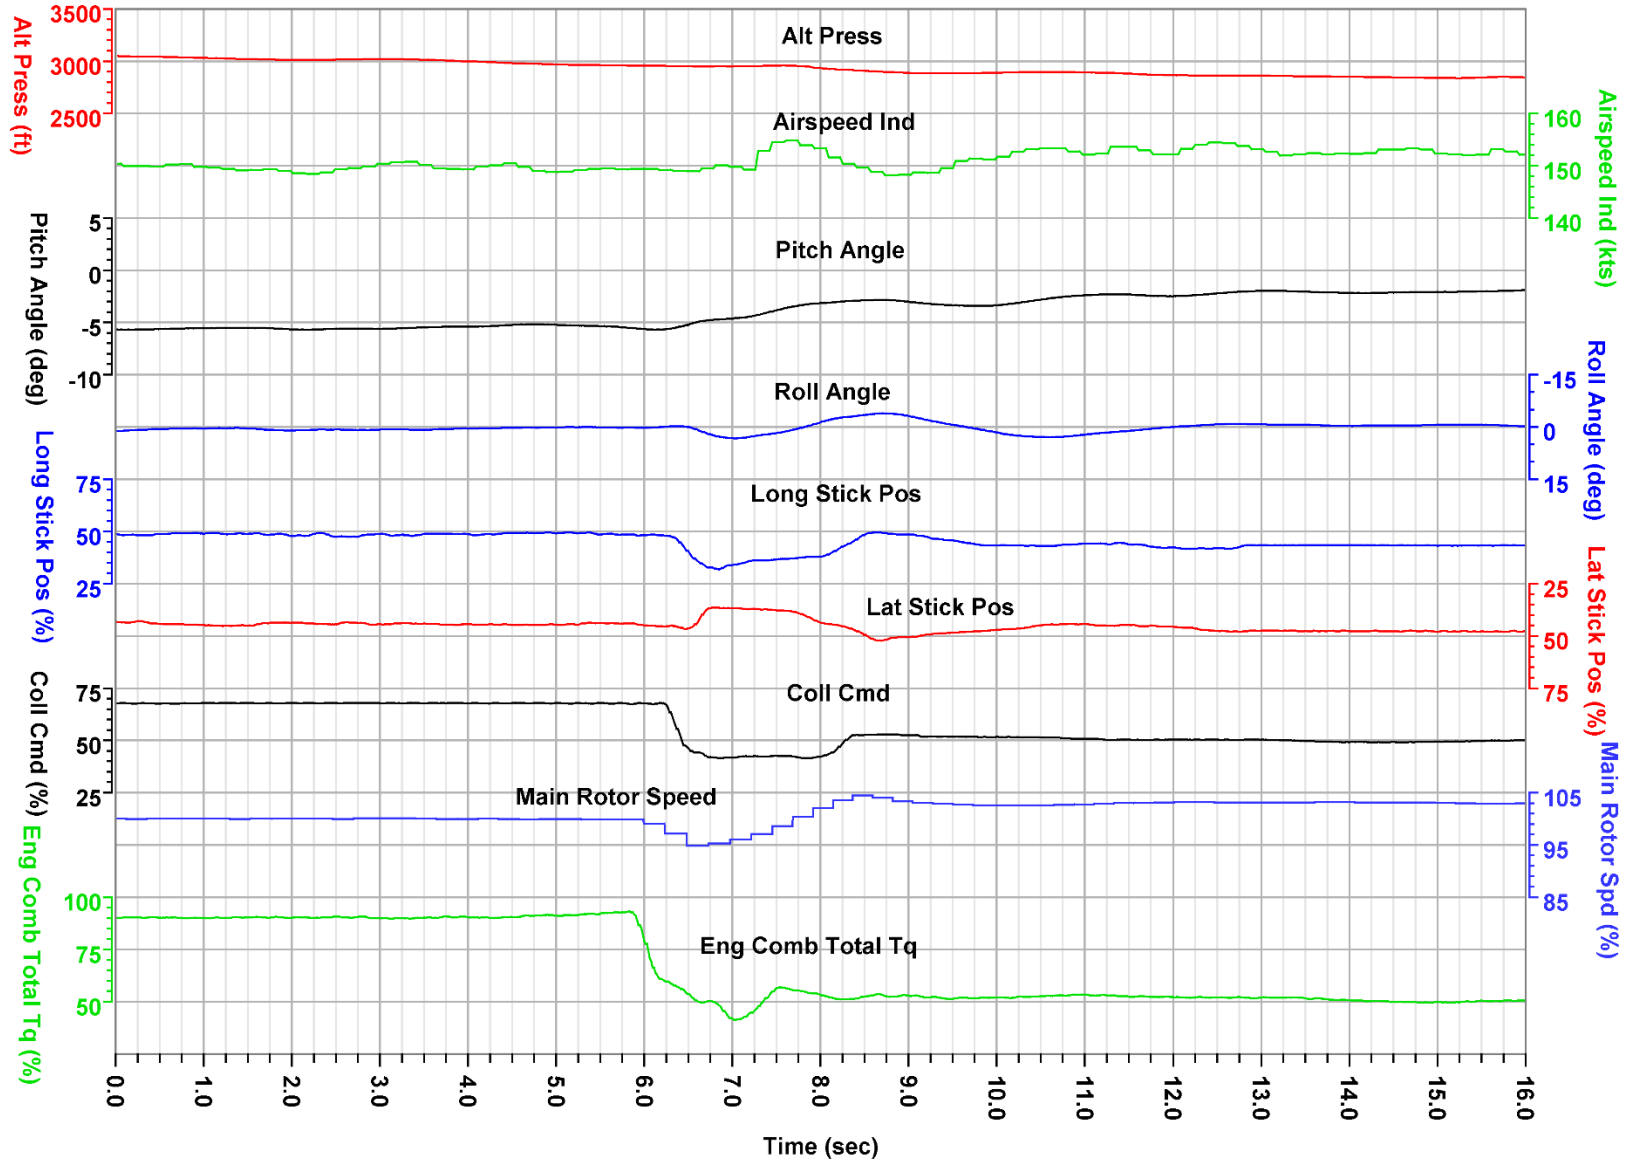
A series of build-up conditions was completed (test points 41-50 shown in figures 23-30), increasing the airspeed by 10 knots in each test point, prior to what was planned to be the final condition at Vne (airframe never exceed speed), test point 51. Table 2 shows the target condition for each test point, the amount the rotor speed drooped during the condition, and the time it took to restore rotor RPM to 103%.

Figure 23. Plot of aircraft basic and flight control command parameters during TP 50.

Figure 24. Plot of aircraft basic and flight control command parameters during TP 48.

Figure 25. Plot of aircraft basic and flight control command parameters during TP 47.

Figure 26. Plot of aircraft basic and flight control command parameters during TP 46.

Figure 27. Plot of aircraft basic and flight control command parameters during TP 44.

Figure 28. Plot of aircraft basic and flight control command parameters during TP 43.

Figure 29. Plot of aircraft basic and flight control command parameters during TP 42.

Figure 30. Plot of aircraft basic and flight control command parameters during TP 41.
