NATIONAL TRANSPORTATION SAFETY BOARD

FLIGHT and SITE INFORMATION

**NTSB Accident: WPR12GA106
Accident Date: February 15, 2012**

Location: Moran Junction, WY
Date: February 15, 2012
Aircraft: Bell 407, N407HL, Serial # 53869
NTSB IIC: Michael Huhn

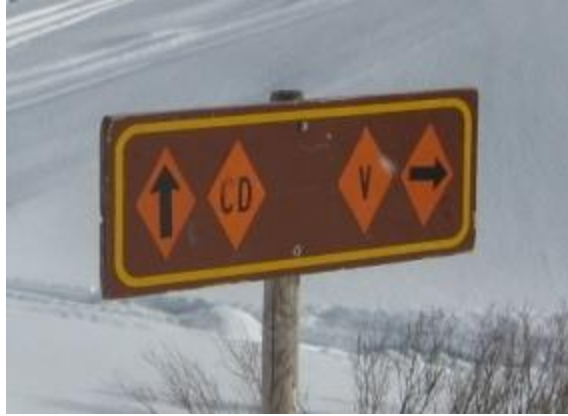
Figure 4 - Trail Sign at Junction of 'CD' and 'V' Trails

- The possibility that the TR struck a small tree during the previously-mentioned hovering maneuver (when the crew was trying to read the trail sign) was considered
- This was prompted by the finding of a small tree whose top was observed to be damaged
 - The tree was observed by personnel enroute to the wreckage
 - The top was still attached, but lying over, roughly parallel to the ground
 - Data provided by the recovery crew indicated that the tree was located at 43° 47.204 N, 110° 16.588 W
- The sign was located at 43° 47.186 N, 110° 16.551 W
 - The trail sign was located 220 feet, on a bearing of 062° magnetic, from the tree
 - The sign denoted the junction of the CD and V trails

- Review of the trail map indicated that the CD and V trails intersected at two locations
- The crew did not specify which trail sign they observed
- GPS data from the helicopter indicated that it conducted low and slow maneuvering at a location consistent with the location of tree and trail sign

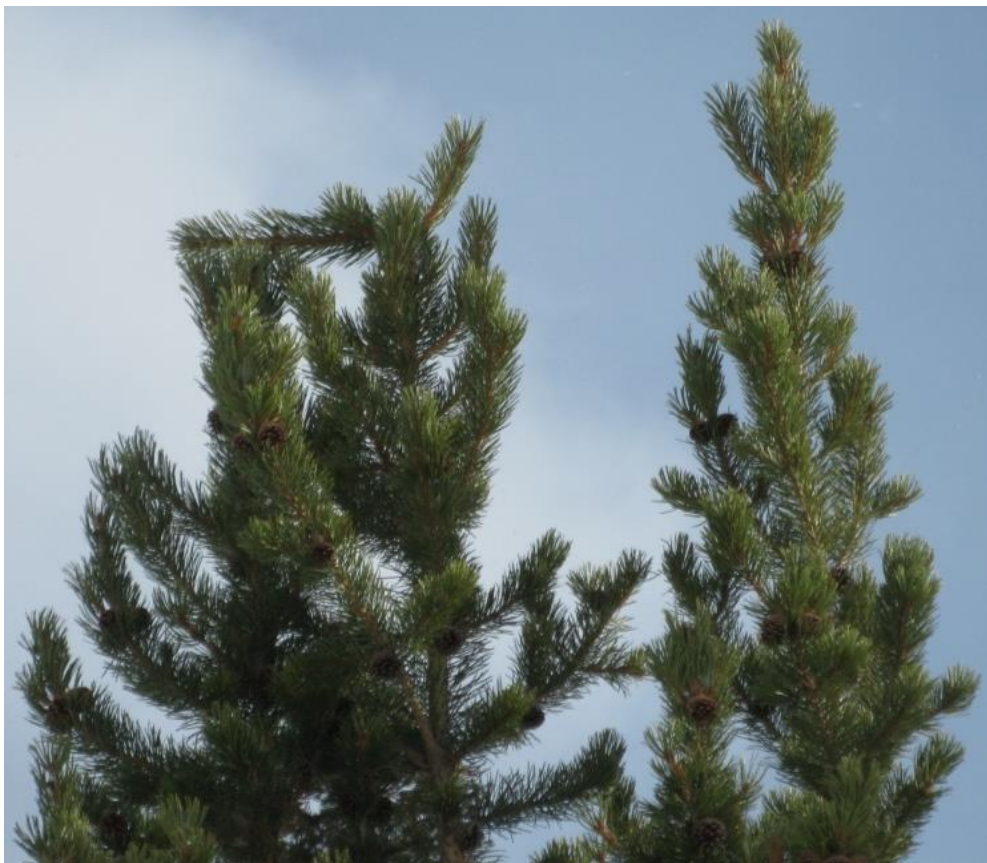
Figure 5 - Suspect Tree (Note horizontal branch on left)

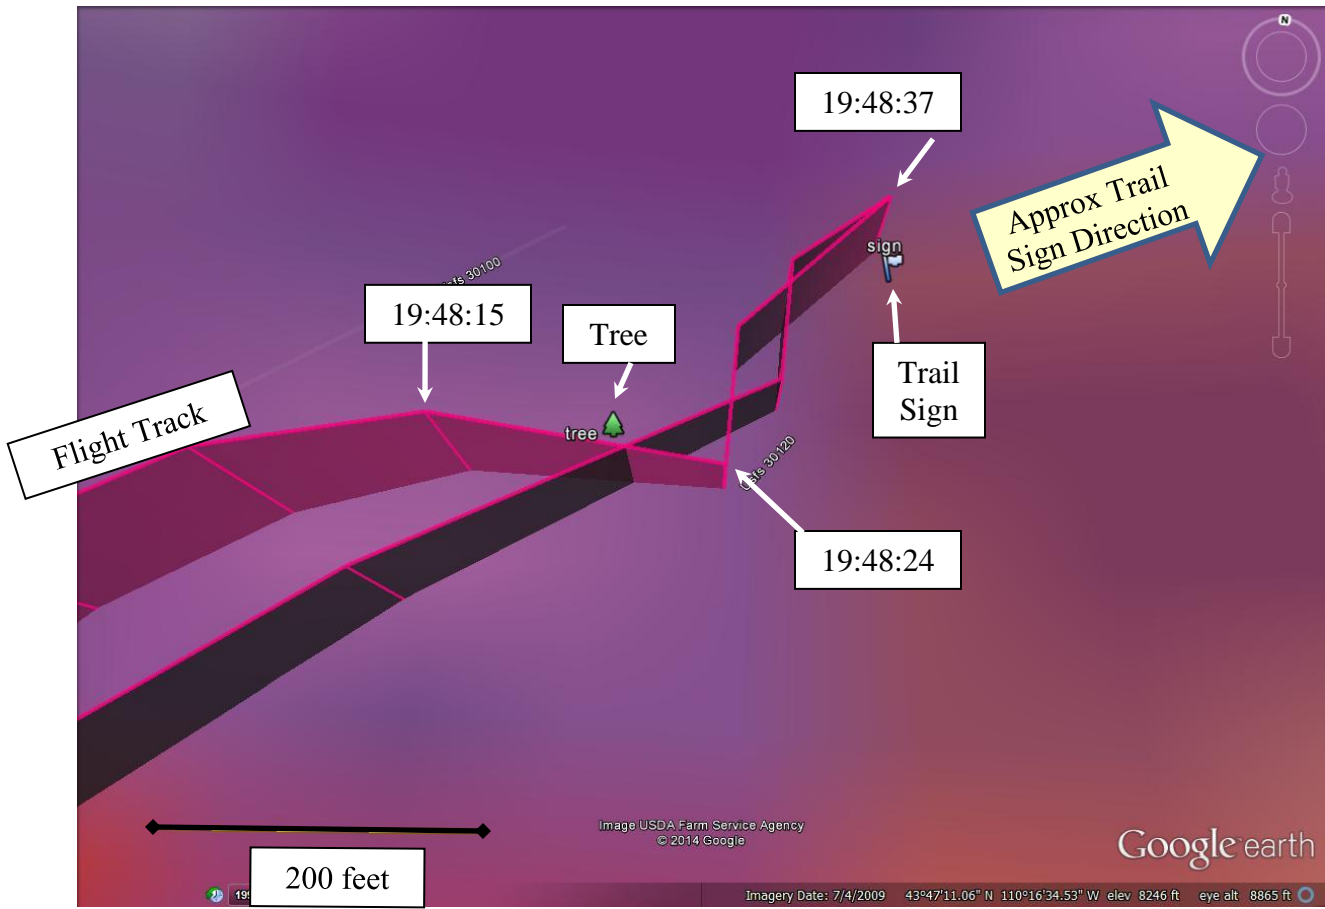
Figure 7 - Close Up of Trail Sign and Tree Area, plus GPS Track s and Times

TIME (UTC, hh:mm:ss)	LAT (Degs)	LONG (Degs)	ALTITUDE (Ft MSL)	GROUND SPEED (Kts)	TRACK (Degs True)	REMARKS
19:48:15	43.78637	-110.277	8330	18	72	Just before tree
19:48:24	43.78635	-110.276	8307	9	94.1	Just after tree
19:48:25	43.78636	-110.276	8307	3	19.2	
19:48:31	43.78656	-110.276	8314	7	15.3	
19:48:37	43.78679	-110.276	8320	11	40.6	Sign & course reversal
19:48:45	43.78666	-110.276	8327	5	225	
19:48:56	43.78651	-110.276	8307	3	183.9	
19:49:06	43.78649	-110.276	8307	1	241	
19:49:13	43.78614	-110.277	8330	19	235.8	
19:49:19	43.78546	-110.278	8363	41	233.5

TIME (UTC, hh:mm:ss)	LAT (Degs)	LONG (Degs)	ALTITUDE (Ft MSL)	GROUND SPEED (Kts)	TRACK (Degs True)	REMARKS
19:48:16	43.78636	-110.277	8327	17	75.1	
19:48:18	43.78636	-110.277	8320	13	90	Just before tree
19:48:27	43.7864	-110.276	8304	4	76.3	Just after tree
19:48:32	43.78662	-110.276	8307	10	22.9	
19:48:36	43.78679	-110.276	8314	11	39.1	Sign & course reversal
19:48:43	43.78669	-110.276	8317	3	211.7	
19:48:54	43.78653	-110.276	8301	3	203.3	
19:49:02	43.78651	-110.276	8304	1	140.3	
19:49:08	43.78645	-110.276	8327	6	251.9	
19:49:15	43.78597	-110.277	8363	26	235.1

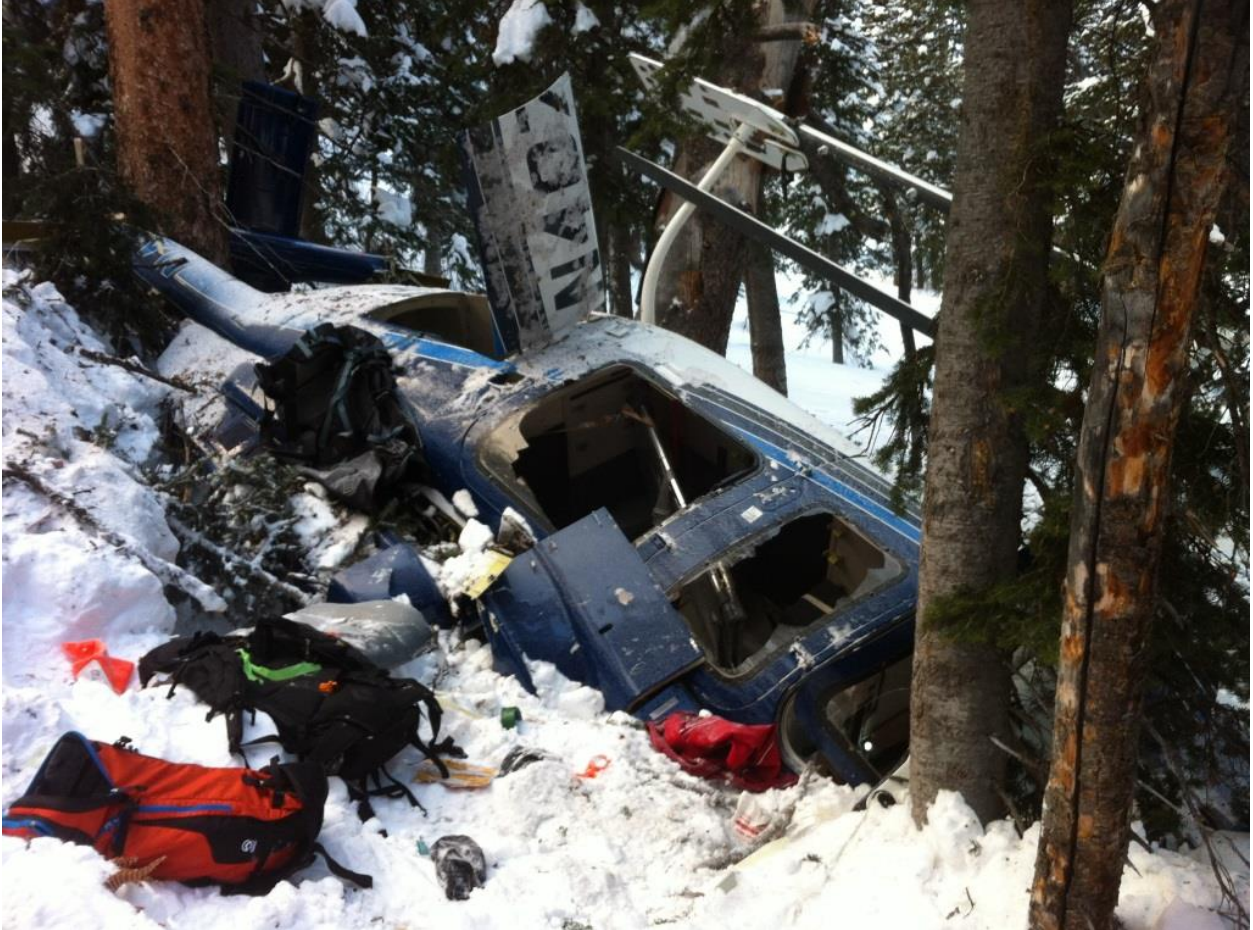
Figure 8 - Front Left View of Helicopter

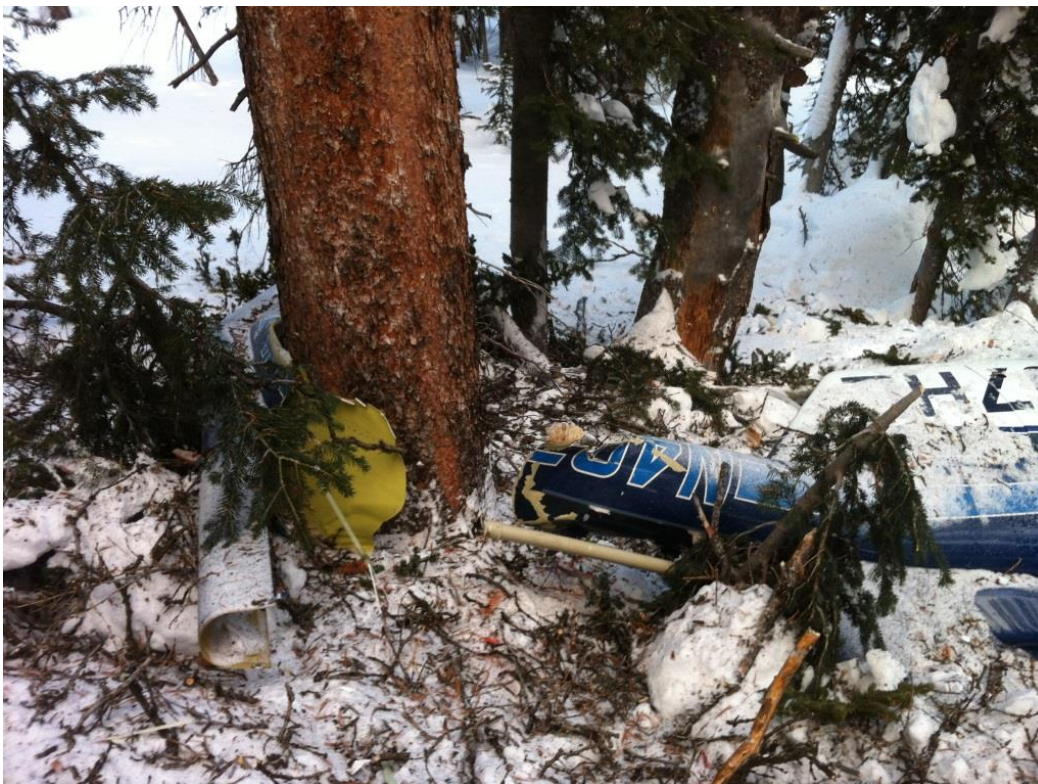
Figure 9 - Aft Fuselage and Forward Tailboom

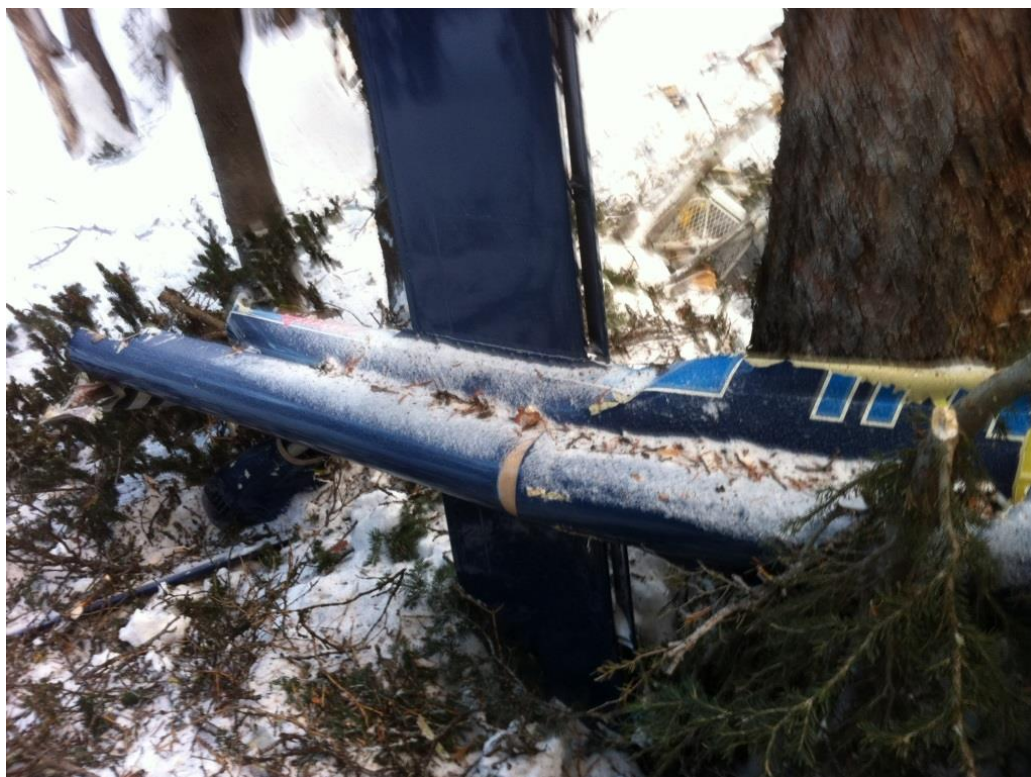
Figure 10 - Tailboom

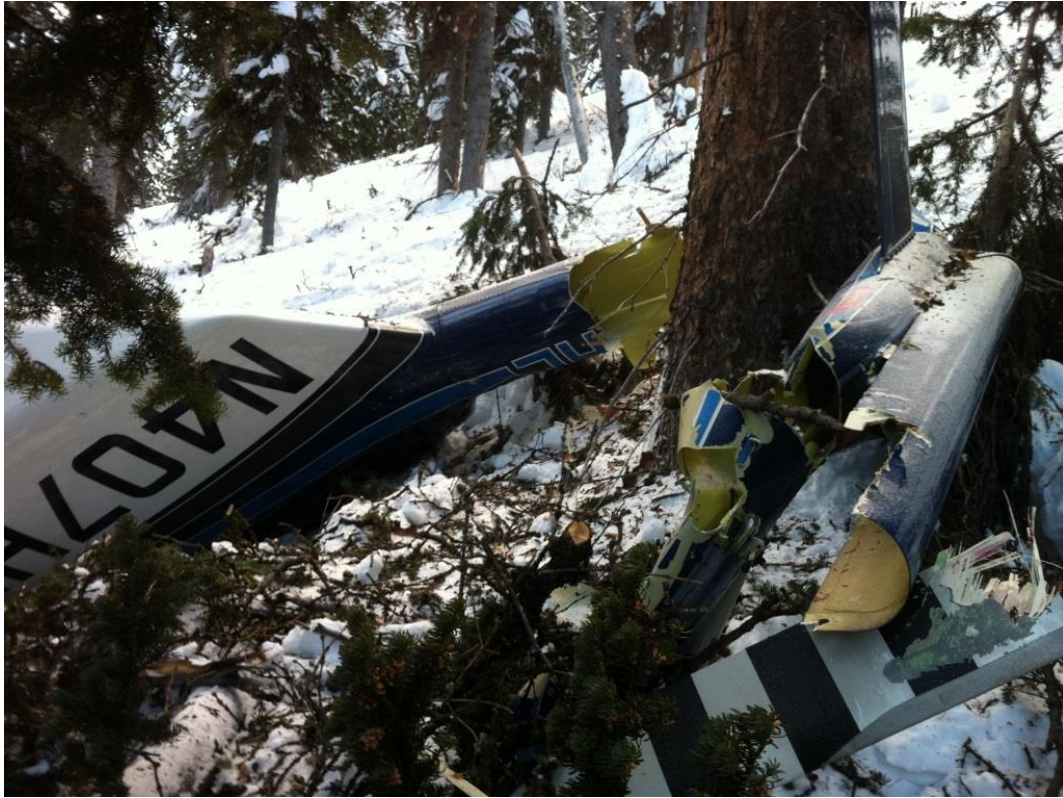
Figure 11 - Aft Left View

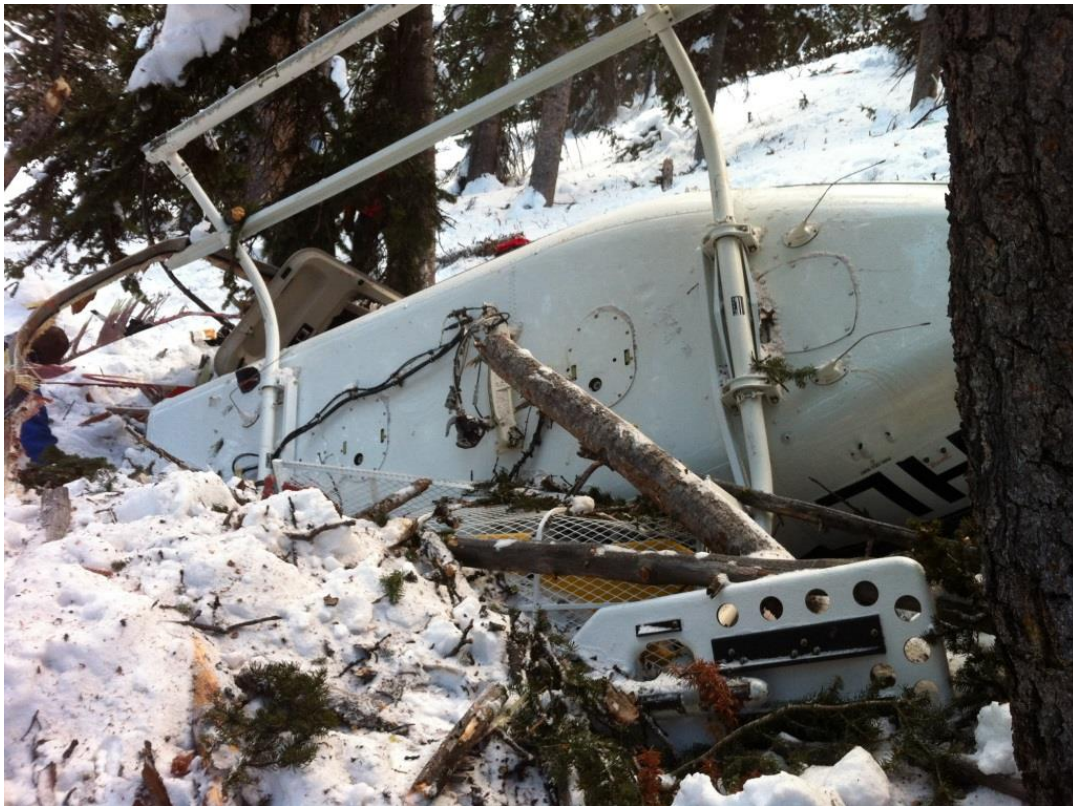
Figure 12 - Underside from Aft

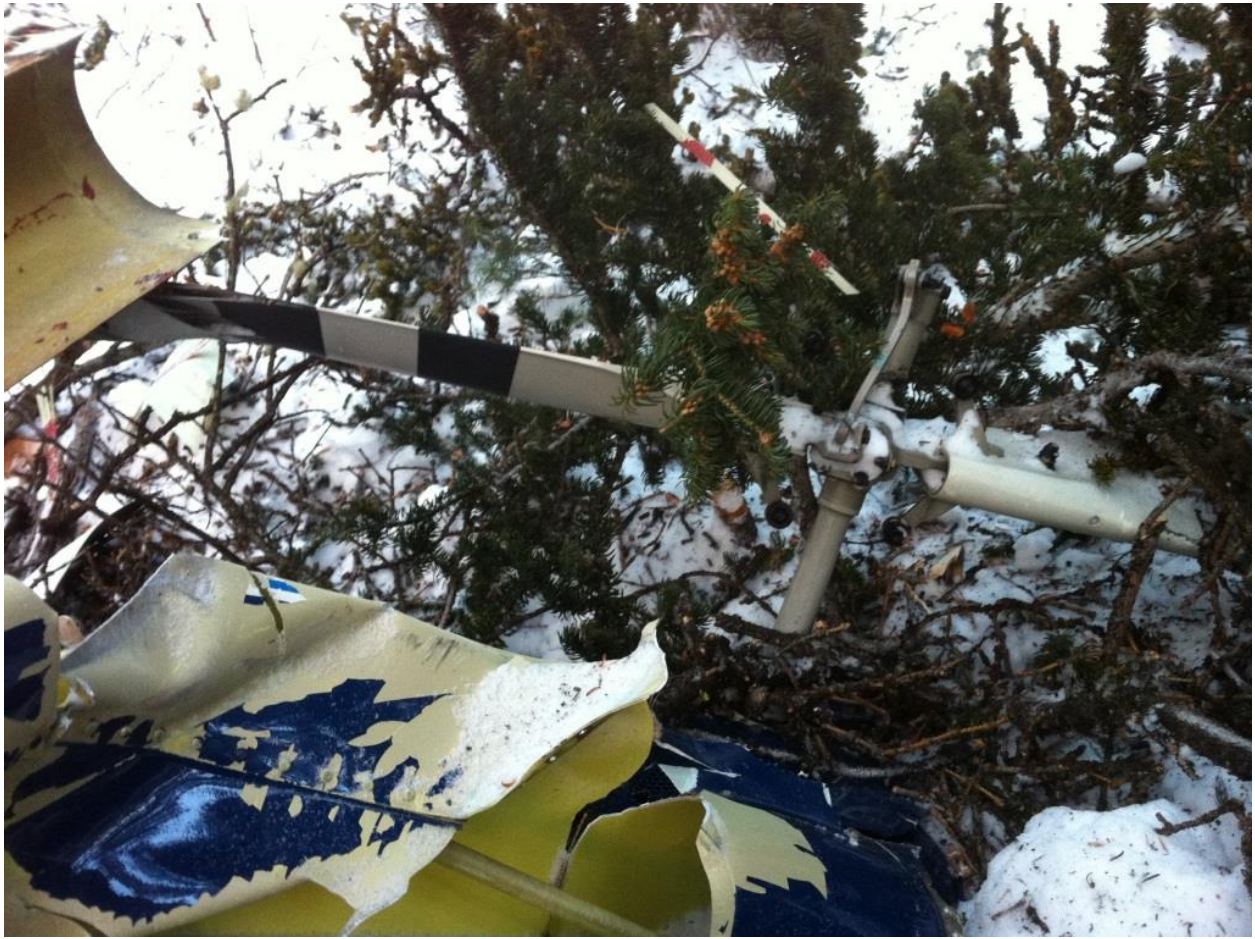
Figure 13 - Tail Rotor

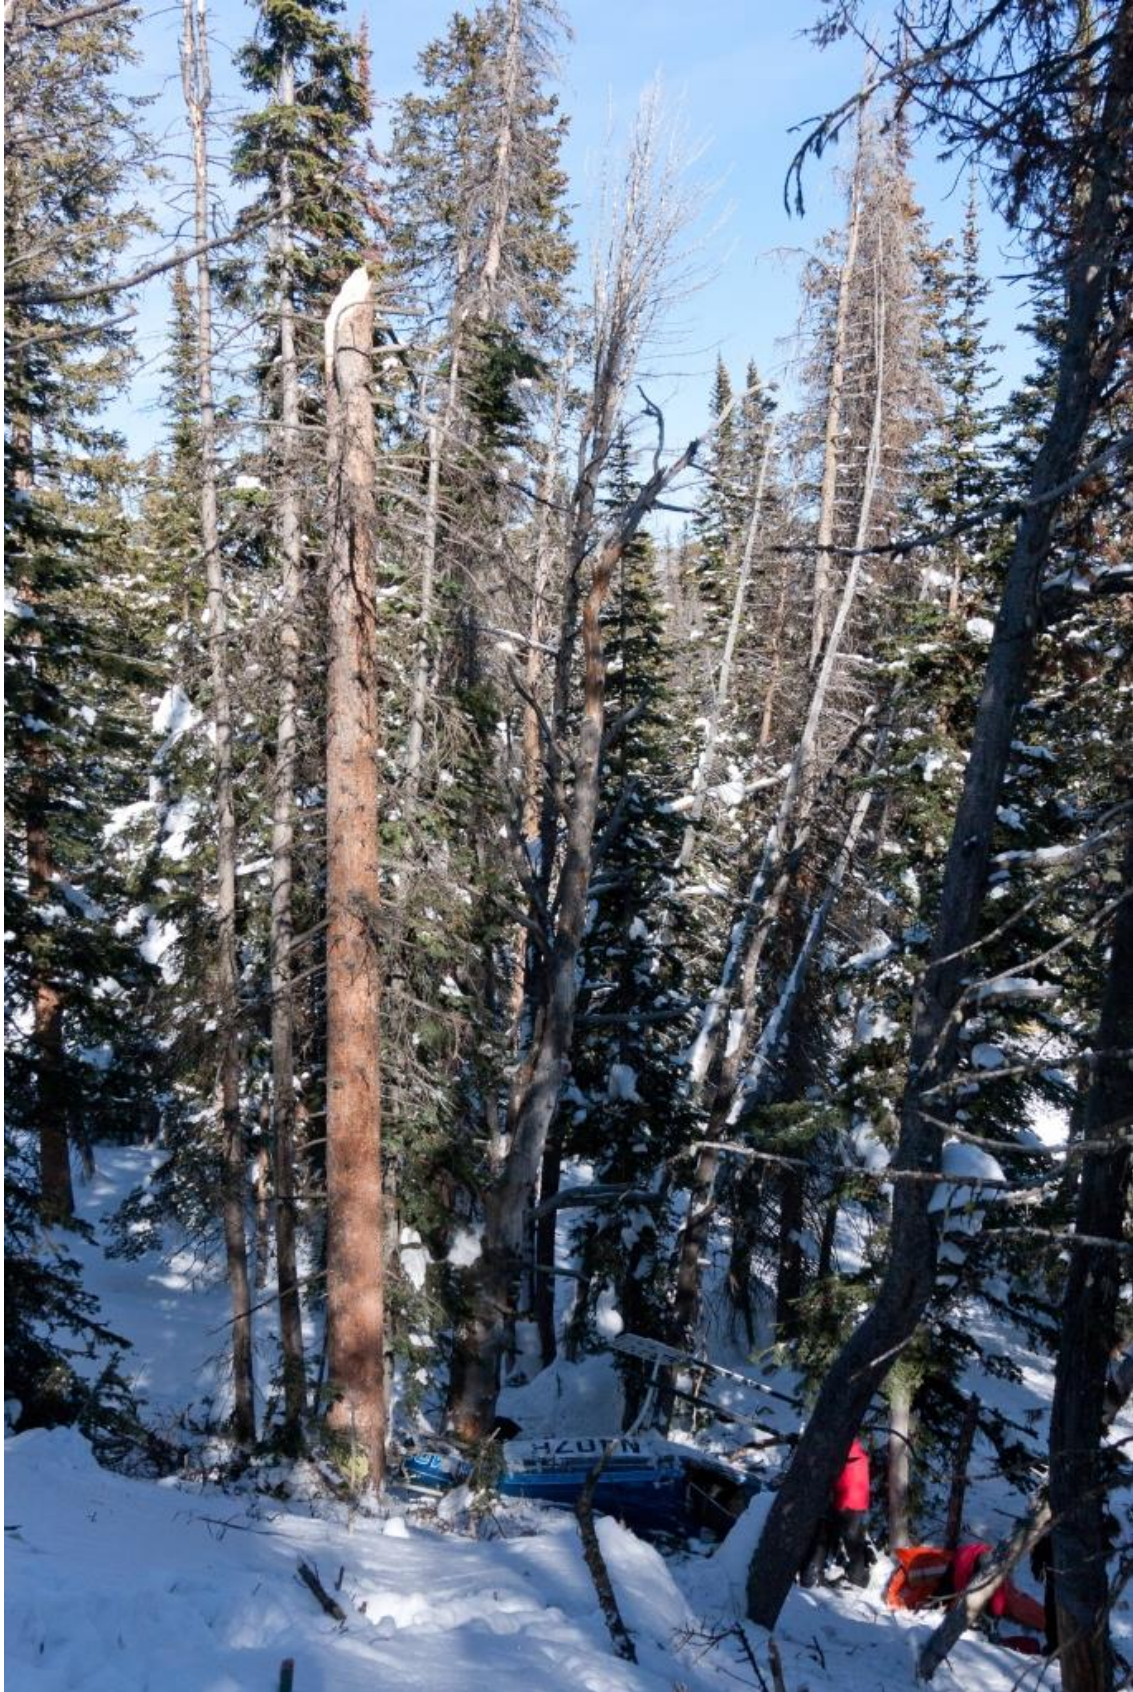
Figure 14 - Site Overview (Note cut tree in upper left frame)

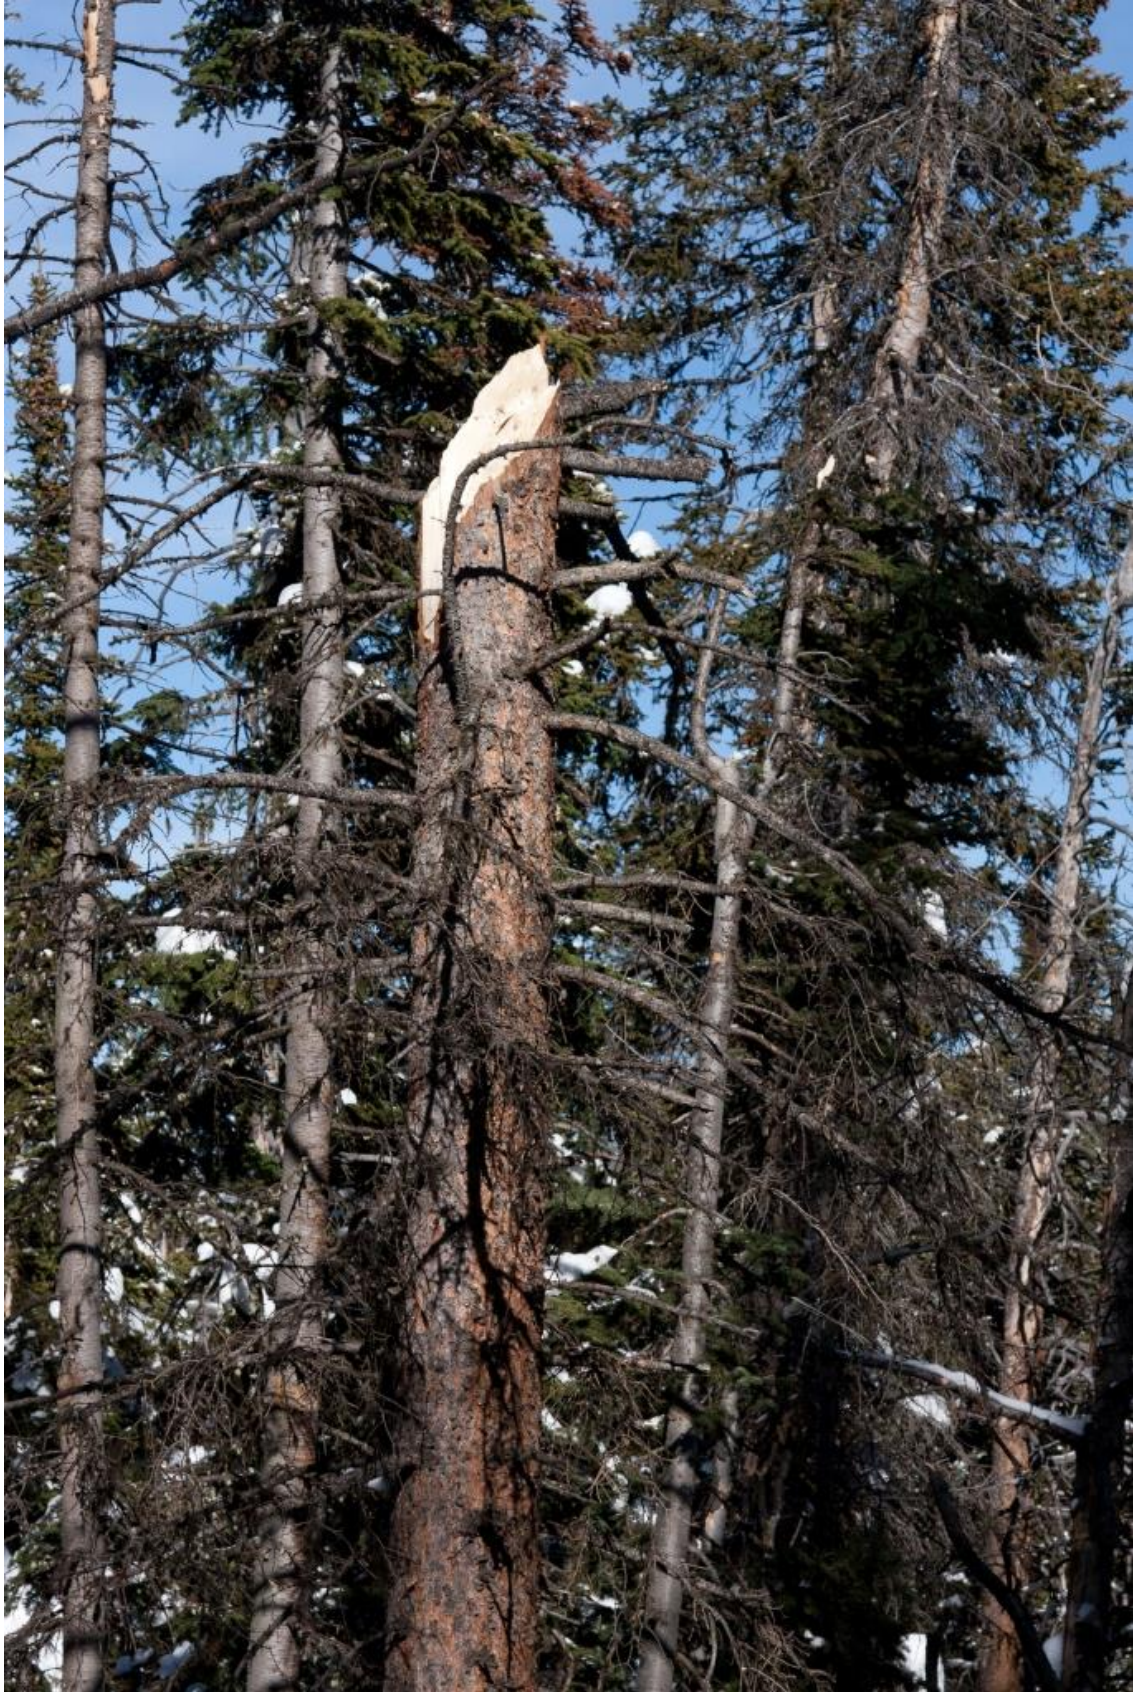
Figure 15 - Cut Tree
