NATIONAL TRANSPORTATION SAFETY BOARD

Fuel Flow Indicator

Specialist's Factual Report
by Bill Tuccio, Ph.D.

Location: Cave-in-Rock, Illinois
Date: August 25, 2016
Aircraft: Cessna U206G
Registration: N891LL
Operator: State of Illinois
NTSB Number: CEN16LA335

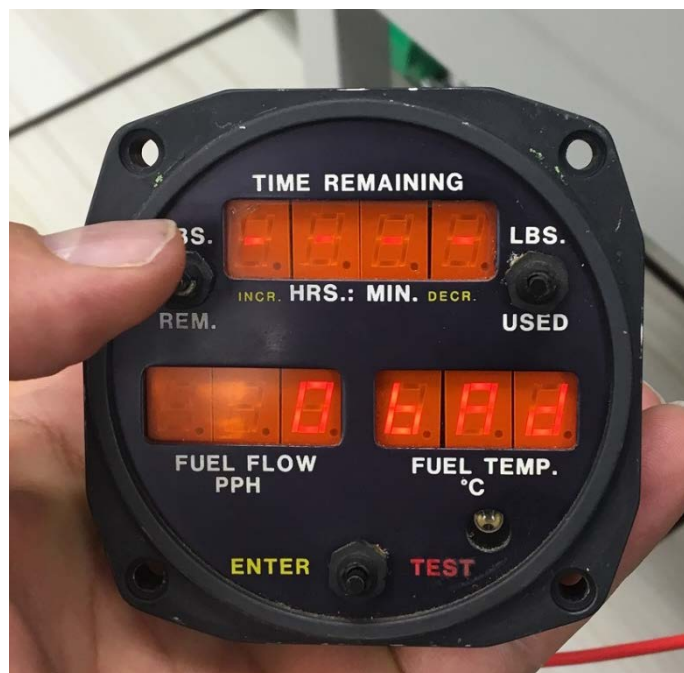
Figure 1. Upon power up.

- **Power up state (figure 1).** No pertinent information.
- **Pounds remaining (figure 2).** 325 pounds displayed.
- **Pounds used (figure 3).** 225 pounds displayed.

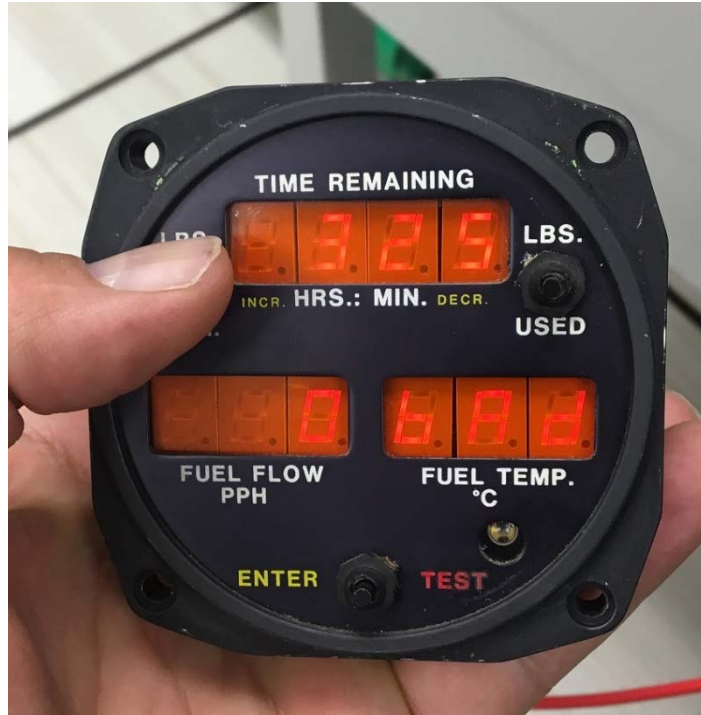
Figure 2. "Lbs. Rem." button pressed.

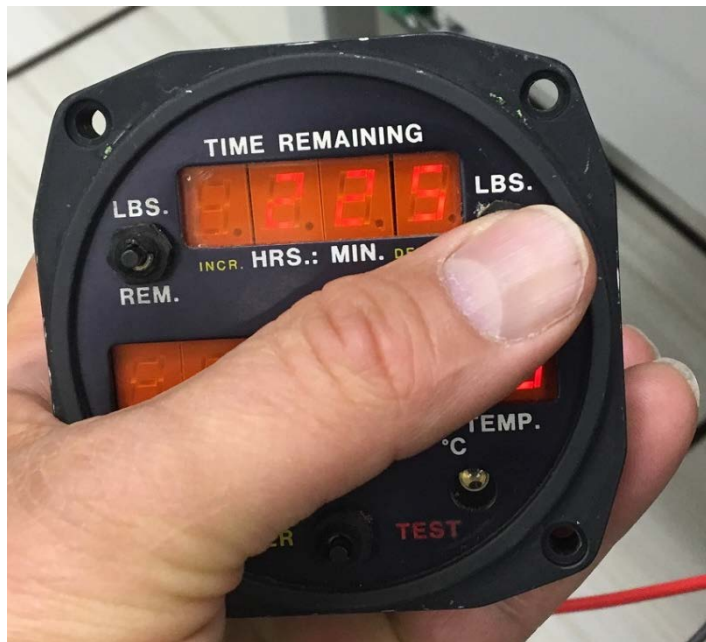
Figure 3. "Lbs. Used" button pressed.
